*The Ohio Department of Transportation
Office of Research & Development
Executive Summary Report*

Dynamic Load Environment of Bridge Mounted Sign Support Structures

Report Number: ST/SS/05-002

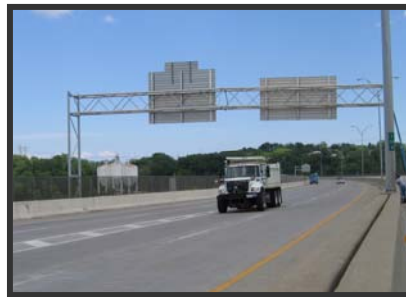
A bridge-mounted welded aluminum sign support structure suffered a fatigue failure on Interstate Route 77, just south of Cleveland, OH. The sign support structure was a 72 foot span, bridge-type, four chord space truss, comprised entirely of tubular members. The failure was

located at a diagonal to chord joint, initiating at the weld toe and progressing completely around the circumference of the chord until fracture of the chord member occurred.

The welded aluminum space truss indicated a typical fatigue failure, with a fatigue crack initiating at a welded chord/diagonal connection detail (AASHTO fatigue category ET). Fatigue testing in the laboratory of surviving segments of the structure produced an identical fatigue failure at a similar location after 3,000,000 load cycles at a nominal 1 ksi stress amplitude.

A policy of frequent inspection of bridge-mounted aluminum sign support structures would seem warranted. These structures are potentially subjected to many more vibration cycles than their ground-mounted counterparts.
