# Investigation of the Dayton IR 75 Sign Truss Failure of 9/11/06

**Arthur Huckelbridge, D.Eng., P.E.  
&  
Andrew Metzger, P.E.**

**Department of Civil Engineering  
Case School of Engineering**

Report for the Ohio Department of Transportation  
Office of Traffic Engineering  
ODOT Agreement Number 14237

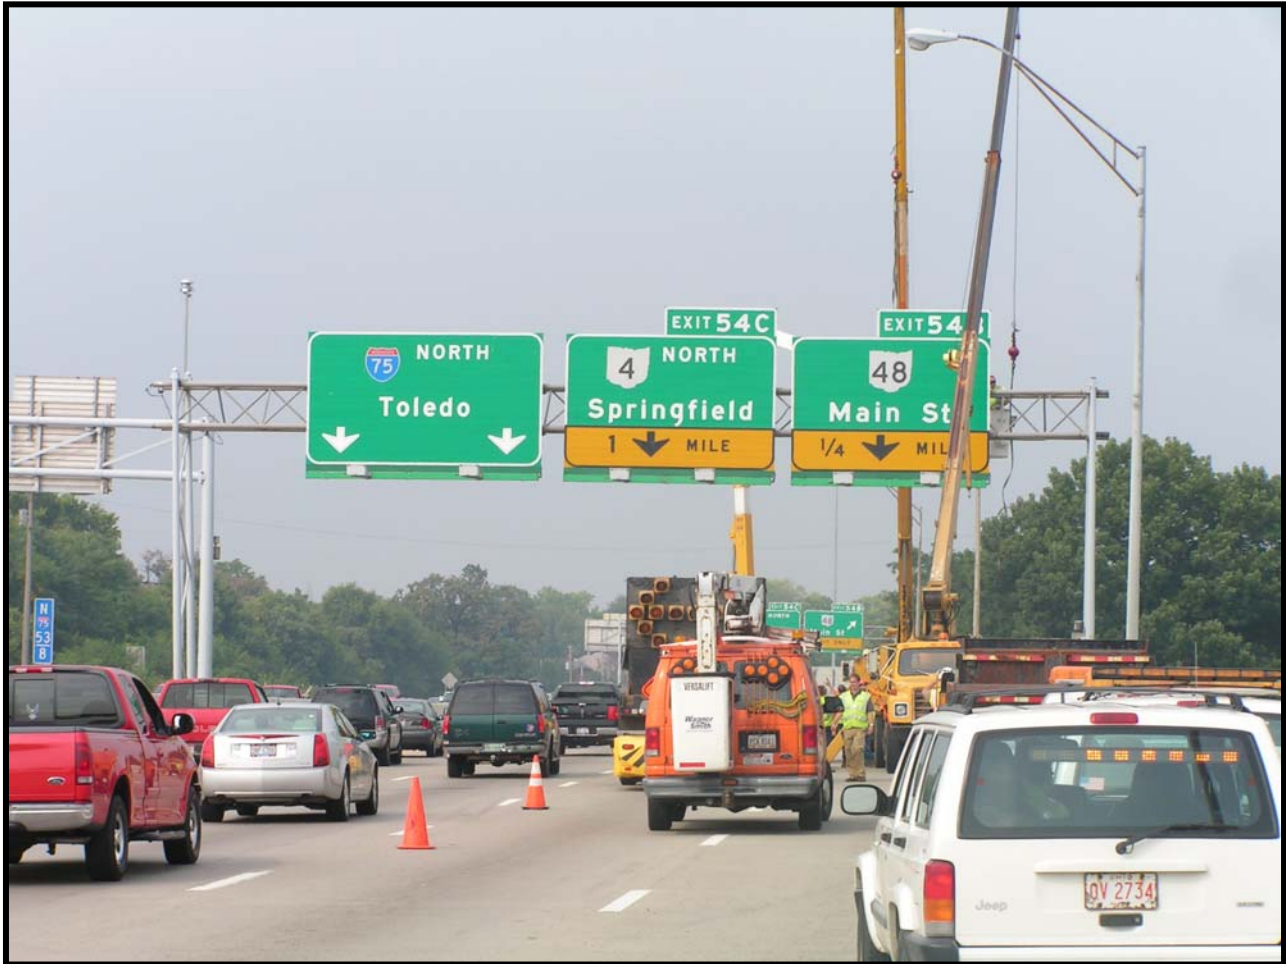
**Figure 3: Sign Truss at the Time of Its Removal**

The sign truss carried a payload consisting of 3 signs (see Figure 3), totaling approximately 468 ft<sup>2</sup> of signage, weighing approximately 1170 lbs. Allowing for lighting hardware, wiring, etc., it was presumed, for the dynamic vibration analysis of the sign truss, that it carried a total payload of 1500 lbs. The design of this stretch of IR75 was completed in 1963; for the fatigue analysis of the sign support truss, the time in service, at the time of failure, was assumed to be approximately 40 years. The observed failure consisted of the complete fracture of a bottom chord member near the eastern end of the truss and the pullout of an adjacent web diagonal member from the diagonally opposite top chord member (see Figure 4).

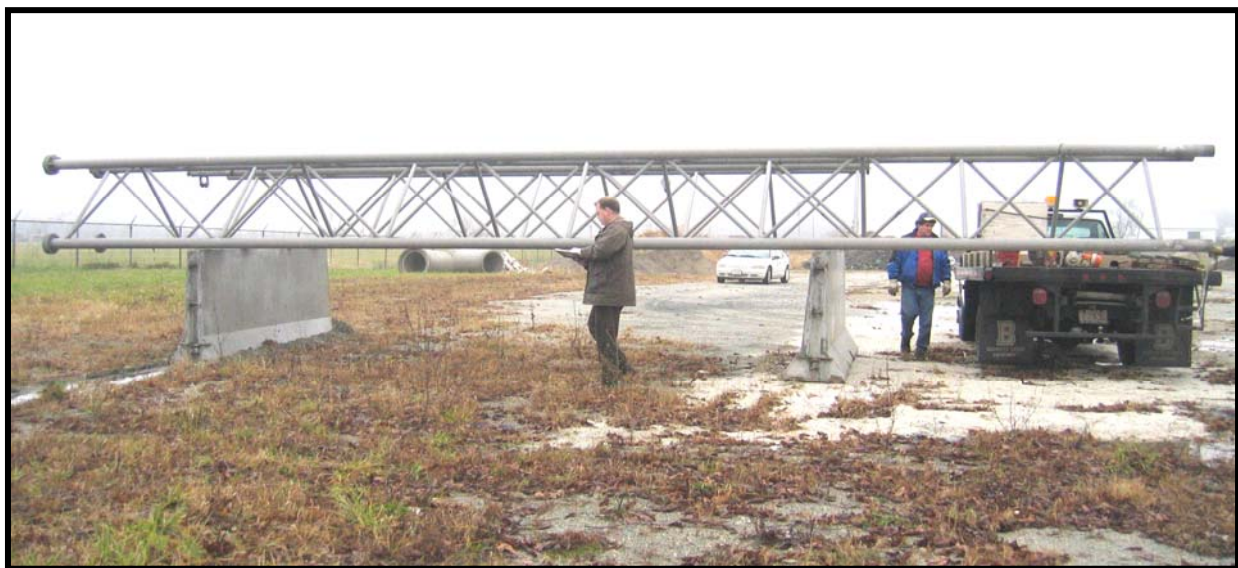
**Figure 5: Remnants of Sign Truss at the District 7 Dixie Outpost**

On Thursday, November 16, 2006 the authors viewed the remnants of the failed sign structure at the District 7 Dixie Outpost, where it had been stored since its removal from the Dayton IR75 Bridge. The truss at this time had been separated into two separate segments at the flanged midspan chord splices, and the signage had been removed (see Figure 5).

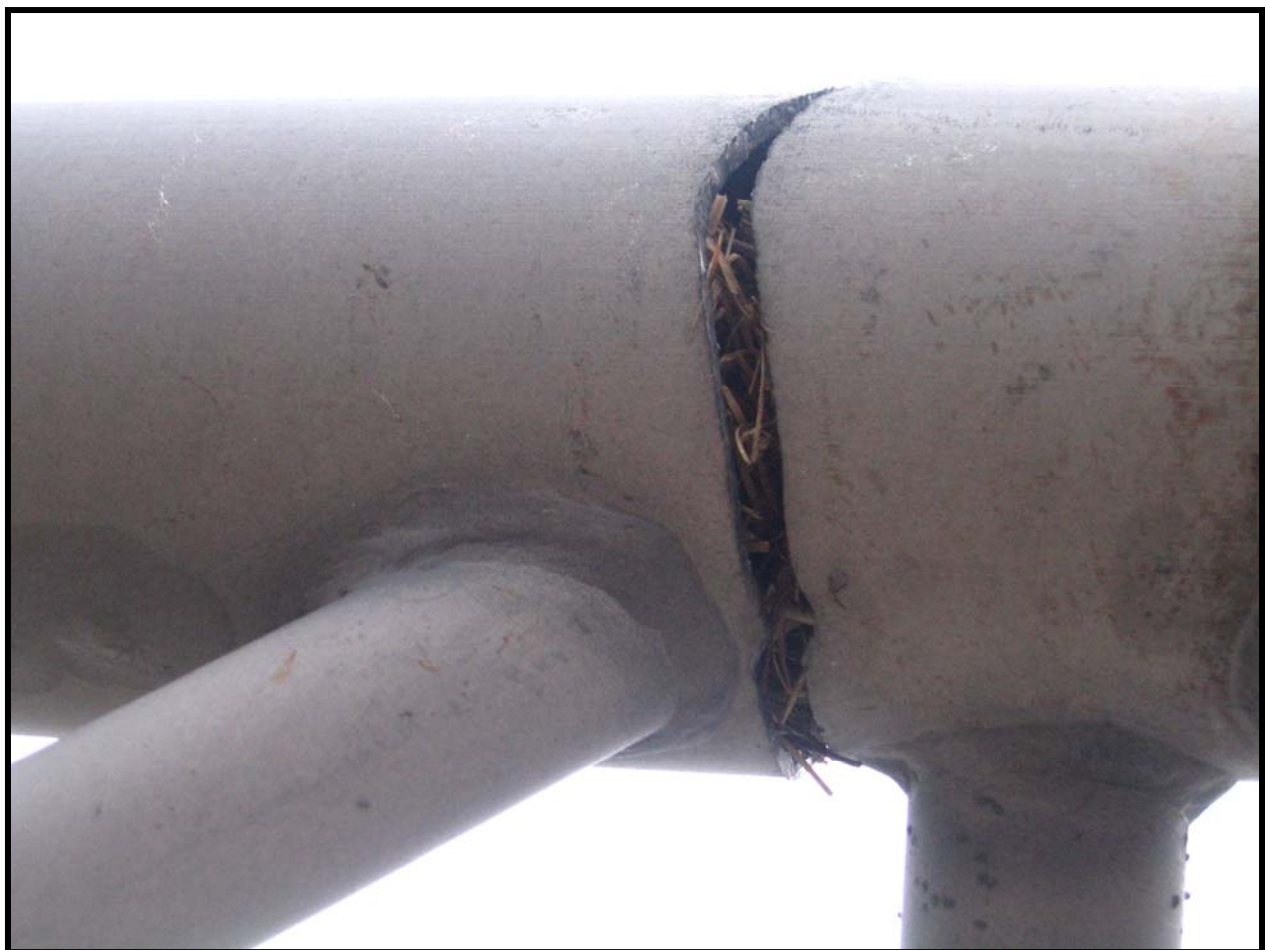
**Figure 6: Close-Up View of Fractured Lower Chord Section**

Close-up views of the fractured chord are shown in Figures 6 and 7. The crack obviously propagated completely around the circumference of the chord cross section, passing closely to, but not actually contacting, the toe of the fillet weld of the diagonal/chord connection. This type of tubular chord to tubular diagonal welded connection is categorized as an AASHTO category ET fatigue detail, in the *Standard Specification for Structural Supports for Highway Sign, Luminaire and Traffic Signals* (AASHTO, 2001).

Category ET is lowest of the AASHTO fatigue categories in the *Sign and Luminaire* specification, assigned a constant amplitude fatigue limit (CAFL) of only 0.44 ksi (axial stress measured in the diagonal) for aluminum members. The CAFL criteria published in the AASHTO *Sign and Luminaire* specification is intended to provide for adequate fatigue lifetimes in the normal wind load environment to which sign and luminaire support structures are subjected. The traffic-induced seismic fatigue environment, to which bridge-mounted sign and luminaire support structures are subjected, however, is not specifically addressed in the specification.

The one somewhat puzzling aspect of the lower chord fracture, namely that the fracture passed near the weld toe but not actually contacting the weld toe, does not appear to be particularly significant. The fracture did indeed pass close to the weld and certainly within the heat affected zone of the weld. The fracture surfaces were too abraded to positively identify the initiation point; small cracks were identified within the weld, however. The original flaw which eventually propagated and produced the rupture apparently, in this case, just happened to be near the weld rather than in the weld.

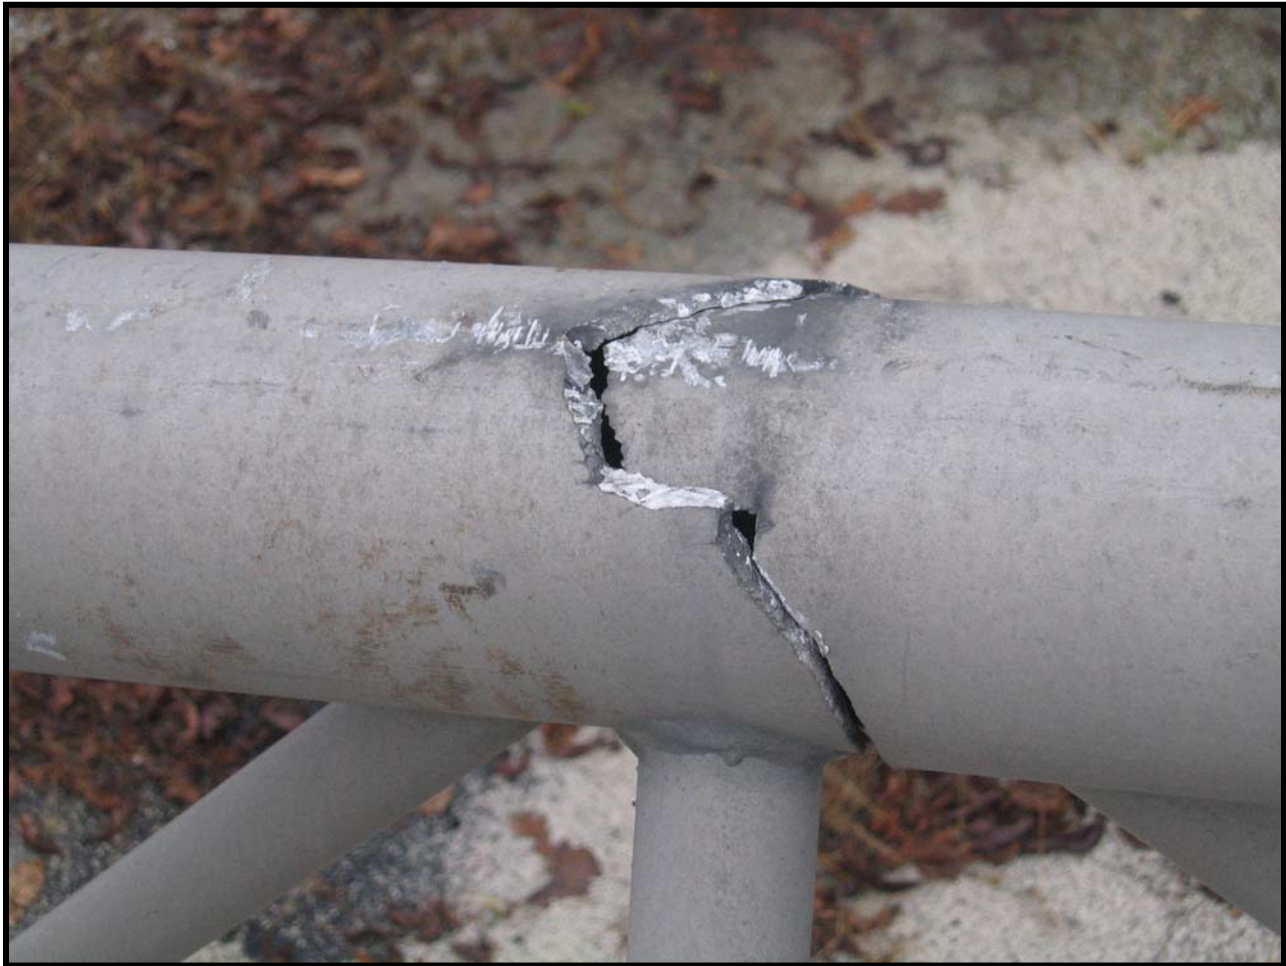
**Figure 7: Additional Close-Up View of the Fractured Lower-Chord Connection**

The fracture surfaces shown in Figure 7, in particular, appear to be rather badly abraded, presumably from impacts and rubs suffered during the load cycles after the crack initiated and while it propagated to the point of failure. Nevertheless sections of both the upper and lower chord members and connecting diagonals at the failure locations were removed for later microscopic metallurgical examination and analysis at CWRU. The upper chord failure surface, shown more closely in Figure 8, did obviously pass through the chord/web diagonal welded connection.

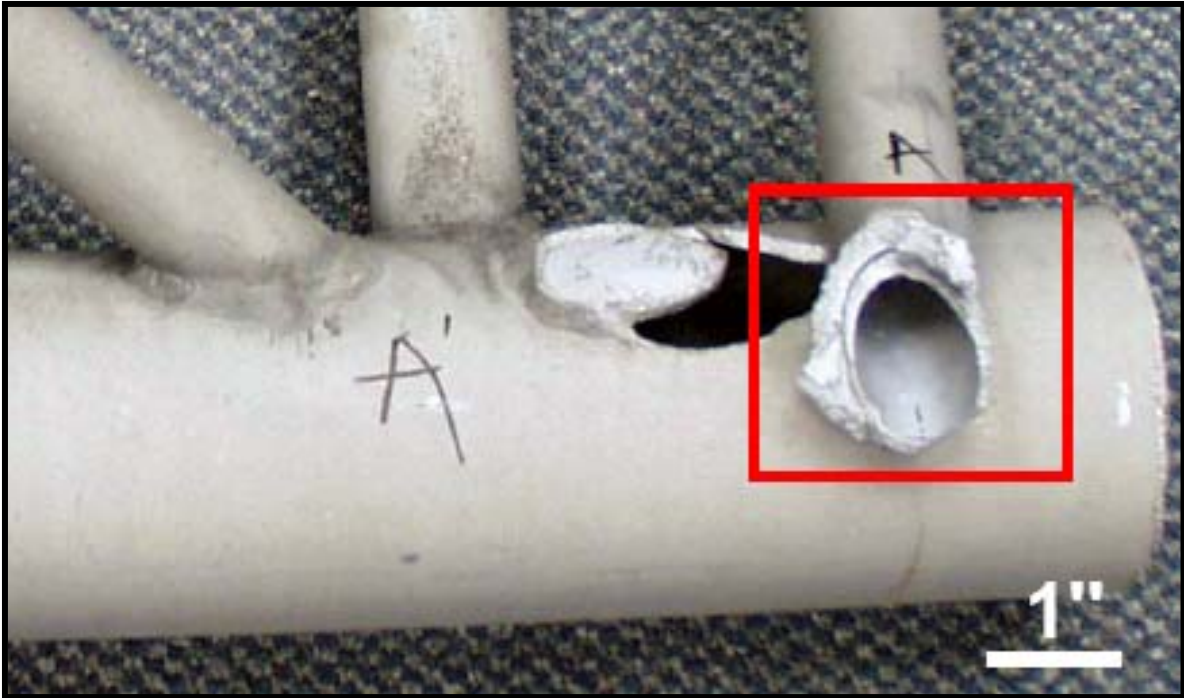
Figure 18: Metallurgical Sample Taken From Upper Chord of Failed Truss

Figure 18 shows the sample examined from the upper chord, designated sample A. A higher magnification optical view of failed member A (boxed region in Figure 18) is shown in Figure 19. Higher magnification optical views shown in Figure 19 clearly reveal the presence of fatigue beach marks in the weld region. Also highlighted in Figure 19 is the presence of various regions of porosity in the weld of sample A.

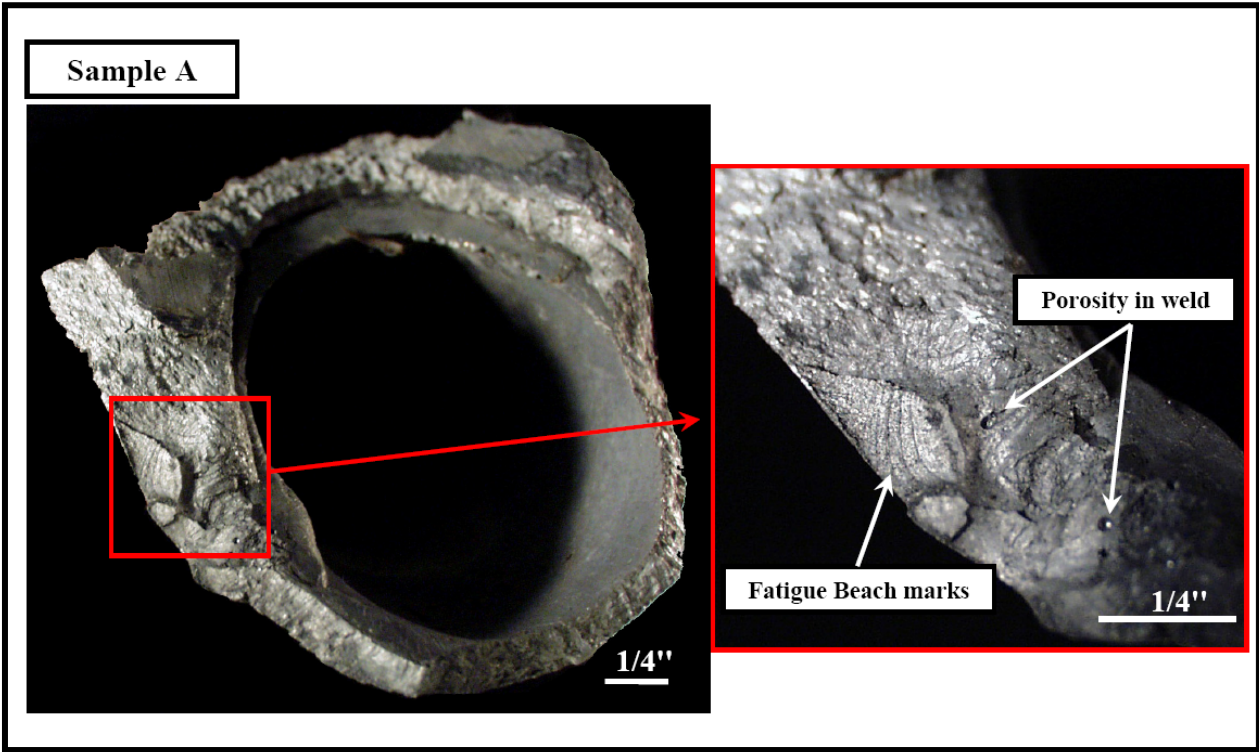
Figure 19: Higher Magnification Views of Boxed Region of Figure 18

Fatigue is clearly responsible for the failure. The presence of porosity in the weld of Sample A could also affect the mechanical behavior of the weld in Sample A. The location of the failure in Sample B occurred somewhat removed from the weld region. Preliminary exam of these regions showed a sub-critical crack in the weld and nothing remarkable in the region of failure in the base metal of tube B.

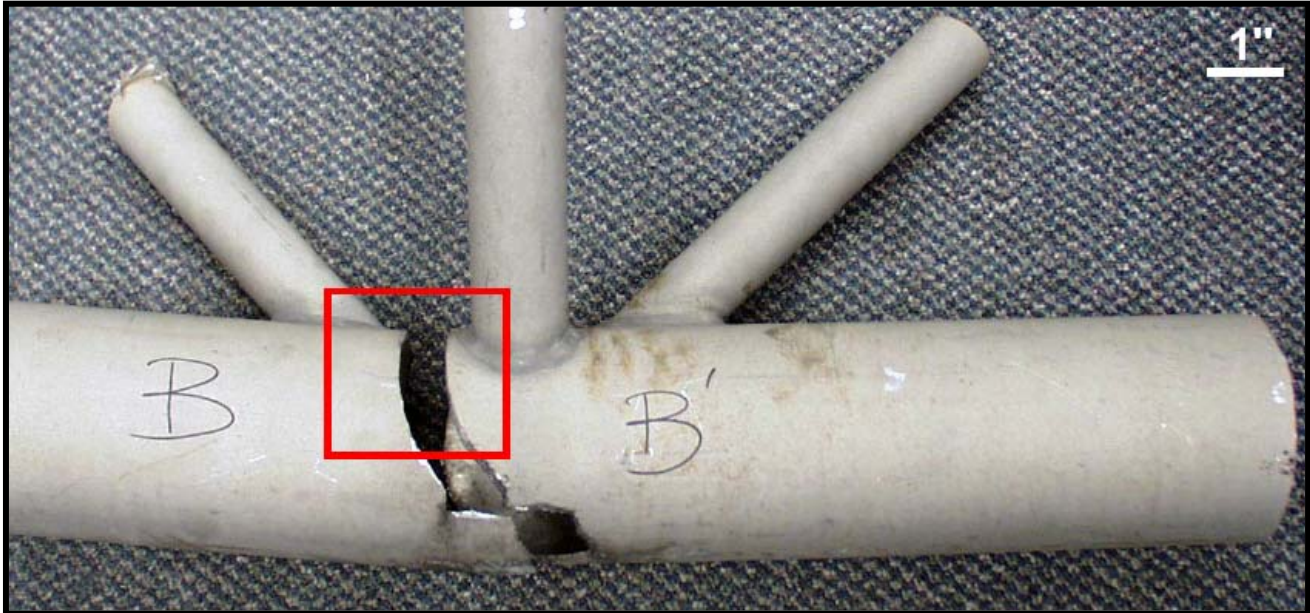
**Figure 20: Sample B Taken From Failed Truss Lower Chord**

Figure 20 (boxed region) shows the regions investigated for sample B, taken from the lower chord of the truss. Failure adjacent to the weld, in the base metal, was exhibited by failed member B as shown in both Figure 20 and 21. Higher magnification views of the failed tube in Figure 21 could not reveal any characteristic features of the fatigue progression, as the fracture surfaces had been destroyed by their continued contact and rubbing together during the failure (propagation) process.

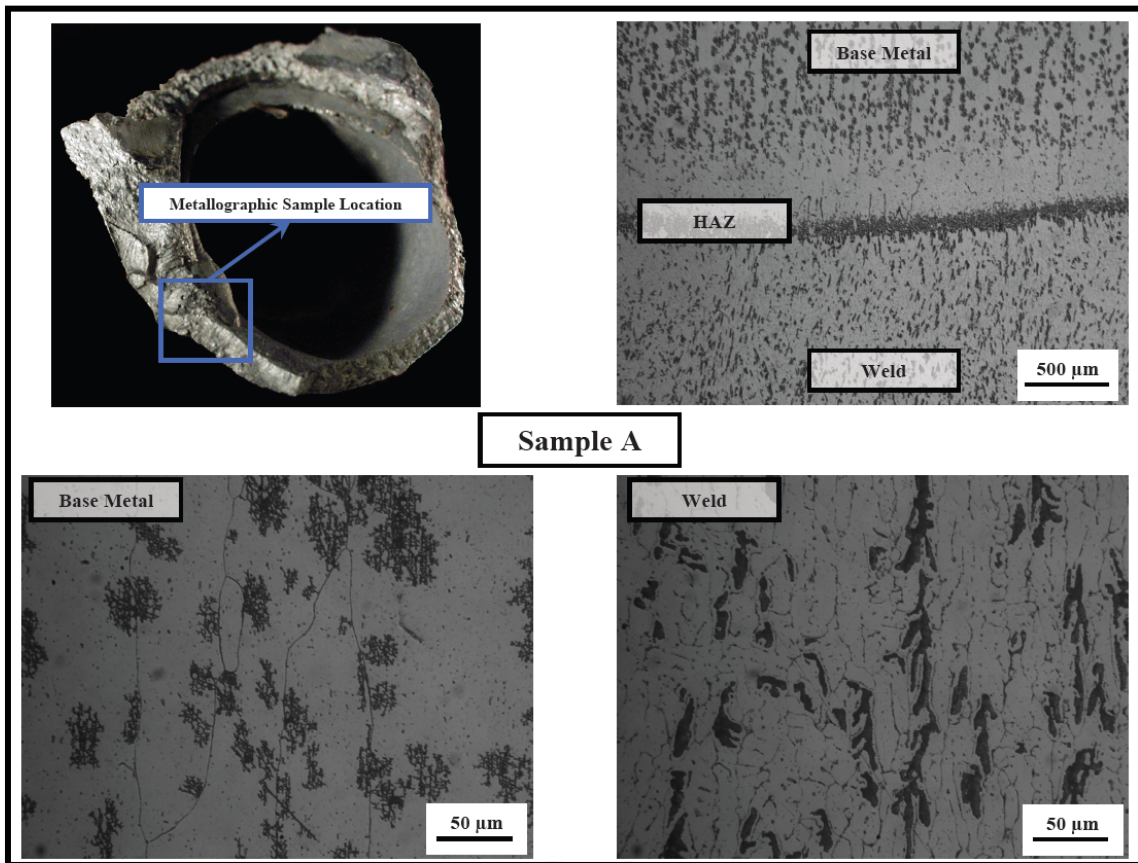
Figure 22: Metallographic Sections From Sample A (Upper Chord)

Metallographic sectioning was conducted to examine the weld metal, base metal, and heat affected zone (HAZ) of sample A as shown in Figure 22. Representative microstructures are shown in the various regions. The base metal exhibited a somewhat large grain size in all areas examined. Figure 23 shows a similar analysis for Sample A' for an intact weld/strut combination. Clear evidence of porosity in the weld is shown both in the as-sectioned (top right) and polished (bottom left and right) photos.

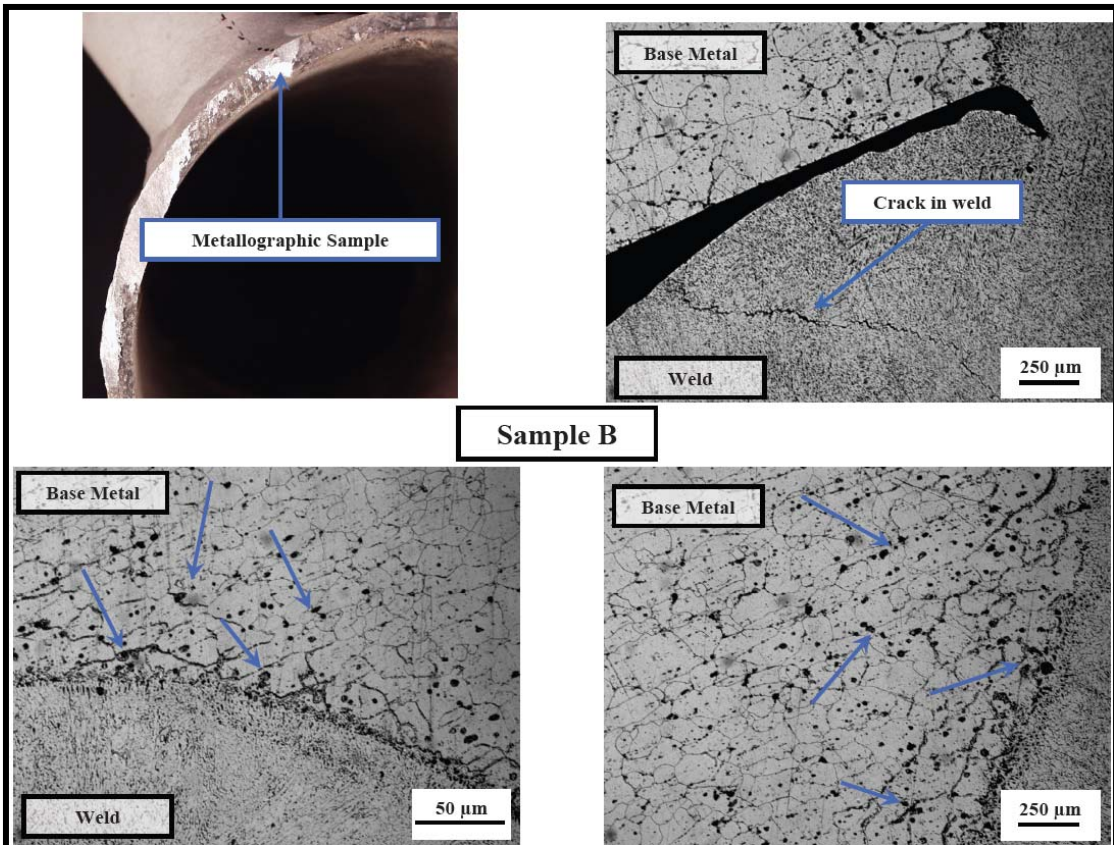
**Figure 24: Metallographic Sections  
From Sample B (Lower Chord)**

Metallographic sections taken from failed sample B are shown in Figure 24. A crack in the weld region is shown (top right) while the weld and base metal are shown in the bottom two photos. Figure 25 provides a similar analysis for Sample B'. Porosity is again evident in the weld region (top right photo), while metallography of the weld and base metal is shown in bottom left photo. The photo on the bottom right compares the microstructure present in the smaller tube (left) to that of the larger tube (right), showing that the grain sizes are similar.
