## **Investigation of Subsidence Along Segment of Missouri Route 65, Springfield, Missouri**

Neil L. Anderson and Evgeniy V. Torgashov

**NUTC  
R221**

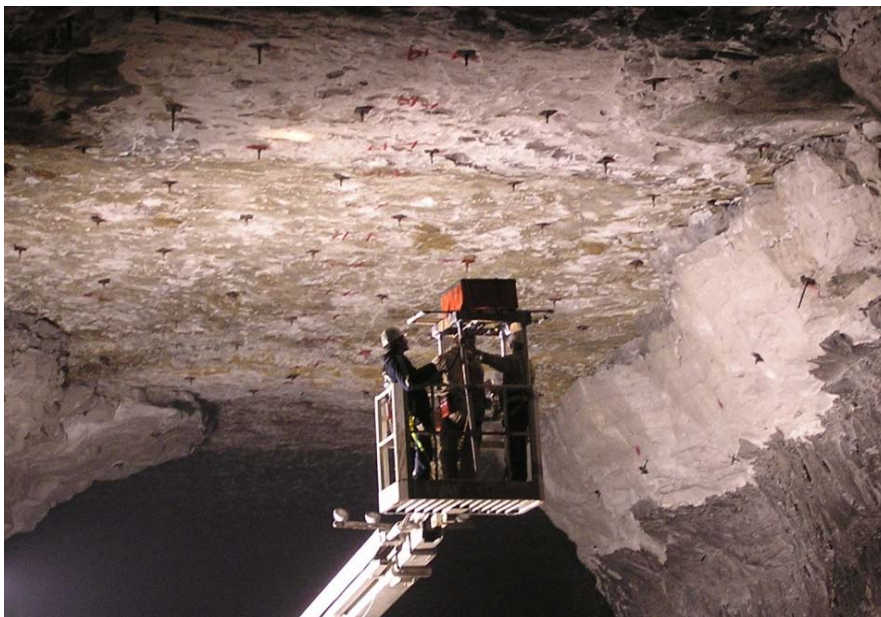
To prevent further rock fall, anchor bolts were installed immediately in the ceiling of the access tunnel (Figure 2). During the installation of the anchor bolts, workers encountered uniform Burlington-Keokuk limestone; there was no evidence of prominent clay-filled solution-widened fractures (Figures 2 and 3). However, water with entrained sediment flowed through several narrow fractures (estimated widths of less than 0.25 in) in the collapse zone (Figure 4). It was noted that the fractures through which water flowed were oriented east-northeast, rather than northwest (parallel to the projected lineament).

**Figure 2:** Photograph of ceiling of access tunnel several tens of feet to the west of the zone of failure. Newly installed rock bolts are observed. The crew is acquiring GPR data using a 200 MHz GSSI antenna in an effort to locate clay-filled solution-widened fractures.

The apparent relative uniformity of the roof rock immediately above the ceiling of the access tunnel is consistent with anchor bolt information and acquired ground penetrating radar (GPR) control. The workers who placed the anchor bolts reported relatively solid rock to depths of 10 ft at all anchor bolt locations. The interpretation of acquired GPR control also suggests the roof rock within 10 ft of the ceiling is not intensely karsted. On the GPR profile of Figure 7, a relatively uniform near-horizontal reflector (parallel to mine ceiling) is imaged at an estimated depth of about 10 ft (dielectric permittivity of 15 for moist limestone). Two less prominent vertical anomalies are observed centered at stations 39 and 46 (collapse zone). These anomalies appear to originate several feet from the mine ceiling and may be images of near-vertical fracture zones that are not prominently exposed on the mine ceiling.

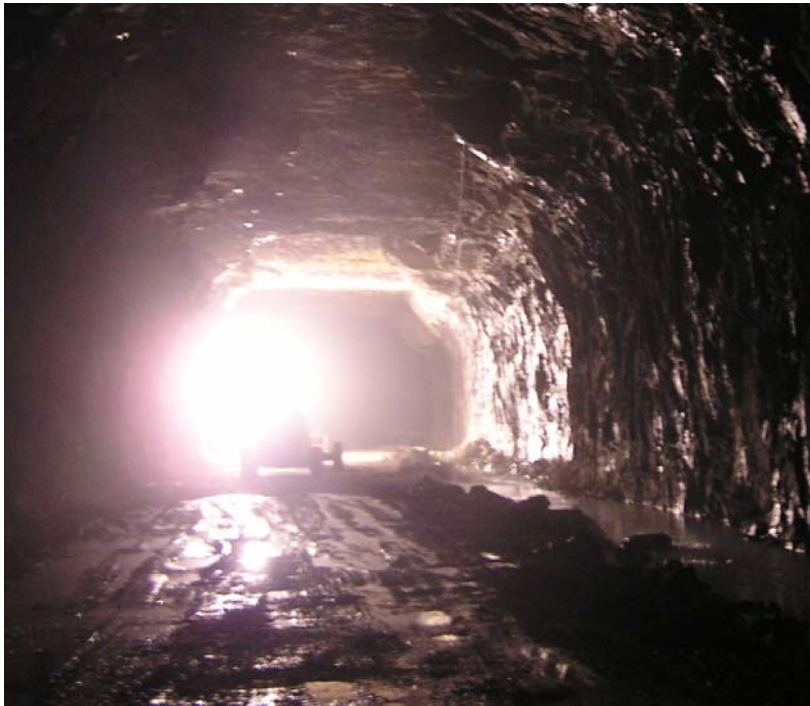
**Figure 4:** Water, with entrained sediment, flowed from several newly-exposed linear fractures in the collapse zone.

The Burlington limestone is “room and pillar” mined in the study area. The ceiling of the access tunnel (connecting mined areas on either side of the roadway; Figure 1) is at a depth of about 80 ft relative to the ground surface (elevated embankment). The ceiling of the access tunnel is not characterized by prominent solution-widened fractures. However, water, with entrained sediment, flowed freely from several newly-exposed linear fractures (estimated widths of less than 0.25 in) in the collapse zone.

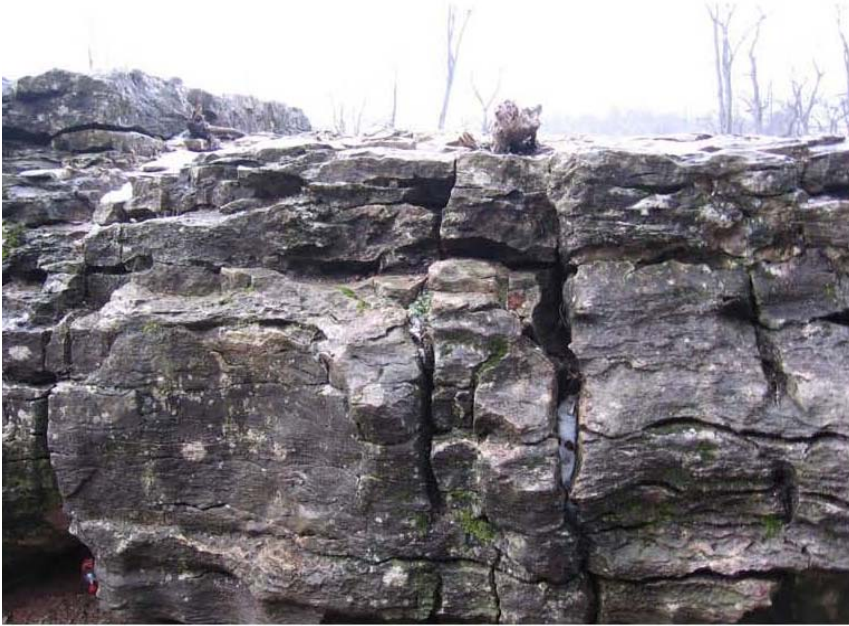
The shallow subsurface in the study area is comprised of a thin veneer of residuum (0-20 ft) overlying Mississippian Burlington-Keokuk limestone (Figure 2). The limestone, where it outcrops, is intensively jointed and faulted (Figure 5). Faults and lineaments in the Greene County tend to strike approximately northwest or northeast (Figure 6).

**Figure 5:** Outcropping Burlington-Keokuk limestone is typically dissected by solution-widened joints or faults. The ceiling of the access tunnel in underground limestone (~100 ft below the ground surface) is not characterized by prominent fractures (Figure 2).

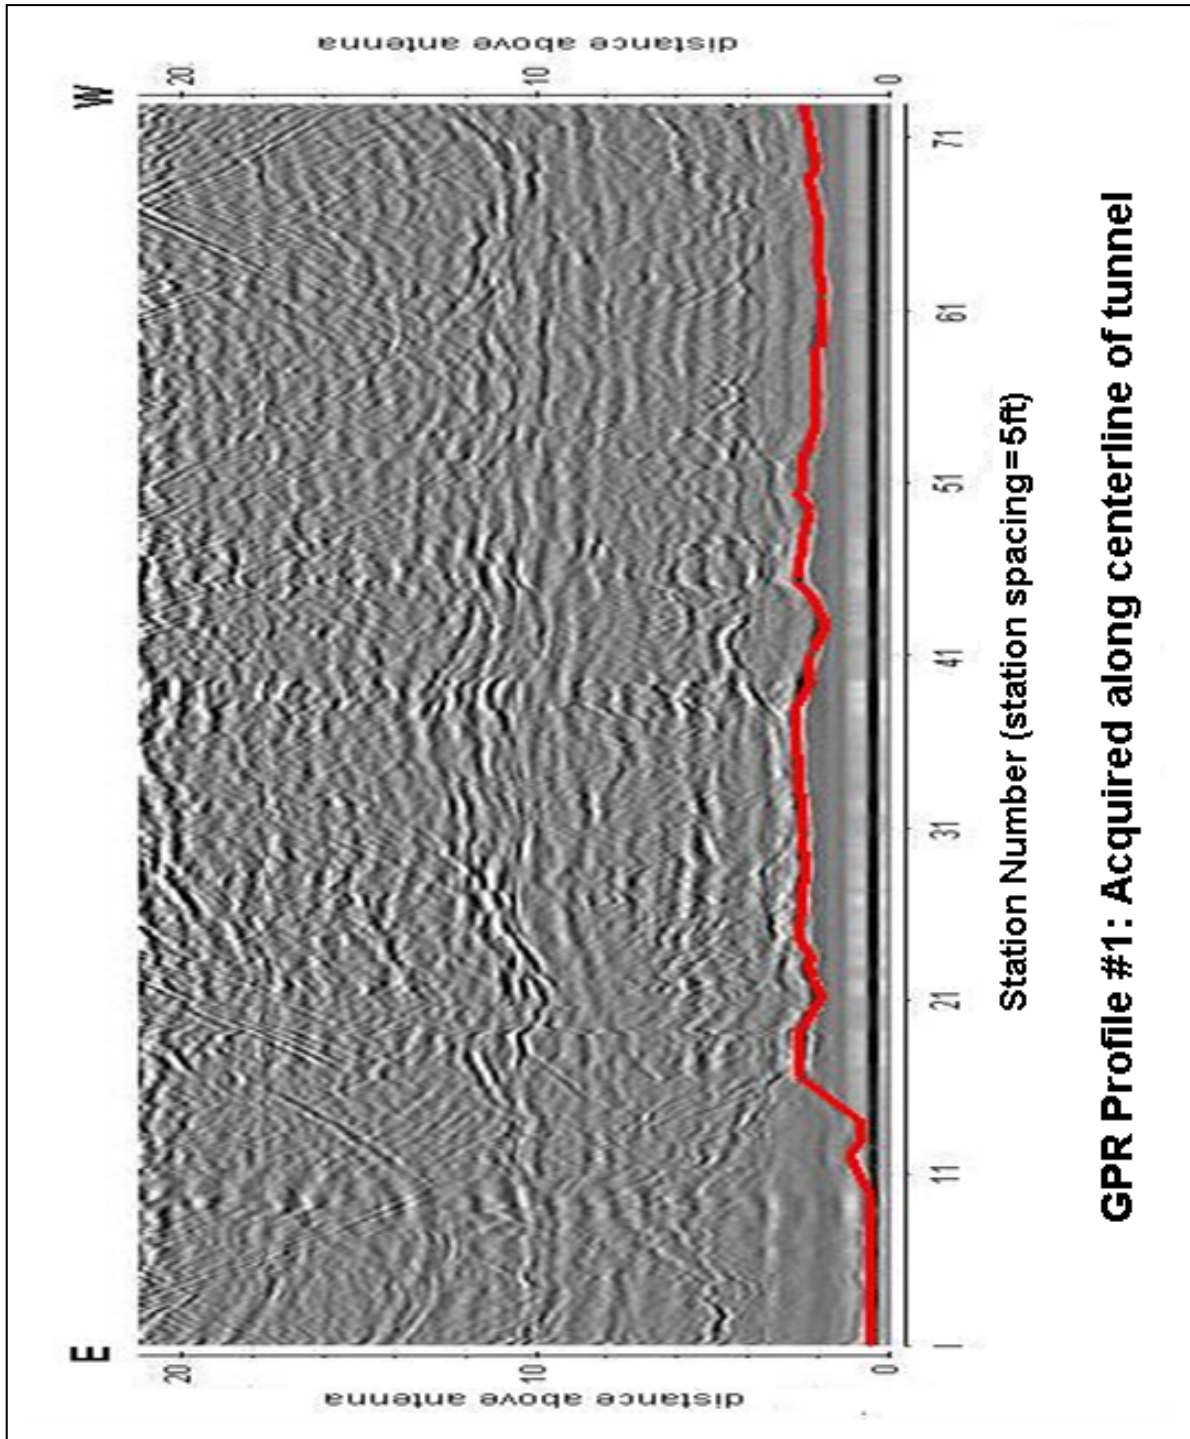
**Figure 7:** Example GPR profile (length ~370 ft) acquired along centerline of access tunnel ceiling using a GSSI 200 MHz antenna. The vertical axis is in feet; the lower continuous red line represents the surface of the ceiling. The apparent effective depth of investigation (highest prominent continuous reflector) is at least 10 ft.

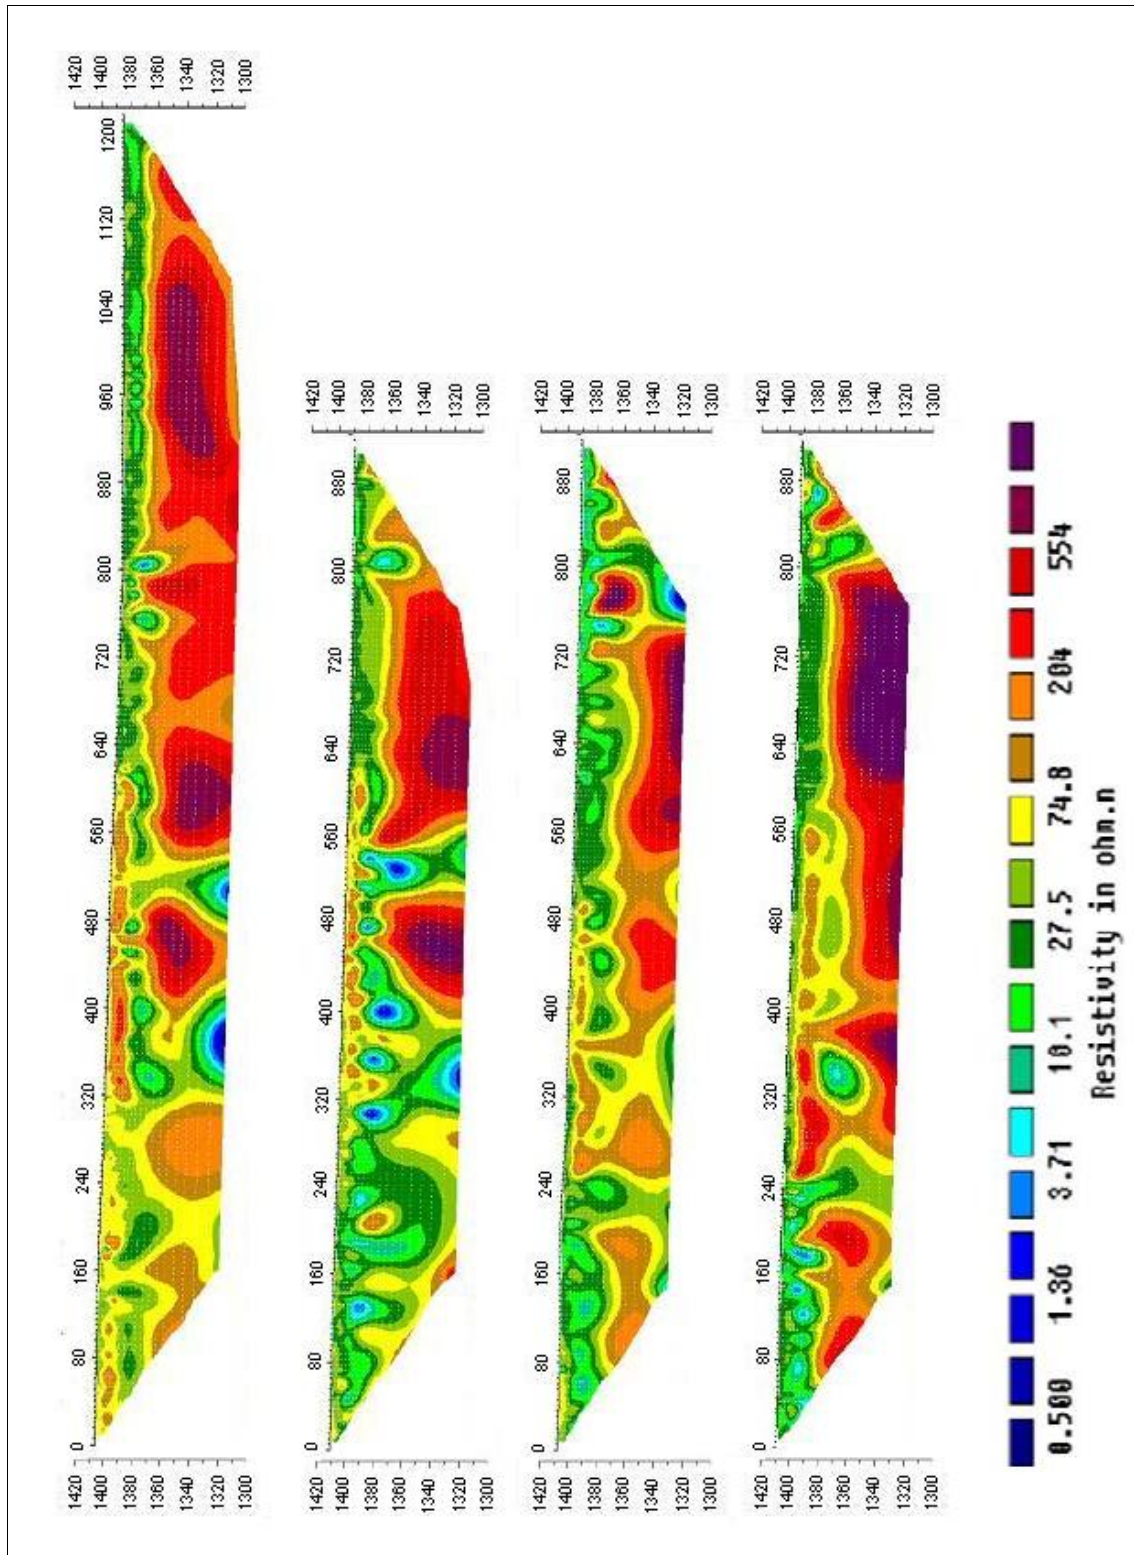
To the south of Station 600, bedrock does not appear to have been extensively dissected by solution-widened fractures. The top of limestone bedrock, as per borehole control, correlates reasonably well with the 50 ohm-m contour interval (except where interpreted fractures are present). Soil to the south of Station 600 is characterized by resistivities less than 50 ohm-m. (The roadway embankment south of station 600 is elevated by only a few feet. The eastern right of way south of station 600 was largely covered by up to 1 ft or more of ponded water.)

**Figure 8:** Un-interpreted ERT profiles (A-D; bottom to top; Figure 1). Distances and depths are in feet. Station 270 overlies the center of the mine access tunnel on all profiles. The top of the mine access tunnel is about 10 feet below the base of the zone imaged on the ERT profiles.

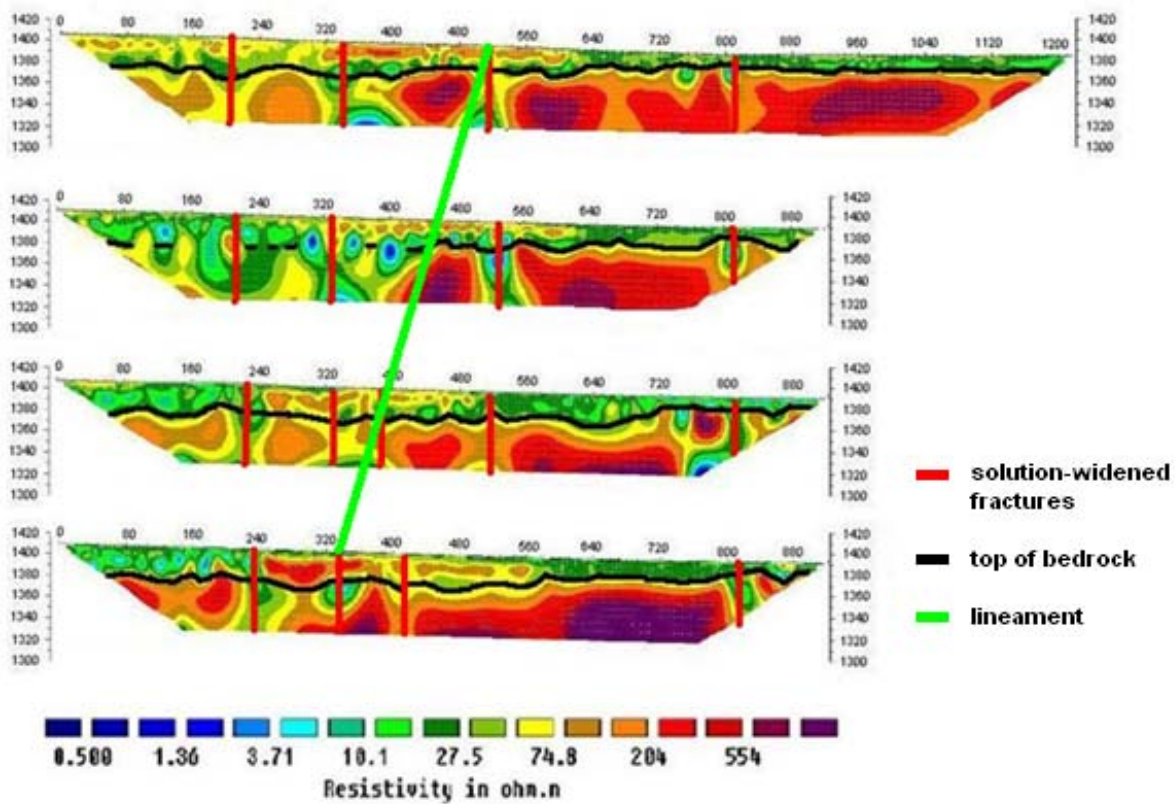
**Figure 9:** Interpreted ERT profiles (A-D; bottom to top; Figure 1). Several prominent interpreted solution-widened fractures and the projected lineament have been superposed on the ERT profiles. Distances and depths are in feet (the horizontal scale is exaggerated so the northwest-trending lineament does not appear to be properly oriented). The top of rock correlates well with borehole control. Station 270 overlies the center of the mine access tunnel on all profiles.

Bedrock to the north of Station 600 is interpreted to be more intensely dissected by solution-widened fractures, so the top of rock, in many places, does not coincide with the 50 ohm-m contour interval (Figure 9). The identification/mapping of top of rock is further complicated because the resistivities of the shallower soils to the north of Station 600 are greatly in excess of 50 ohm-m in places. These higher soil resistivities north of station 600 are attributed to the presence of thicker and drier

In Figure 9, the northwest lineament along which roof failure occurred has also been superposed. (This lineament does not appear to be oriented northwest because the horizontal and vertical axes use different scales.) We note that the projected lineament correlates reasonably well with the locations of interpreted solution-widened fractures and conclude that roof rock failure in the mine access tunnel (and elsewhere) probably occurred along a prominent northwest-trending solution-widened fracture.

Several other prominent interpreted solution-widened fractures have been highlighted on Figure 9. These solution-widened fractures are characterized on the ERT profiles as near-vertical zones of low electrical resistivity (relative to adjacent more intact limestone). The lowered relative resistivity of the fractured rock is attributed to some combination of enhanced porosity and permeability, increased water saturation, and increased clay content. Our inclination is to correlate these features as shown in Figure 10. This interpretation appears to be reasonable based on the ERT images and the observation that waters flowed primarily from east-northeast trending fractures on the ceiling of the access tunnel where failure occurred. This interpretation is also supported by the literature. As shown in Figure 6, the dominant near-orthogonal faults and lineaments in Greene County trend approximately north-northwest and east-northeast, respectively.

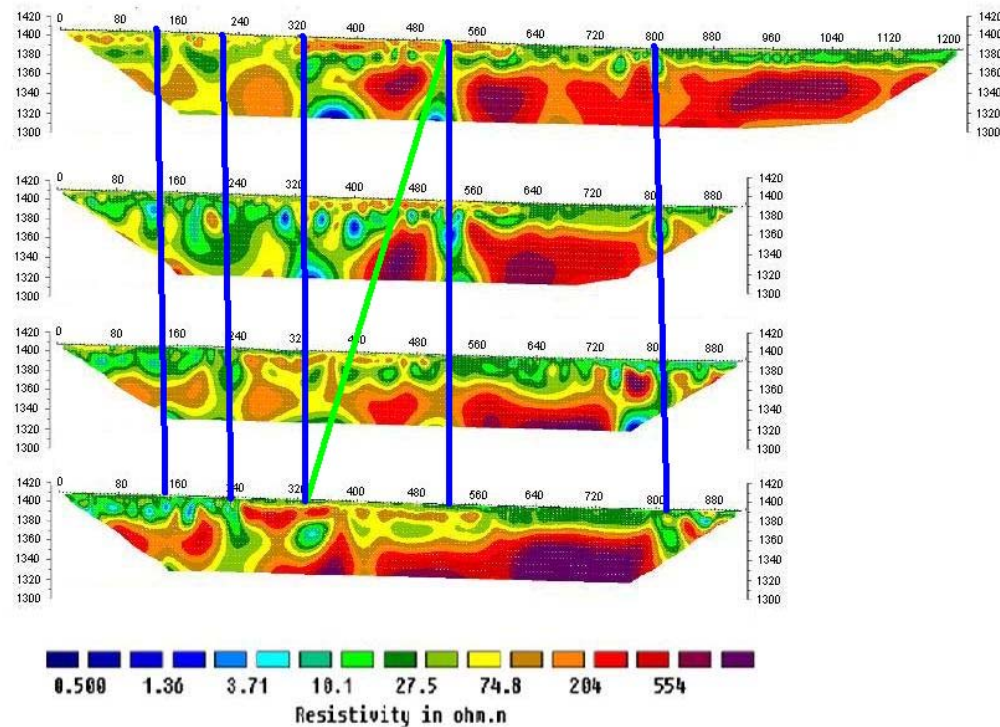
**Figure 10:** Interpreted ERT profiles (A-D; bottom to top; Figure 1). Several prominent interpreted solution-widened fractures (blue) and the projected lineament (green) have been superposed on the ERT profiles. Station 270 overlies the center of the mine access tunnel on all profiles.

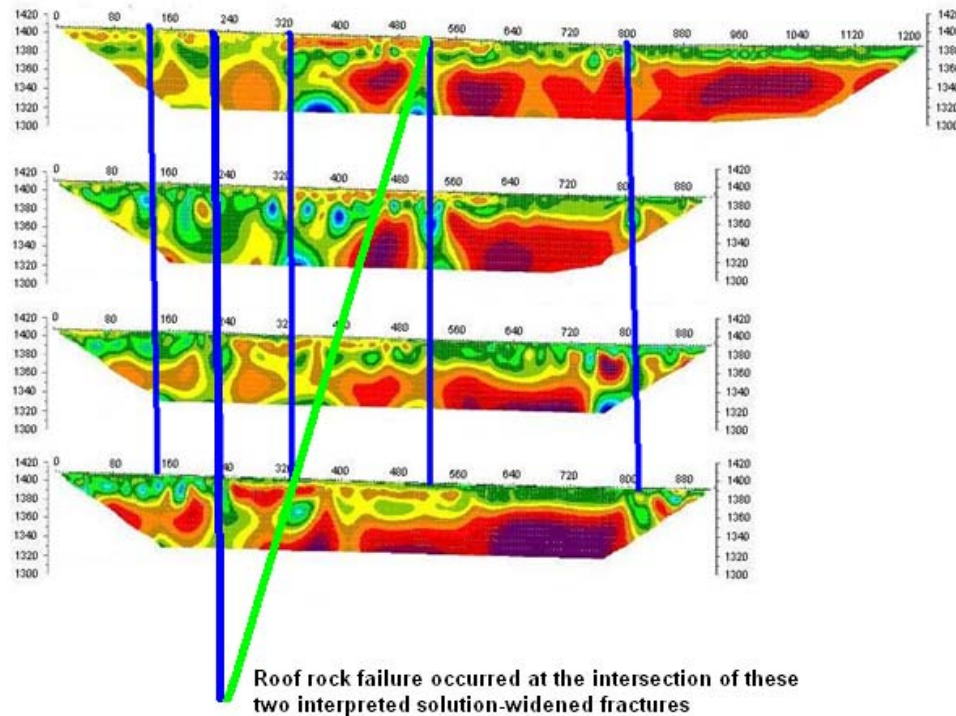
It is interesting to note that roof rock failure in the mine access tunnel occurred at the intersection of projected lineament and one of the more prominent interpreted solution-widened fractures (Figure 11), and speculate this zone was especially susceptible to failure. Similar observations have been reported by Robison and Anderson (2008).

**Figure 11:** Interpreted ERT profiles (A-D; bottom to top; Figure 1). Station 270 overlies the center of the mine access tunnel on all profiles. Roof rock failure in the mine access tunnel occurred at the intersection of the projected lineament (green) and one of the more prominent interpreted solution-widened fractures (blue).

Roof rock failure on the ceiling of the mine access tunnel appears to have occurred at the intersection of a two prominent solution-widened fractures: one trending northwest; one trending east-northeast. This intersection zone was probably most susceptible to failure.
