1. Report No. FHWA/TX-10/5-4687-01-1		2. Government Accession No.		3. Recipient's Catalog No.	
4. Title and Subtitle RUBBLIZATION AND BASE OVERLAY OF FM 912 AND FM 1155		5. Report Date October 2009 Published: January 2010		6. Performing Organization Code

# **RUBBLIZATION AND BASE OVERLAY OF FM 912 AND FM 1155**

Report 5-4687-01-1  
Project 5-4687

Project Title: Pilot Implementation of Rubblization for Rehabilitation of Concrete Pavements

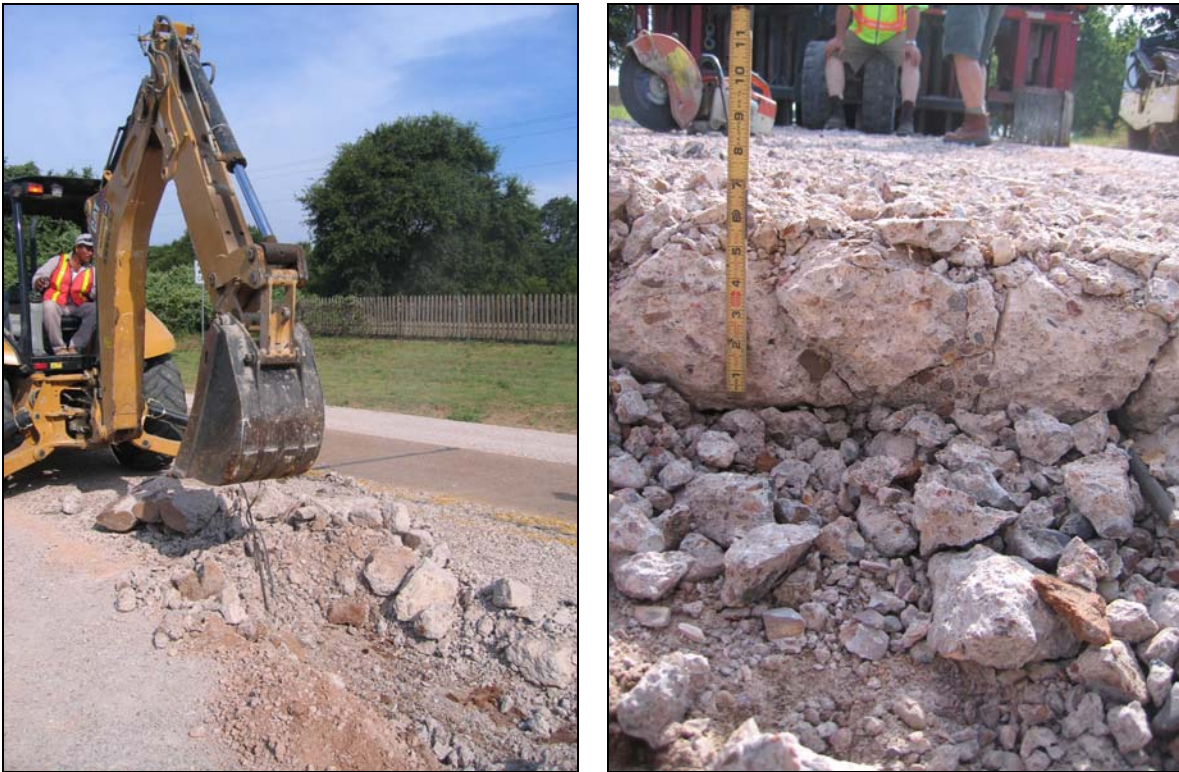
After rubblizing approximately 200 feet, the contractor excavated the first test pit. Obtaining entry into the concrete with the back hoe proved difficult, indicating that the concrete still maintained a high degree of interlock. Figure 2.2 shows both a surface and cross-section view of the test pit. Although the break pattern appeared acceptable from the surface, the test pit revealed that the particle size distribution did not meet the specification. The specification required all particles in the top half of the slab to be less than 6 inches, with at least 40 percent under 3 inches. The test pit revealed only the top 1.5 to 3 inches of the slab were fractured to this particle size distribution.

**Figure 2.2. Surface and Side View of Test Pit with Type II Rubblization.**

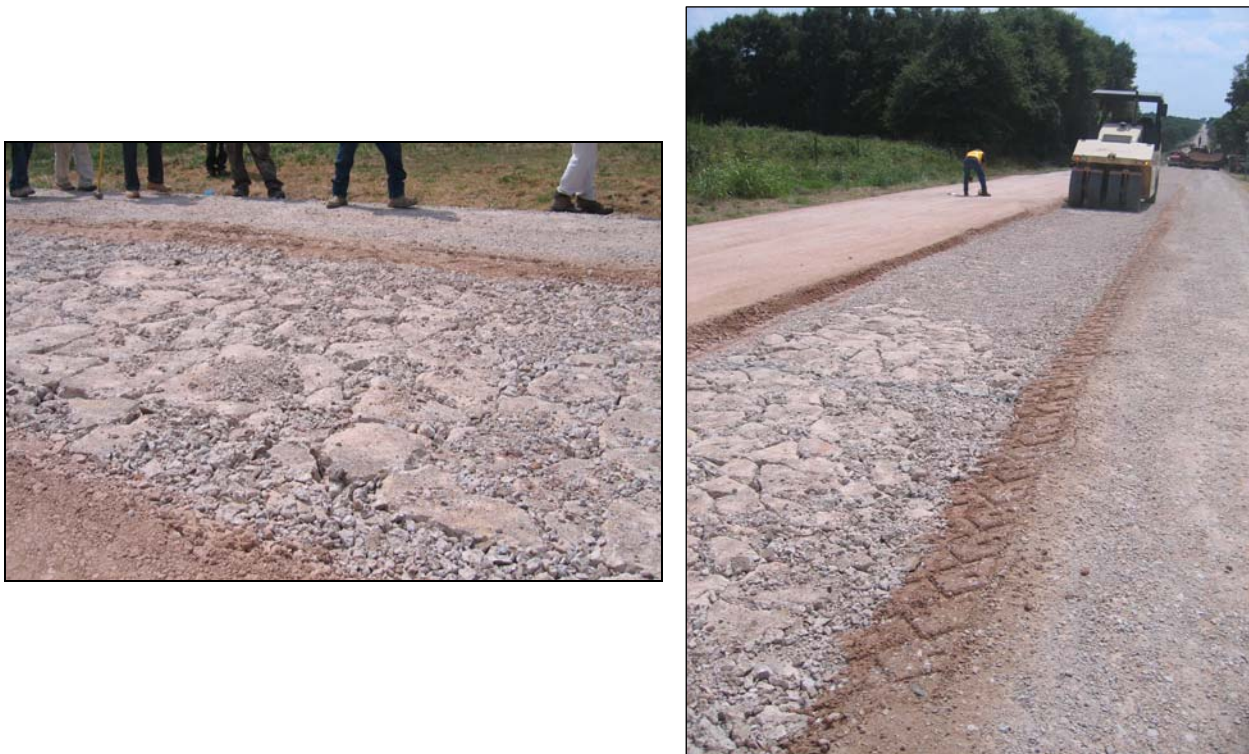
As an example, Figure 2.3 shows a location where the break pattern significantly shifted. Large concrete blocks, typically 12 inches in size or larger, remained visible at the surface after rubblization. The photo on the right in Figure 2.3 illustrates the drastic difference in break patterns between the suspect location (foreground), and a normal area.

**Figure 2.3. Poor Break Pattern at Unstable Location.**

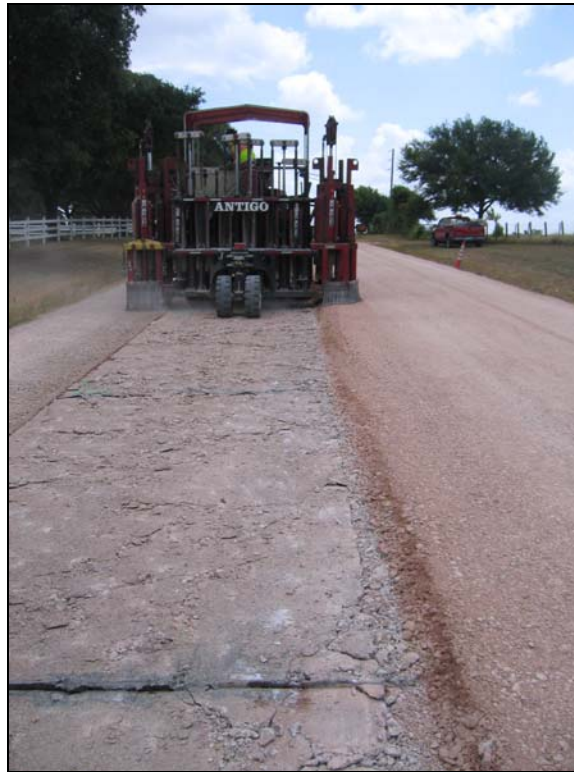
Clearly full-depth repair involves extra labor and cost on a project, so after discussion with the TxDOT engineer, the decision was made to utilize a reduced break pattern on sections at high risk of instability after rubblization. Such an approach relies largely on the operator of the rubblizing equipment, who through experience must assess the machine's operation to determine whether a reduced break pattern is necessary. The goal of the reduced break pattern is to adequately fracture the concrete to eliminate slab action, yet retain stability. Such a pattern could be thought of as between crack-and-seat and rubblization. Figure 2.5 shows a section employing the reduced break pattern. Table 2.3 summarizes the locations on the project known to receive the reduced break pattern.

**Figure 2.5. Modified Break Pattern with Type II Rubblization.**

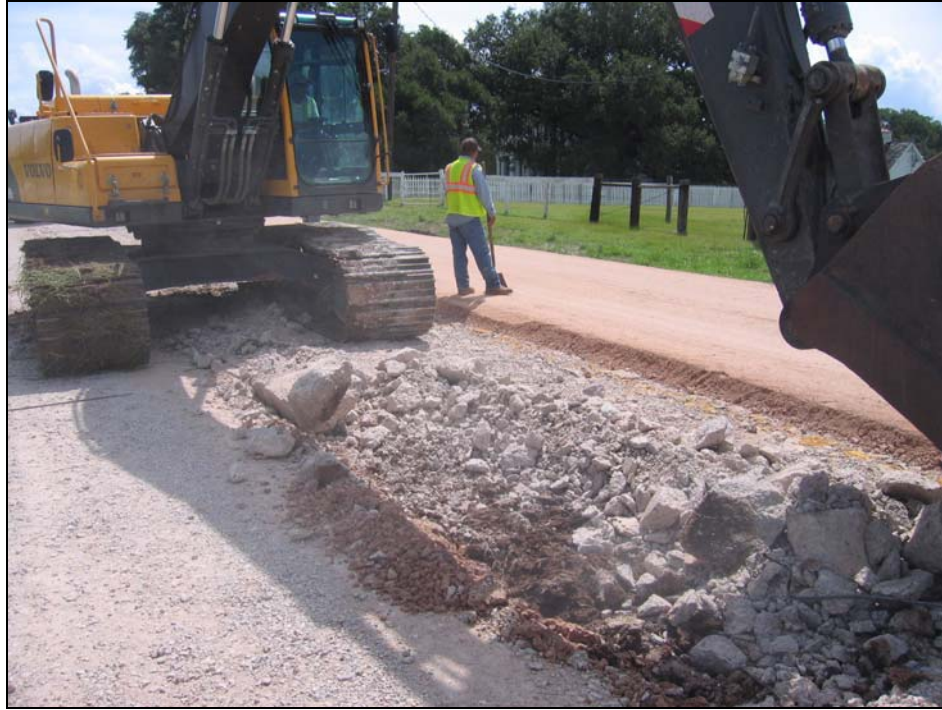
TxDOT elected to not specifically conduct a test pit upon startup of the Type 1 rubblization. Instead, they used the observed break pattern at the first location needing full-depth repair as the test pit. Figure 2.8 shows an excavation of the JCP rubblized with the Type I equipment. When contrasted with the excavation from the Type II equipment shown in Figure 2.2, the JCP rubblized with Type I equipment was easier to excavate and exhibited a finer gradation through the depth profile.

**Figure 2.8. Test Pit with Type I Equipment.**

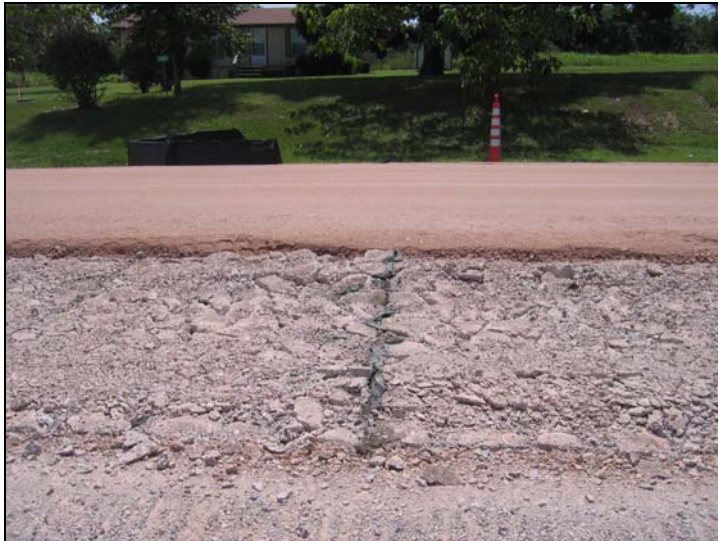
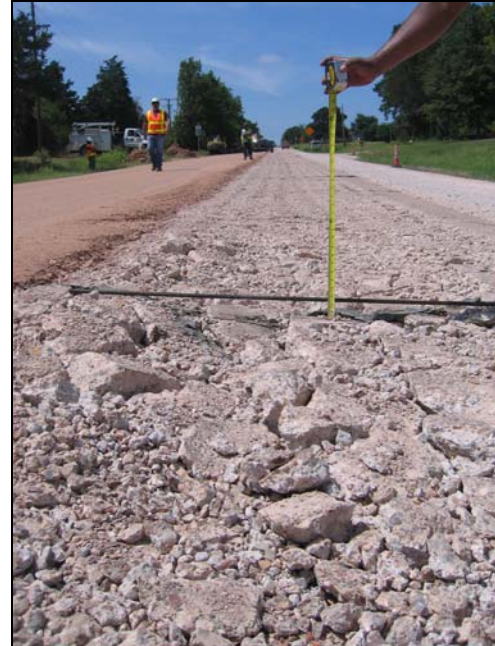
Due to the number of passes the Type 1 rubblizer must perform to break the entire lane width, the machine itself serves as a good proof roller and oftentimes the locations of instability were evident even before rubblizing the entire lane width. However, TxDOT also required a roller on the section after completion of rubblization to finalize the limits of any removal locations. As is typical, many sections of instability also exhibited larger particle sizes after rubblization, and in some cases substantial rutting from the Type I equipment performing passes over the pavement. Figure 2.9 illustrates one such location that required removal.

**Figure 2.9. Example Location Requiring Full-Depth Repair with Type I Rubblization.**

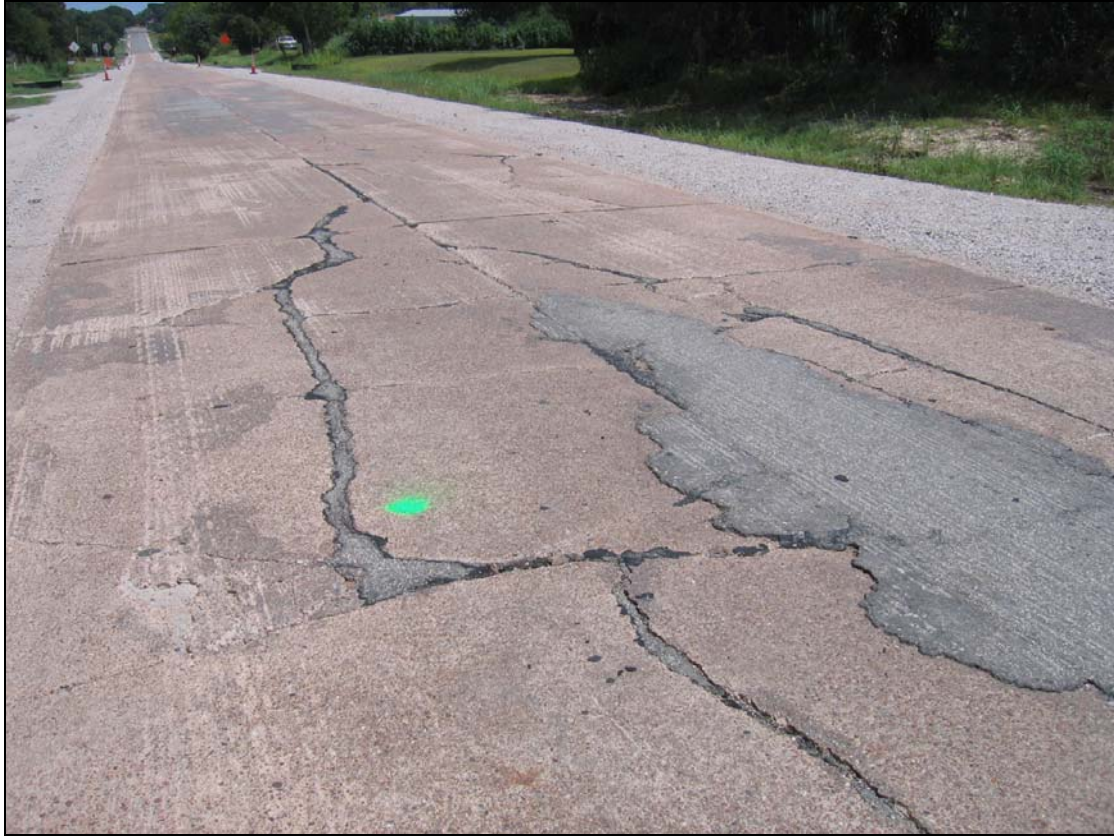
**Figure 2.10. Existing JCP at Station 214.**

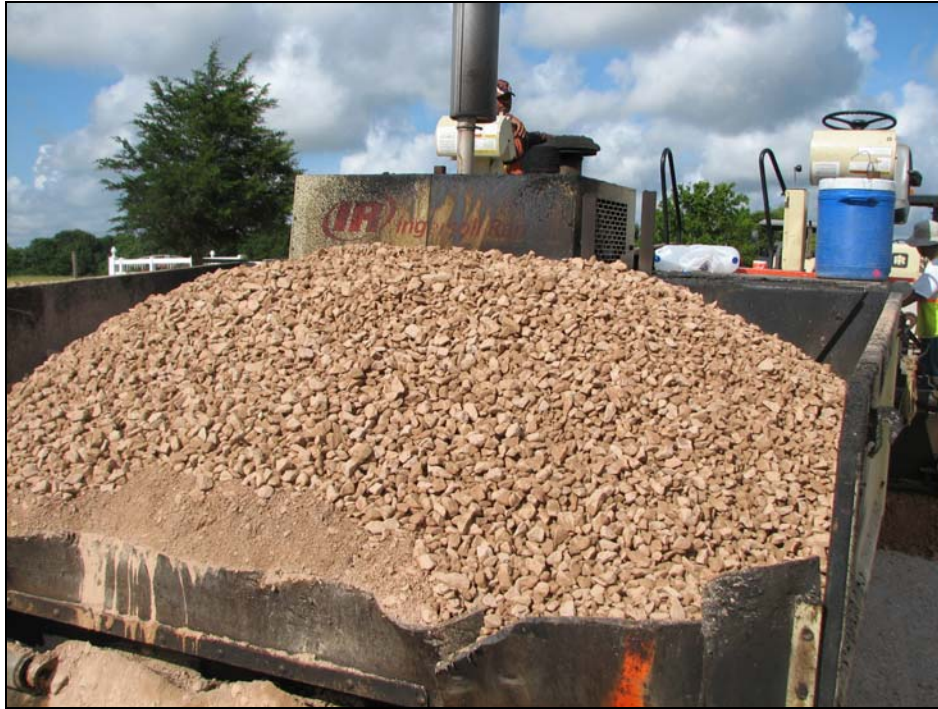
This handling did result in segregation of the base both inside the paver hopper and on the ground as Figures 2.14 and 2.15, respectively, illustrate. Additionally, traffic had to be allowed on the base after compaction, and the drainable base tended to ravel, particularly at the segregated locations, as Figure 2.16 illustrates. To remedy the deterioration in surface finish, the contractor re-worked the surface immediately prior to sealing.

**Figure 2.14. Segregation of Grade 4 Base in Paver Hopper.**

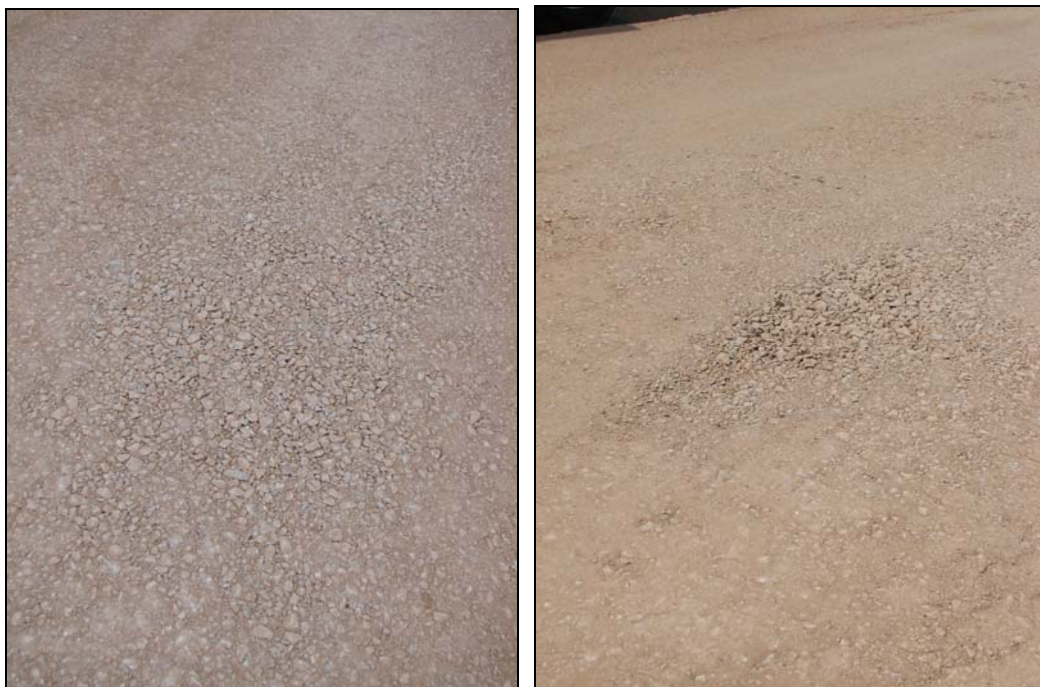
**Figure 2.15. Segregation of Grade 4 Base after Placement.**

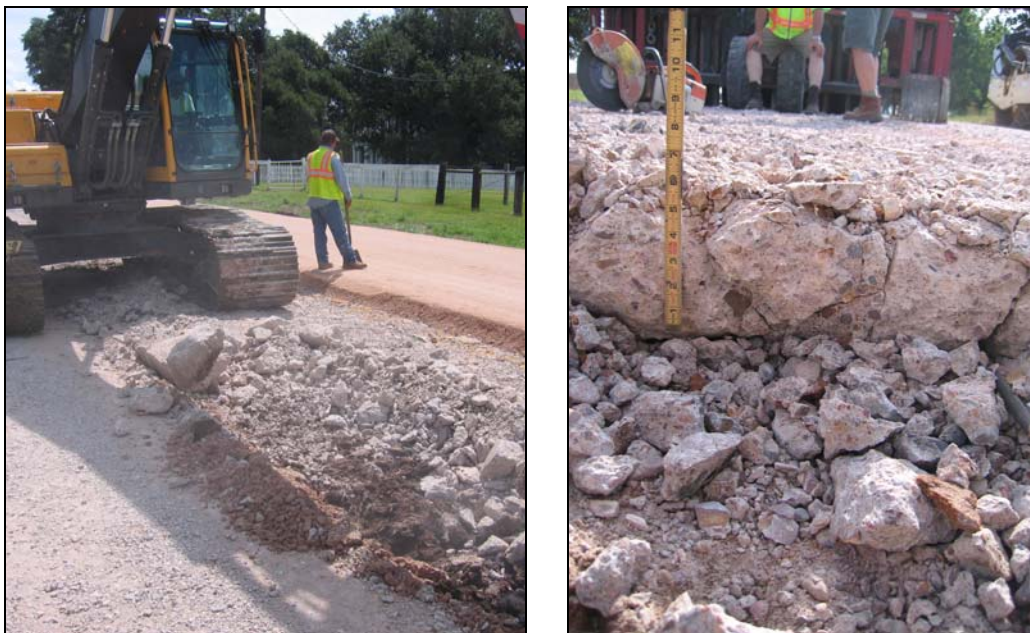
As on other projects, the Type I (resonant breaker) machine was observed to produce a smaller particle size throughout the depth profile of the concrete as compared to the Type II (multiple head breaker) equipment, as Figure 4.1 illustrates. Additionally, with both pieces of equipment, the break pattern serves as a first indicator of stability. While break pattern alone cannot serve as the only stability check, both machines produce break patterns with significantly larger particles at areas of poor stability, as Figure 4.2 shows.

**Figure 4.1. Rubblized Product from Type I (Left) and Type II (Right) Equipment.**

particle size requirements. On this project, which had marginal subgrade support, the depth of smaller particles with the Type II equipment was judged adequate even though that depth did not reach half the slab thickness (see Figure 4.1). It is recommended therefore that the particle size requirements be modified to relax the minimum required depth of the smallest particles to the top third of the slab thickness, instead of half the slab thickness, as Table 4.1 shows. Appendix B of this report presents a revised construction specification with the rubblization requirements modified as discussed.

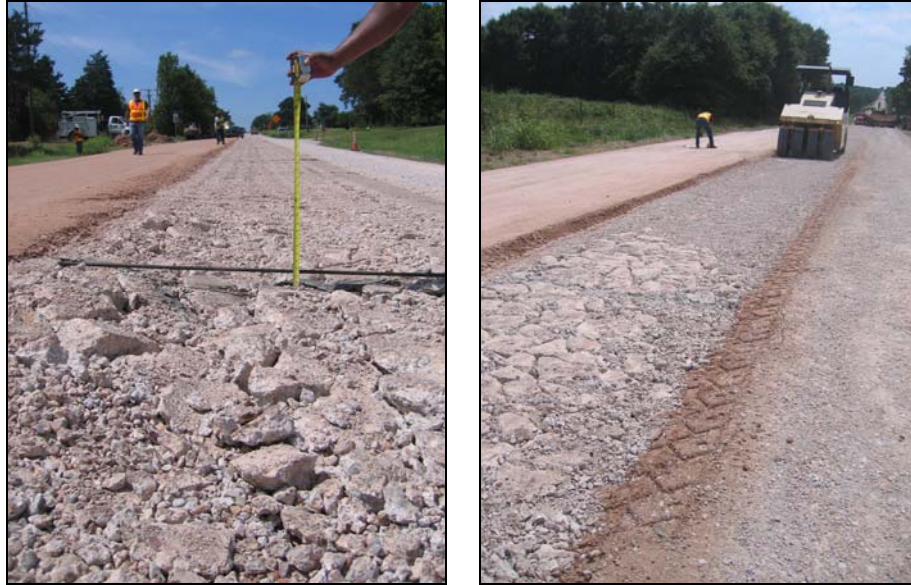
**Figure 4.2. Poor Break Patterns Observed at Areas of Instability from Type I (Left) and Type II (Right) Equipment.**

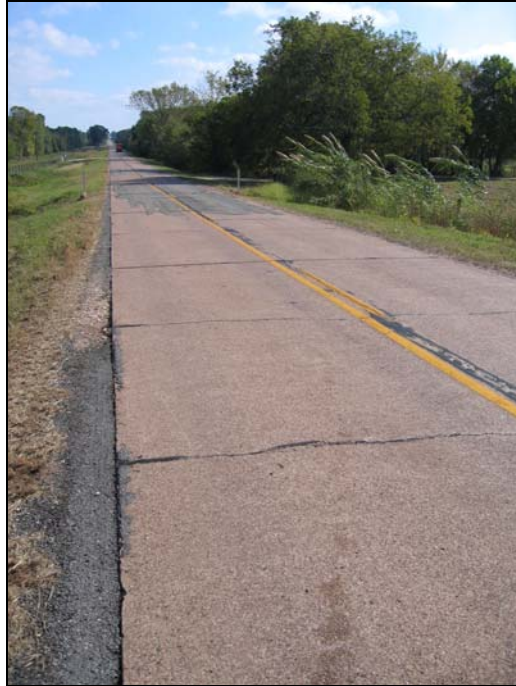
Figure C.1. Cracked Slabs on FM 912.

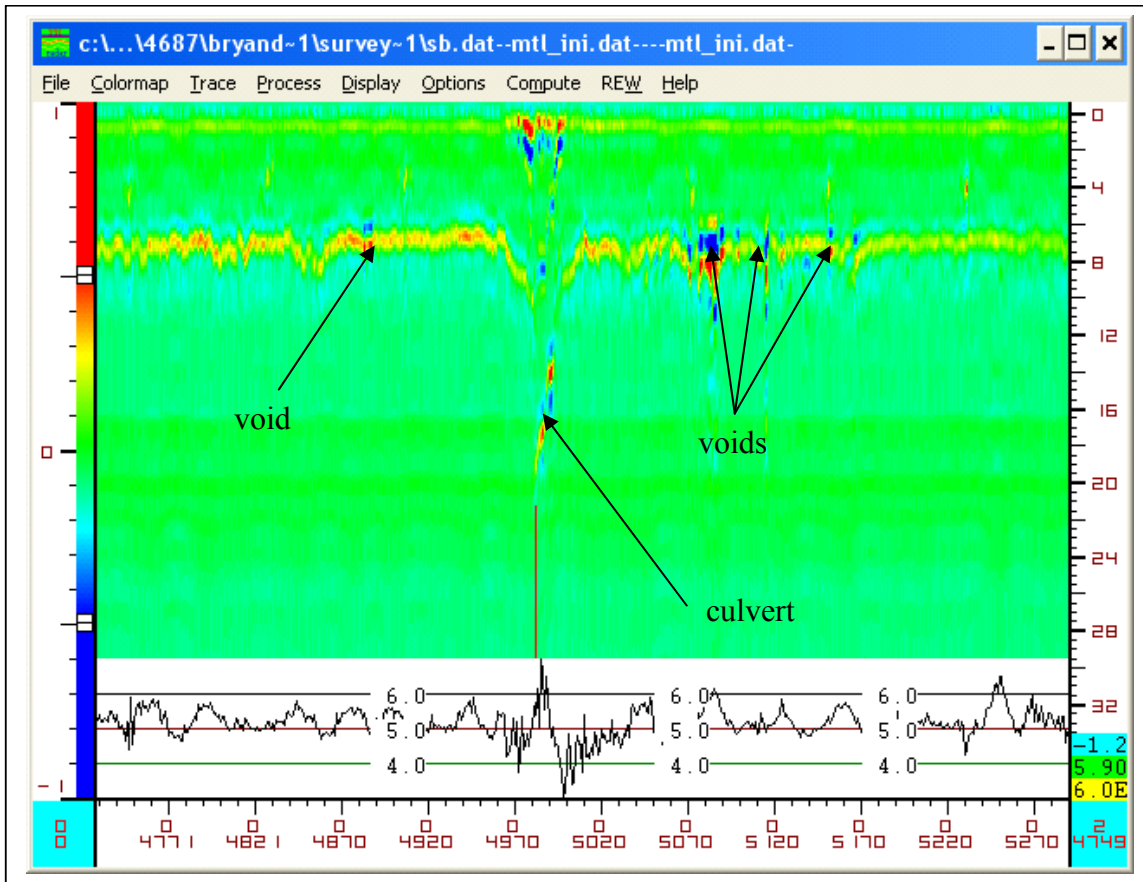
The GPR survey serves two primary purposes. First, the survey can identify locations of excessively wet subgrade or trapped water, both of which hinder the rubblization process. Second, the GPR survey can identify section breaks or changes in structure. In the GPR data, no locations of excessively wet subgrade were identified. The highest subgrade dielectric value was 7.3 (values above 10 can indicate excessively wet material). However, at the time of testing the weather had been dry for several months. From discussions with TxDOT personnel, portions of the FM 912 project have a history of developing voids underneath the slabs, particularly in the low-lying areas. While TxDOT reported that maintenance work had recently been performed on locations with voids, the GPR data still detected areas of voids beneath the slabs. Figure C.3 illustrates GPR data where voids exist. Follow-up testing with the DCP at selected locations verified the existence of voids beneath the slab. In the southbound (SB) travel direction, evidence of intermittent voids in the GPR data exist from RM 629 + 0.108 to 629 + 0.513. In the northbound (NB) travel direction, evidence of intermittent voids beneath the slabs exist from RM 629 + 0.898 to 628 + 0.936.

**Figure C.3. Voids beneath Slabs on FM 912.**
