A-JACKS AND AQUAWRAP INSTALLATIONS IN UTAH

SCOUR REVETMENT PERFORMANCE EVALUATION

Experimental Feature Final Report

December 2009

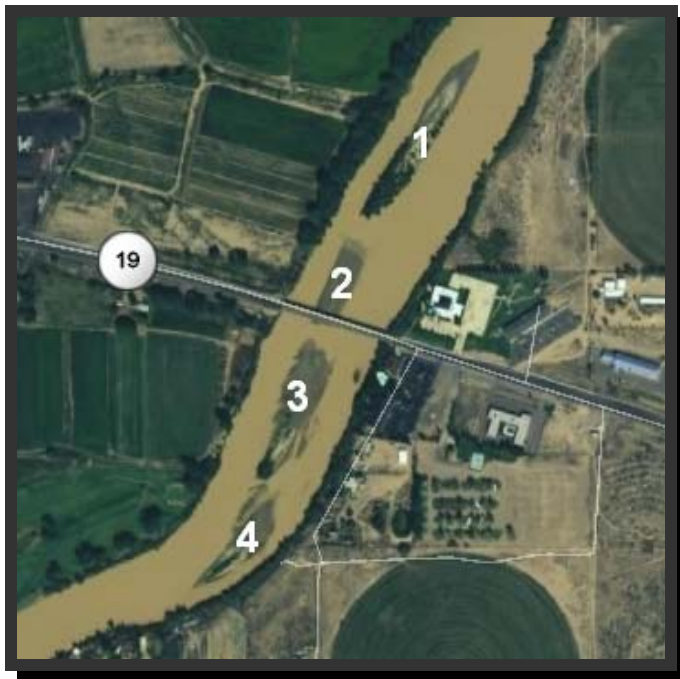
Figure 2: SR-19 Green River Sand Bars, Google Image 2006

Over time, the scour along the west abutment continued to develop. The aggradation near the center of the channel caused the flow through the span to hit the Piers at an angle, increasing scour. The aggradation also caused two sand bars to develop containing moderate to heavy vegetation.

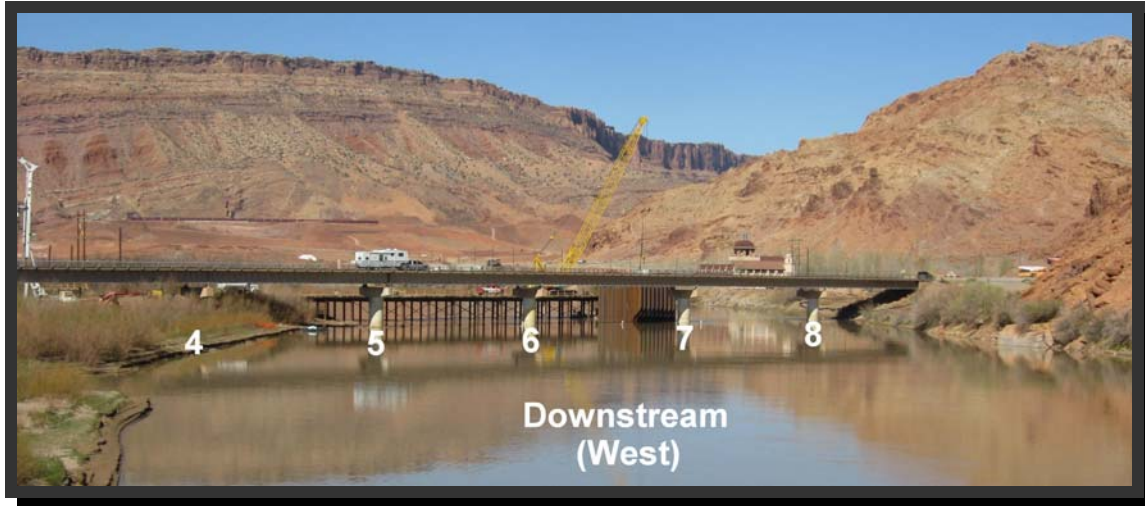
Figure 5: US 191 Colorado River Bridge during construction, April 2009. Notice the dramatic changes in the river bed width from the time of the original bridge construction up until now.

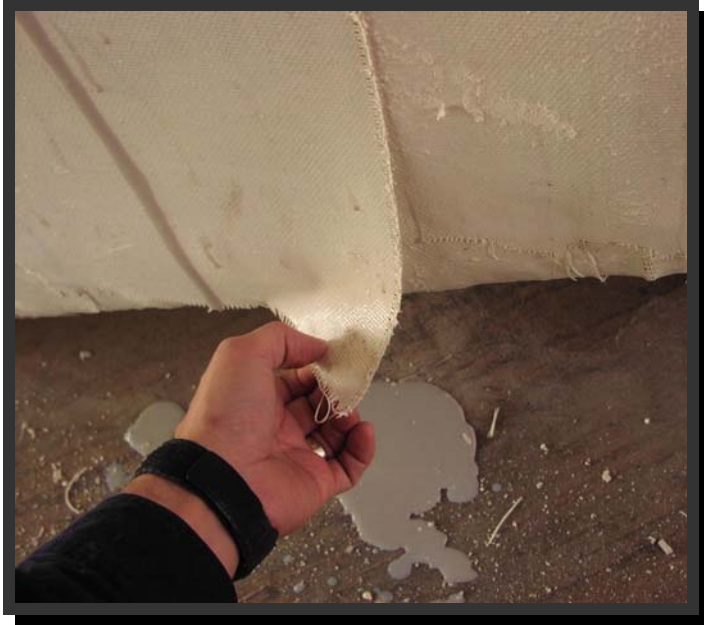
Figure 29: Close-up view of Aquawrap not sticking to the surface below, 2003

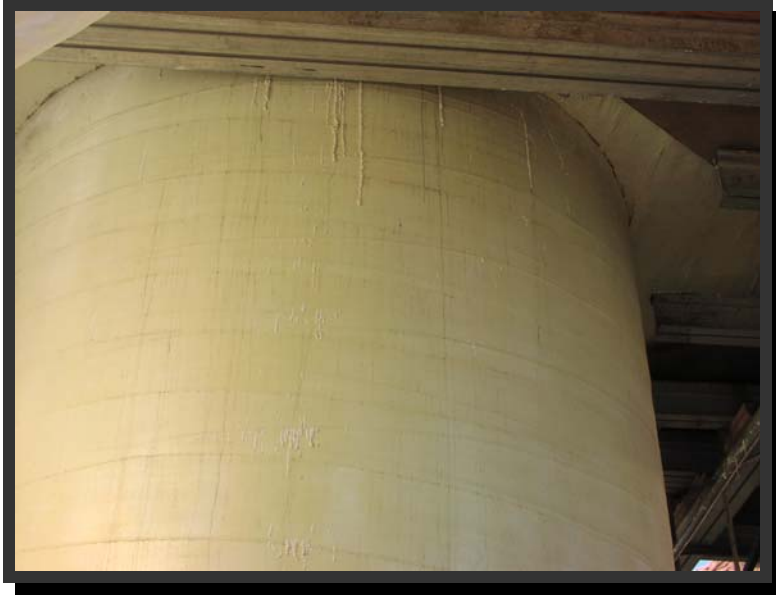
Figure 31: Aquawrap oozeage, 2003

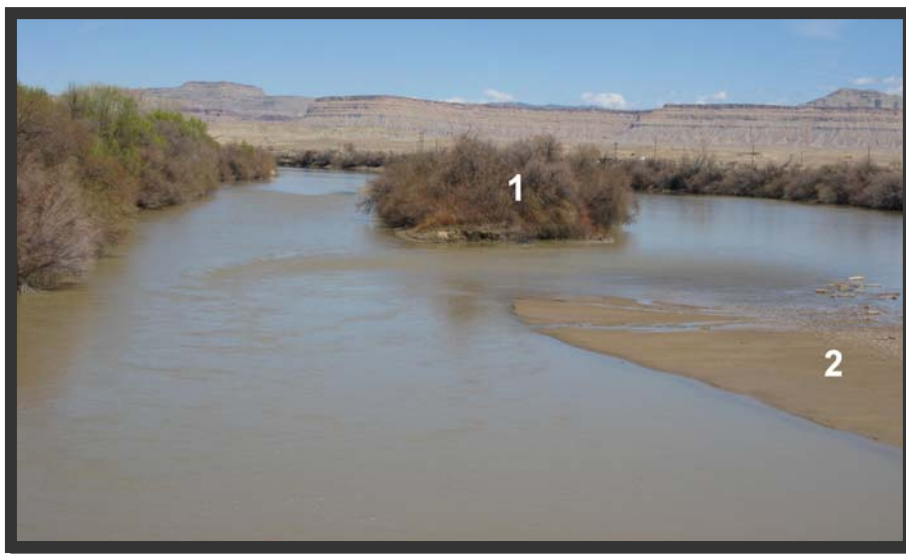
Representatives from UDOT Research, Hydraulics and Structures conducted an additional site survey in April 2009. The sand bars at the Green River Bridge have been significantly reduced since the installation of the A-Jacks, especially upstream of the bridge.

Figure 36: Green River Bridge sand bars looking upstream (North)

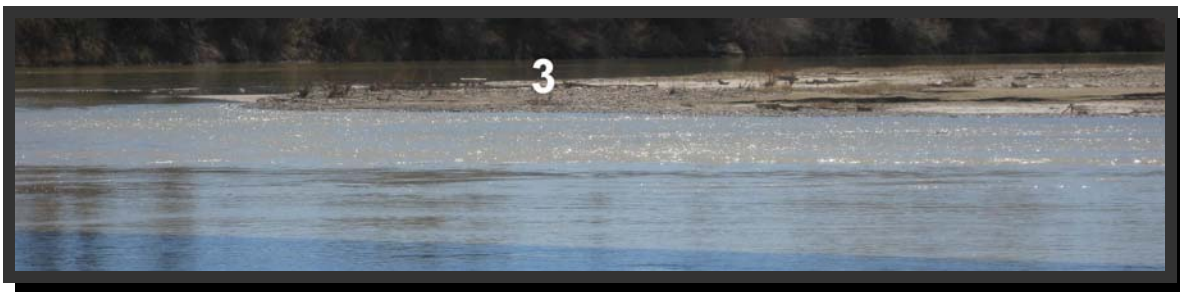
As the river merges together downstream of the bridge, there is a noticeable elevation change between the east and west channels.

Figure 38: Green River Bridge elevation change from the East channel to the West channel (Pre)

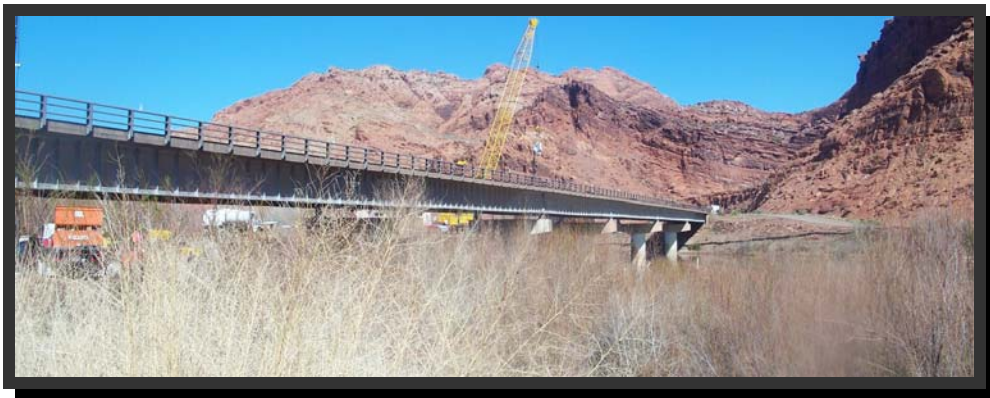
Representatives from UDOT Research, Hydraulics and Structures conducted an additional site survey of the Colorado River Bridge site in April 2009. The tamarisk now occupies most of the south bank.

Figure 40: Colorado River Bridge and Tamarisk, 2009

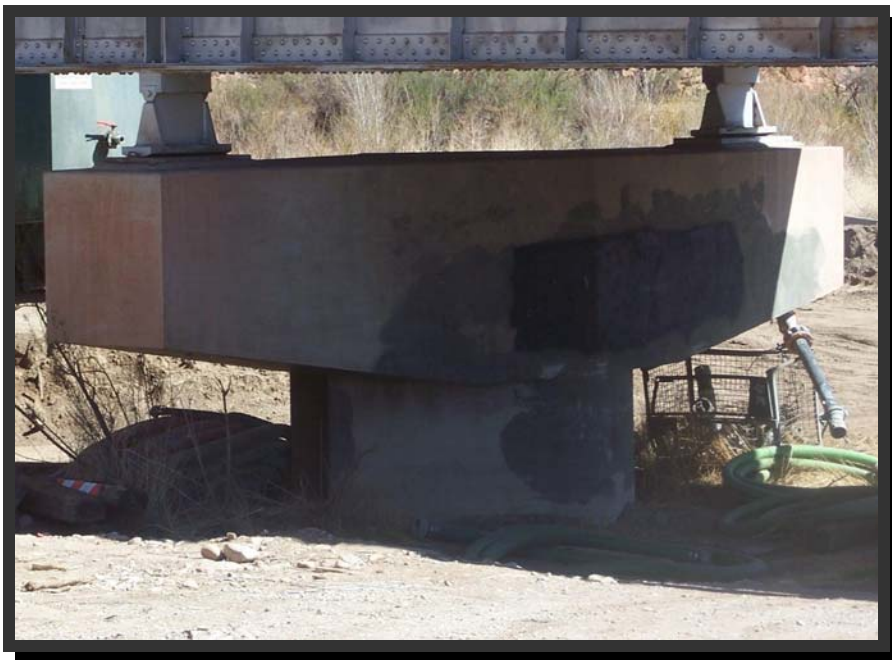
The once developing sand bar on the south end of the bridge has now become the newly defined river bank, nearly covering Piers 1 through 4.

Figure 41: Pier 4 on the Colorado River Bridge, 2009

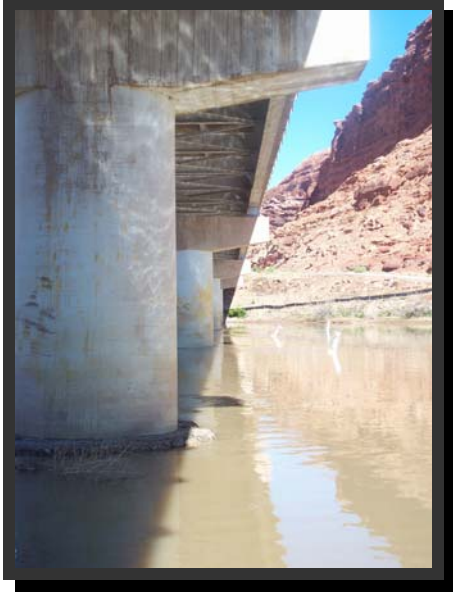
The Aquawrap on Piers 5 through 8 is still in good condition. The following pictures were taken before peak runoff season.

Figure 42: Colorado River Bridge Piers 5-8, 2009

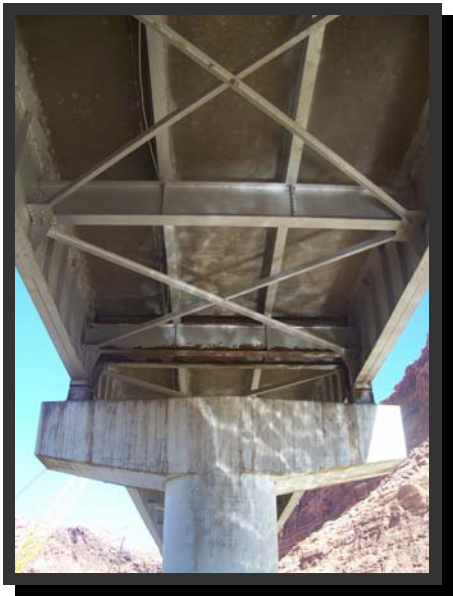
Figure 43: Colorado River Bridge Bent 5, 2009
