Evaluation of the SafeLane™ Overlay System for Crash Reduction on Bridge Deck Surfaces

Minnesota
Department of
Transportation

March 2010

Research Project
Final Report #2010-13

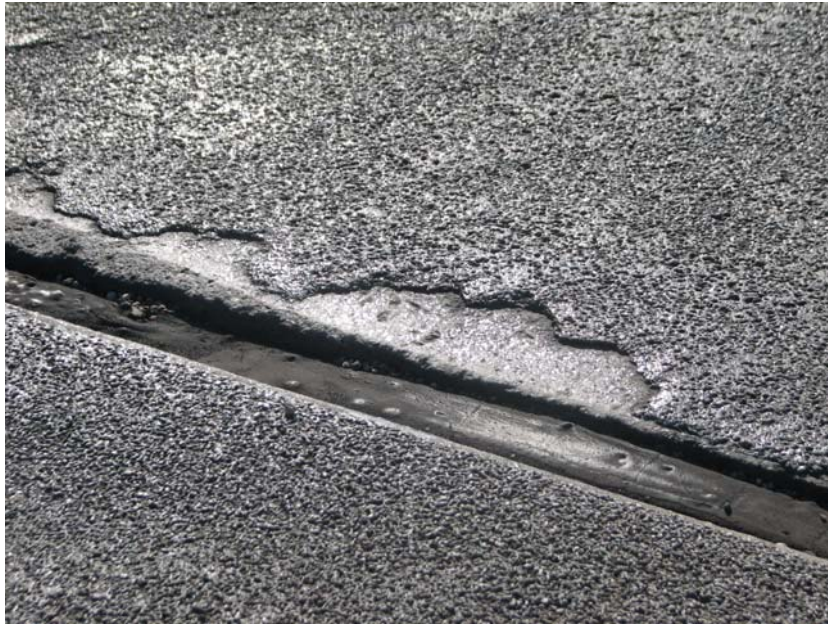
Figure 4.5. De-bonding at an expansion joint.

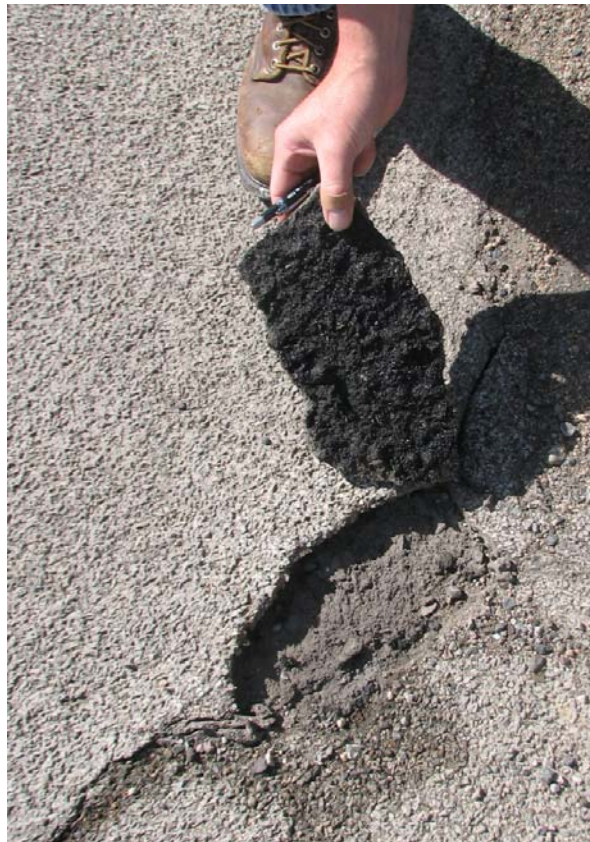
Figure 4.6. De-bonding over an asphalt repair patch.

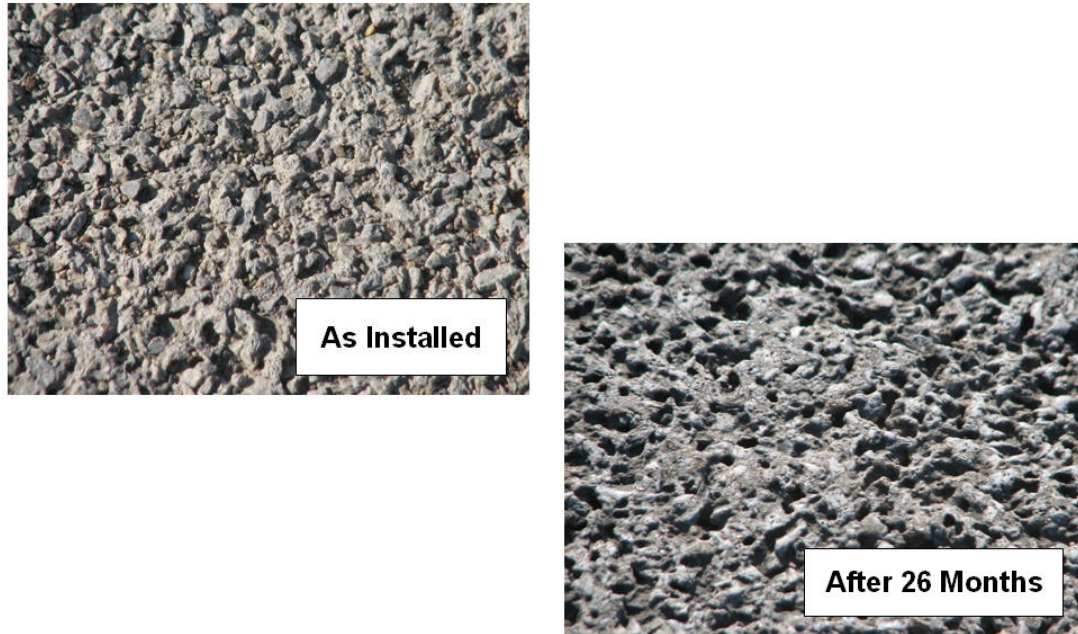
Although the integrity of the bonding of this overlay system to the concrete surface of the bridge deck on which it was installed was found to be excellent, as discussed in the previous chapter, other aspects of the mechanical performance of the system were less than satisfactory. These relate to wear observed in both the wheel lanes and the overall surface that were attributed to normal traffic and plowing. The plows used for winter maintenance all use significant down-force on the blades. Both contributed to significant shearing as shown in the photos below.

Figure 5.1. Photographs showing surface wear after two winters. Areas shown are approximately 4 x 6 inches.

The wear seemed in large part to be attributable to shearing of the aggregate and epoxy (above right). There was little, if any evidence of the aggregate being pulled out of the epoxy sealcoat, rather the surface appeared to have been milled after the first two winters, and more extensively so after the third. The consequences of this wear are twofold. Firstly there is a reduction of interstitial depressions between the aggregate pieces, which leaves less area to trap deicing chemicals between winter storms or icing “events”. Secondly, there is a significant reduction in traction as the surface wears. Both of these are expected to contribute adversely to performance from a traffic safety perspective.

The term of this study is too short. It is recommended that this overlay system be subjected to more long-term studies to determine if the short service life predicted above is correct. Other overlay systems that utilize aggregates that are less susceptible to ablation by plow blade shearing should also be evaluated for comparison.
