Aggregate Distribution Investigation in Box Beams Fabricated With Self Consolidating Concrete

CTR Technical Report:	0-5197-01-1
Report Date:	October 2009
Project:	0-5197-01
Project Title:	Continuing Research on Allowable Design Release Stresses for Prestressed Concrete Beams
Sponsoring Agency:	Texas Department of Transportation
Performing Agency:	Center for Transportation Research at The University of Texas at Austin

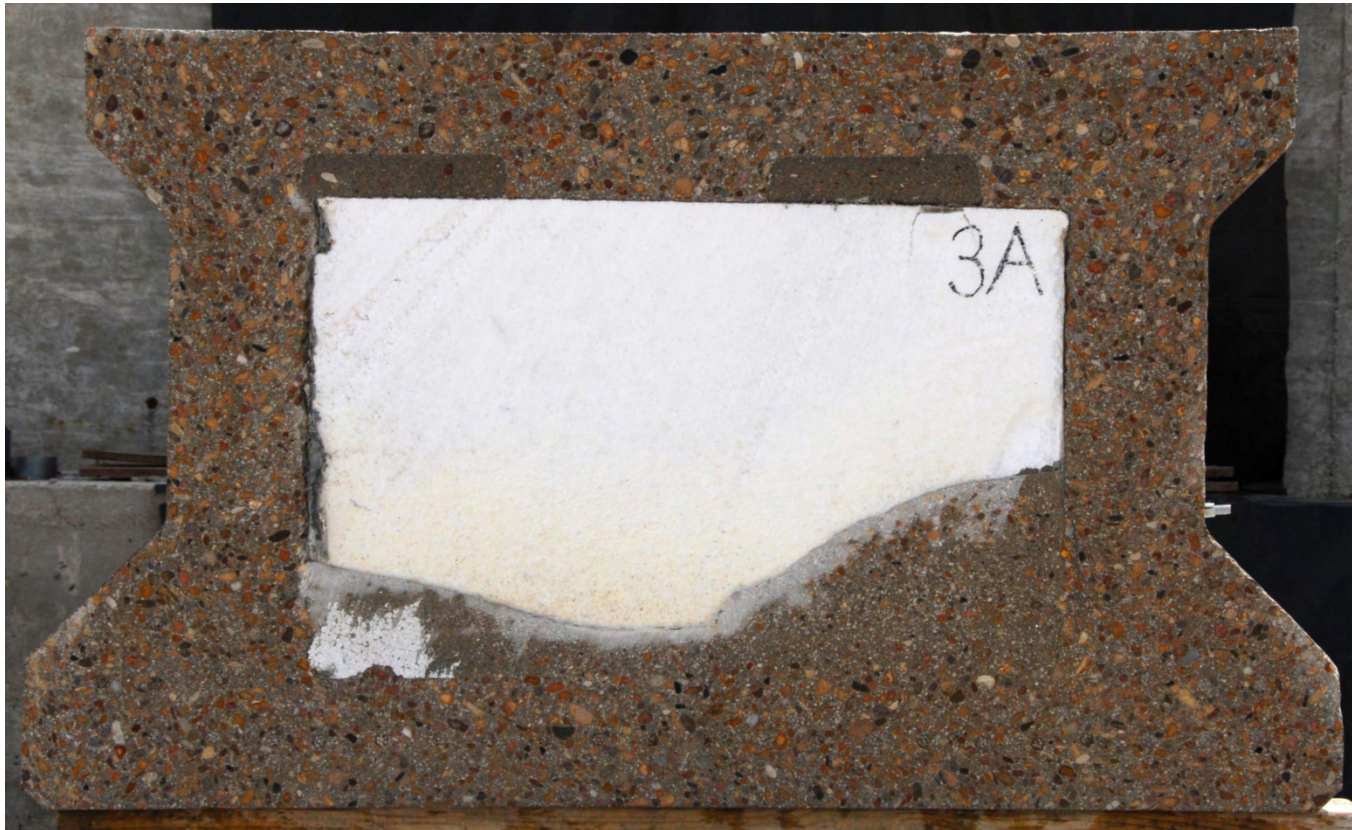
Figure A. 41: Picture BB09C3A

Beam Mark:	BB09	Cut Location and View:
Concrete Type:	Self consolidating	
Aggregate:	River Rock	
Cut ID:	BB09C3A	
Observations: This cut coincided with the joint between two Styrofoam blocks. The fabricator tapes together the top and sides of the blocks but since nothing is done to keep the bottom of the blocks together, concrete is able to flow up into the space between the blocks. This creates a thin layer of concrete (about 1/4 inch) as it is observed in this picture.
