Pennsylvania Department of Transportation Bureau of Planning and Research Project Contract No. 355I01 / Project No. 070202

Inspection Methods & Techniques to Determine Non Visible Corrosion of Prestressing Strands in Concrete Bridge Components

# Task 3 – Forensic Evaluation and Rating Methodology

ATLSS REPORT NO. 09-10

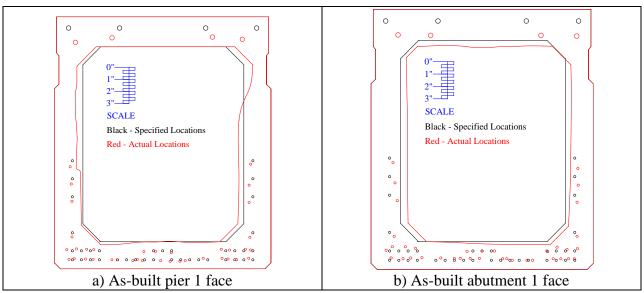
Figure 3-2: As-Built Section Geometry of Span 1 Beam 3 of Clearfield Creek Bridge

The as-built drawings in Figure 3-2 indicate that the cardboard forms shifted during the concrete placement. As a result, it appears that the thickness of the box girder webs and flanges change along the length; this can lead to detrimental behavior of the section. A reduced web thickness will reduce the shear strength of the member, whereas a reduced bottom flange thickness will allow the top layer of strands to corrode more easily due to a resulting decrease in the concrete cover (when water is present in the box void). It is also noted that reinforcing steel placement deviates from the specified locations. The bottom strand locations varied primarily along the horizontal axis, thus cover on the bottom strands was not significantly reduced. The average clear cover to the bottom layer of strands was 1.45 in.

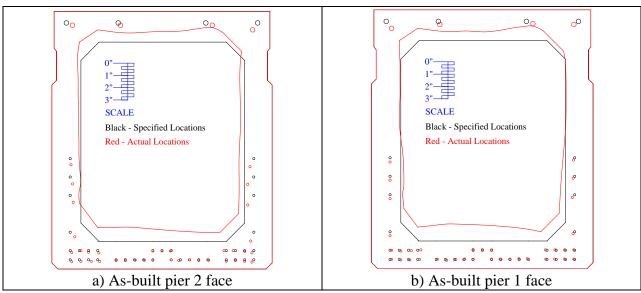
Figure 3-4: As-Built Section Geometry of Span 2 Beam 4 of Clearfield Creek Bridge

The as-built drawings in Figure 3-4 indicate that the cardboard forms shifted during the concrete placement. As a result, the thickness of the box-girders webs and flanges change along the length. A reduced web thickness will reduce the shear strength of the member, whereas a reduced bottom flange thickness will allow the top layer of strands to corrode more easily. It is also noted that reinforcing steel placement exhibited only minor deviations from the specified locations, most noticeably in the prestressing strands within the webs of the box-girders. The bottom strand locations varied primarily along the horizontal axis, thus cover on the bottom strands was not significantly reduced. The average clear cover to the bottom layer of strands was 1.25 in.

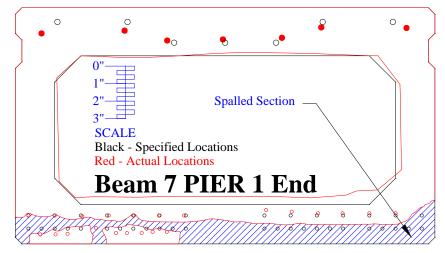
Figure 3-6: As-Built Section Geometry of Span 1 Beam 7 of Lakeview Drive Bridge

The as-built drawings in Figure 3-6 indicate that the cardboard forms shifted during the concrete placement. As a result, it appears that the thickness of the box-girders webs and flanges change along the length of the beam segment. The bottom flange thickness was increased. It is also noted that reinforcing steel placement deviates from the specified locations. Fifteen of the 38 strands were missing at the cut section due to corrosion and spalling. The remaining strands located in the bottom layer of the section varied laterally and vertically in the section. The strands remaining had reduced cover.

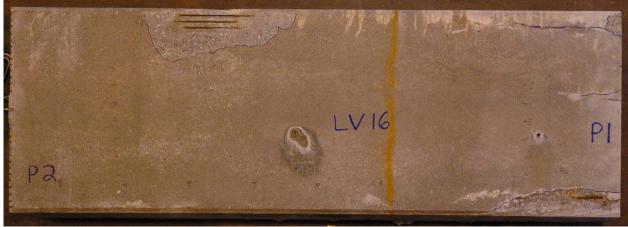
Figure 3-7: Bottom Flange Crack and Spall Condition Span 2 Beam 16

The visual inspection for this beam, Figure 3-7, shows no noteworthy cracks along the bottom flange of the member. The cracks were limited to hairline widths. However, there are three distinct areas where concrete has spalled off of the beam, displaying the corroded prestressing steel underneath; this totaled to approximately 7% of the overall concrete surface. Some rust staining and mild efflorescence is also noted.

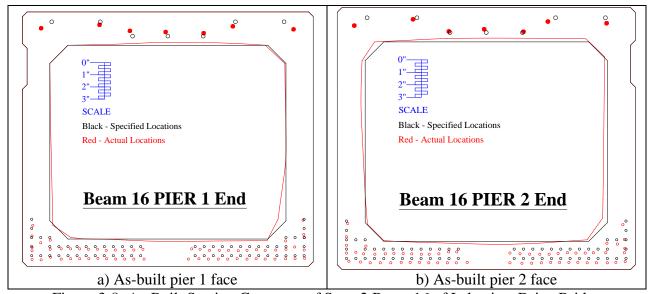
Figure 3-8: As-Built Section Geometry of Span 2 Beam 16 of Lakeview Drive Bridge

The as-built drawings in Figure 3-8 indicate that the cardboard forms shifted slightly during the concrete placement. The web width was larger for the beams and the top and bottom flange thickness was reduced. It is also noted that reinforcing steel placement deviates from the specified locations such that there is less clear cover than specified. The average clear cover to the bottom layer of strands was 0.975 in. This is of important due to the fact that clear cover has a large effect on protecting the reinforcing steel from corrosion due to chlorides. This reduction in cover could be attributed to the fact that the beam transverse reinforcement was placed on top of the bottom layer of prestressing strand. Without proper support of the transverse reinforcement the added weight would have easily deflected the strands. This effect would have been amplified if a long strand length was used; for example, cases where multiple beams are fabricated in one line. Current PCI construction methods do not allow for support of the transverse reinforcement on strands.

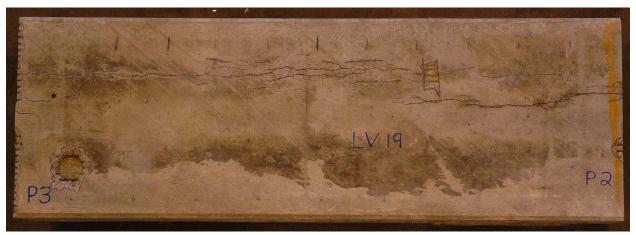
Figure 3-9: Bottom Flange Crack and Spall Condition Span 3 Beam 19

The visual inspection for this beam, Figure 3-9, reveals two prominent cracks along the length of the member. The cracks along the beam varied from hairline to 0.05 in. wide. One crack extending from each pier end. The crack path bifurcates at many points along its length. There is heavy rust-staining present on the member, as well as one minor area of spalling at the pier 2 end of the beam; thus the beam had less than 1% of its concrete surface spalled off. The circular damaged area near the P3 end on the beam was created during previous inspections.

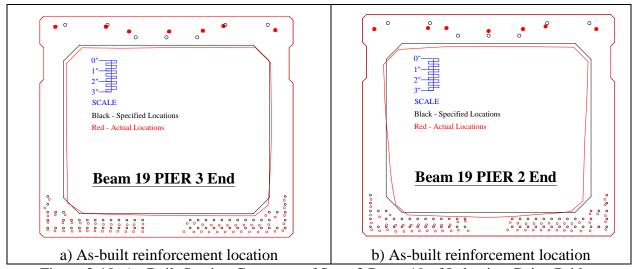
Figure 3-10: As-Built Section Geometry of Span 3 Beam 19 of Lakeview Drive Bridge

The as-built drawings in Figure 3-10 indicate that the cardboard forms shifted slightly during the concrete placement. The web thickness was increased at the bottom of the beam and the bottom flange thickness was reduced. It is also noted that reinforcing steel placement deviates from the specified locations such that there is less clear cover than called for. The average clear cover to the bottom layer of strands was 0.90 in. This is important due to the fact that clear cover has a large effect on protecting the reinforcing steel from corrosion due to chlorides.

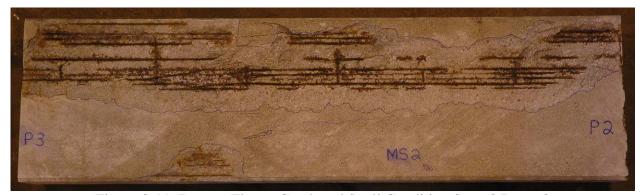
Figure 3-11: Bottom Flange Crack and Spall Condition Span 3 Beam 2

The visual inspection for this beam, Figure 3-11, revealed severe spalling along the length. Strands are completely exposed over a large area of the bottom flange. The strands in the spalled area were heavily corroded and in some cases completely deteriorated. Minor hairline cracking occurred between the spalled region. Due to the significant spalling – approximately 49% of the concrete surface – and corrosion damage the beam is in very poor condition.

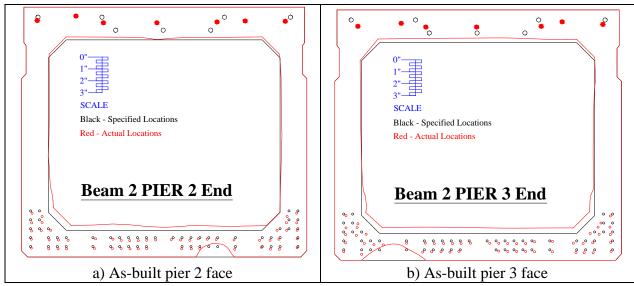
Figure 3-12: As-Built Section Geometry of Span 3 Beam 2 of Main Street Bridge

The as-built drawings in Figure 3-12 indicate that the cardboard forms shifted slightly during the concrete placement. The web thickness was essentially maintained, however the bottom flange thickness was increased and the top flange thickness was reduced. It is also noted that reinforcing steel placement deviates from the specified locations such that there is less clear cover than called for. The average clear cover to the bottom layer of strands was 1.18 in. In addition two strands were lost at the pier 2 end of the beam and 3 were lost from the pier 3 end.

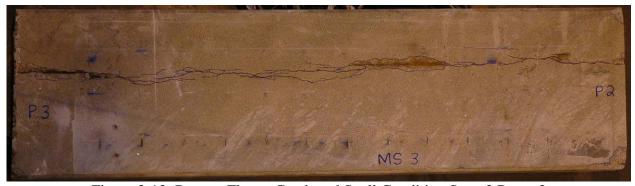
Figure 3-13: Bottom Flange Crack and Spall Condition Span 3 Beam 3

The visual inspection for this beam, Figure 3-13, revealed a longitudinal crack along the entire beam length. In some portions of the crack, light spalling had occurred; totaling approximately 2% of the concrete surface. The crack width varied. Efflorescence and rust staining have also been detected.

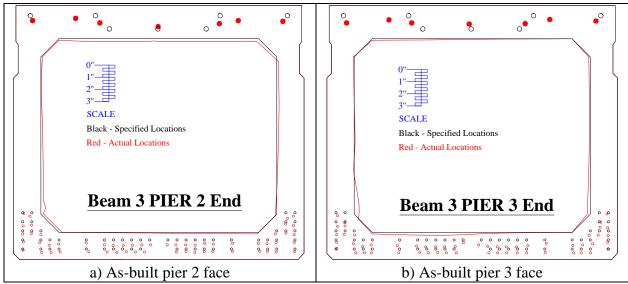
Figure 3-14: As-Built Section Geometry of Span 3 Beam 3 of Main Street Bridge

The as-built drawings in Figure 3-14 indicate that the cardboard forms shifted slightly during the concrete placement. As a result, it appears that the thickness of the box-girders web and flanges change slightly along the sections length. It is also noted that reinforcing steel placement is off such that there is less clear cover than called for. The average clear cover to the bottom layer of strands was 1.06 in.

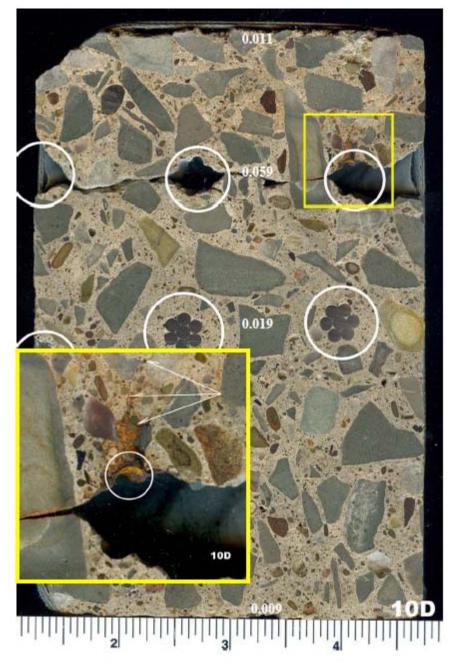
Figure 4-11: Petrographic Examination of Core 10D from Beam MS2

A cross-section of Core 10D showing relatively good grading and distribution of aggregates is shown in Figure 4-11. The crack separated the concrete such that the strand wires – lightly to severely corroded – were displaced. Within the yellow-boxed area is a vertically trending crack (arrows) and severely corroded wire strand (circled). The circled bottom strands are non-corroded. Aside from the cracks and corroded strand there is no evidence of distress to the concrete. The core was taped to facilitate processing. The acid-soluble chloride contents shown are percent by concrete mass. The scale is in inches.

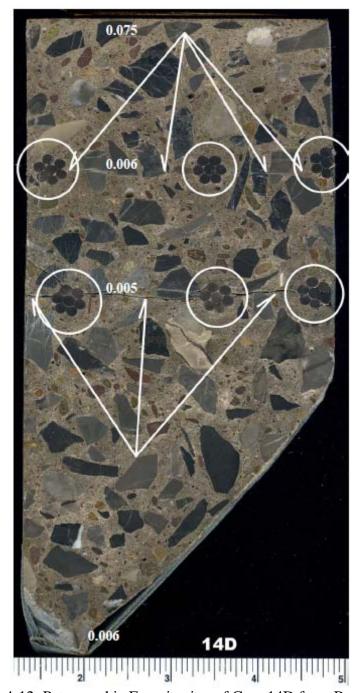
Figure 4-12: Petrographic Examination of Core 14D from Beam CC3

at the strand level. Aside from cracks there is no evidence of distress to the concrete. The core was taped to facilitate processing. The acid-soluble chloride contents shown are percent by concrete mass. The scale is in inches.

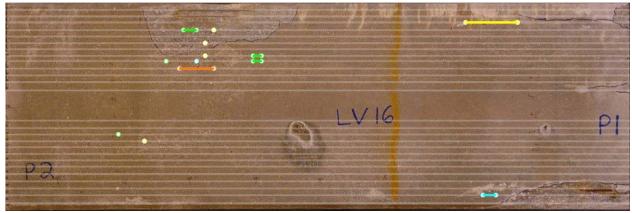
Figure 5-6: Damage Profile for Lakeview Drive Bridge Beam 16

As can be seen in Figure 5-6, most of the damage is focused in one distinct area. When using this data jointly with the visual inspection, it is noticed that the large cluster of damage found just off-center toward the P2 side is near the location of a large spall. Heavy pitting was found on strand three, toward the P1 end of the beam; there was a crack found at this location during the visual inspection. The most severe damage is the wire loss found on strand ten; where there were no surface indicators of corrosion.

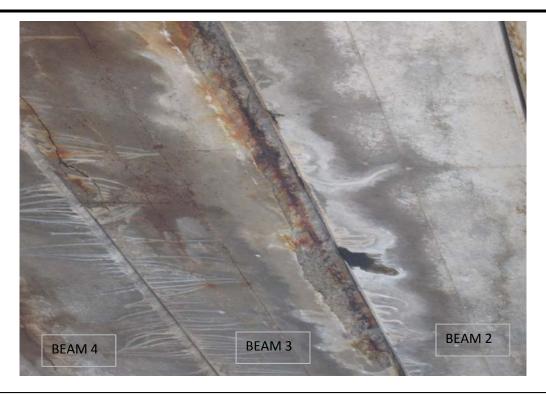
Figure 3 Underside of Beam 3 at mid-span, Looking back. Exposed strand on Beam 3 and longitudinal cracks.
