Final Report RC-1526

Estimate of Cliff Recession Rates for the Baraga Cliffs

Michigan Department of Transportation

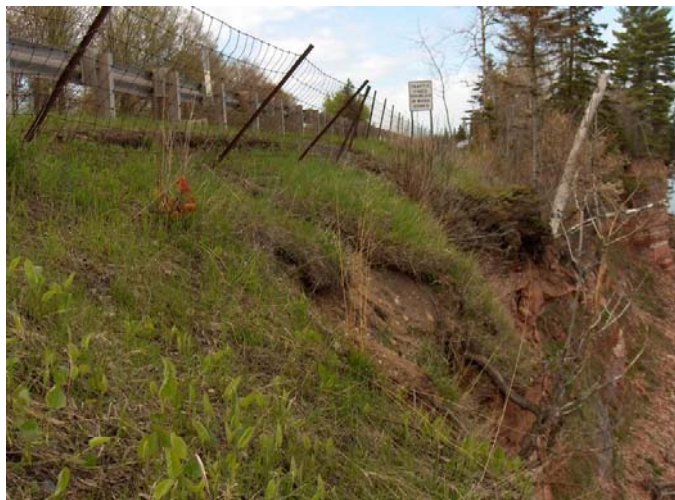
Unfortunately, due to cliff recession the cliff has eroded and has started to undermine the stability of the highway. Figure 2 shows the shoulder of the highway with the overburden material slumping towards the cliff. Figure 3 shows the cliff just below the slumping section, while Figure 4 shows a view of the cliff from the water. In the fall of 2007 the guardrail was moved several feet toward the highway, however, this spring additional slumping was observed close to the new guardrail.

Figure 2: Two views of overburden slumping on the top of the cliff adjacent to the highway (a) south view and (b) north view.

process. Since the recession of the cliff has advanced to a point where it is beginning to affect the stability of the highway, it is recommended that action be taken as soon as possible to relocate the road to a more stable position with respect to the cliff. Survey data of talus slope angles as well as stable slopes to the south of the cliff indicate that stable slopes develop at between 30° and 33° slopes. It is likely that the Baraga Cliffs will naturally evolve to this slope angle similar to the slopes to the south of the cliffs. It is recommended that the highway be relocated to a position beyond where this stable slope will develop. This recommendation, however, is premised on a stable talus slope forming and successful vegetation developing on the slope. This also assumes that the lake levels remain at their current level or near the long term lake average.

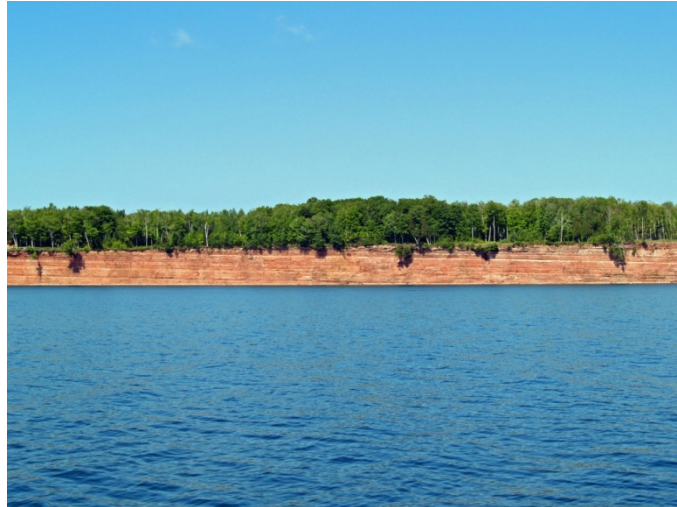
Figure 6: Section of consistent cliff structure north of MDOT Roadside Park; note the lack of talus slope formation due to direct long shore current removing the sandstone talus slope.

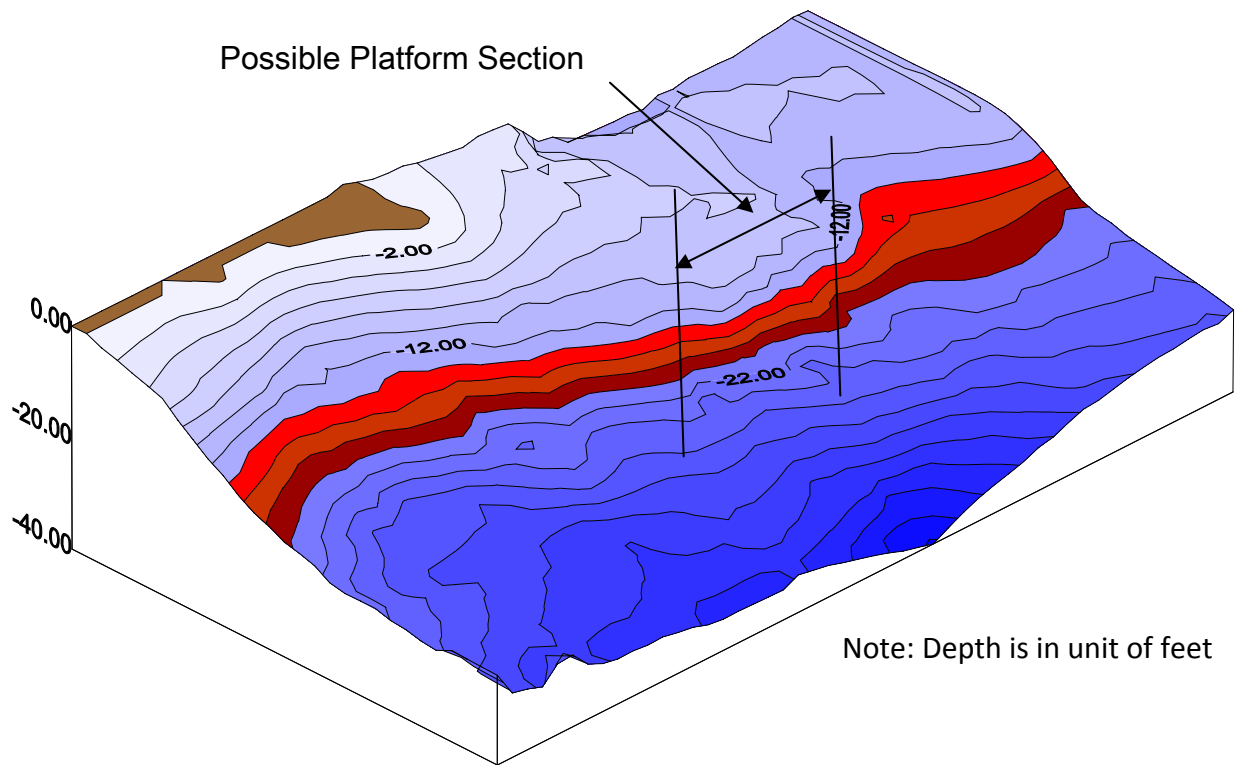
Figure 33: Bathymetric map of the shore platform and shoreline.

The method utilizes the assumption that the shore platform has not been eroded since the water level rose above the platform drop-off to its current level. Further the model assumes that the water was low enough that the cliff and platform edge were eroded as a continuous slope. The rate at which the cliff is receding can be determined by dividing the width of the shore platform by the time that has passed since the water level was below the shore platform drop-off depth. In the case of the cliffs the depth of the drop-off is 20 ft below the current levels and the distance from shore to the estimated shore platform edge was 800 ft.
