*PERFORMANCE OF
MICHIGAN'S CONCRETE BARRIERS*

Michigan Department of Transportation

1. Report No. R-1498	2. Government Accession No.	3. MDOT Project Manager	
4. Title and Subtitle Performance of Michigan's Concrete Barriers		5. Report Date

**Materials Section
Construction and Technology Division
Research Report R-1498**

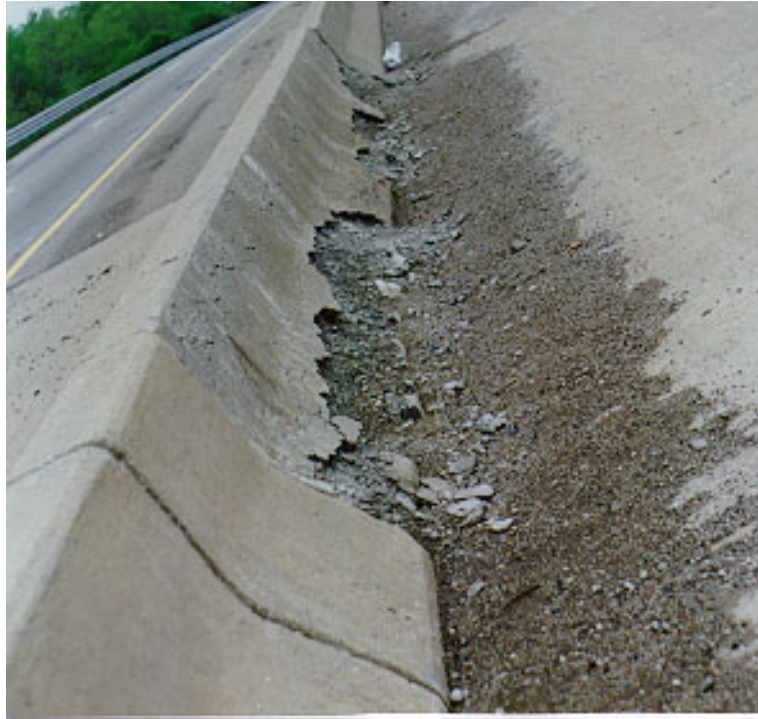
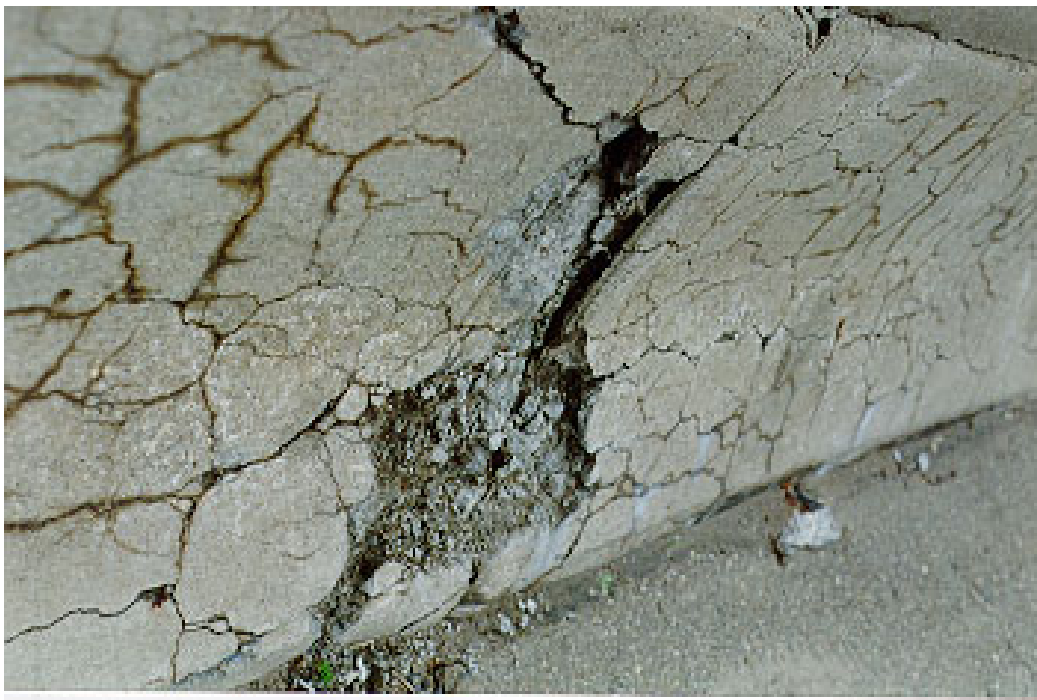
Deicers - Perhaps the most destructive assault on Portland cement concretes exposed to harsh Michigan freeze thaw environments occurs as a result of heavy applications of deicers. The osmotic and hydraulic pore pressures developed during internal expansions and movements of freezing liquids throughout the hardened concrete matrix induce localized tensile stresses ultimately causing micro-fracturing of the concrete paste. These micro-cracks eventually conglomerate to form macro-cracks which then provide wider avenues for further deicing chemicals and moisture intrusion. Osmotic pressures generated within the pore structure of concrete from water/deicer solutions are estimated to be approximately twice the magnitude of those generated by deicer-free pore waters. In addition, since the freezing point of deicer latent water is lower than that of water, the number of freeze thaw cycles experienced by the concrete over a given period of time may be greatly increased. In other words, the cyclic transformation of the pore fluids from a liquid state to a frozen state could compress the deterioration time-frame from decades to years. This, in turn, results in accelerated deterioration of the concrete structure. Further, as the concrete interior matrix is progressively eroded and exposed, carbonation and other complex chemical reactions manifest leaching of soluble calcium hydroxide from the concrete paste, and deposition of harmful mineral compound precipitate into the entrained air voids. This, in turn, reduces the concrete's resistance to future freeze thaw and chemical attack. Figures 10A and 10B show the accelerated deterioration of a concrete barrier caused by aggressive freezing and thawing.

Figures 10A and 10B: Typical deterioration caused by freeze thaw attack.

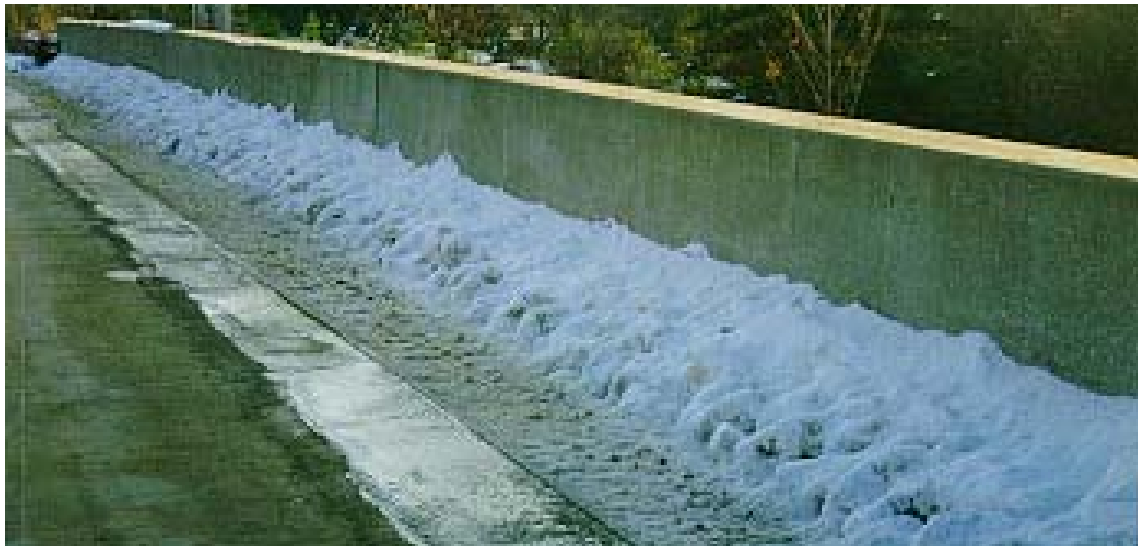
snow, built-up against the barrier from highway snow removal operations, melts and freezes daily. Thawing snow concentrated against the lower face of these barriers feed moisture into the concrete surface contributing to induced hydraulic and osmotic pore pressures, which were discussed earlier. The snow build-up against the northerly faced traffic-bearing surfaces experiences very little solar warming and, therefore, remains in a cryonic state for a longer period. As long as the snow remains frozen, the accelerated cyclic fatigue brought on by the movement of pore fluids is temporarily stabilized. This can be seen in Figures 11 and 12.

Figure 11: Example of snow build-up on northerly facing traffic-bearing barrier surface.

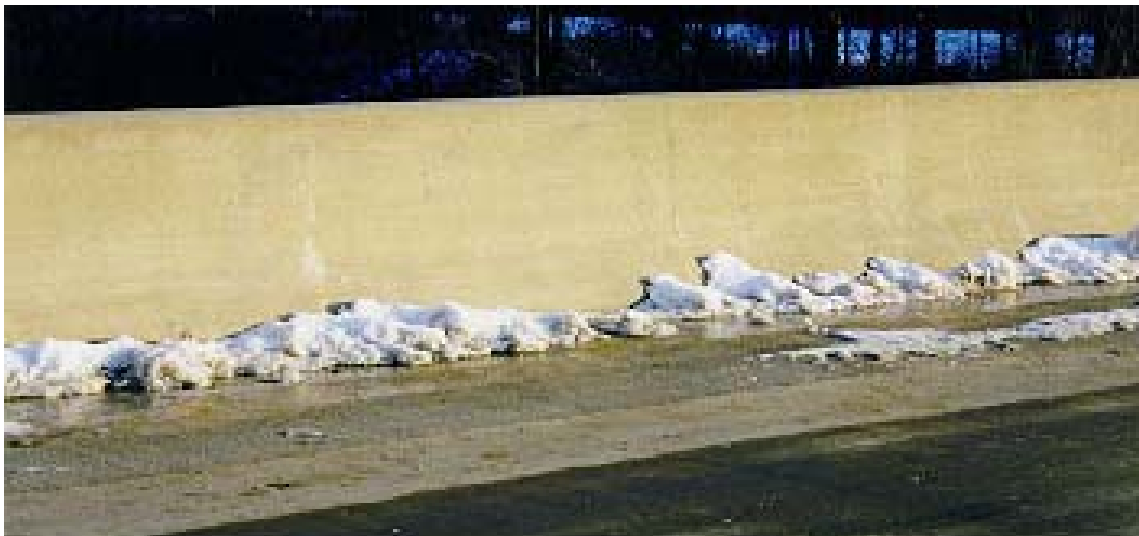
Figure 12: Example of snow build-up on southerly faced traffic-bearing concrete surface.

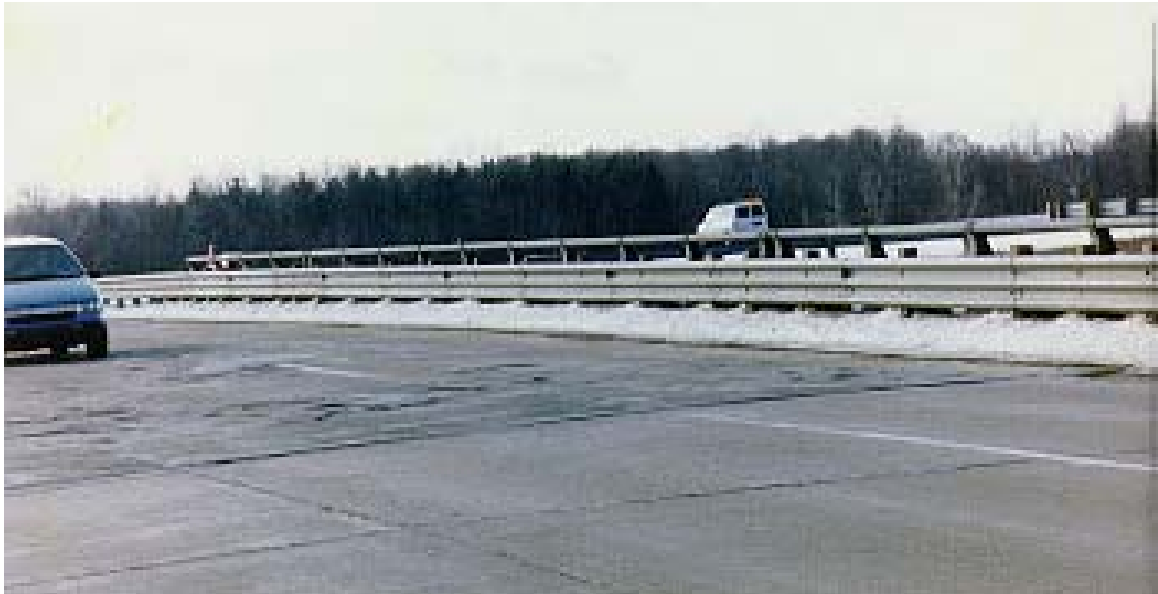
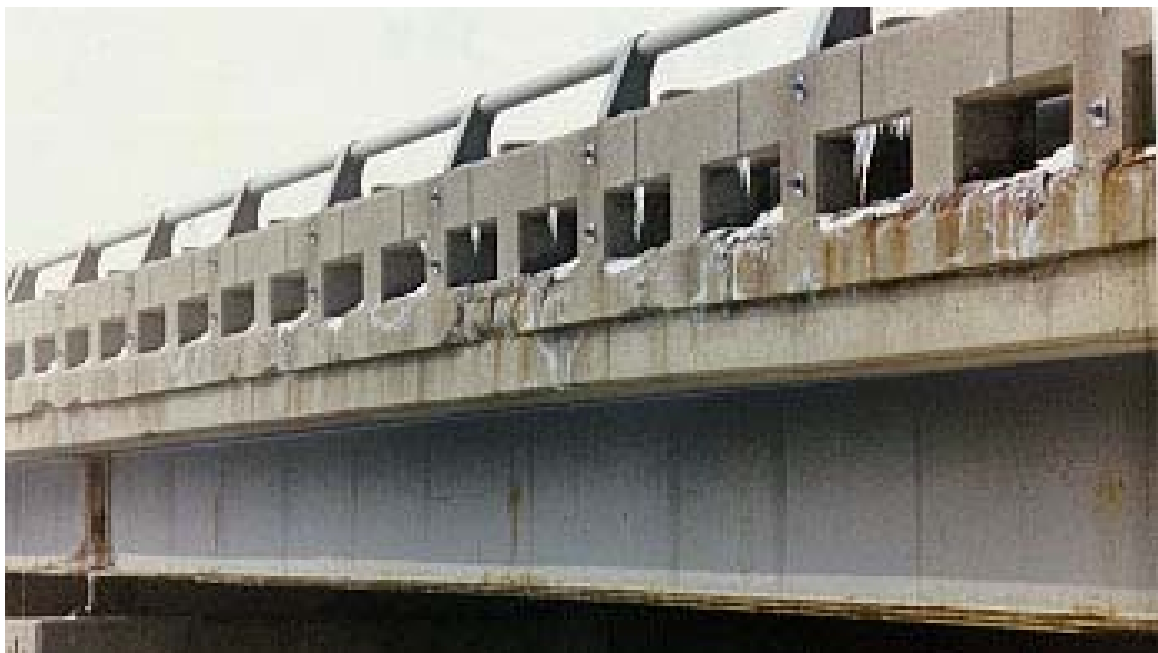
Figure 13A and 13B: Example of open parapet concrete railing retrofitted with beam guardrail.

faces. However, many are still in excellent condition. One method to retrofit the open parapet railings still in-service on main trunkline routes is to face it with beam guardrail across the structure, attaching it to the bridge railing. To a certain extent, facing the bridge railing with guardrail could aid toward protecting the concrete from aggressive deterioration. An example of an open parapet concrete railing retrofitted with beam guardrail is shown in Figures 13A and 13B.

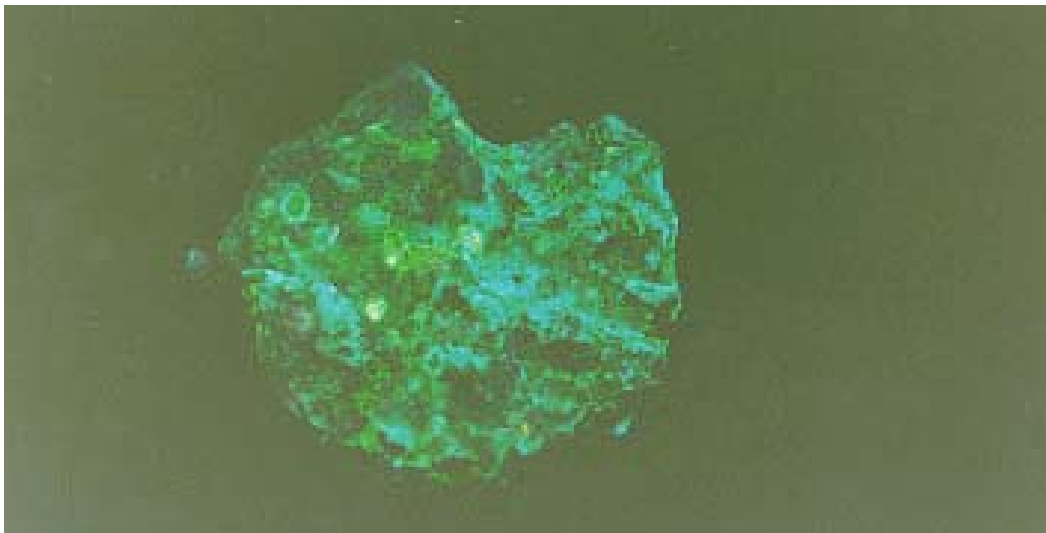
Laboratory evaluation of loose rubble fragments collected from a barrier site containing natural gravel coarse aggregate shows the detectible quantities of alkali-silica gel formations within the concrete matrix to be minimal, hence, not necessarily considered to be a controlling factor toward the internal decay of the concrete. The SHRP-C-315 uranyl acetate indicator solution flagged a blue-green fluorescence under ultraviolet lighting. However, MDOT laboratory investigations have shown this blue-green hue to represent sodium chloride (typical rock salt). The SHRP-C-315 flags alkali-silica gel formations as yellow-blue colored fluorescence. Evaluations of these specimens noted only isolated areas of yellow-blue fluorescence, thus, ruling out ASR as the controlling deterioration mechanism for the barrier samples analyzed. Figure 14 shows photographs of barrier concrete fragments examined in accordance with the SHRP-C-315 test method.

Figure 14: Photos of a concrete barrier specimen examined according to SHRP-315. Note the blue-green colored predominant fluorescence indicating sodium-chlorides presence.

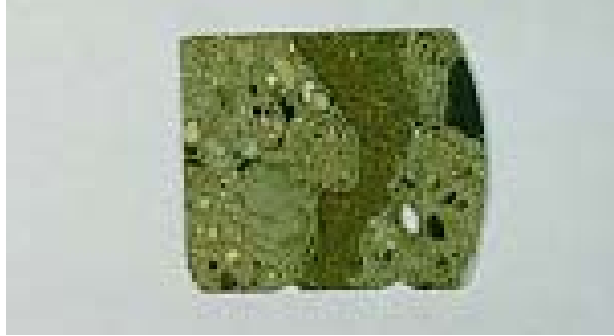
According to laboratory inspection of concrete specimens extracted from both slipform and cast-in-place concrete barriers, the rapid-chloride permeability (ASTM C 1202 Standard Test Method for Electrical Indication of Concrete's Ability to Resist Chloride Ion Penetration) for the two concretes are quite low, relative to normal quality concrete. However, an interesting observation was that the surface of the slipform specimen, to a depth of approximately 1/8-inch, was very porous and of very low quality. Sand streaks and a very porous matrix were noted within this thin cover layer. Visual evidence indicates that potential causes could likely be the result of improper mixing, handling, finishing and/or curing during construction. Figure 15 shows the lens of sand detected in the outer 1/8-inch of the slipform barrier traffic-bearing surface. In any case, the laboratory sample was taken at random and considered to be representative of normal slipform barrier concrete. Petrographic evaluation of concrete slices representing the surface of the cast-in-place concrete barrier was consistent and homogeneous in appearance with interior.

Figure 15: Lens of sand detected in concrete core specimen sampled from slipform barrier. The lens was observed to be located within approximately 6 mm from the traffic-bearing surface.

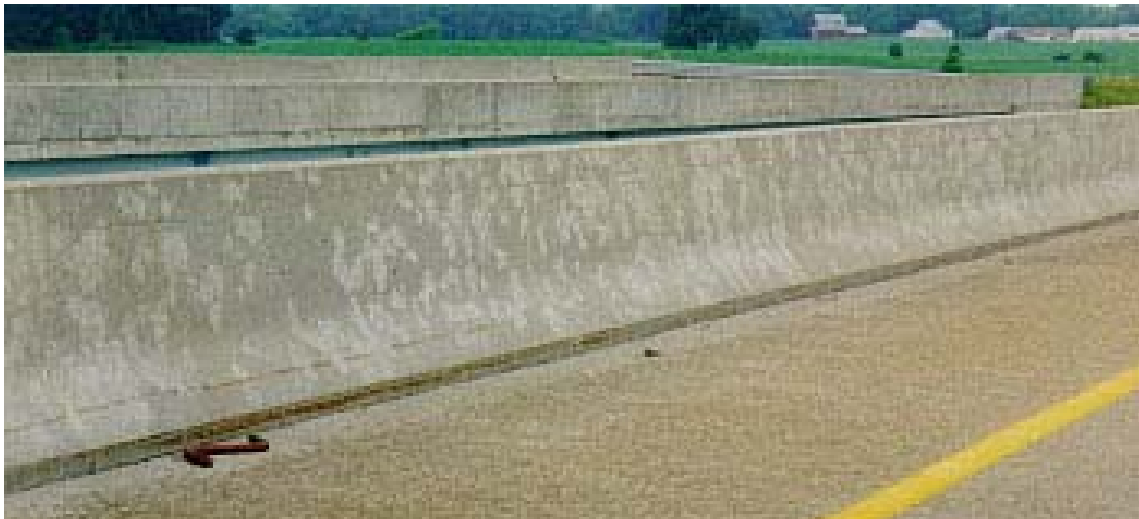
Figure 16: S02 of 19042, WB I-69 over US-127 near Lansing, MI. Constructed in 1985, this concrete barrier is a typical example of cast-in-place construction. This barrier is nearly crack-free.

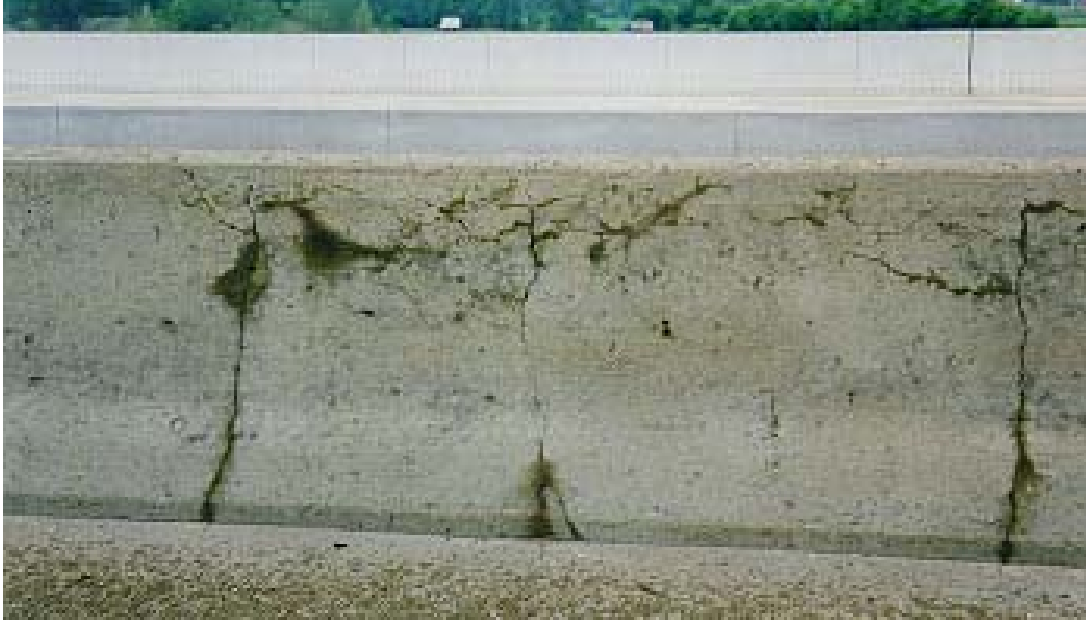
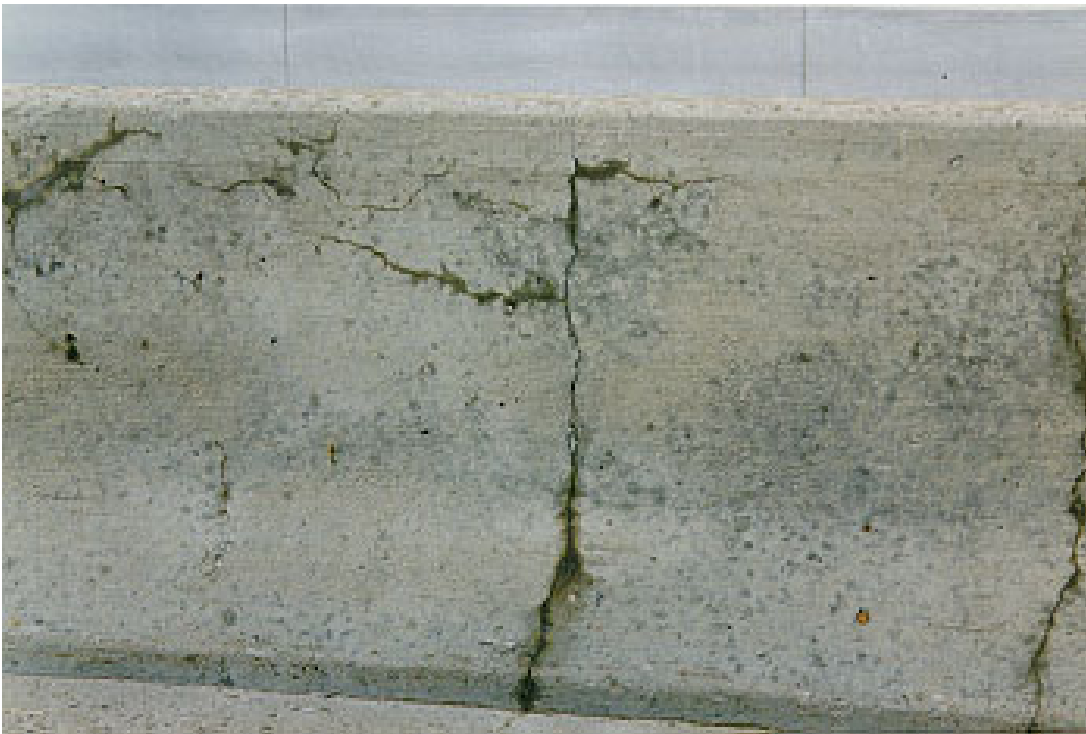
It is interesting to observe the divergence in performance between the conventional cast-in-place Portland cement concrete barriers and ones constructed using slipform technology. In particular, slipform barriers constructed without epoxy coated reinforcement show the highest level of premature deterioration than others (excluding blast-furnace slag coarse aggregate concretes), regardless of their exposures to aggressive deicer chemicals. An example of this was observed at the I-69/US-127 interchange located north of Lansing in Ingham County, shown in Figures 16 and 17. One characteristic mode of deterioration noted with slipform barriers without epoxy coated reinforcement is cracking of the concrete cover directly over the surface steel. These avenues for ingress expose the black reinforcing steel to corrosive environments; initially observed as a brownish oxidation staining, followed by spalling of the concrete cover from expanding oxides.

Figures 17A and 17B: S01 of 19042, EB I-69 over US-127 near Lansing, MI. Constructed in 1985, this slipform concrete barrier was constructed at the same time, using the same materials as the cast-in-place barrier described in Figure 16. The type and magnitude of distress is typical of slipform barriers in Michigan.

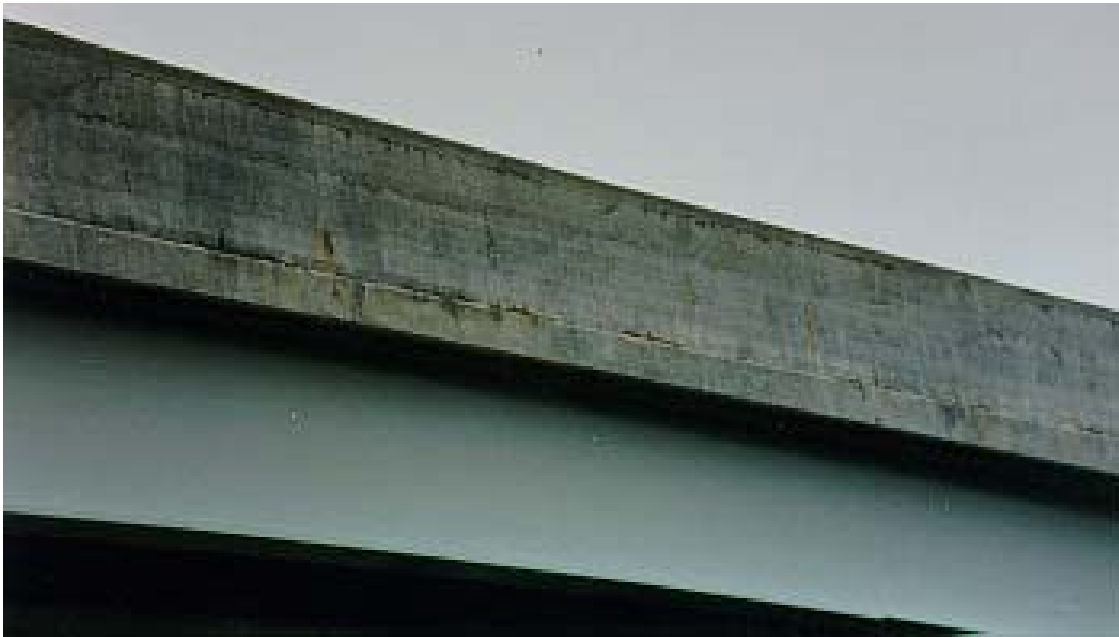
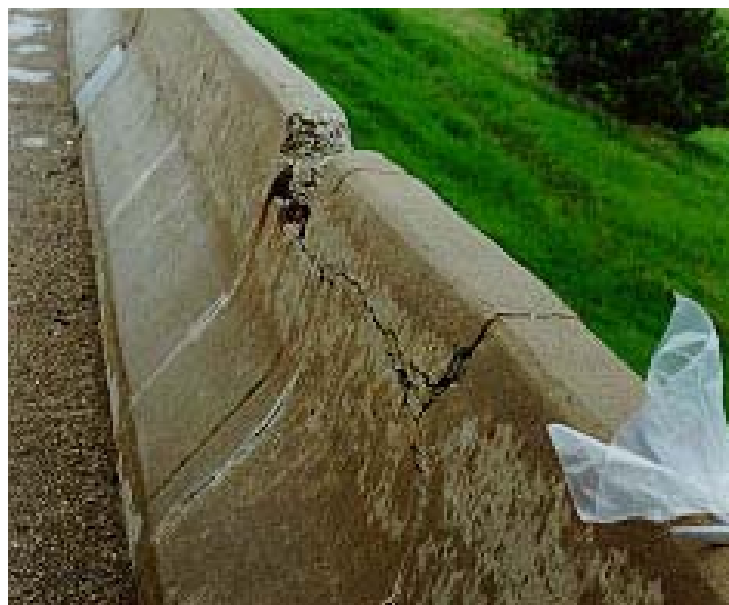
One location of particular interest is near the top of the barrier structure. Many barriers (particularly slipform) experience distinct continuous longitudinal/horizontal cracking and staining approximately 4 inches below the top surface of the barrier. These cracks are believed to originate during the concrete's early-age semi-hardened state. As the concrete slumps under its own weight (often the case when the uniformity of the concrete slump is poorly maintained),

the top 4 inches of the barrier supported by the top longitudinal reinforcement is restrained from settlement as its parent the lower mass slumps downward. The early-age tensile stresses experienced at the interface between the supported top concrete and the slumping lower concrete mass produce longitudinal micro-cracks not noticeable to the naked eye. Over time, the top 4 inches of the barrier breaks away, either as a result of corrosion of the reinforcing steel, thermal stresses, or from deterioration caused by freezing and thawing of the moisture within the concrete. This mode of deterioration is a noted concern especially at structures where falling concrete is a safety hazard. This can be seen in Figures 18A and 18B.

Figure 18A and 18B: Typical advanced deterioration of horizontal crack. Note the oxidation staining from the black reinforcing steel, further leading to expansion and ultimate failure of the concrete due to corrosion expansion.

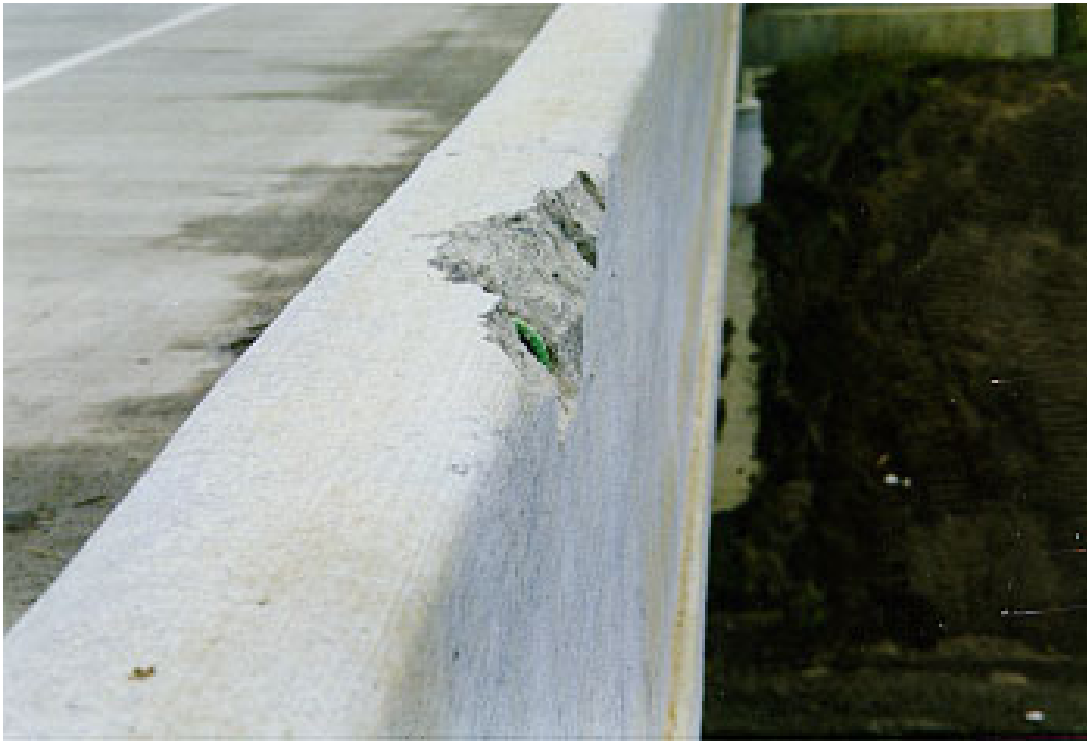
Observations supporting even early-age potential problems at this interface were noted on two newly constructed barriers at Walker Road and Alward Road over US-27 in Clinton County. At these locations, approximately 18 inches longitudinally along the top surface of two of the barriers delaminated to the depth exposing the top longitudinal No. 4 reinforcing bar and stirrup. Voids were noted under the steel at the exposed locations which also are believed to have contributed to suspected stress concentrations and eventual breakaway spalling of concrete surface at these locations. Figure 19 shows the early-age surface failure of the barrier at Alward Road just six weeks after barrier construction.

Figure 19: Early-age surface failure of barrier at Alward Road over US-27 in Clinton County.

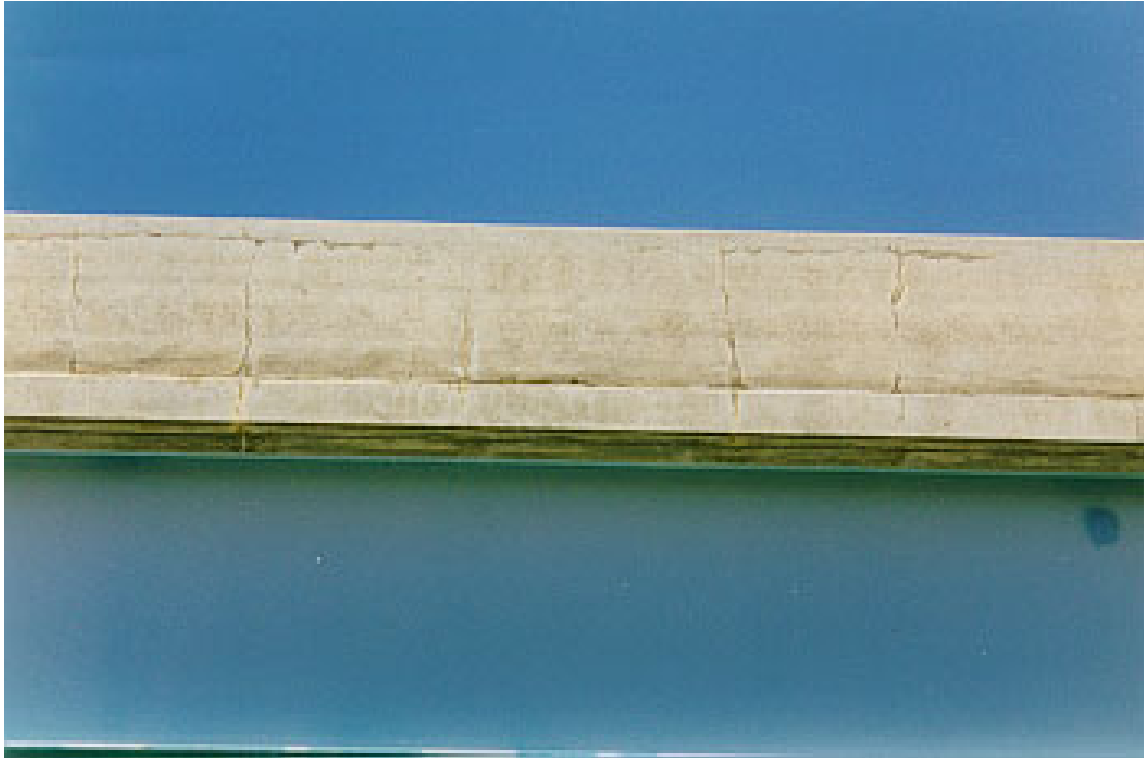
Spalling of these barrier tops was reported during a distinct warming period in late spring. Another barrier located on westbound I-496 over the Red Cedar River in Lansing, as seen in Figure 20, shows longitudinal cracking within three years after construction. Laboratory technical staff was on-site during construction in 1995 to observe slipform barrier construction. As observed, the ambient weather conditions were hot and windy. This contributed to excessive loss of moisture from the fresh concrete surface due to the typical time that the fresh concrete was exposed to the environment prior to application of curing compound. The result was an unwarranted need for excessive hand-finishing after concrete placement of the concrete barrier surfaces in attempts to restore its visual appearance. Many concrete barriers visually noted but not documented in this study exhibit similar premature deterioration characteristics.

Figure 20: Typical horizontal crack deterioration noted within three years after barrier construction (WB I-496 over the Red Cedar River in Lansing). These tensile stress cracks in slipform barriers are a result of early-age stresses developed from slumping plastic concrete.

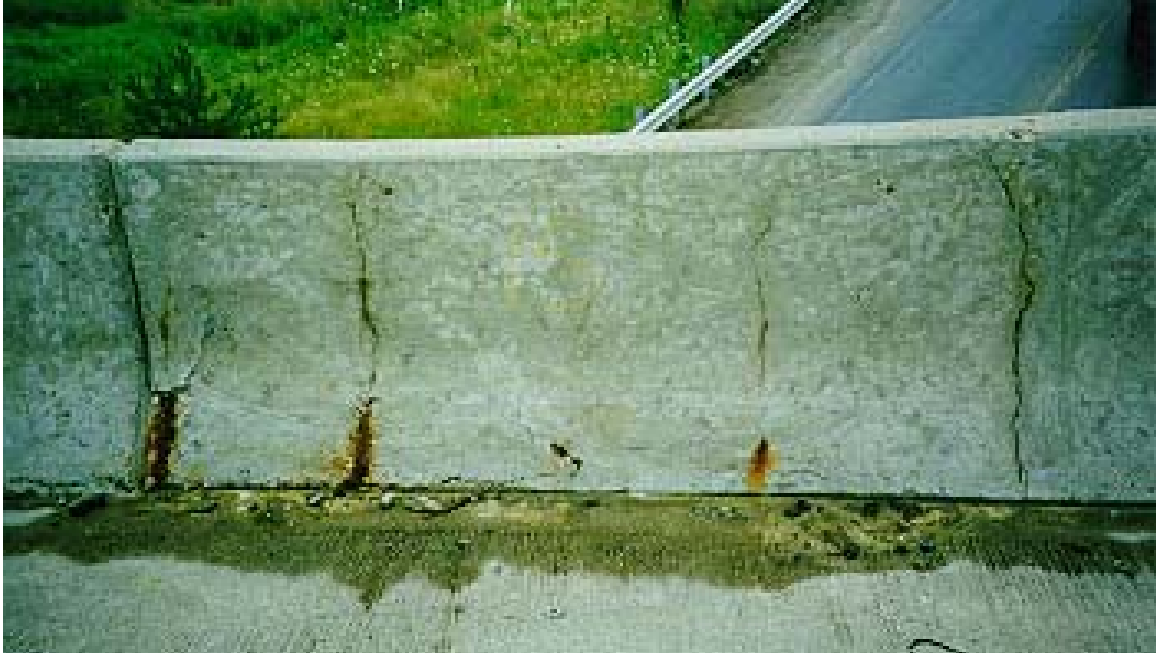
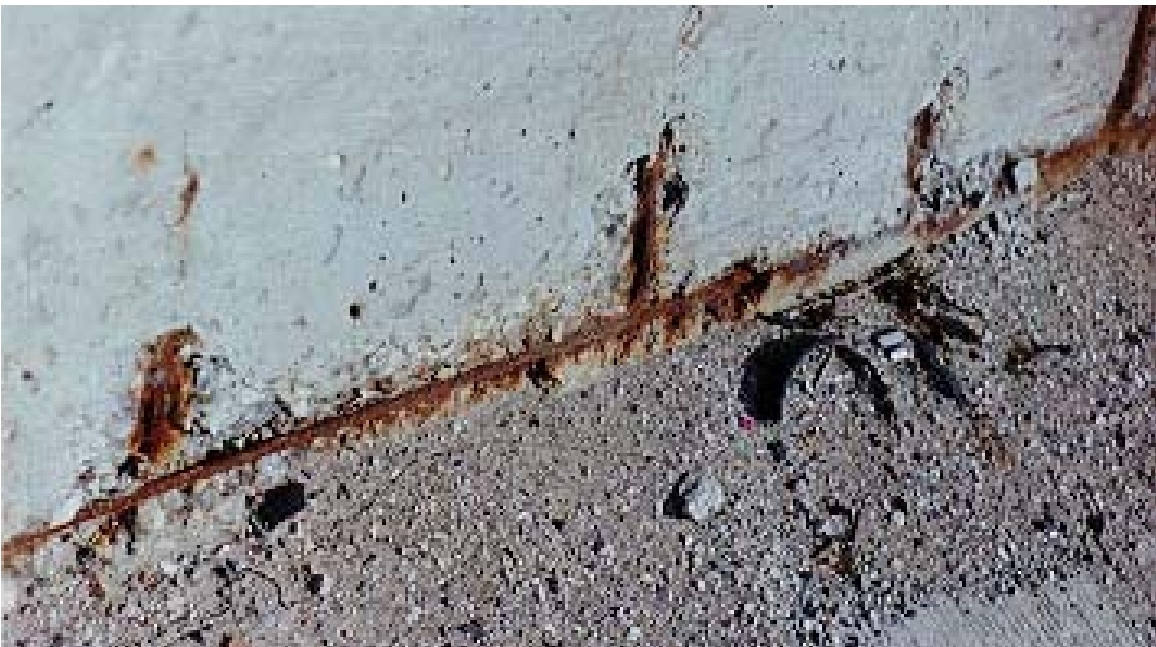
A concern that contributes to poor performance of slipform barriers is the lack of the ability to conduct thorough quality control construction inspections to assure minimum protective concrete cover over reinforcing steel prior to slipform concrete placement. Figures 21A and 21B show typical deterioration due to insufficient concrete cover over black reinforcing steel. Further aggressive concrete deterioration and corrosion of black reinforcing steel as a result of inadequate protective concrete cover at the toe of the barrier may be further aggravated by impact and abrasion brought on by highway snow removal equipment.

Figures 21A and 21B: Examples of corrosion of black reinforcing steel due to insufficient concrete cover.

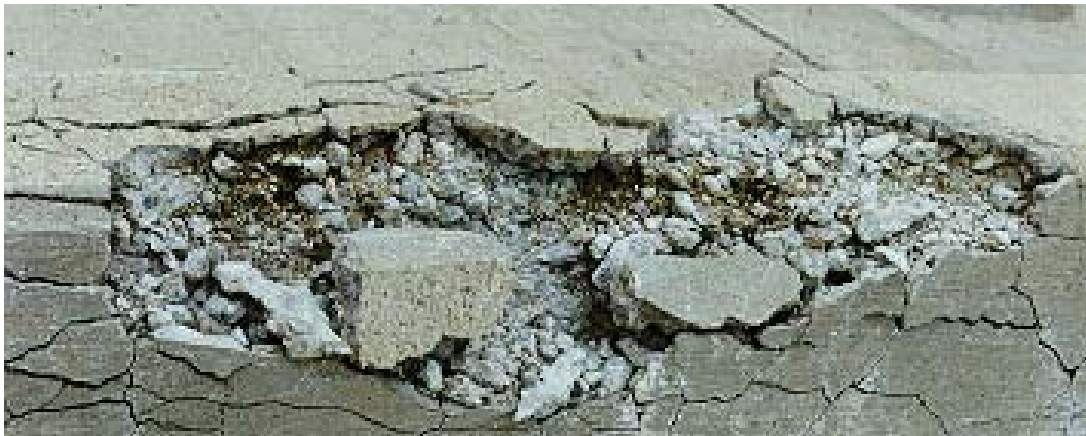
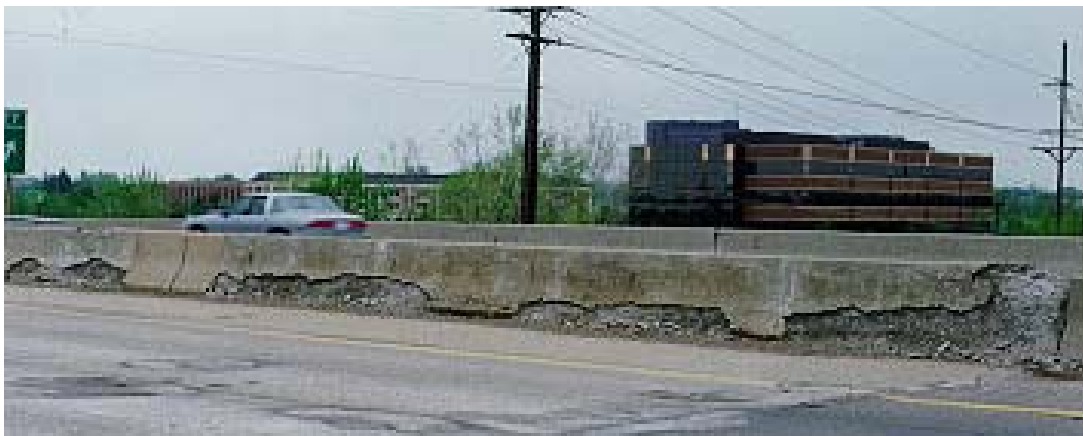
Figure 22A and 22B: Median barrier on I-94 west of State Road in Ann Arbor.

Regardless of the method of construction, concrete barriers constructed using blast-furnace slag coarse aggregate show significantly higher levels of premature decay than barriers constructed with higher quality quarried or natural gravel coarse aggregates. A characteristic indicator of a barrier constructed using blast-furnace slag coarse aggregate is one possessing a massive amount of surface drying shrinkage cracks. Many are clustered representing a “turtle shell” pattern initially noticeable only shortly after rainfall when the surface has dried, but moisture is still observed weeping from these fine surface cracks. Eventually, the thin platelets encompassed by the turtle shell cracking patterns spall. The spalling then exposes the interior concrete to the harsh environment. One other characteristic indicative of barriers constructed using blast-furnace slag coarse aggregate is severe longitudinal deep cracks propagating along the top concrete surface. Over time, aggressive environmental stresses from moisture absorption widen and deepen the longitudinal cracks, eventually causing the barrier top to crumble and fall away. It is evident by field observations that slipform barriers constructed using blast-furnace slag coarse aggregate show the highest level of premature decay. Figures 22 through 24 show characteristic deterioration of the median barrier on I-94 west of State Street in Ann Arbor, and a fascia barrier on US-23 over the Huron River in Washtenaw County, both constructed using blast-furnace slag coarse aggregates.

- Conduct thorough candidate surveys by region to assess barriers for programmed replacement.
- Discontinue the use of blast-furnace slag and other highly absorptive/low durability coarse aggregates in Portland cement concretes used for all barrier/railing applications.
- Discontinue the use of slipform construction method for barrier construction applications.
