## **Field Test and Finite Element of I-345 Bridge in Dallas**

CTR Technical Report:	5-4124-01-2
Report Date:	July 10, 2009
Project:	5-4124-01
Project Title:	Field Test and Finite Element of I-345 Bridge in Dallas
Sponsoring Agency:	Texas Department of Transportation
Performing Agency:	Center for Transportation Research at The University of Texas at Austin

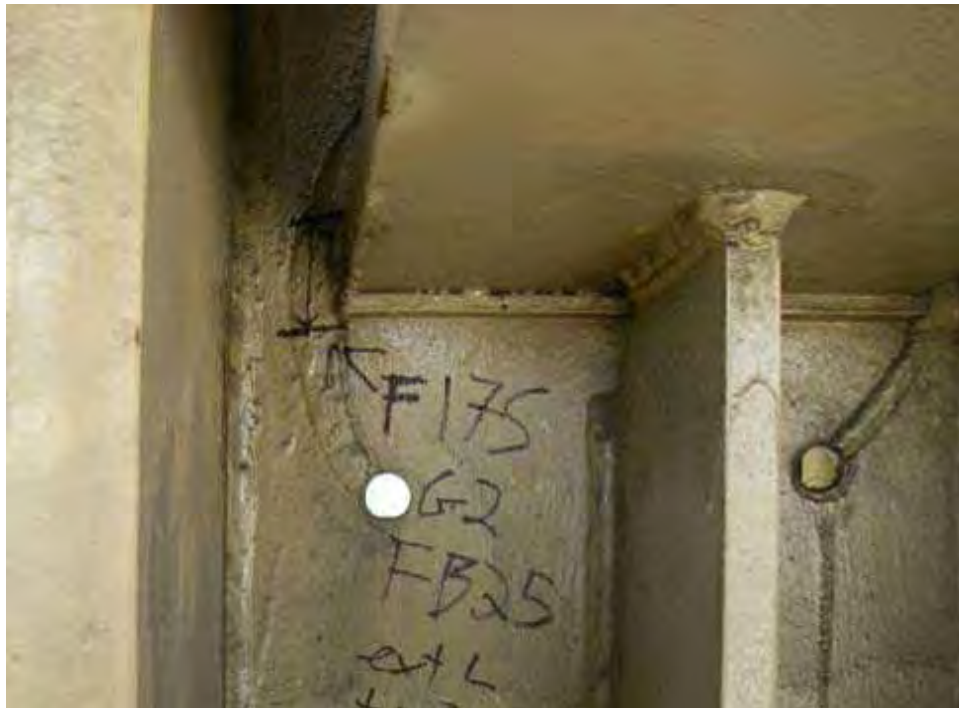
*Figure 1.3: Cracked Weld Repair in Gap between Bearing Stiffener and Bottom Flange of Floor Beam*

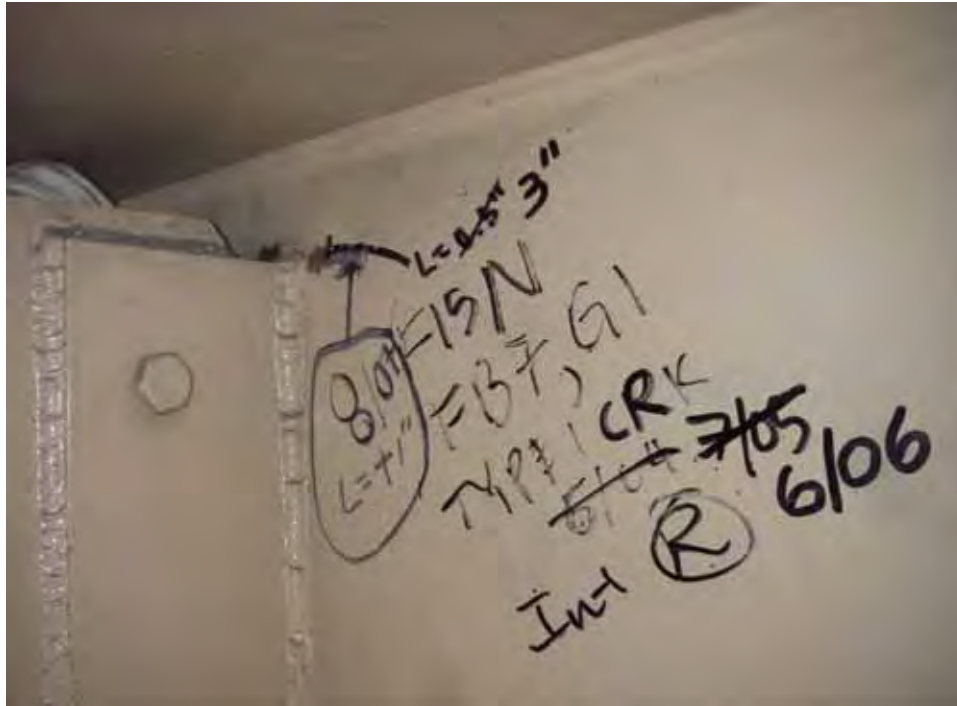
Cracking occurred in the girder web where the bottom floor beam flange is welded to the girder web. When the floor beam is at a pier the floor beam flanges frame into the web between the bearing stiffeners (Figure 1.2). The resulting small gap between the stiffener and flange welds causes high stresses to occur at the weld toes from displacement of the floor beam flange. These cracks typically formed an arc shape in the girder web around the edges of the bottom floor beam flange. Figure 1.3 shows the cracking that occurred at these locations. Cracking also occurred on the girder web in the gap between the top flange of the girder and the web of the connecting floor beam. The stiffener connecting the floor beam and girder webs is not attached to the top flange of the girder. This creates a small gap in the girder web where differential deflection between the two girders causes the floor beam to rotate creating very high stresses. Figure 1.4 shows an example of cracking at this location.

*Figure 1.4: Crack in Web Gap*

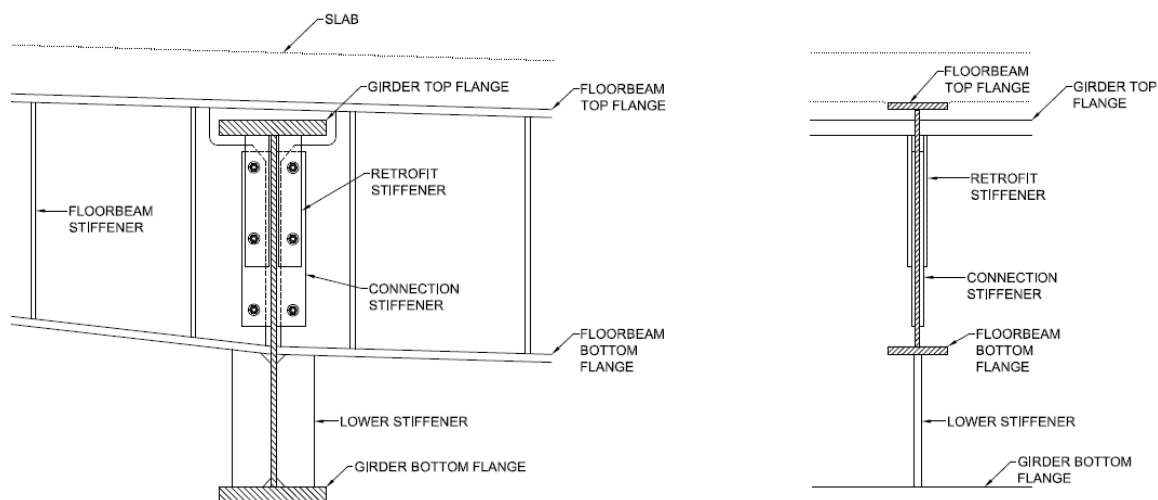
*Figure 1.5: Typical Retrofitted Connection of Floor Beam to Girder*

A retrofit was performed in 2004 in an attempt to mitigate the cracking. Many of the cracks were welded and arrestor holes were drilled at the crack tips to relieve the stress. This repair can be seen in Figure 1.3. The retrofit also consisted of adding retrofit stiffeners on top of the stiffeners connecting the floor beams to the girders. These stiffeners were welded to the top flange of the girder in order to close the previously mentioned gap where cracking had occurred. Figures 1.5 and 1.6 show a detail and picture of a retrofitted connection. Some of the welds were also subjected to ultrasonic impact treatment to improve their fatigue performance.

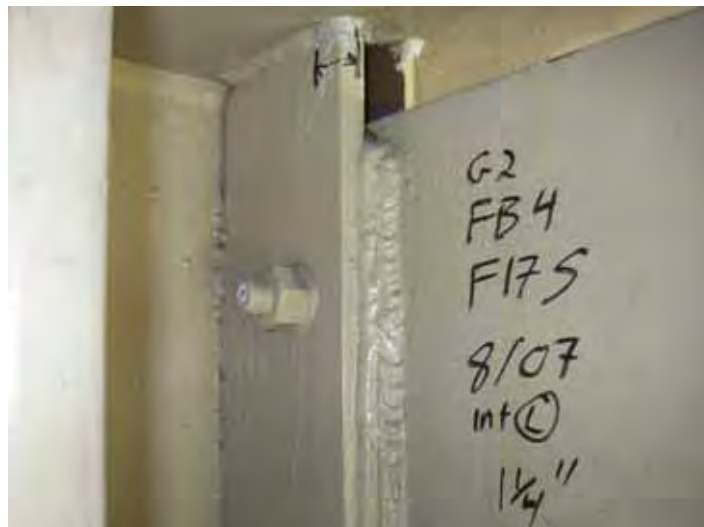
Since the retrofit, new cracks have developed at the connections. Figures 1.7 through 1.9 show three types of new cracks that formed where retrofit stiffeners were placed. New cracks also developed in the area between the bearing stiffeners and the bottom flange of the floor beams. Figure 1.10 shows an example of this type of crack that formed at the toe of the bearing stiffener weld. This type of crack formed due to the rotation of the floor beams, creating a region of high stress in this small area.

*Figure 1.7: Crack at Connection of Retrofit Stiffener to Top Girder Flange*

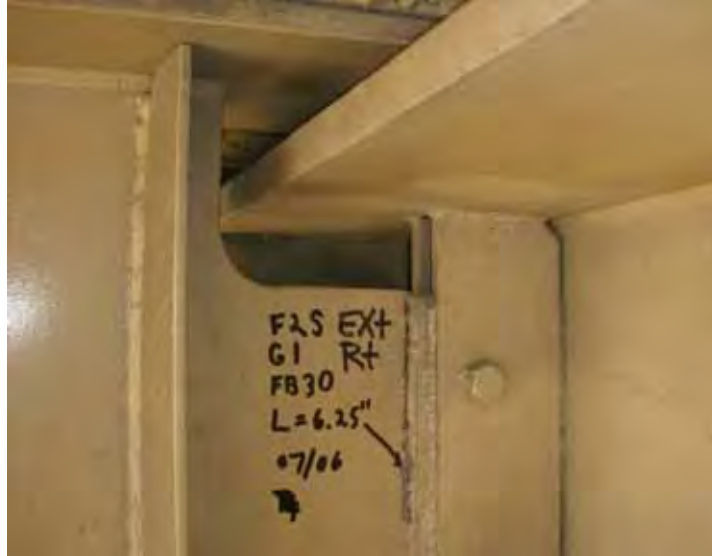
*Figure 1.8: Crack at Weld Connecting Existing Stiffener to Floor Beam Web*

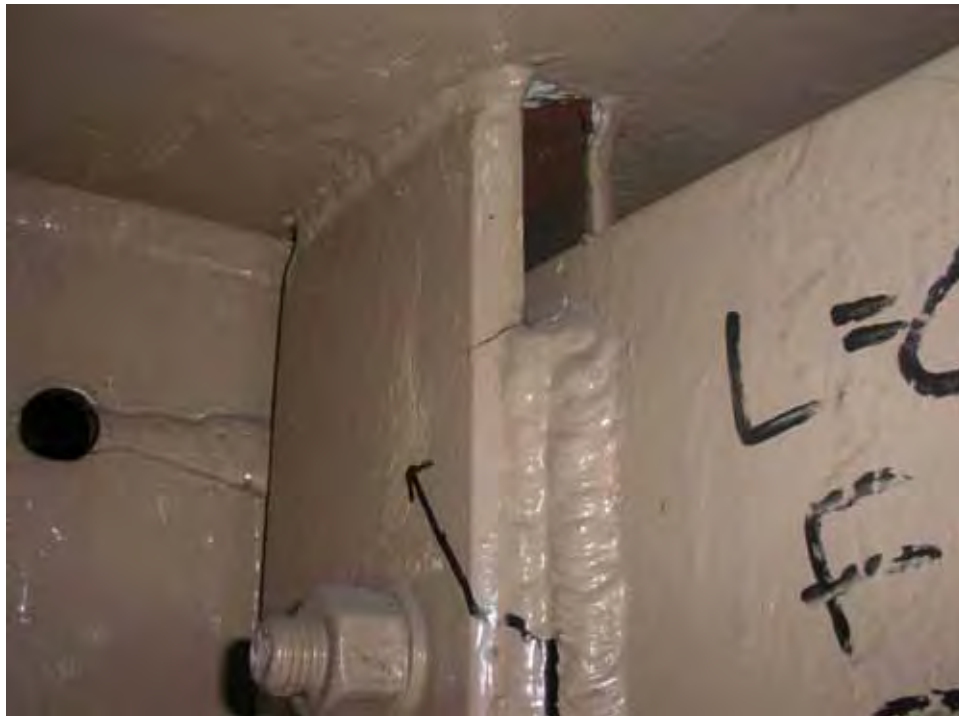
*Figure 1.9: Crack at Weld Connecting Retrofit Stiffener to Existing Stiffener*

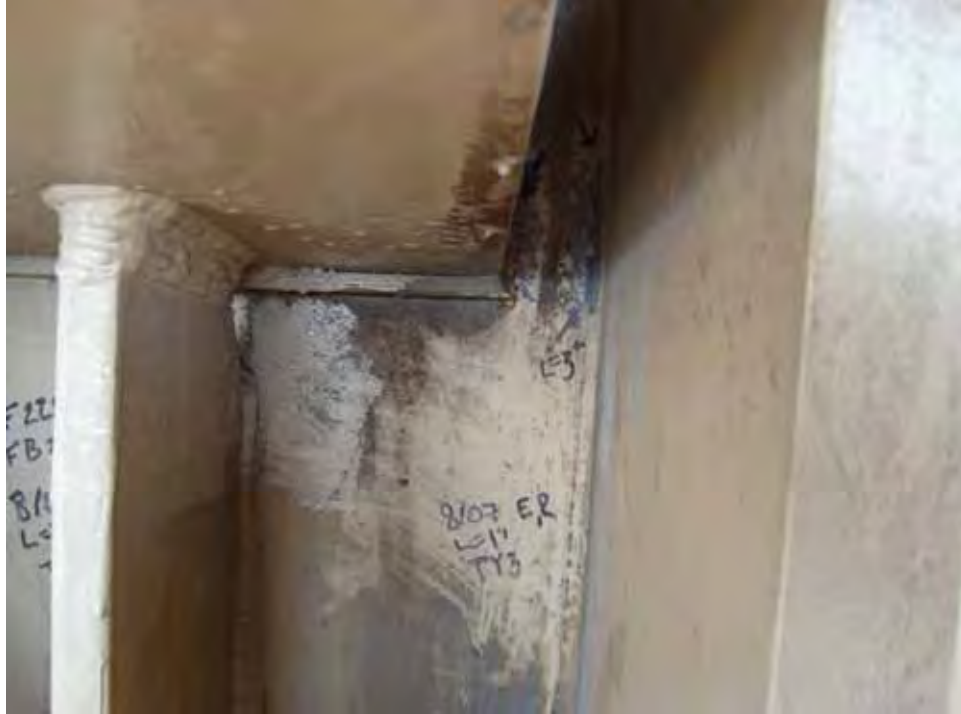
*Figure 1.10: Cracks between Bearing Stiffener and Bottom Flange of Floor Beam*

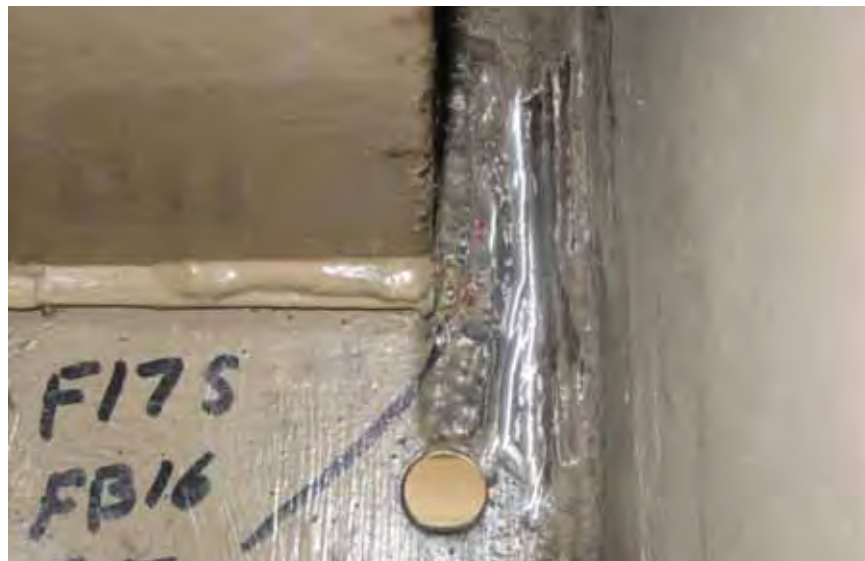
*Figure 2.8: Gap between Bottom Flange of Floor Beam 16 and Bearing Stiffener*
