Structural Steel Coatings for Corrosion Mitigation

**NUTC
R233
R238**

Prepared for
Missouri Department of Transportation
Organizational Results

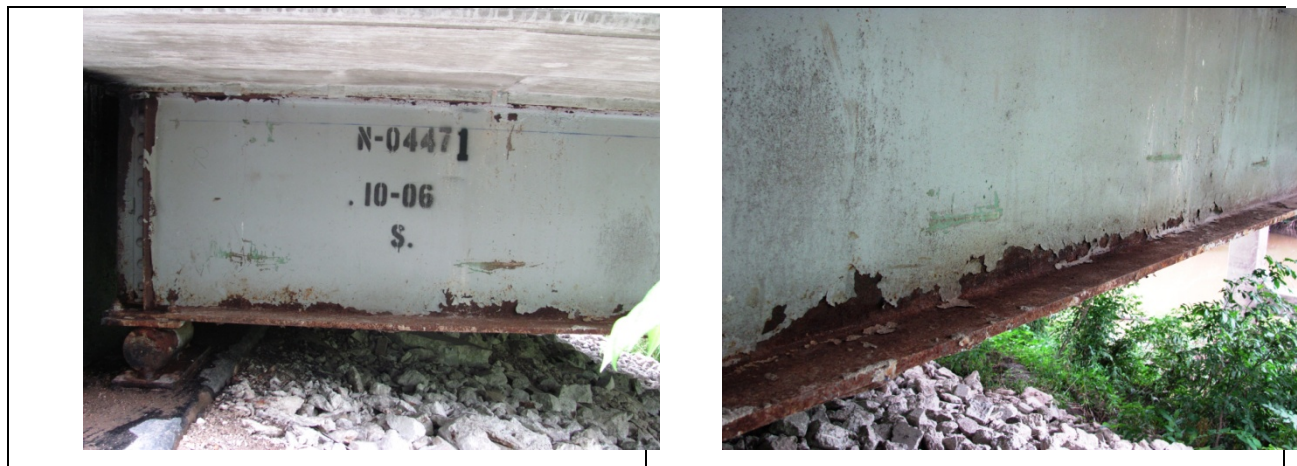
An example of the over-coating with an early failure is shown in Figures 4.2 and 4.3 below. The photos below show zone painting, or limited over-coating by a maintenance crew.

Figure 4.2 Example of System S Coating with Early Failure, End-span of Fascia Girder.

Original paint was System C and fascia girders and end-span zone were painted with System S in 2006. Current condition of the end-span is rated as very poor since rust amount is more than 10%. This might result from inadequate adhesion between the existing coat and the new coating system. However, more likely it's a combination of limited mechanical surface cleaning resulting in corrosion and chlorides remaining on the surface of the steel, the continued exposure to aggressive wet-dry cycles from the leaking joint above. This combination of conditions results in an early over-coating failure. For this bridge, a deck renovation has likely improved the local environment and a second round of over-coating would likely perform much better. However, even with the renovated deck, the wet abutment face

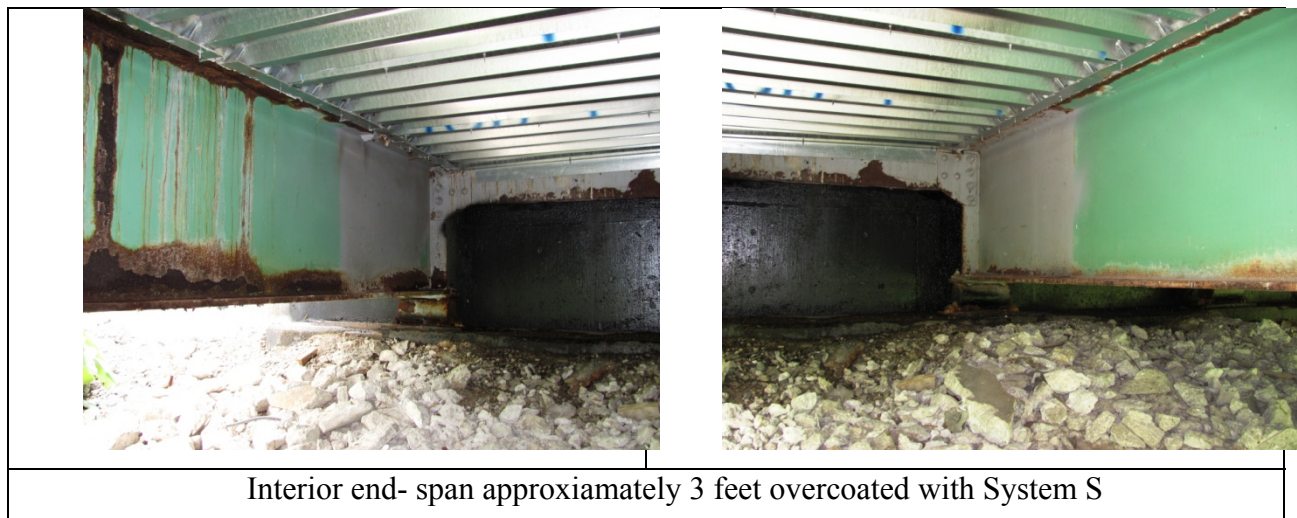
Figure 4.3 Example of a System S End-span Recoating at the Bearing Area with Early Failure.

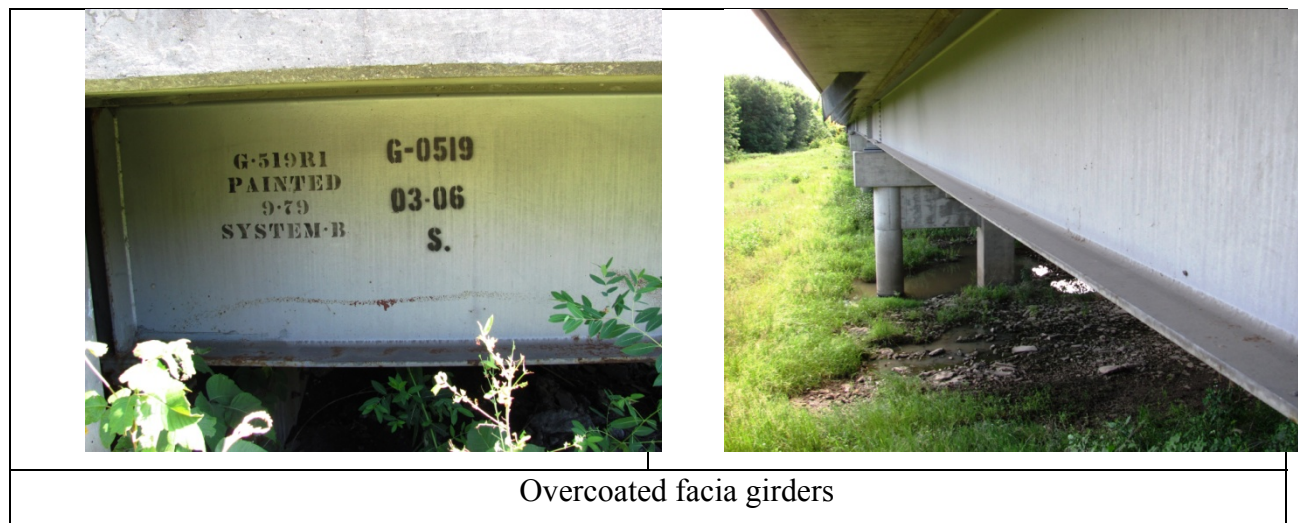
In contrast, Figure 4.4 below shows the fascia girders and beam-end for a bridge overcoated in 2006 with a beam-end rating of fair. Rust amount is less than 1%. This bridge shows good performance of the overcoat with regard to its condition rating. In this case the over-coating is performing well, though there is some rust-back beginning to appear in certain areas near the beam-ends where there is leakage from the expansion joint. In this case, a bridge deck renovation with prestressed panels and extended scuppers is successfully keeping deck drainage from the superstructure.

Figure 4.4 Example of System S Overcoating with Good Performance.

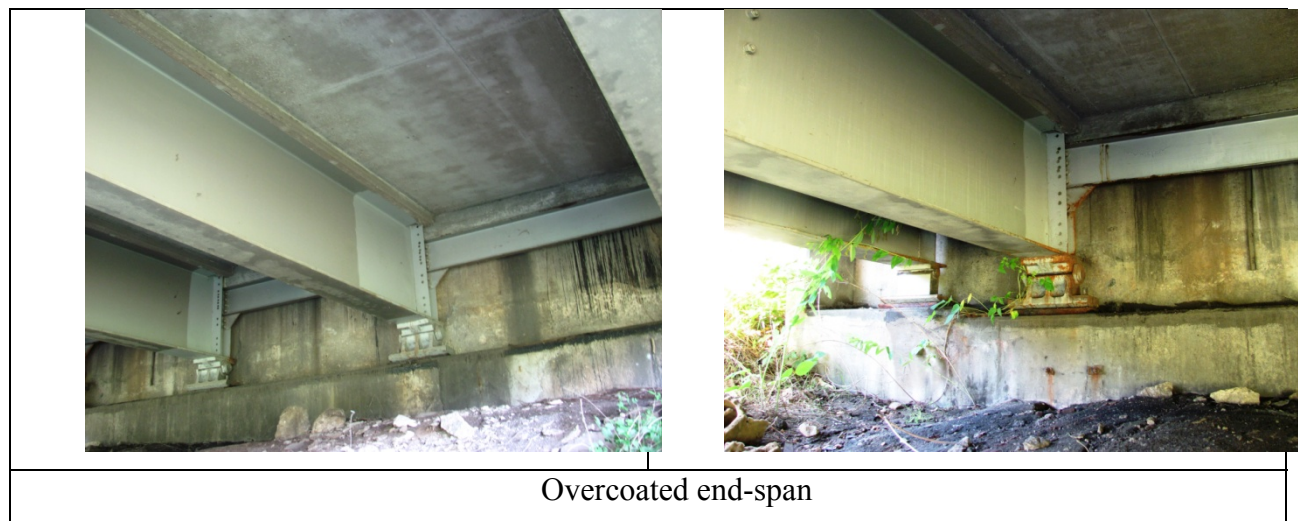
Figure 4.5 Example of Interior Beam-ends with System S Overcoating.

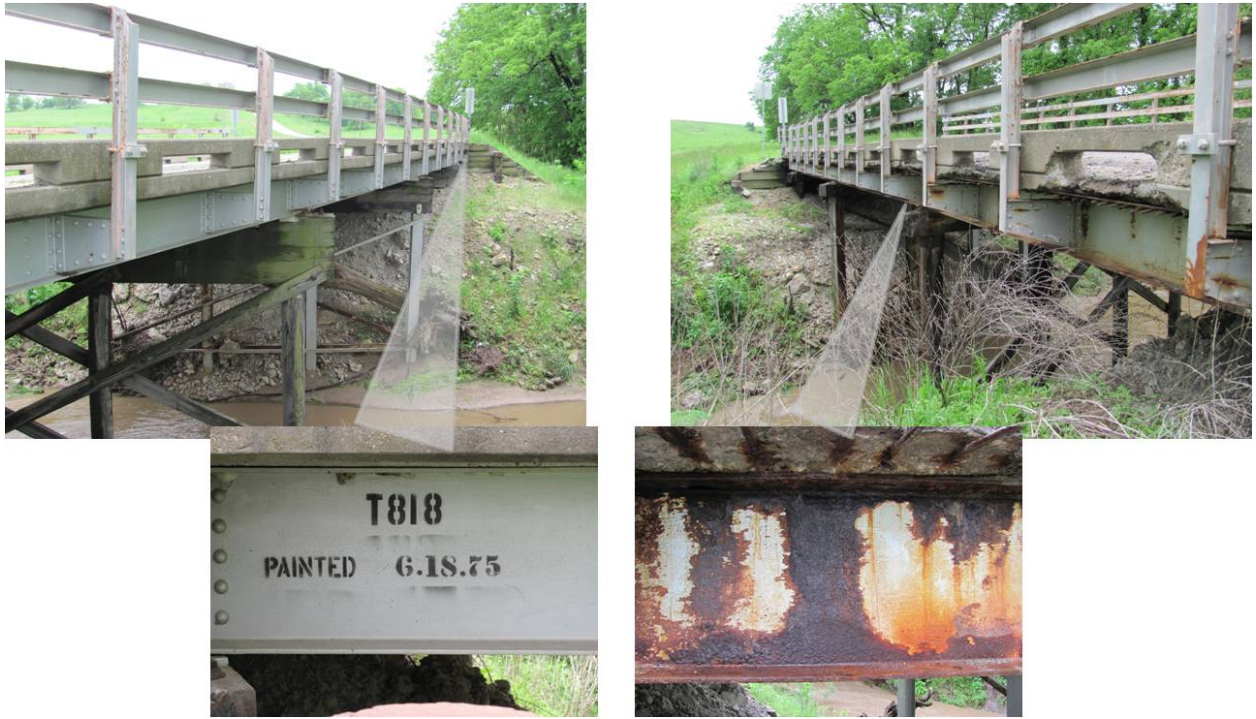
An example of the deck drainage issue is shown in Figure 4.7 that shows a System A coating after 35 years of service life. In this case, the deck drains primarily through deck drains on one side of the bridge. On the uphill side, where little drainage occurs, the coating system is in nearly pristine conditions after a little more than 35 years in service. On the other hand, on the downhill side where the primary deck drainage is occurring, the coating system is in advanced stages of deterioration and in very poor condition. As this Figure illustrates, the age in service of the coating has little relevance to its condition; the condition is driven primarily by the drainage patterns at the particular bridge.

Figure 4.7 Example of the Effects of Deck Drainage on Coating Condition.

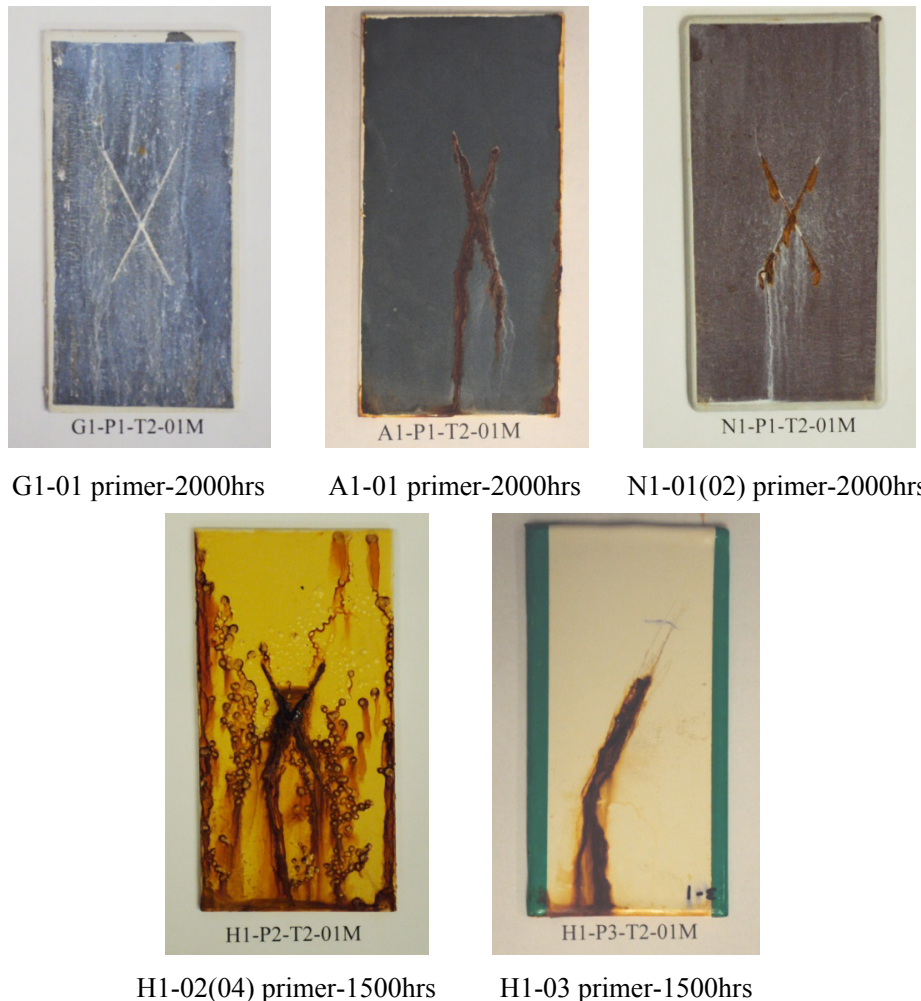
According to the evaluations and descriptions presented in Table 5.6, system G, having high solid inorganic zinc silicate as its primer, performed the best of all the systems in phase I. Systems A1-01, N1-01, and N1-02 performed well as expected due to the existence of organic primer. System A1-01, which used a polyaspartic polyurea as the topcoat, and system N2-02, which used a fluoropolymer topcoat, had remarkable performance in the lab tests. Both of these systems had better (i.e. higher) adhesion strength and higher UV weathering stability than other coatings with zinc primer. Besides system A1-01, systems H1-03, H1-04, and I1-02 also performed very well as far as polyurea type coatings systems were concerned in the salt fog testing evaluation. Some polyurea type coatings investigated had less desirable test results due to the inferior performance of their primers. The primers were vulnerable to the salt fog test which can be seen in Figure 5.1.

Figure 5.1 Primer Performance After 2000 (or 1500)-hour Salt Fog Test.

Figure 5.1 illustrates the salt fog resistant performance of several primers used in Phase I. Table 5.7 presents the adhesion results after 3000-hr of salt fog exposure. Within this table, the failure mode of the adhesion test is also reported. The primer for system G performed the best of all and there was no rust bleeding that occurred at the scribe. Primer for system H1-02/H1-04 had a full blistering surface and large creepage at the scribe. However, system H1-04 performed very well due to the thick and tough topcoat. The primer without sacrificial zinc corroded fast in the salt fog test, but was also able to give good protection if the topcoat can be properly selected.
