CENTER FOR TRANSPORTATION INFRASTRUCTURE AND SAFETY

Spalling Solution of Precast -Prestressed Bridge Deck Panels

Lesley Sneed, Ph.D., P.E. Abdeldjelil "DJ" Belarbi, Ph.D., P.E. Young-Min You, Ph.D., P.E.

FINAL REPORT

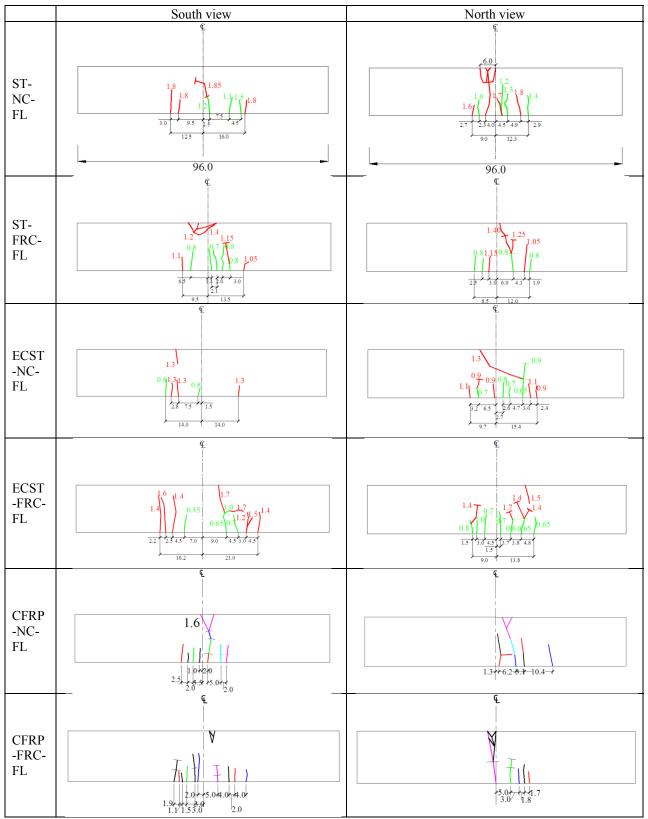
Figure 5-15 Crack Patterns from Quasi-static Test after 2 Million Cycles

Due to the nature of the test setup, the bottom surface of the test specimens was not visible during testing. Thus, cracks were observed and marked on the two side surfaces during testing. Cracks were visible on the side surfaces at load and displacement levels slightly higher than these values. The initial cracks were flexural cracks that appeared beneath the spreader beam location. As the applied displacement (and resulting applied load) was increased, additional flexural cracks appeared and existing cracks propagated upward. At the maximum load, the cracks near the edge of the loading zone propagated through the entire thickness of the panel penetrating the flexural compression zone. Crack patterns for each specimen are shown in Figure 5-15 and Appendix C.
