# **Bathymetric Surveys at Highway Bridges Crossing the Missouri River in Kansas City, Missouri, using a Multibeam Echo Sounder, 2010**

Scientific Investigations Report 2010–5207

By Richard J. Huizinga

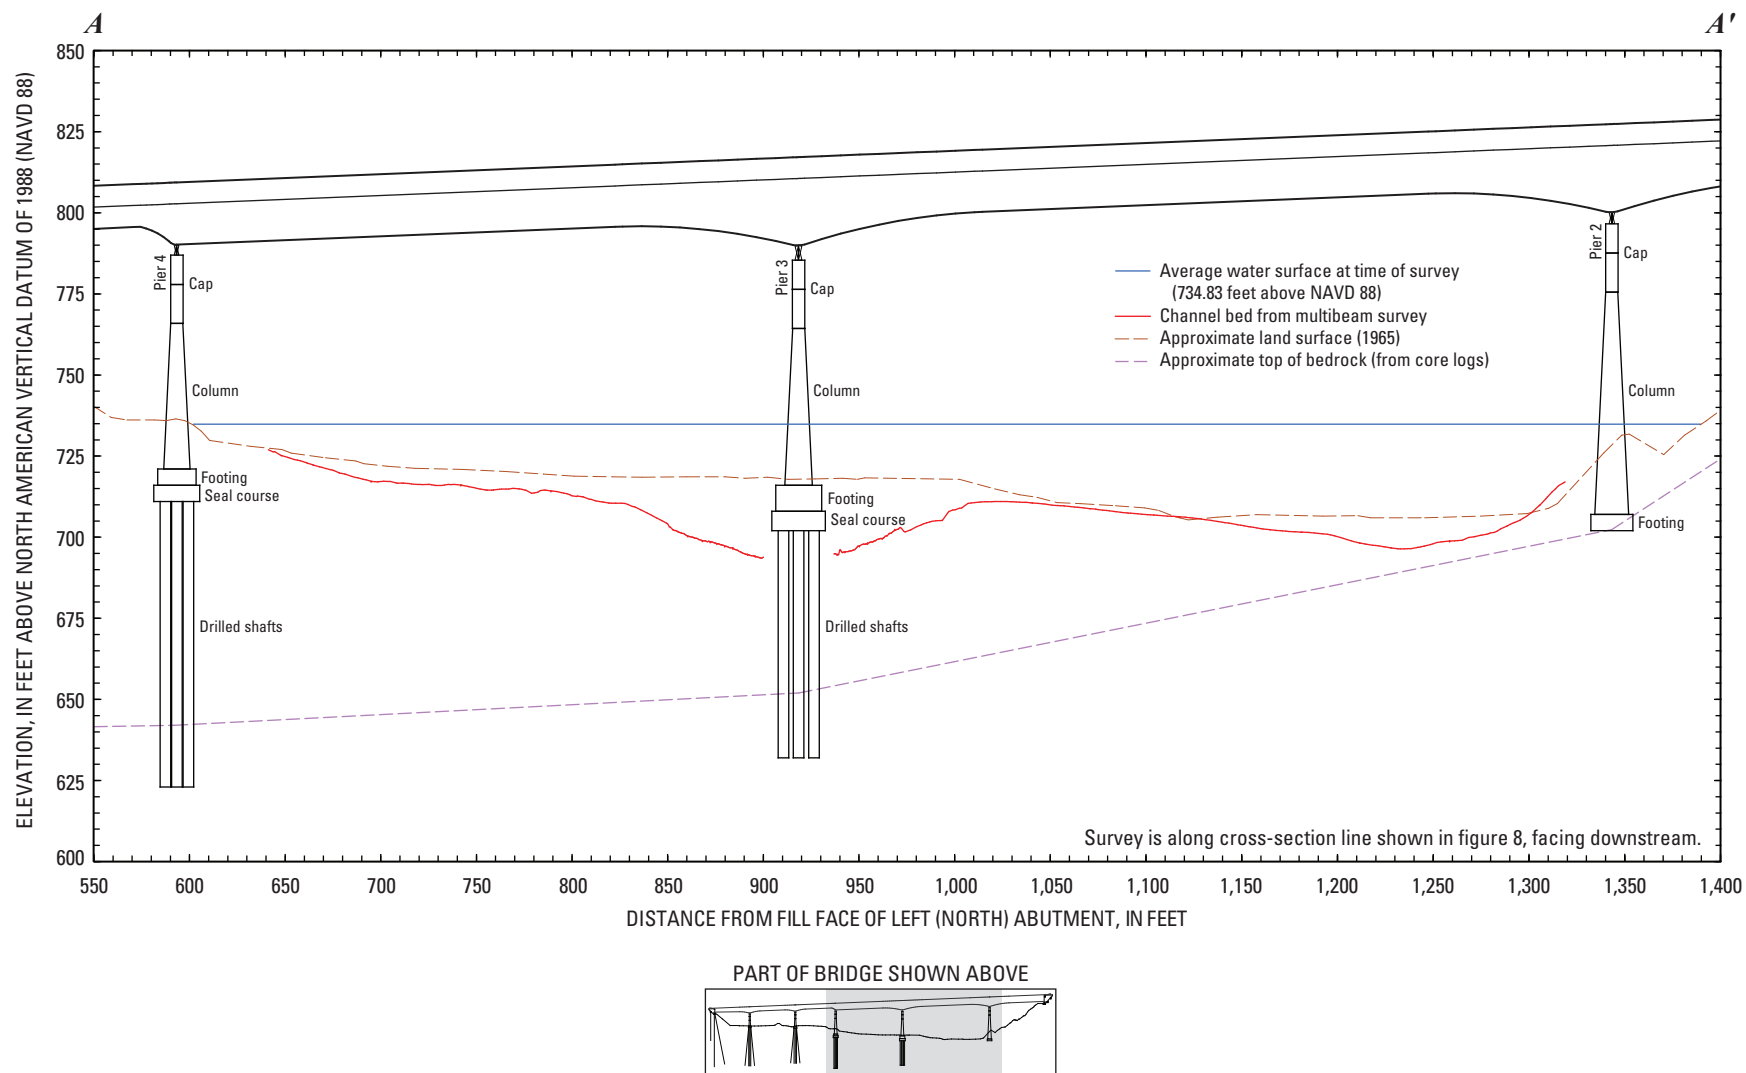
**Figure 10.** Key features, substructural and superstructural details, and surveyed channel bed of structure A1800 on Interstate 635 over the Missouri River in Kansas City, Missouri.

In the vicinity of the main channel pier (pier 3, fig. 9), a scour hole had a minimum elevation of about 693 ft (table 4), about 18 ft below the average channel bed immediately upstream from the pier and 9 ft below the elevation of the bottom of the pier seal course of 702.28 ft (fig. 10; table 5). Information from bridge plans indicates that the main channel pier of structure A1800 is founded on shafts drilled 20 ft into bedrock, with about 41 ft of bed material between the bottom of the scour hole and bedrock (table 5). A point cloud visualization of the multibeam depth points obtained during the survey indicated the bottom of the seal course as a sonic “shadow” (fig. 11).

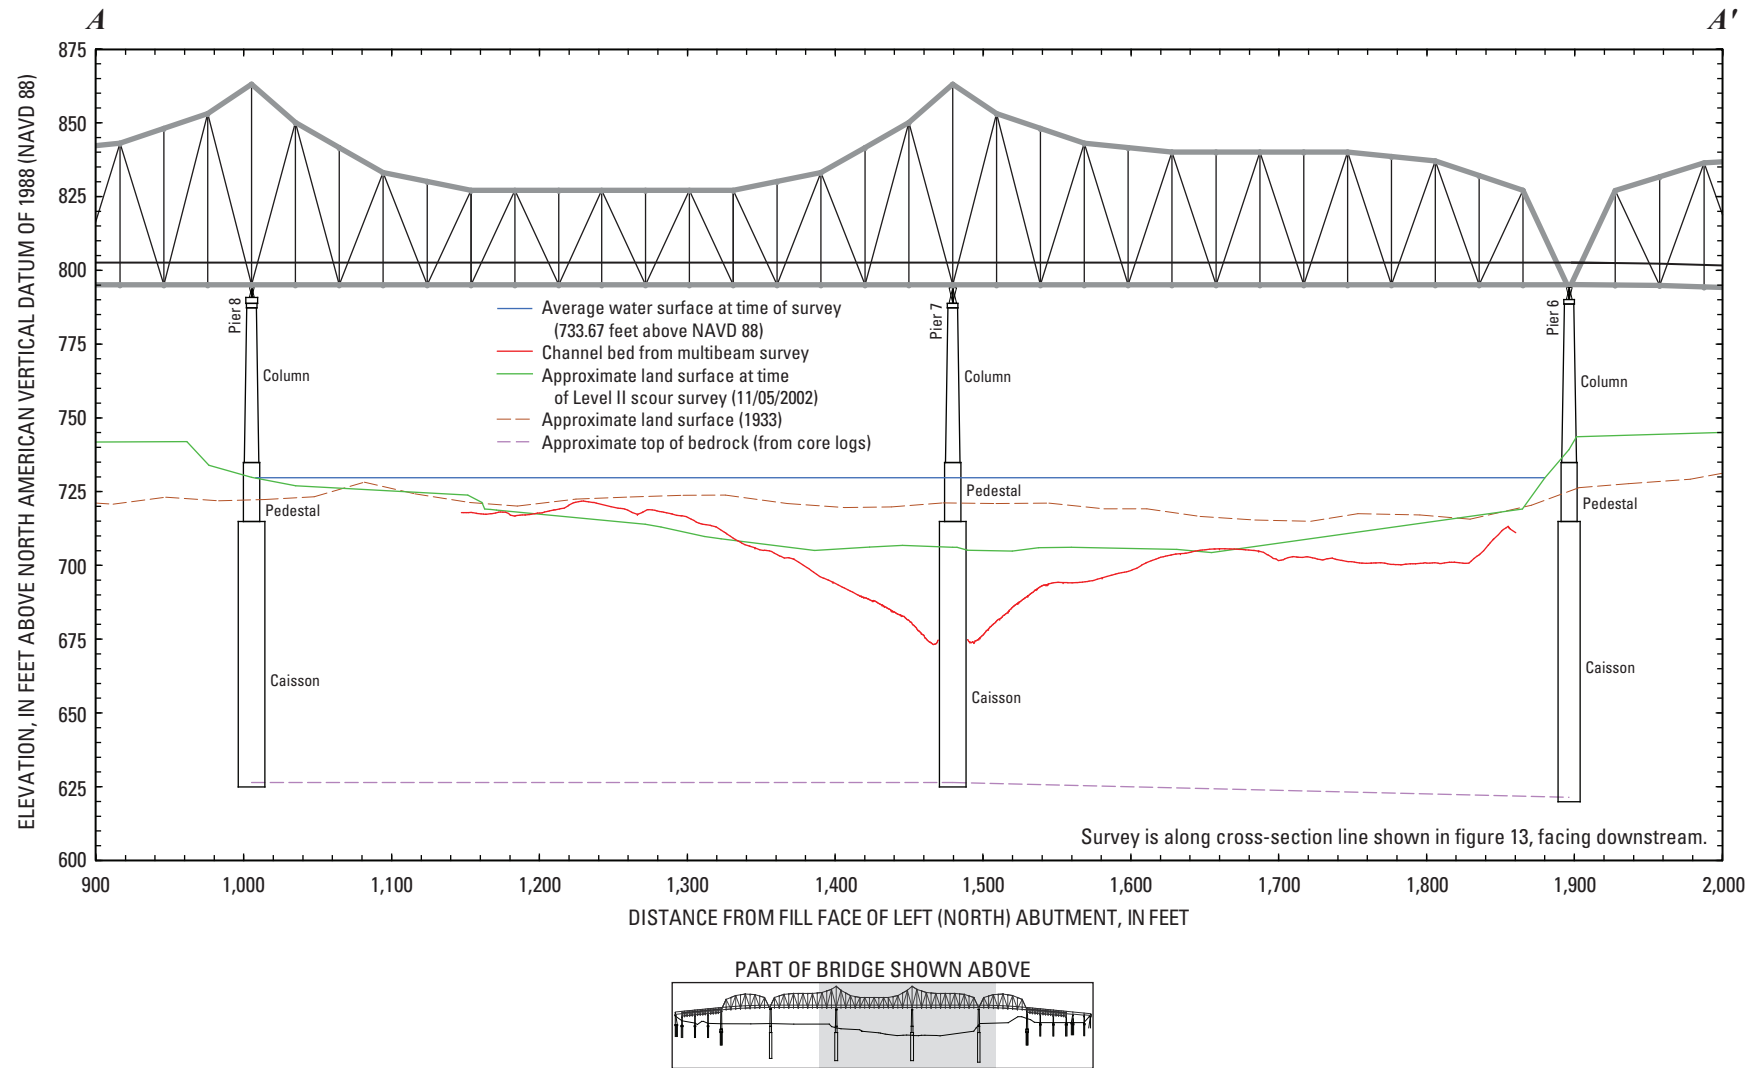
**Figure 15.** Key features, substructural and superstructural details, and surveyed channel bed of structure K0456 on U.S. Highway 69 over the Missouri River in Kansas City, Missouri.

Information from bridge plans indicates that the main channel piers of both structures K0456 and A0450 are caissons on bedrock (figs. 15, 16). About 45 ft of bed material was between the bottom of the deeper scour hole at structure K0456 and the bottom of the caissons (fig. 15; table 5). The surveyed channel bed was about 18 ft deeper than the channel bed from the Level II scour survey in 2002 along the right (south) bank (figs. 15, 16).

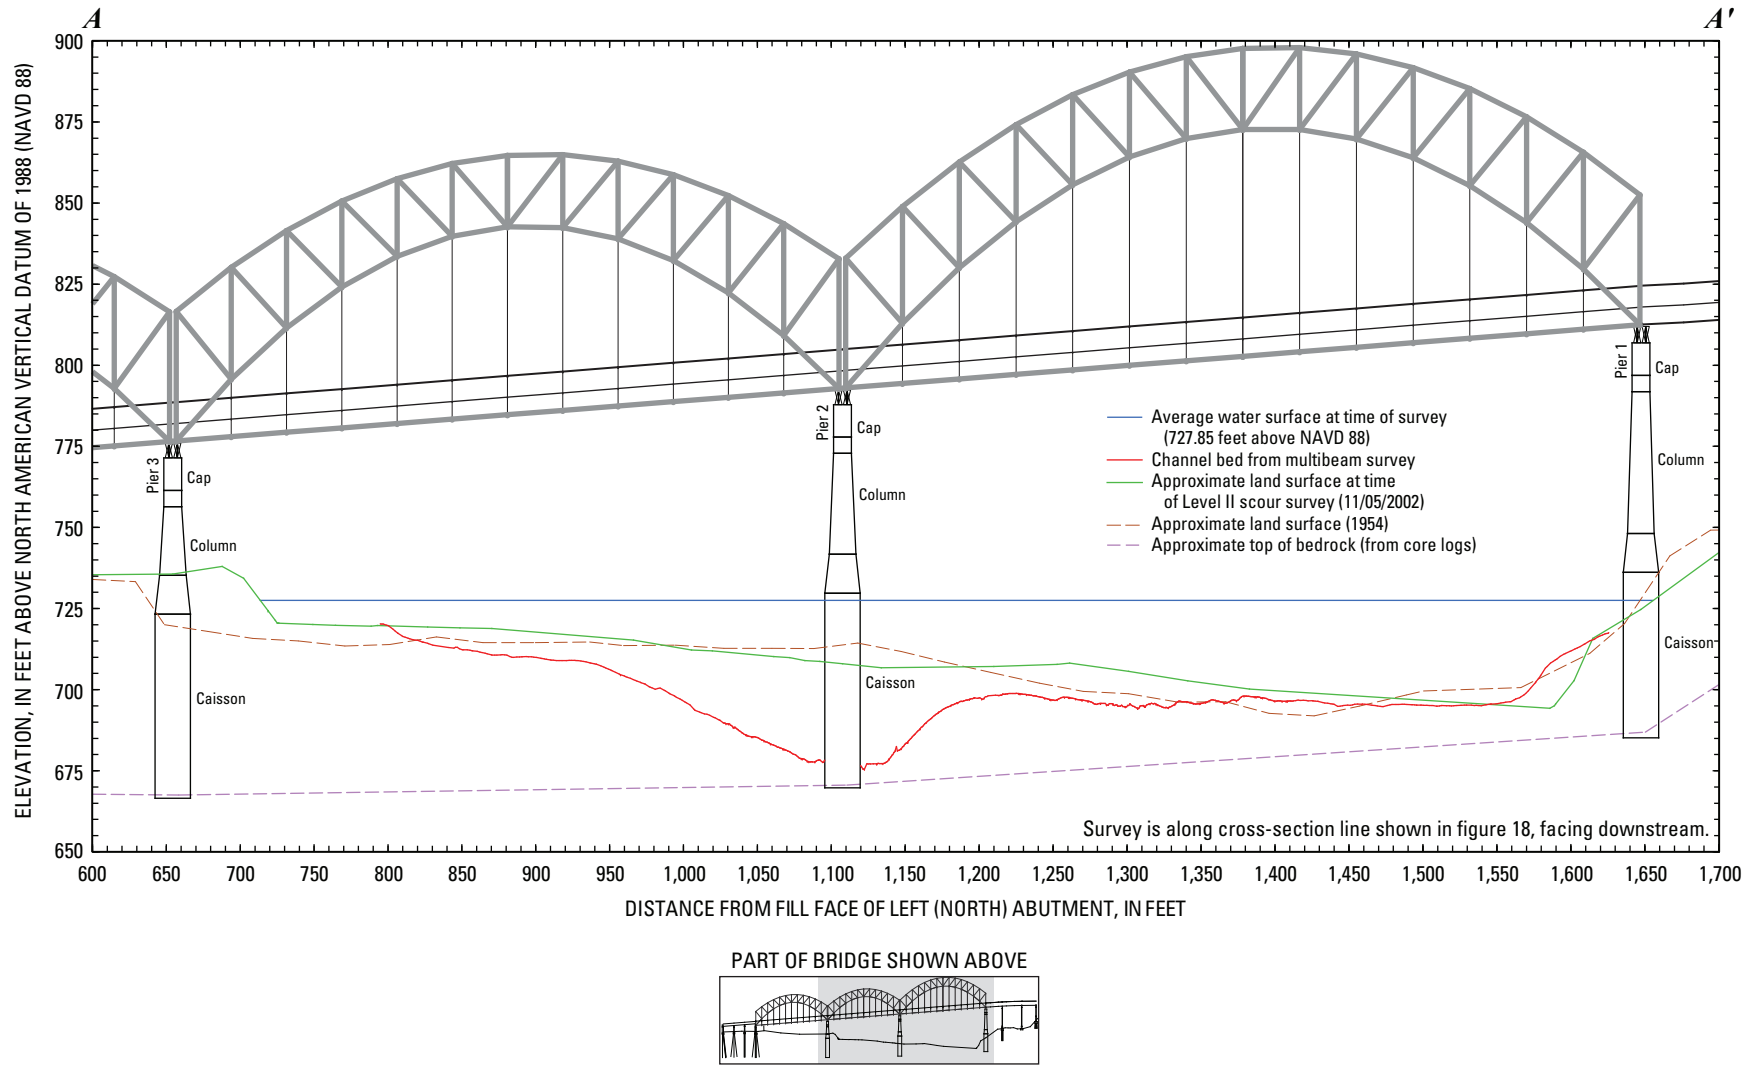
**Figure 20.** Key features, substructural and superstructural details, and surveyed channel bed of structure A4649 on U.S. Highway 169 over the Missouri River in Kansas City, Missouri.

Information from bridge plans indicate that the main channel pier structure A4649 is a caisson on bedrock, but only about 5 ft of bed material was between the bottom of the scour hole and the bottom of the caissons (fig. 20; table 5). The surveyed channel bed was approximately the same as the channel bed from the Level II scour survey in 2002 near the thalweg on the right (south) side of the channel, but was about 25 ft deeper in mid-channel (fig. 20).

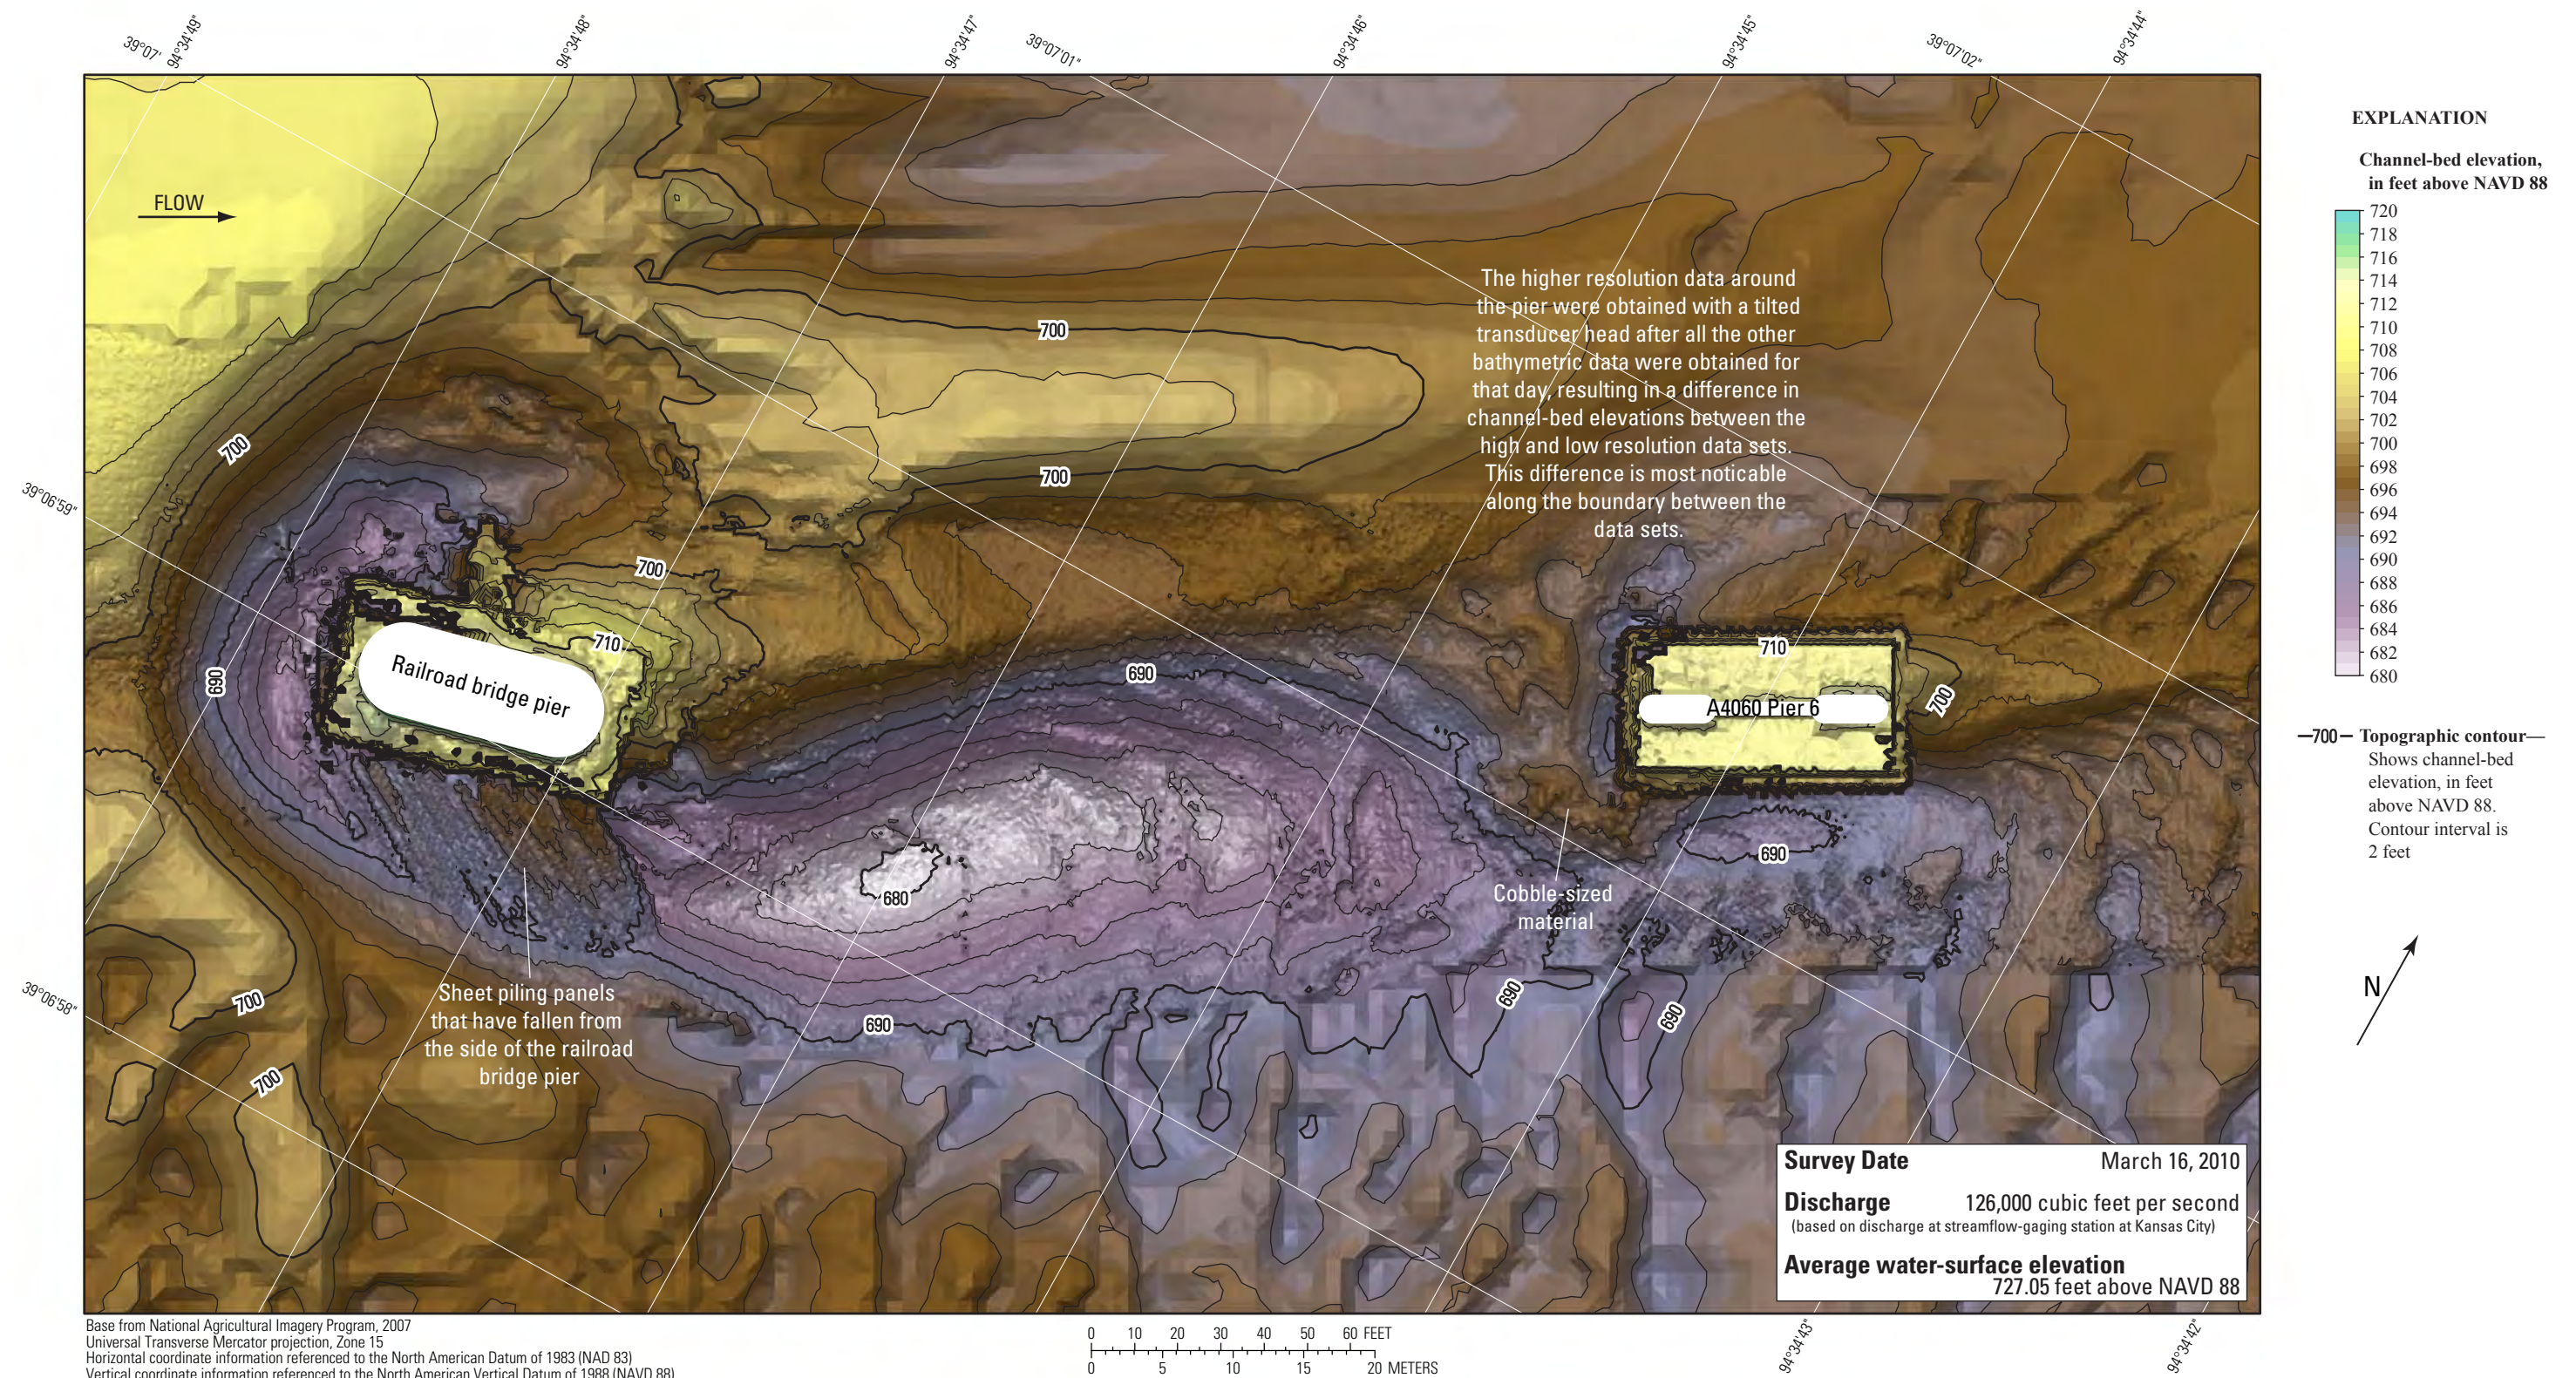
Figure 23. Bathymetric survey of the Missouri River channel in the vicinity of the right main channel pier of structure A4060 on State Highway 9 in Kansas City, Missouri.

A pile of cobble-sized material immediately upstream from pier 6 of structure A4060 appeared to extend around the right (south) side (fig. 23), but it was about 1 ft below the elevation of the bottom of the pier seal course of 696.26 ft (fig. 24; table 5). The minimum elevation in the vicinity of pier 6 was about 7 ft below the elevation of the bottom of the pier seal course (figs. 23, 24; table 5). Information from bridge plans indicates that pier 6 is founded on shafts drilled 20 ft into bedrock, with about 19 ft of bed material between the bottom of the scour hole and bedrock (fig. 24; table 5). A point cloud visualization of the multibeam depth points obtained during the survey indicates the bottom of the seal course as a sonic “shadow” (fig. 25).

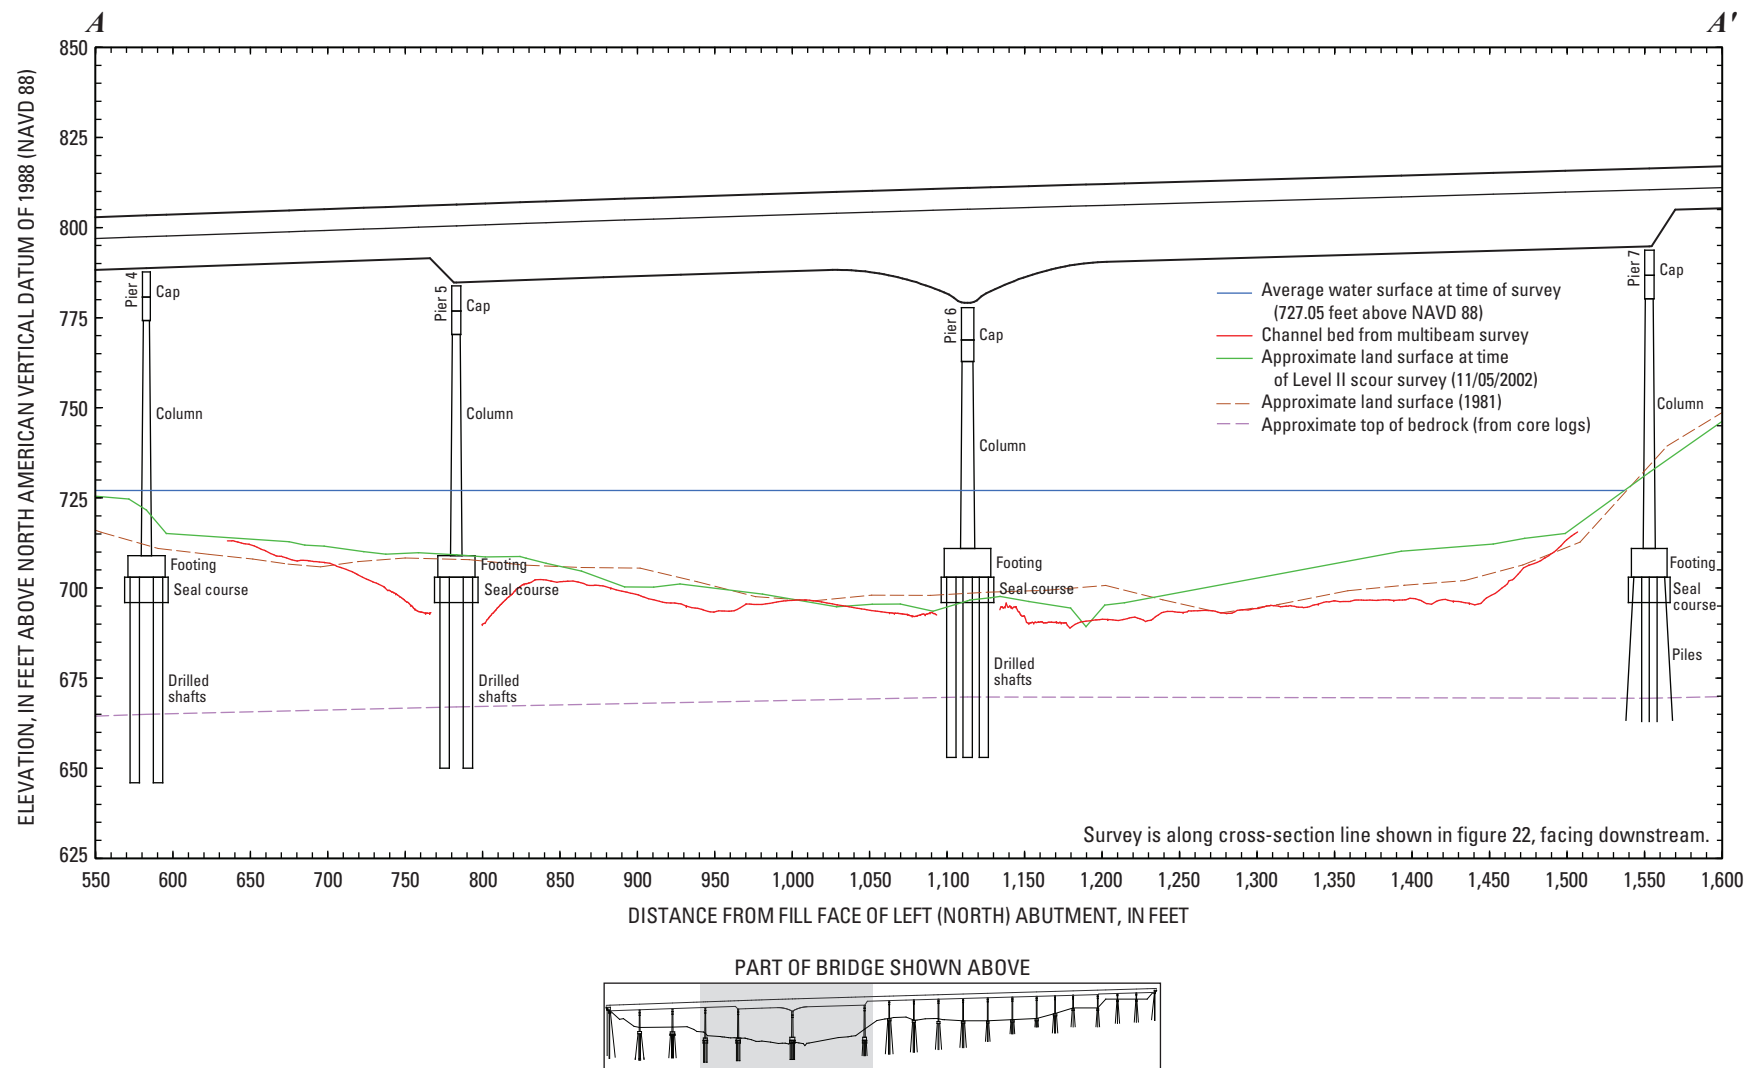
**Figure 24.** Key features, substructural and superstructural details, and surveyed channel bed of structure A4060 on State Highway 9 over the Missouri River in Kansas City, Missouri.

In the immediate vicinity of the left main channel pier (pier 5; fig. 26), a scour hole had a minimum elevation of about 691 ft (table 4), about 5 ft below the elevation of the bottom of the pier seal course of 696.26 ft (fig. 24; table 5). Information from bridge plans indicates that pier 5 also is founded on shafts drilled 20 ft into bedrock, with about 24 ft of bed material between the bottom of the scour hole and bedrock (fig. 24; table 5). The point cloud visualization of the multibeam depth points obtained during the survey does not clearly indicate the bottom of the seal course as a sonic “shadow” because the side of the seal course did not have as many return pings, resulting in poor point coverage. However, the difference in elevation between the top of the seal course and bed can be seen, and is greater than the depth of the seal course (fig. 27). Several beams or piles protruded from the channel bed immediately upstream from pier 5 (fig. 26).

The surveyed channel bed was about the same as the channel bed from the Level II scour survey in 2002 on the left (north) side and middle of the channel except near pier 5 (fig. 24). Near the thalweg on the right (south) side of the channel, the surveyed channel was about 15 ft deeper than during the Level II scour survey in 2002, but was similar to the channel configuration from 1981 (fig. 24).

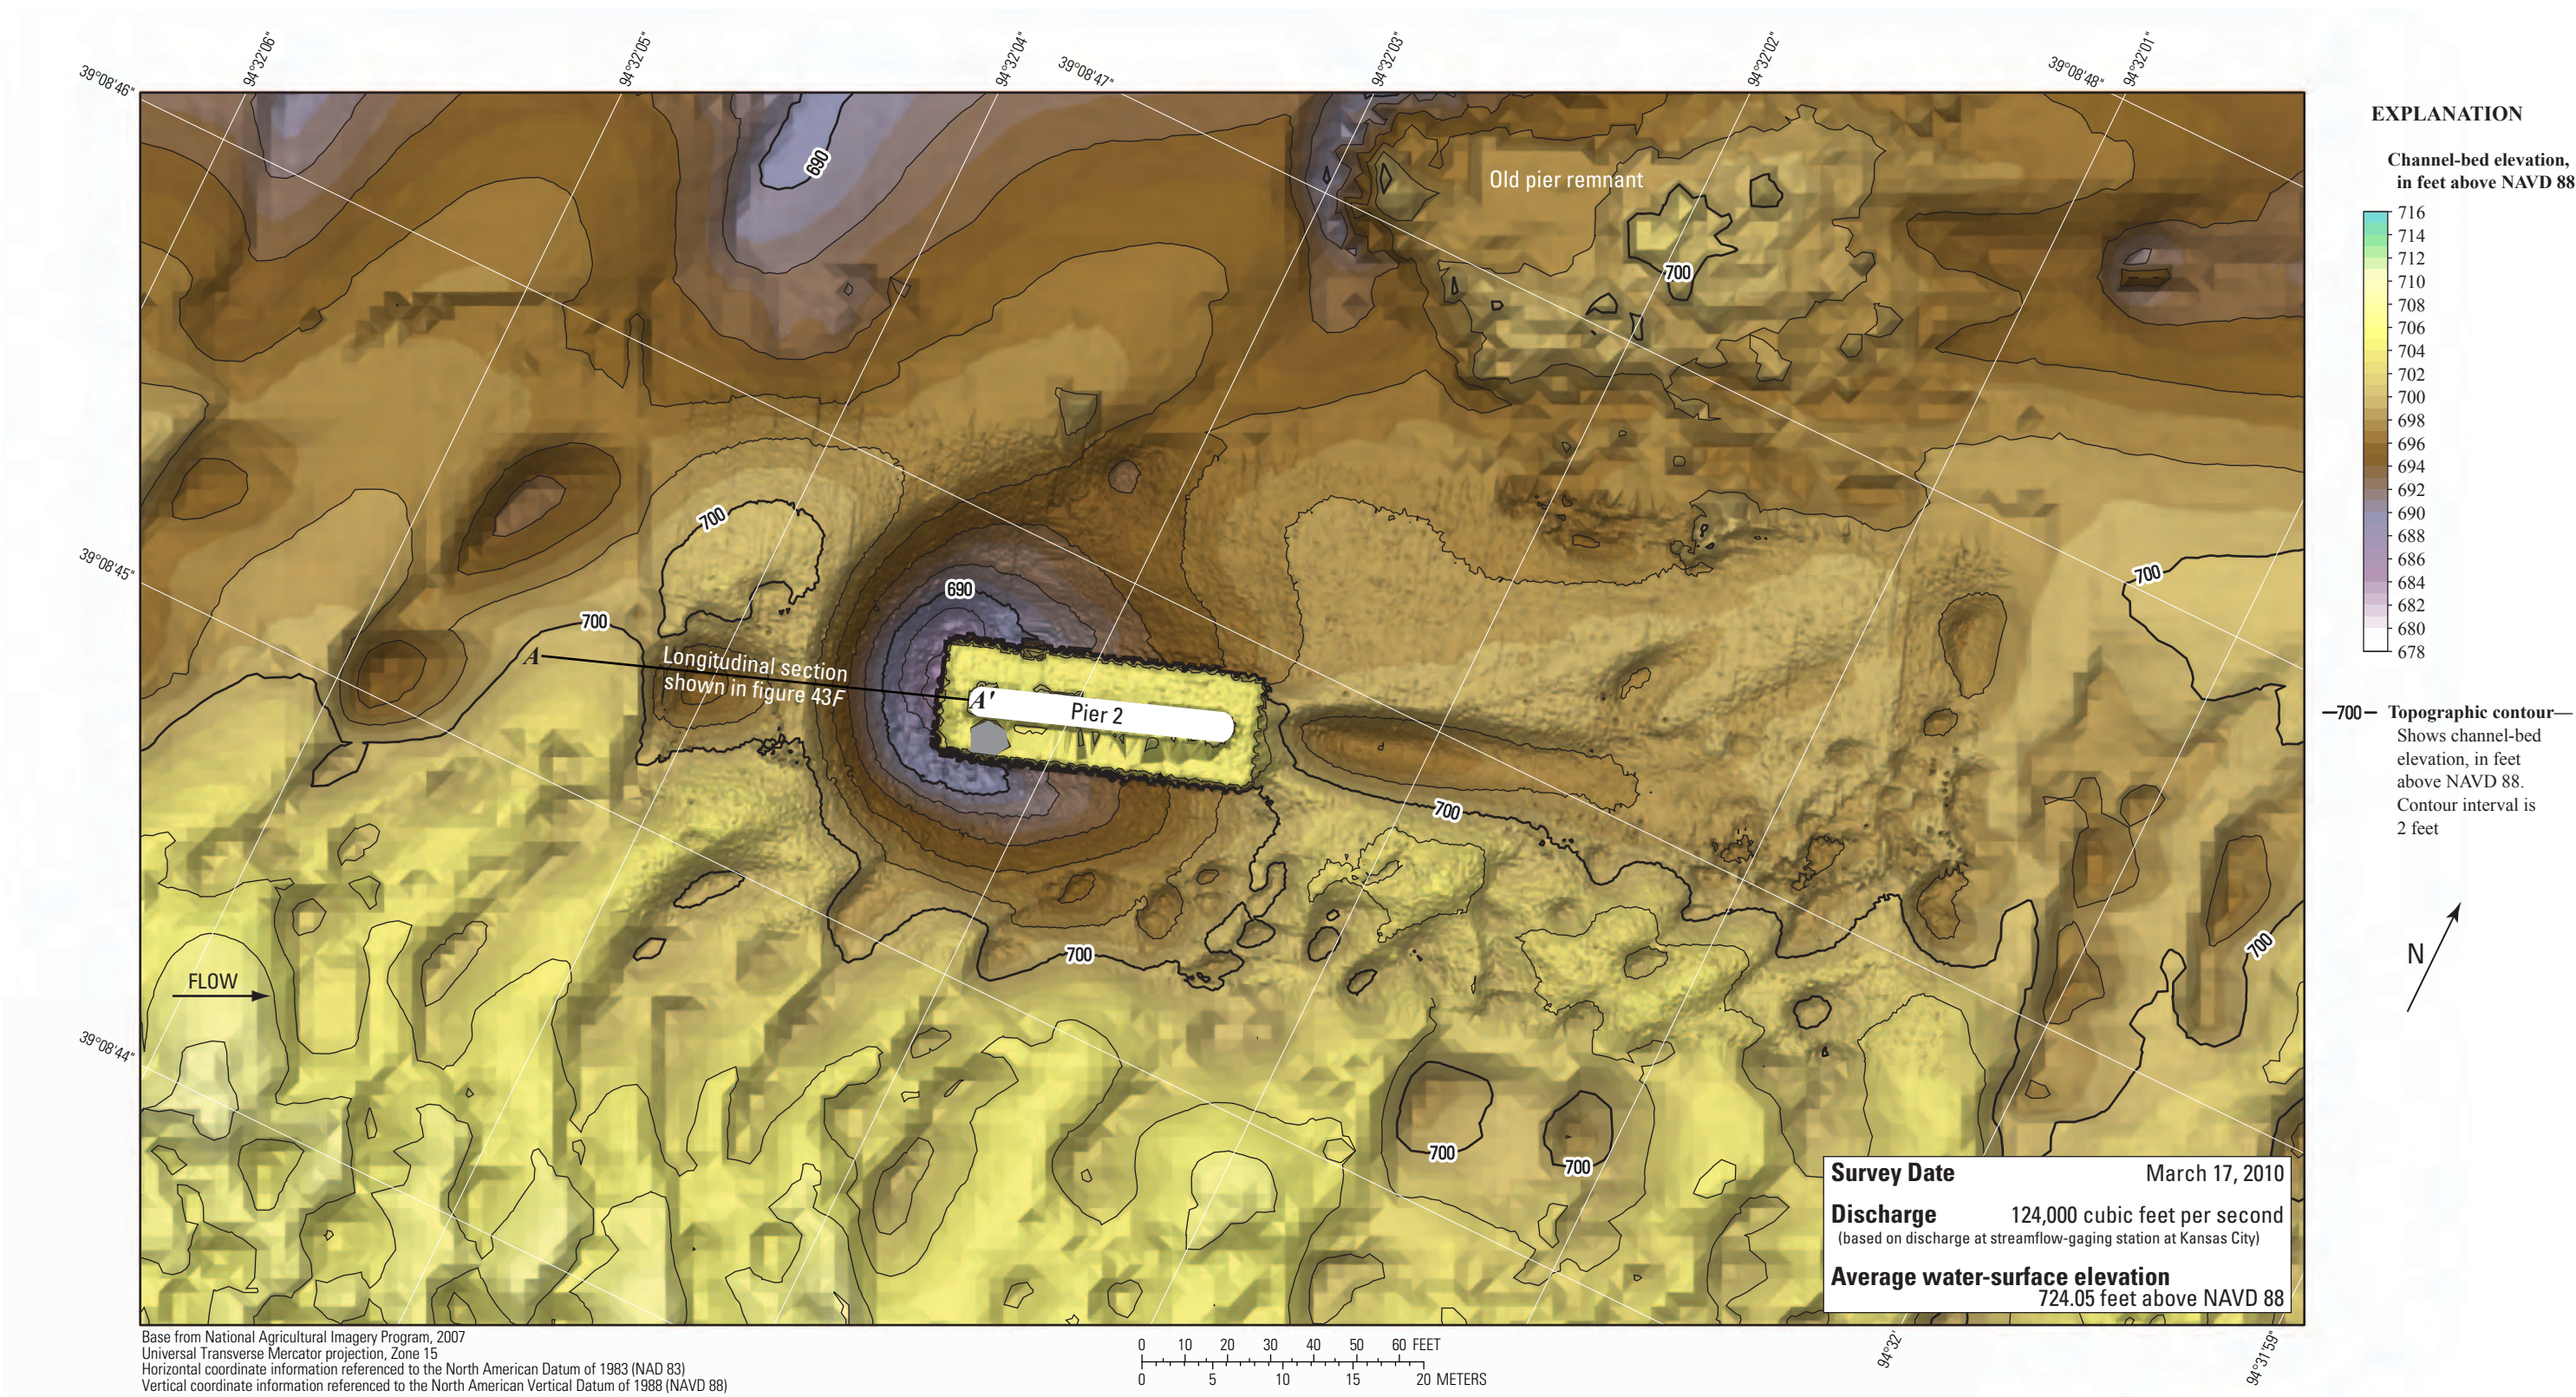
Figure 30. Bathymetric survey of the Missouri River channel in the vicinity of the main channel pier of structure A5817 on State Highway 269 in Kansas City, Missouri.

In the vicinity of the main channel pier 2 (fig. 30), a scour hole had a minimum elevation of about 685 ft (table 4), about 1 ft below the elevation of the bottom of the pier seal course of 687.26 ft (fig. 31; table 5). Information from bridge plans indicates that pier 2 of structure A5817 is founded on shafts drilled 20 ft into bedrock, with about 8 ft of bed material between the bottom of the scour hole and bedrock (fig. 31; table 5). A point cloud visualization of the multibeam depth points obtained during the survey shows the potential minor undermining as a sonic “shadow” when the bottom of the seal course is shown (fig. 32).

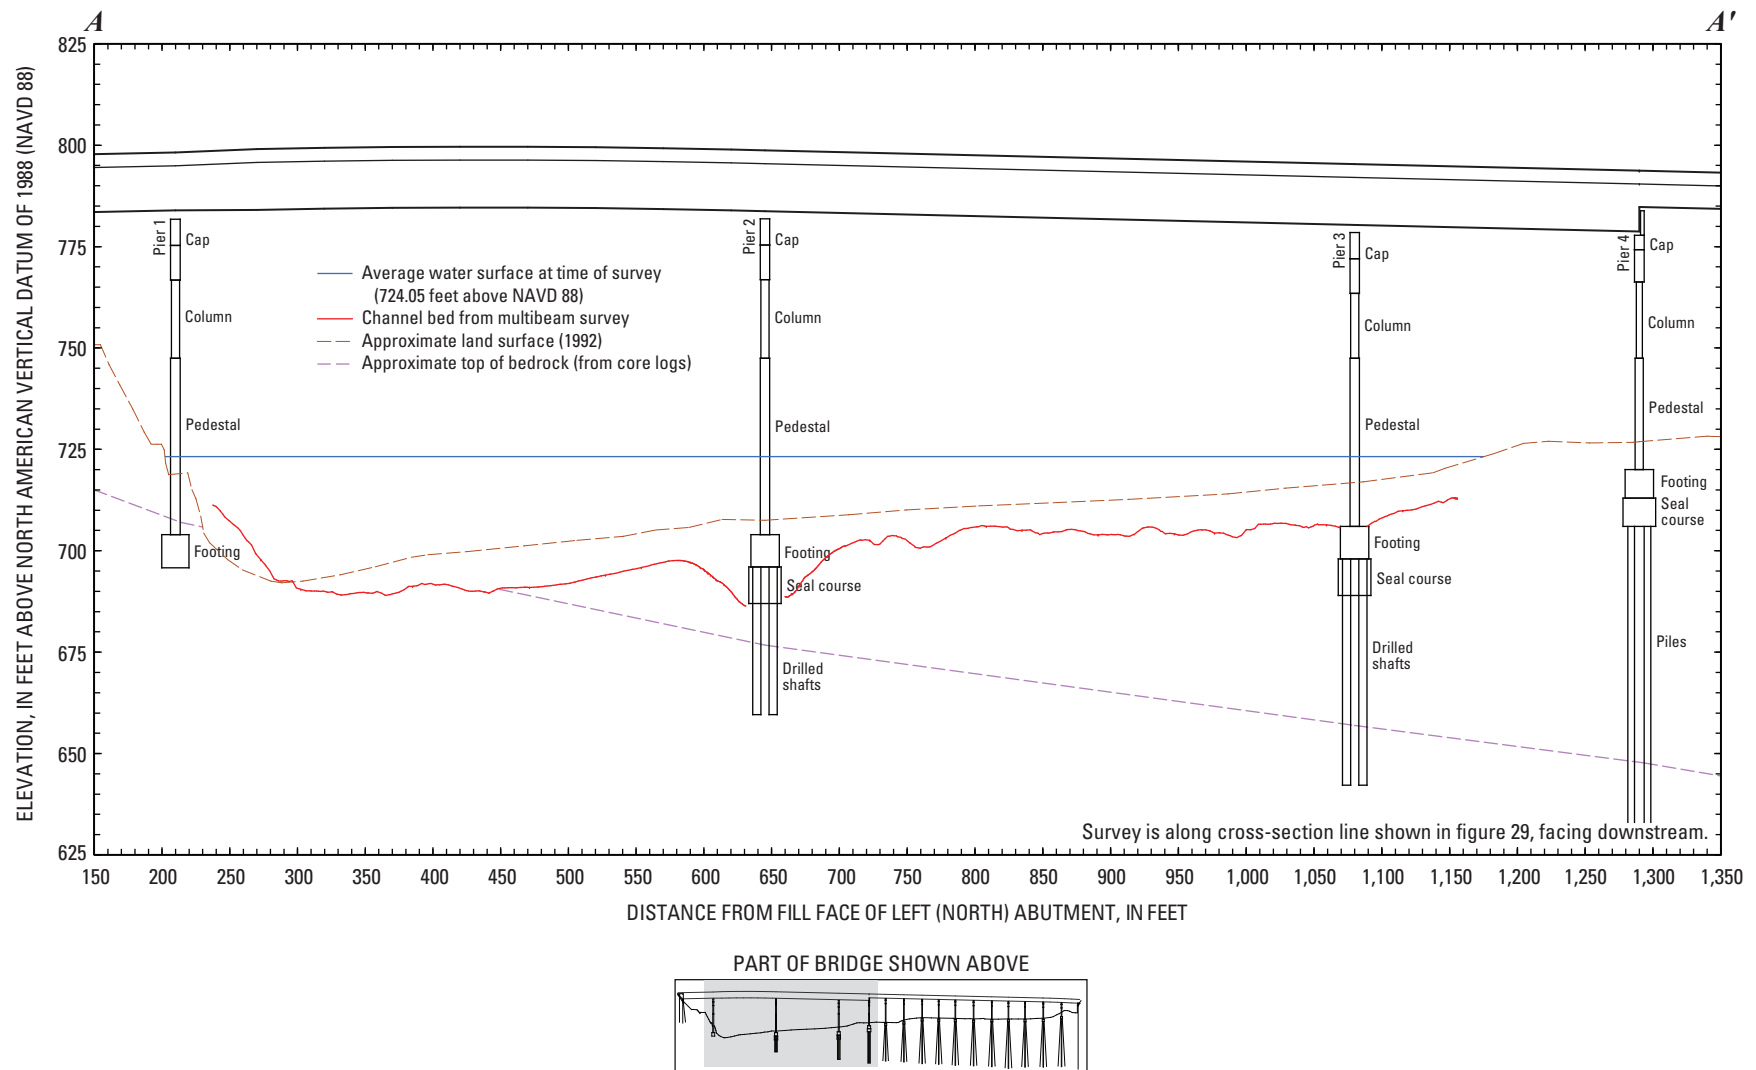
**Figure 31.** Key features, substructural and superstructural details, and surveyed channel bed of structure A5817 on State Highway 269 over the Missouri River in Kansas City, Missouri.

The surveyed channel bed was about 8 to 10 ft lower than the channel configuration from 1992 (fig. 31). The approximate top of bedrock line from bridge plans further substantiates the likelihood of the channel thalweg having penetrated the fluvial material to bedrock (fig. 31).

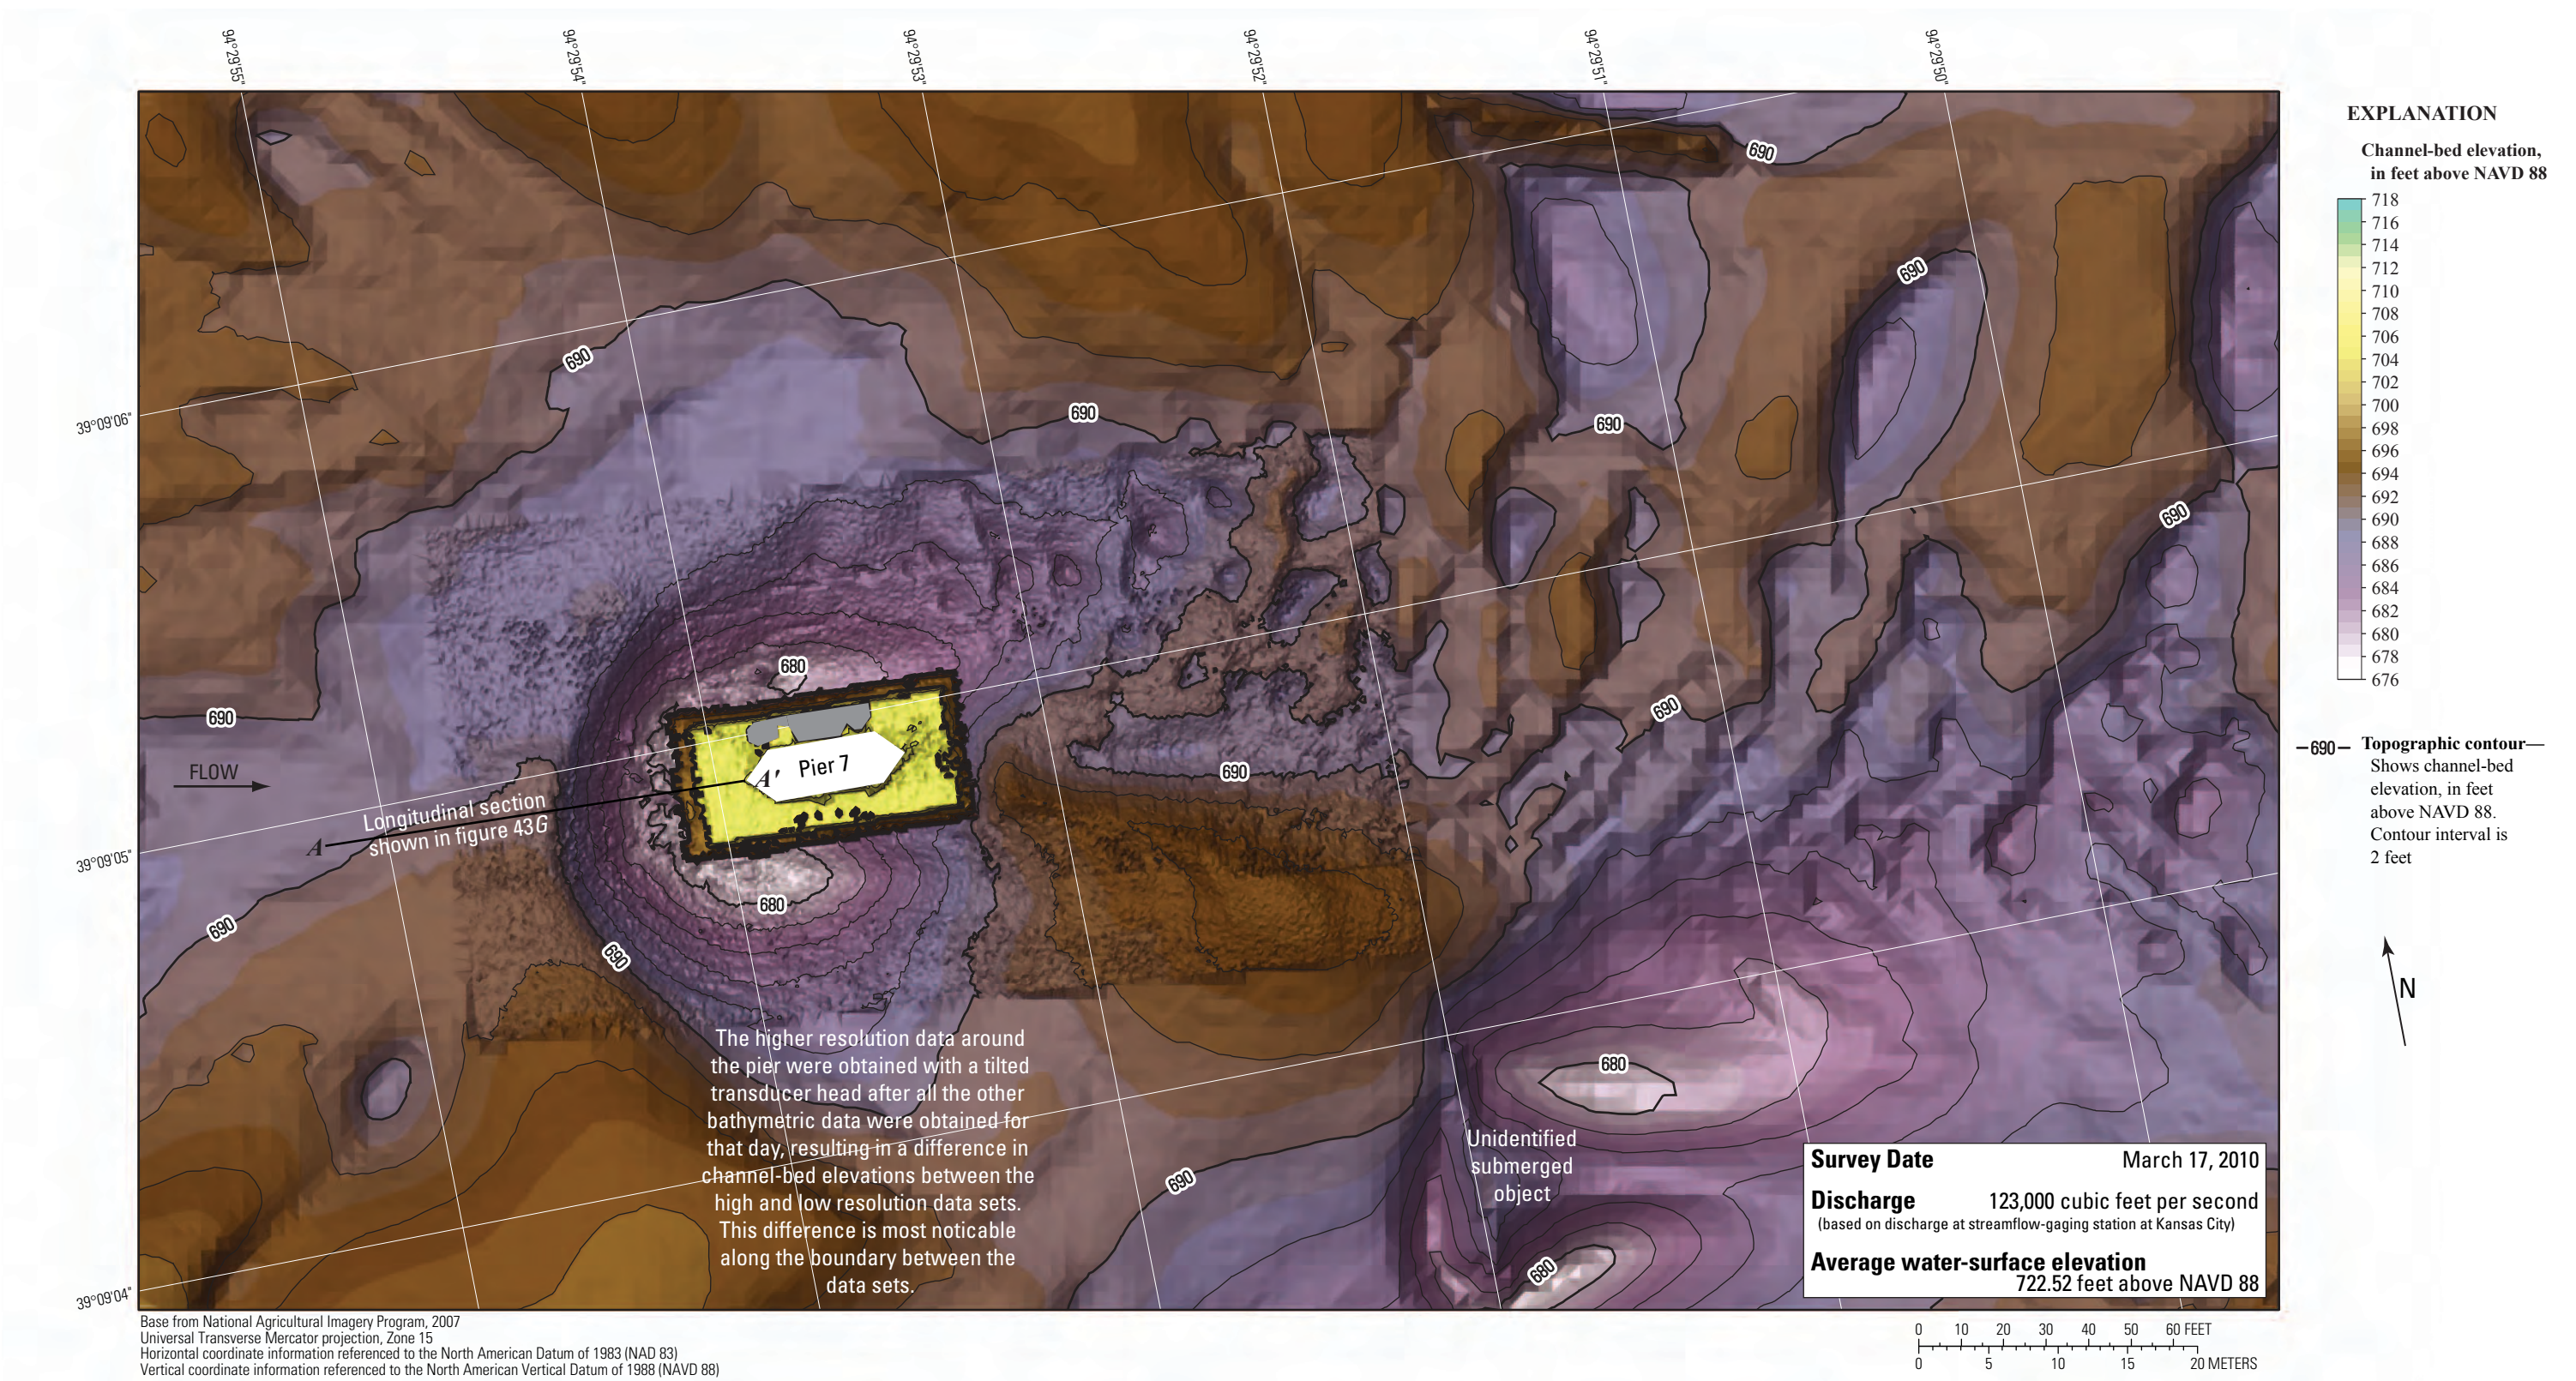
Figure 35. Bathymetric survey of the Missouri River channel in the vicinity of the main channel pier of structure A0767 on Interstate 435 in Kansas City, Missouri.

In the immediate vicinity of the main channel pier 7 (fig. 35), a scour hole had a minimum elevation of about 679 ft (table 4), about 10 ft below the elevation of the bottom of the pier seal course of 689.26 ft (fig. 36; table 5). Information from bridge plans indicates that pier 7 is founded on shafts drilled 20 ft into bedrock, with about 19 ft of bed material between the bottom of the scour hole and bedrock (fig. 36; table 5). A point cloud visualization of the multibeam depth points obtained during the survey indicates the bottom of the seal course as a sonic “shadow,” with the sides of drilled shafts appearing as points in the shadow (fig. 37).
