# **Bathymetric Surveys at Highway Bridges Crossing the Missouri River in Kansas City, Missouri, using a Multibeam Echo Sounder, 2010**

Scientific Investigations Report 2010–5207

By Richard J. Huizinga

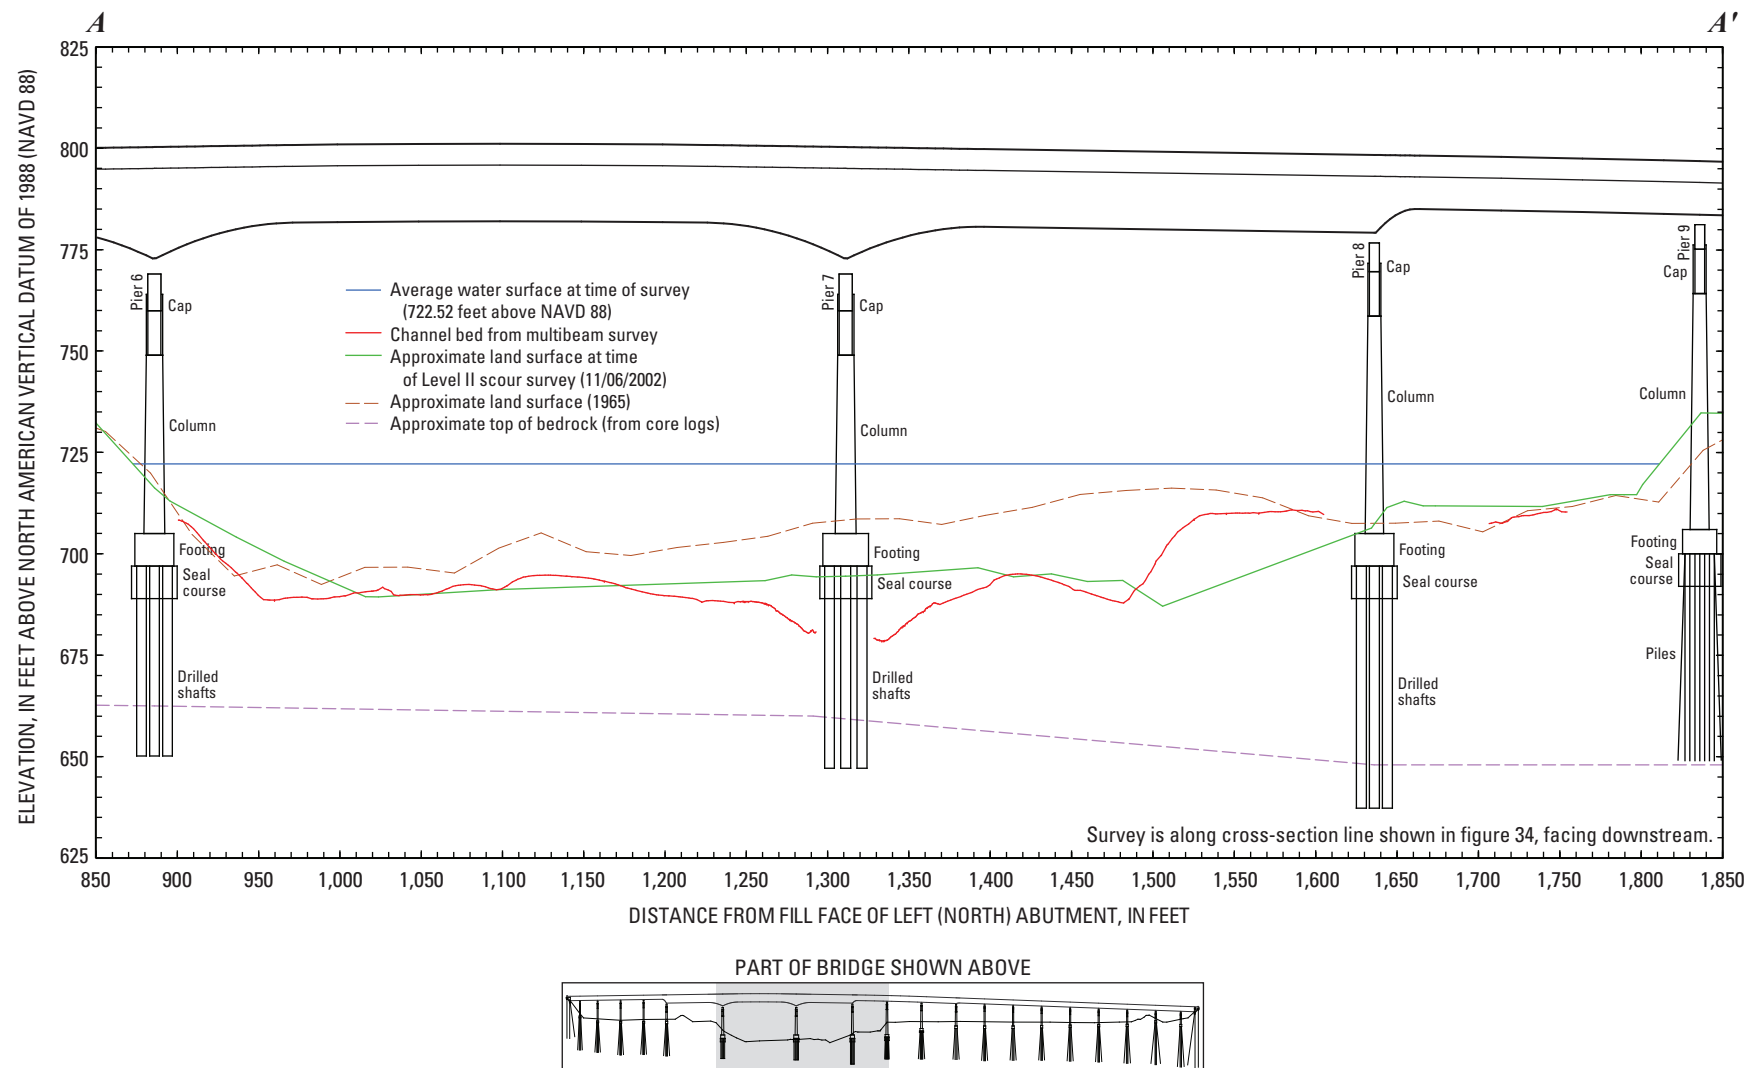
**Figure 36.** Key features, substructural and superstructural details, and surveyed channel bed of structure A0767 on Interstate 435 over the Missouri River in Kansas City, Missouri.

In the immediate vicinity of the main channel pier 7 (fig. 35), a scour hole had a minimum elevation of about 679 ft (table 4), about 10 ft below the elevation of the bottom of the pier seal course of 689.26 ft (fig. 36; table 5). Information from bridge plans indicates that pier 7 is founded on shafts drilled 20 ft into bedrock, with about 19 ft of bed material between the bottom of the scour hole and bedrock (fig. 36; table 5). A point cloud visualization of the multibeam depth points obtained during the survey indicates the bottom of the seal course as a sonic “shadow,” with the sides of drilled shafts appearing as points in the shadow (fig. 37).

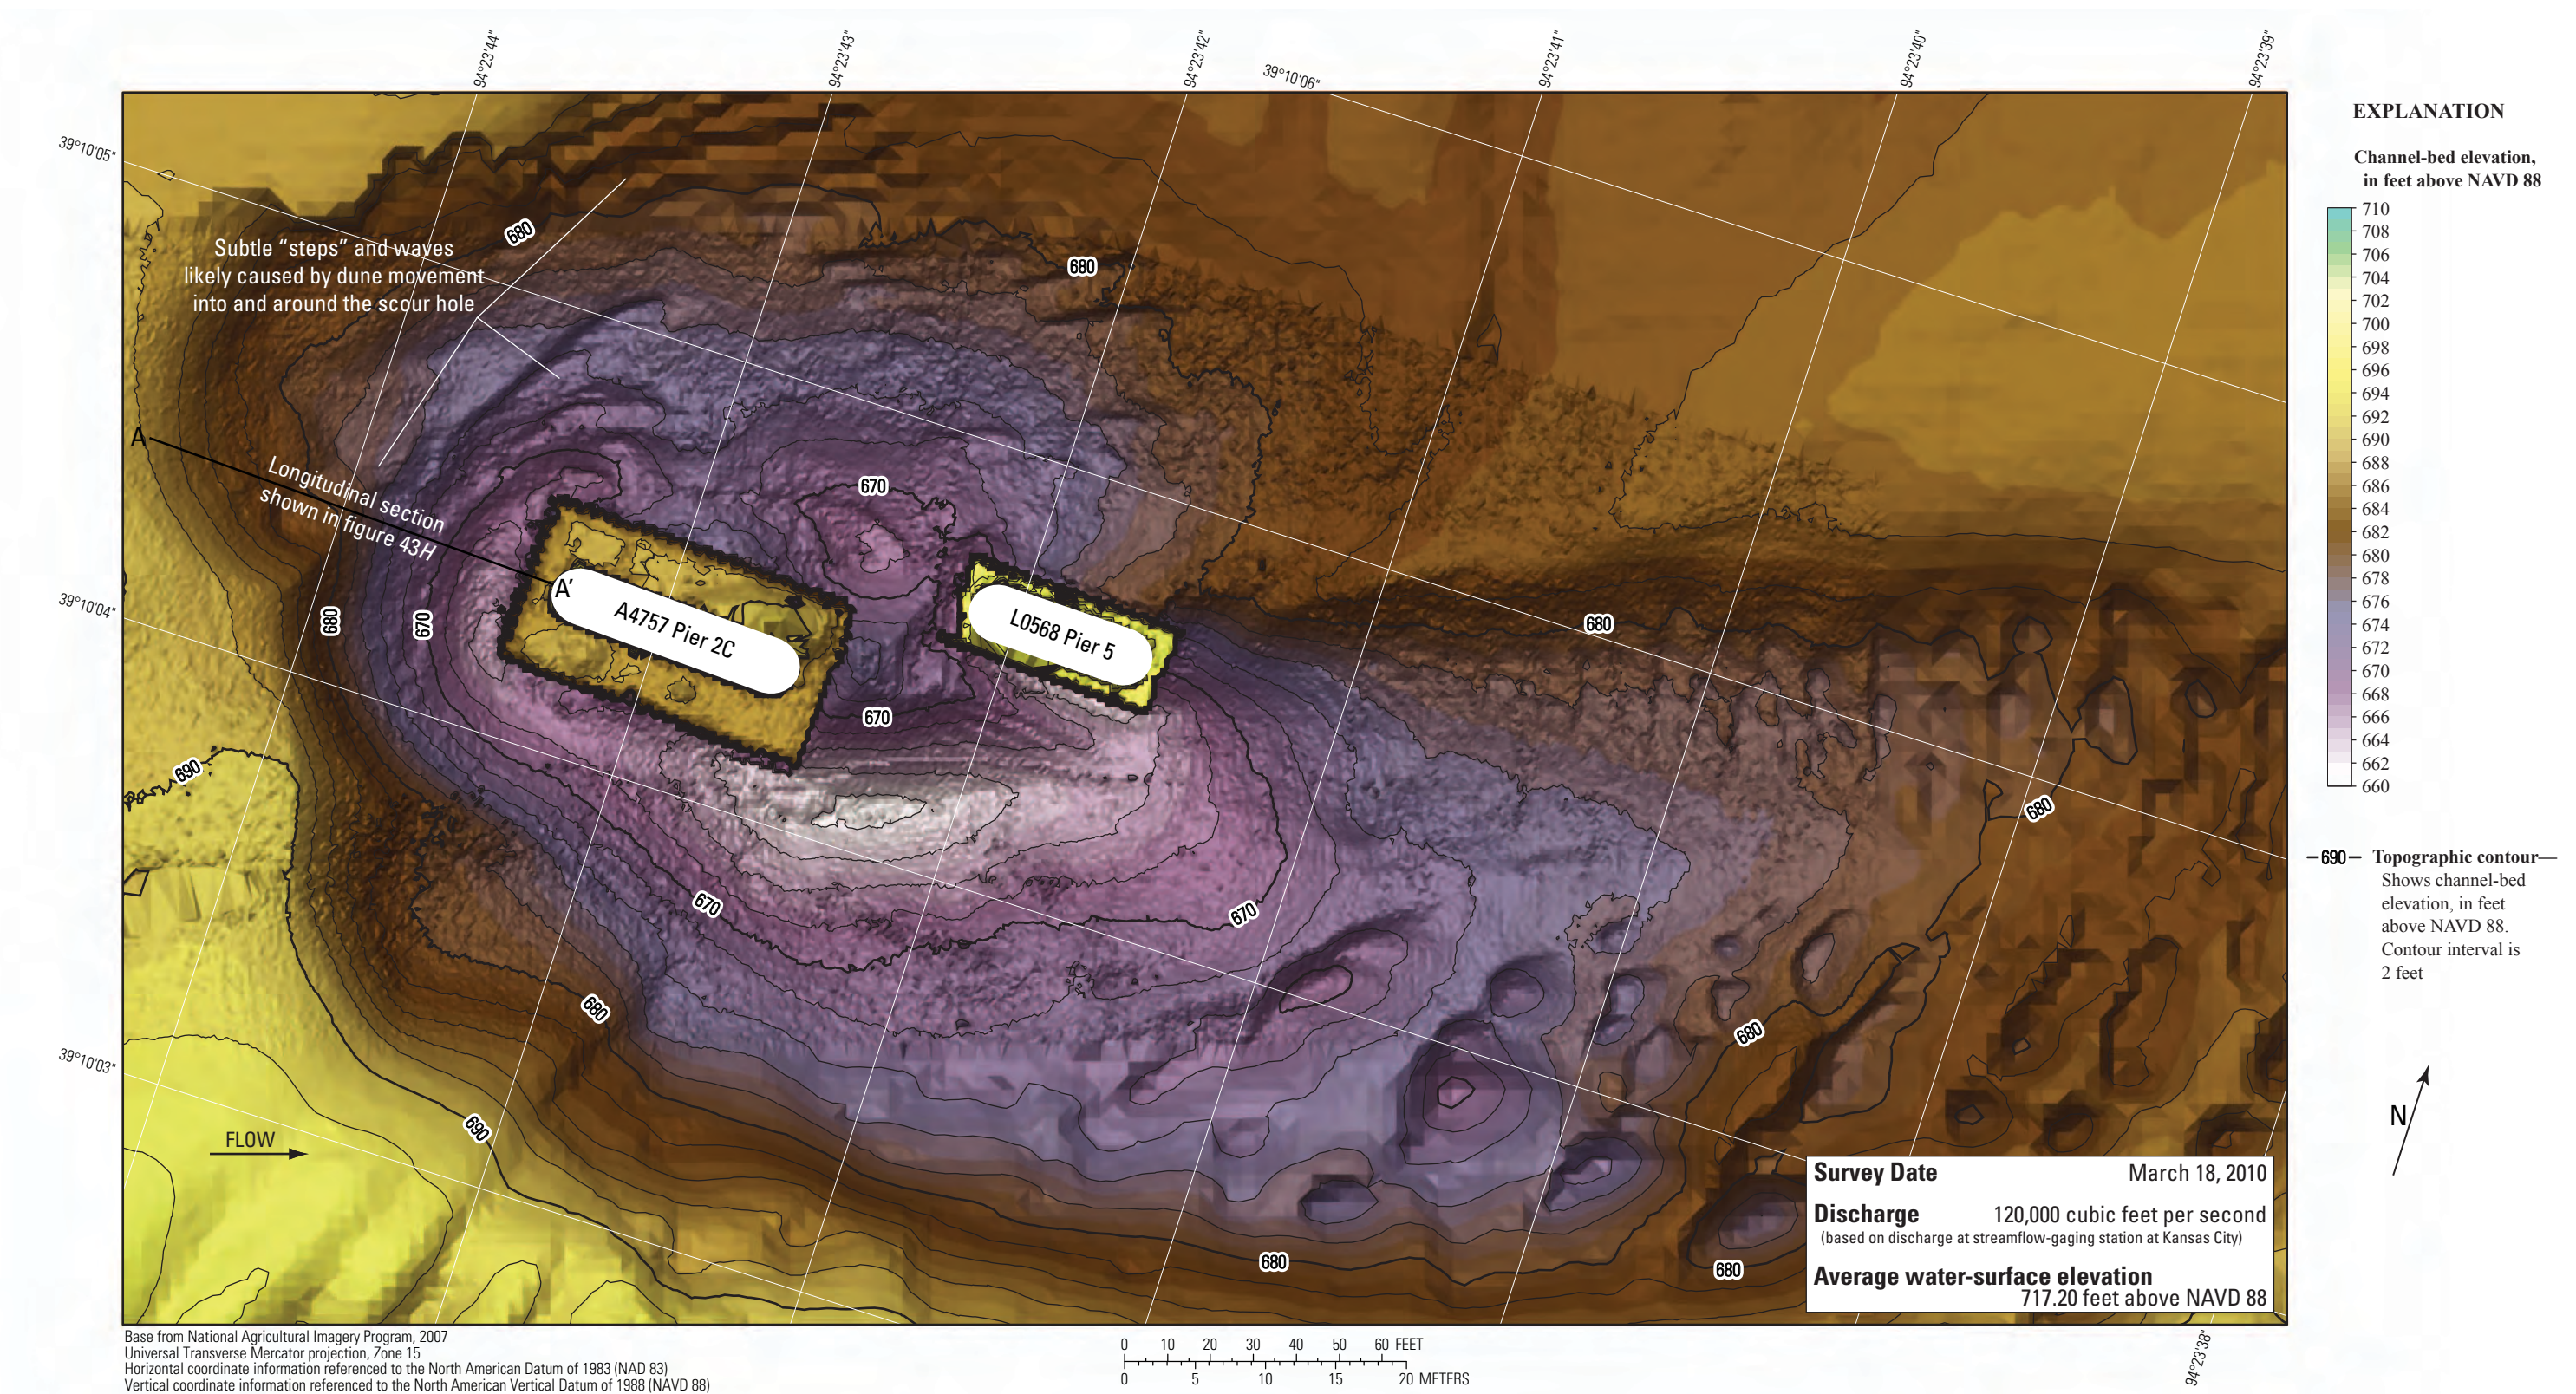
Figure 40. Bathymetric survey of the Missouri River channel in the vicinity of the main channel piers of structures A4757 and L0568 on State Highway 291 in Kansas City, Missouri.

In the vicinity of the main channel piers (fig. 40), a large scour hole had a minimum elevation of about 661 ft (table 4), about 25 ft below the average channel bed immediately upstream from the piers. The main channel piers were skewed to approach flow, which caused a wide scour hole with somewhat unique characteristics as compared to scour holes at the other surveyed bridges. Pier 5 of structure L0568 was in the wake of pier 2C of structure A4757, and, therefore, had no well-defined scour hole specific to it. The point of overall minimum elevation occurred downstream from the

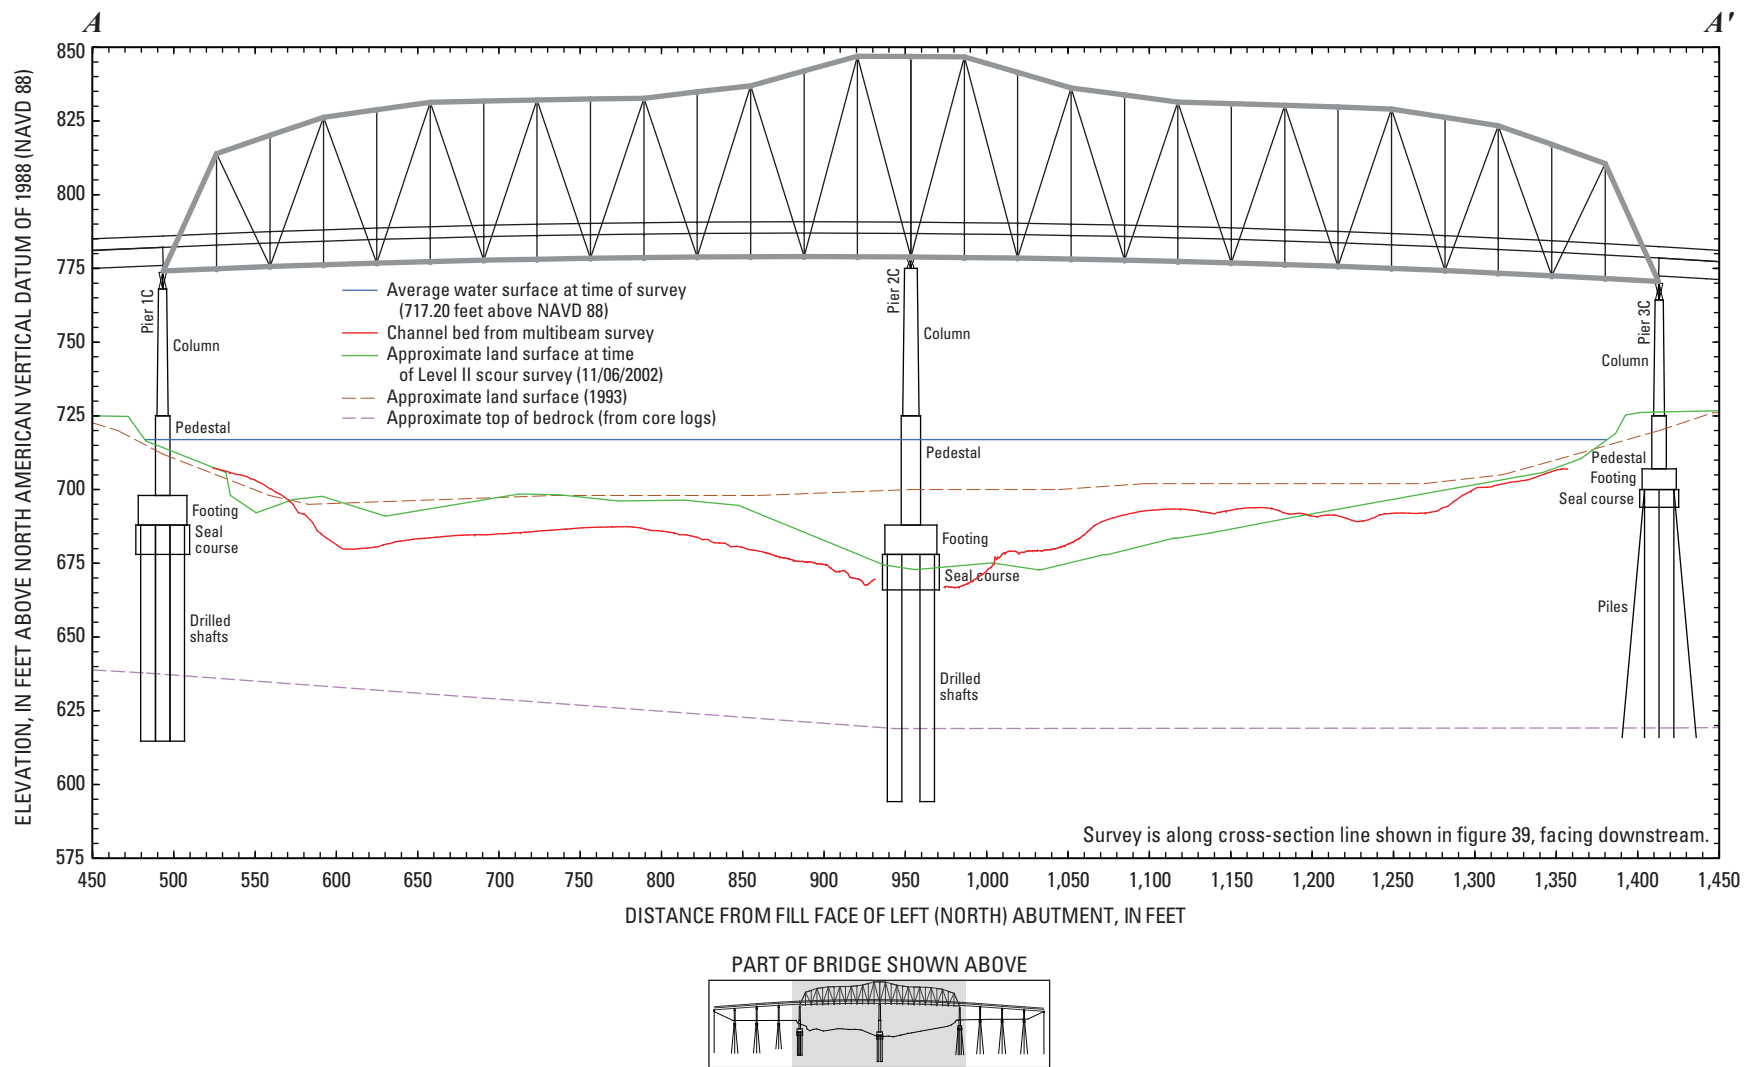
Information from bridge plans indicates that the main channel pier of structure A4757 is founded on shafts drilled 20 ft into bedrock, with about 47 ft of bed material between the bottom of the scour hole and bedrock at the upstream end of the pier (fig. 41; table 5), and about 46 ft of bed material between the bottom of the hole and bedrock at the point of minimum elevation at the downstream end of the pier. At the point of minimum elevation, the surveyed channel bed was about 1 ft lower than the bottom of the seal course elevation of 666.26 ft (table 5). The surveyed bed was about 15 ft deeper than the channel bed from the Level II scour survey in 2002 on the left (north) side of the channel, and about 10 feet shallower on the right (south) side, except near the right (south) bank (fig. 41).

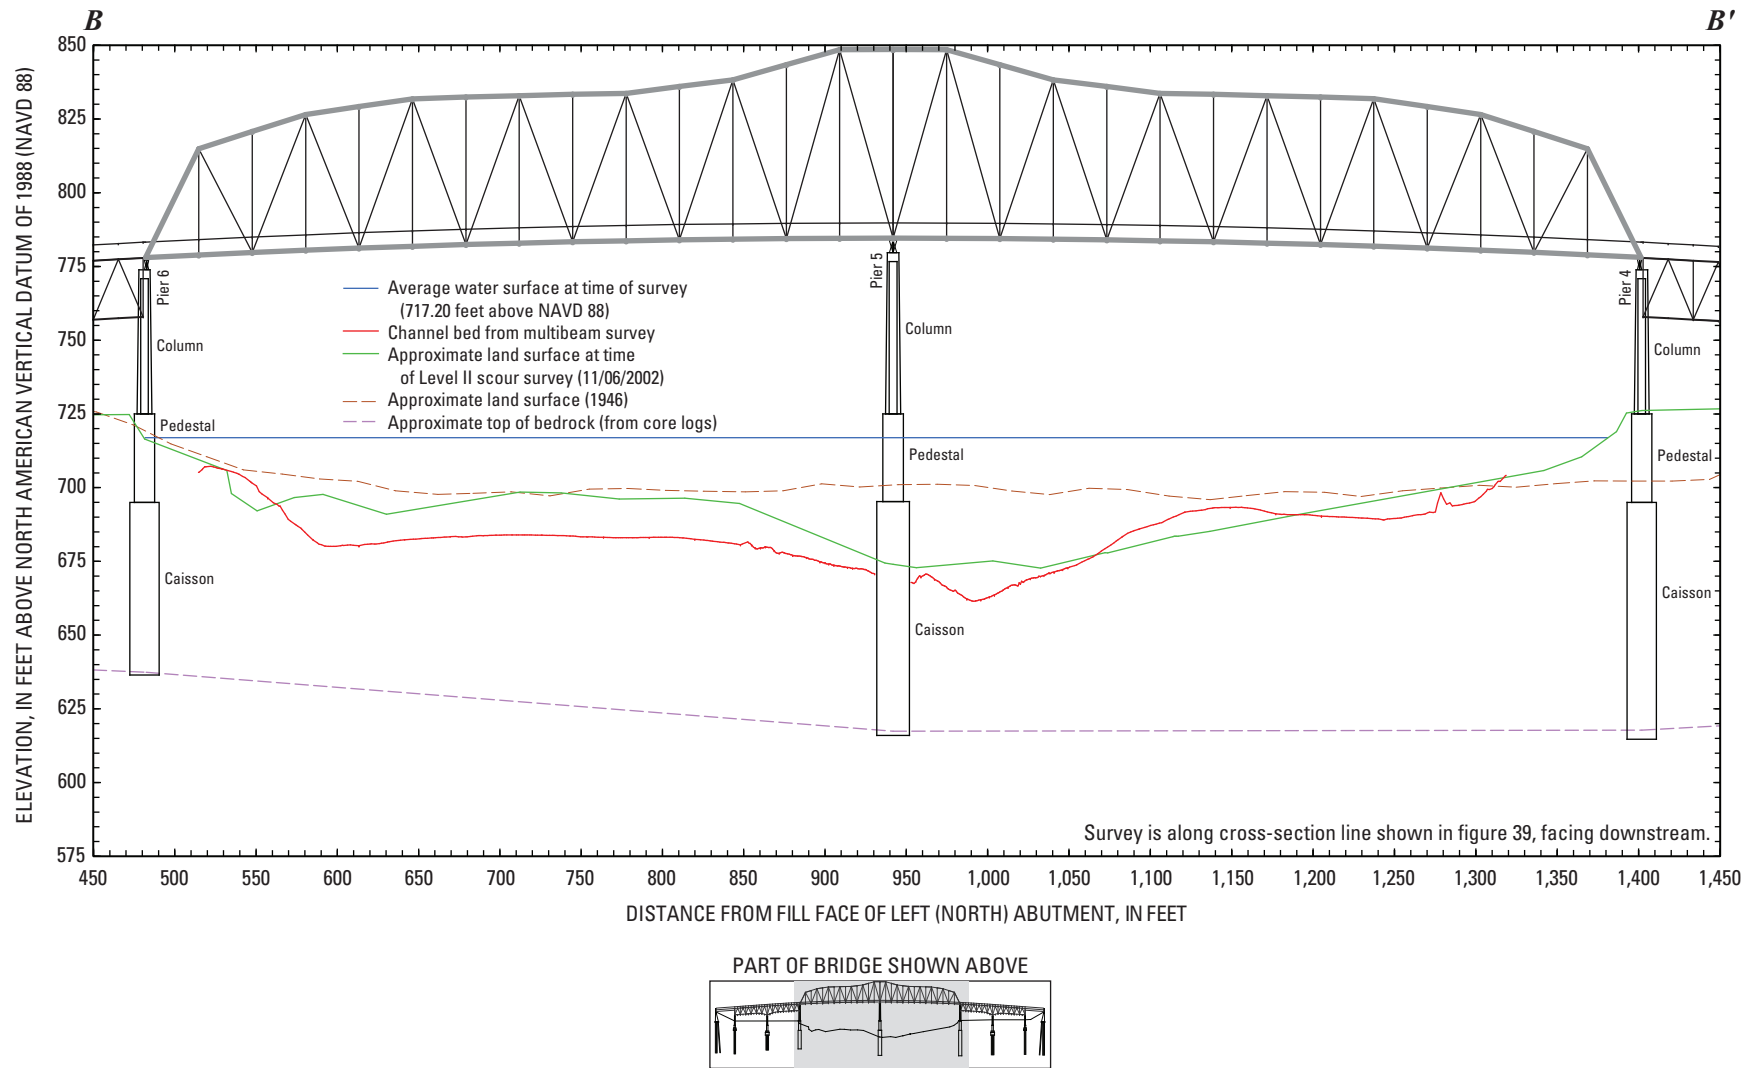
**Figure 42.** Key features, substructural and superstructural details, and surveyed channel bed of structure L0568 on State Highway 291 over the Missouri River in Kansas City, Missouri.

Information from bridge plans indicates that the main channel pier of structure L0568 is a caisson on bedrock (fig. 42), with about 50 ft of bed material between the bottom of the scour hole and bedrock at the upstream end of the pier (fig. 42; table 5), and about 45 ft of bed material between the bottom of the hole and bedrock at the point of minimum elevation at the downstream end of the pier. Similar to structure A4757, the surveyed channel bed was about 15 ft deeper than the channel bed from the Level II scour survey in 2002 on the left (north) side of the channel and varied from about 10 ft deeper to 10 ft shallower on the right (south) side of the channel (fig. 42).

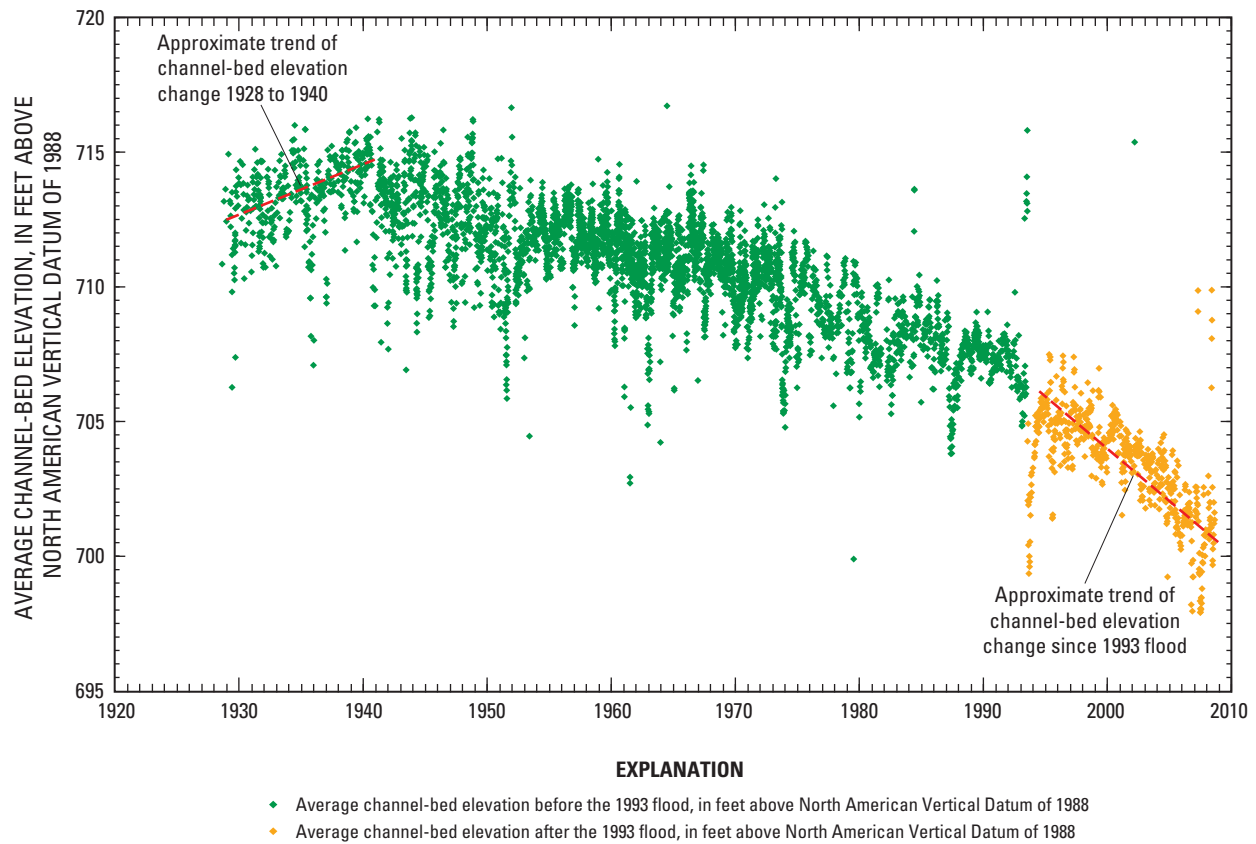
**Figure 45.** Average channel-bed elevation with time from measurements made at the streamflow-gaging station on the Missouri River at Kansas City, Missouri (station number 06893000).

Since the time of the 1993 flood, the average channel-bed elevation has decreased by about 6 ft (fig. 45). This long-term change in channel-bed elevation is part of the reason that the pier foundations were exposed and undermined at the time of the bathymetric surveys.
