Report No. UT-10.20

ASSESSING CORROSION OF MSE WALL REINFORCEMENT

Utah Department of Transportation
Research Division

September 2010

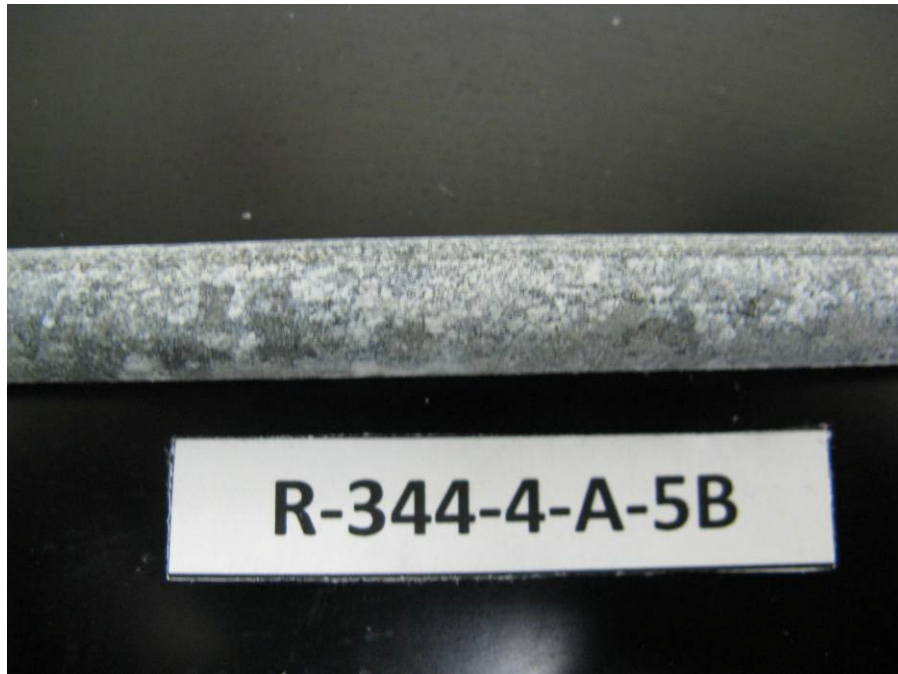
Figure 7 Typical condition of extracted wire coupons

In some places the galvanization appeared to have flaked or spalled from the underlying steel. A minor amount of localized steel corrosion (i.e., “red rust”) was observed on several of such specimens. Photographs illustrating these conditions are presented later in Section 4.2.3.

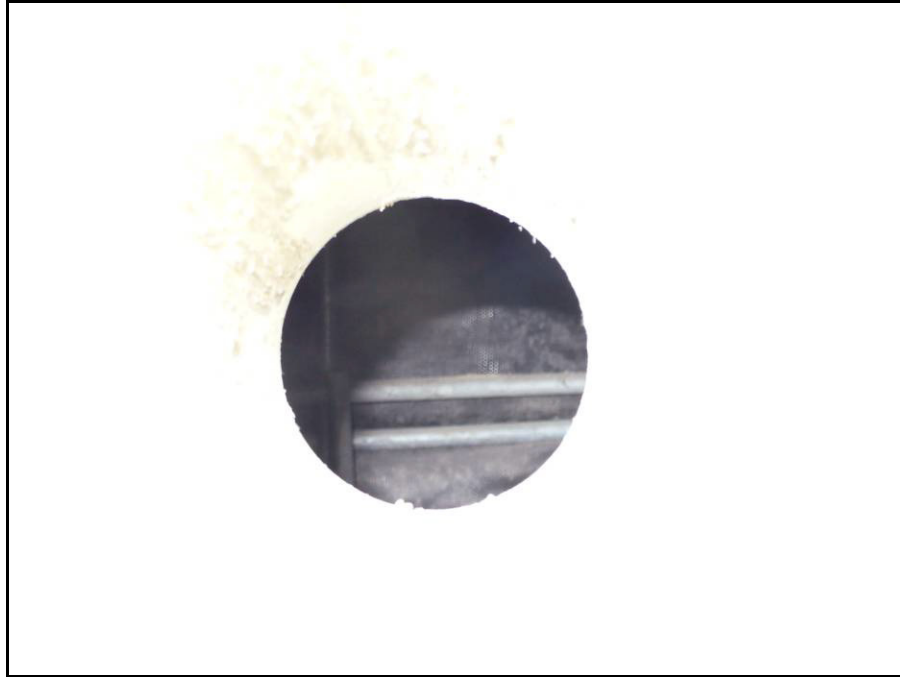
After extracting the coupons from the two-stage walls, we tried to observe the condition of the vertical welded wire mesh facing through the 2-inch access holes. We were generally able to see one or two segments of wire and/or portions of the loops/clevis ends for the connectors across the gap between the first and second stages of the wall. A typical view through an access hole for a two-stage MSE wall is shown in Figure 8. Generally, the conditions of these elements with respect to corrosion appeared to be similar to (or at least no worse than) those exhibited by the coupons themselves.

Figure 8 Typical view of welded wire mesh through coupon access hole in two-stage MSE wall

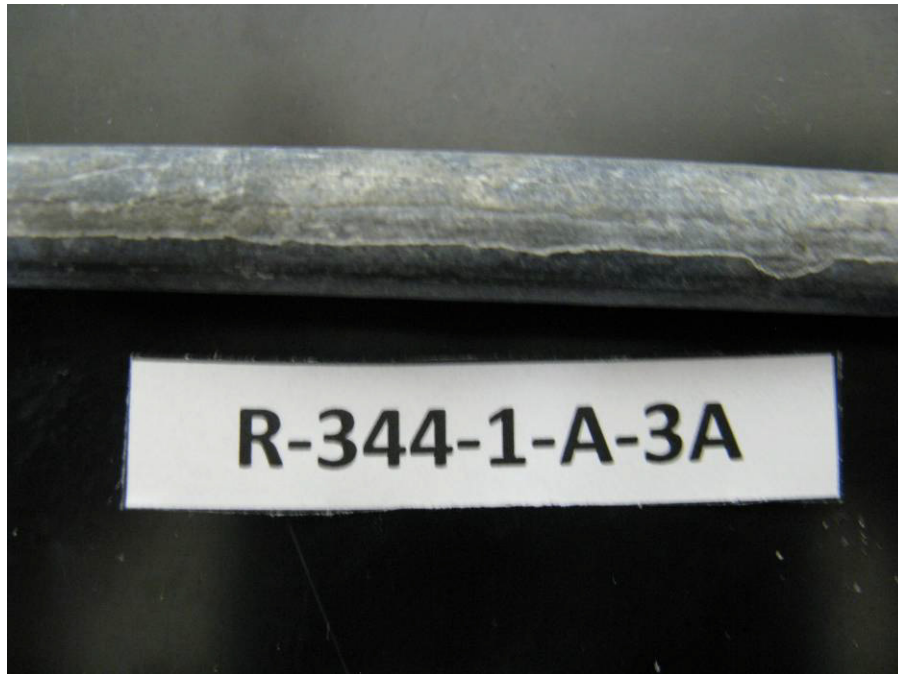
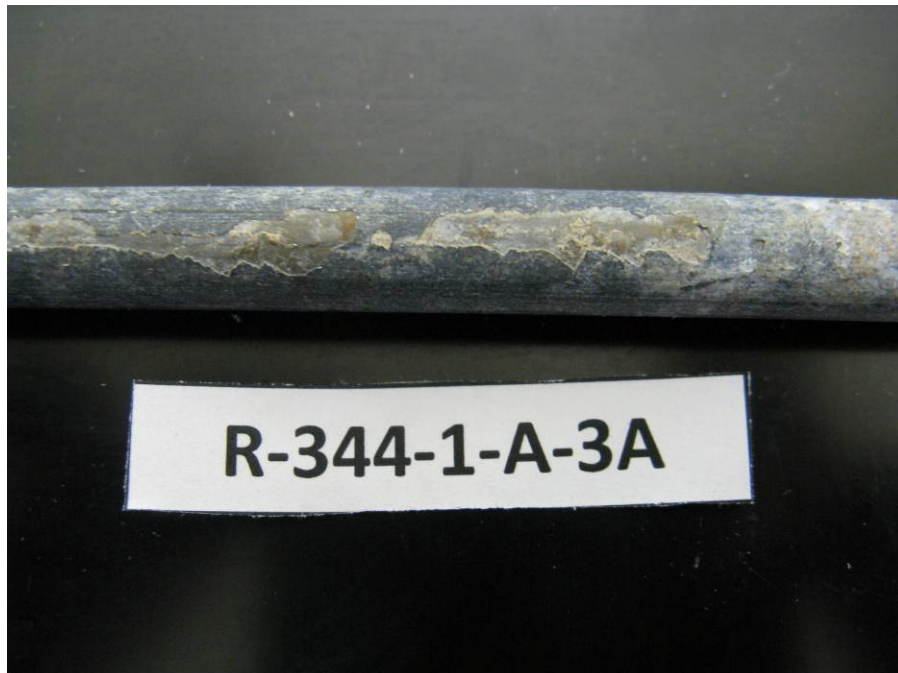
The center portion of coupon R-344-1-A-3, specimen A, is shown in Figure 11. In the upper photograph, it appears that the zinc coating was damaged near the end of the galvanization process, leaving a long narrow strip where the galvanization detached or peeled away from the steel. Fortunately, corrosion of the underlying steel was not observed in this particular segment. However, in the lower photograph showing an area of similarly peeled zinc coating (notice the sharply defined edges for the zinc coating), steel oxidation has started. Fortunately, this corrosion is localized to only a small portion of the exposed steel, and the oxidation is shallow in

Figure 11 Photographs detailing damage/loss of galvanization for coupon R-344-1-A-3

nature and absent of pitting. The presence of this kind of galvanization damage (particularly on monitoring coupons rather than production reinforcement) suggests a need for more effective inspection of MSE wall materials prior to installation.

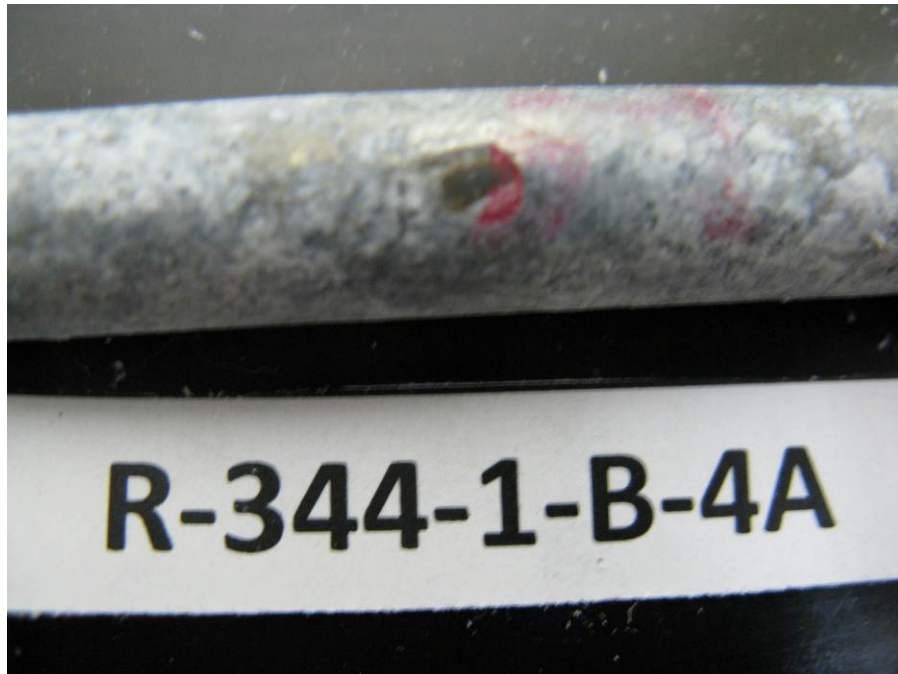
Figure 12 Photograph detailing corrosion by localized pitting on coupon R-344-1-B-4, specimen A

Figure 12 shows a section of coupon R-344-1-B-4, specimen A, located immediately behind the inner neoprene plug in the access hole. This section exhibits several small locations of steel oxidation (i.e., red rust). Figure 13 shows similar, but somewhat larger, areas of steel corrosion on coupon R-344-7-A-15, specimen A. A small area of the galvanization is missing, and the exposed steel is showing some oxidation with a textured surface beginning to become apparent.

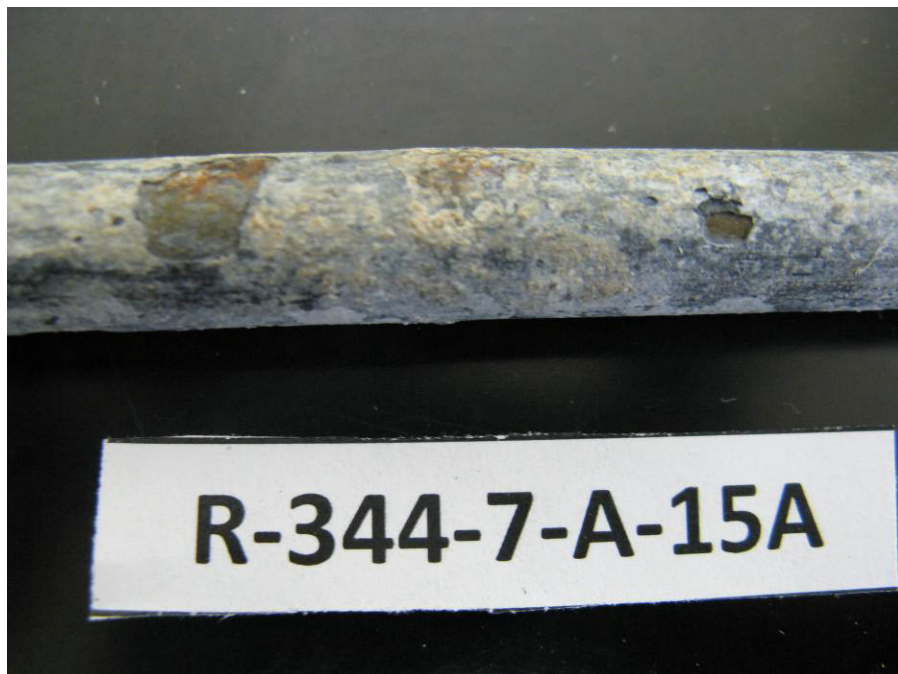
Figure 13 Photograph detailing corrosion on coupon R-344-7-A-15, specimen A

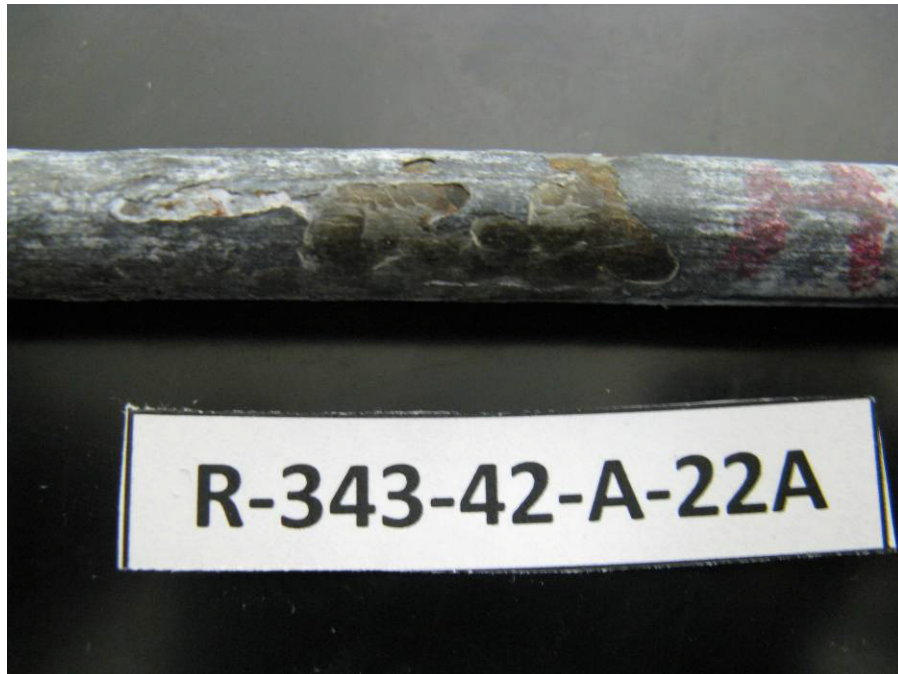
Figure 14 Photograph detailing corrosion of galvanization and steel on coupon R-343-42-A-22, specimen A

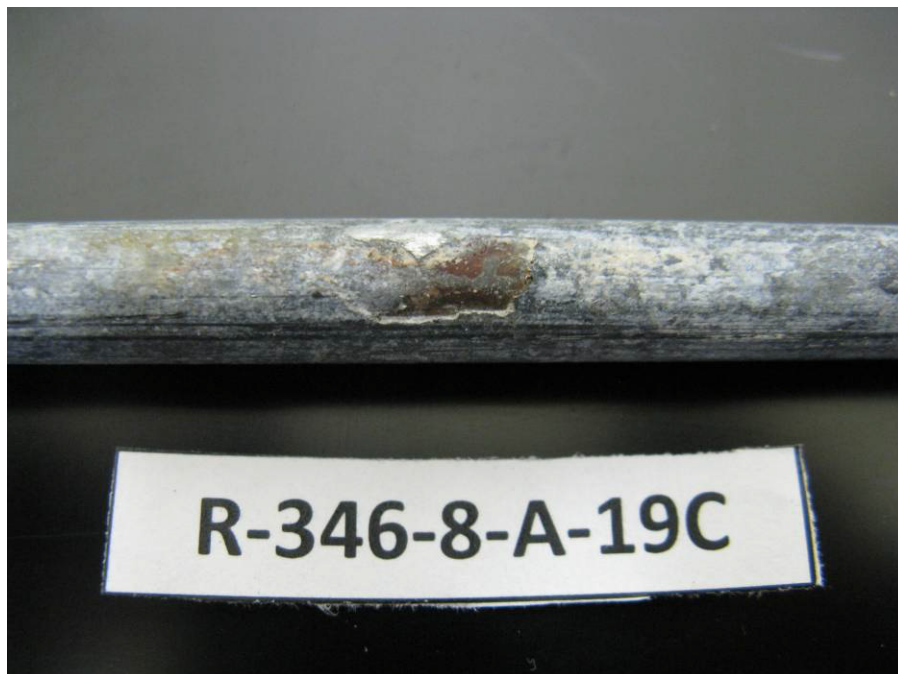
Figure 15 Photograph detailing localized corrosion on coupon R-346-8-A-19, specimen C

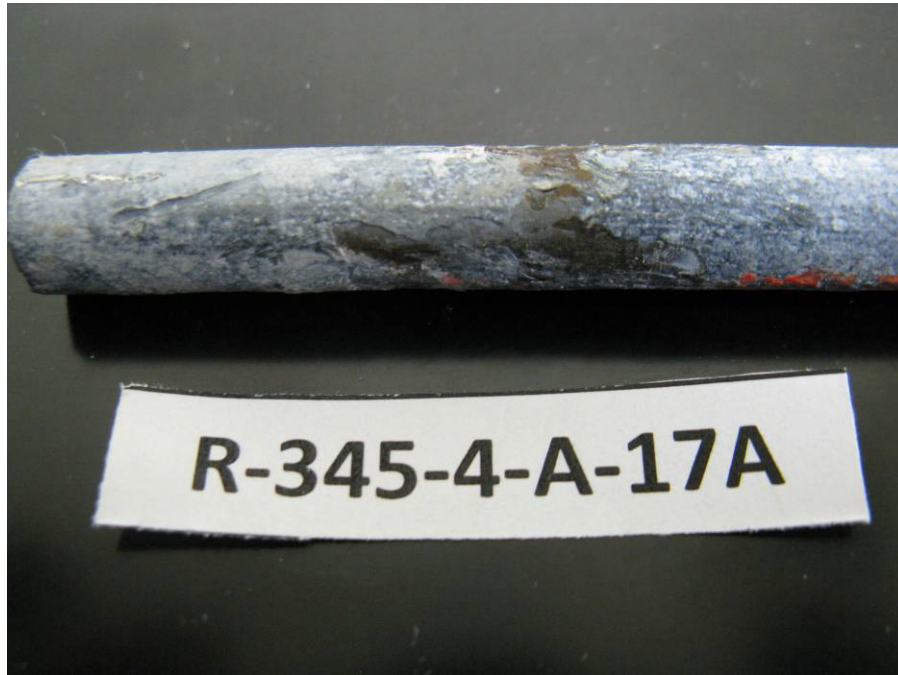
Figure 16 Photograph detailing localized corrosion on coupon R-345-4-A-17, specimen A

corrosion of the steel. The latter instance is the greatest loss of steel that we measured. Figure 16 shows coupon R-345-4-A-17, specimen A, with an instance where steel oxidation is present on a segment of the coupon, and extends a significant portion along the coupon circumference. The measurement of diametral steel loss was taken at the darkest and apparently most severe location at the top of the specimen as shown in the photograph.

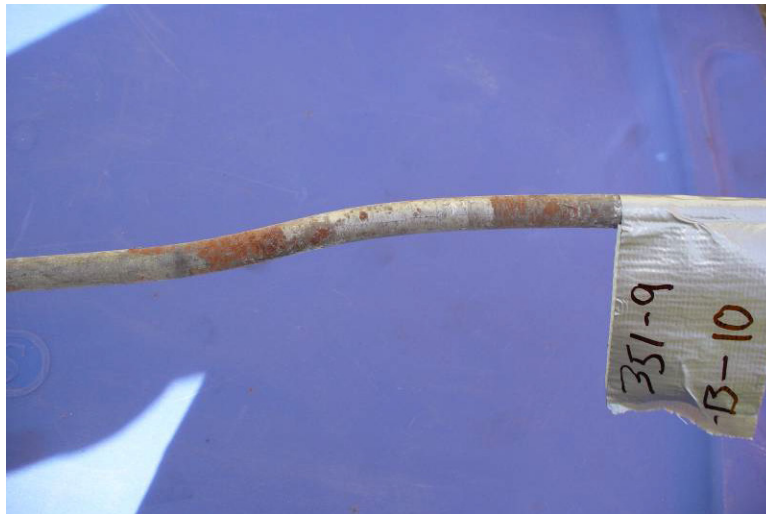
Coupon R-351-9-B-10 is of particular note with respect to the corrosion we observed. This coupon was initially extracted to help assess vertical variations in corrosion by comparing it with coupon R-351-9-A-9 which was located at the same horizontal location in a wall, but at a lower elevation. However, as the coupon was extracted, it was obvious that the coupon had been damaged either at, or prior to, installation. The bent coupon is shown in Figure 17. The galvanization appears to have flaked or spalled in the areas of greatest bending, and steel has subsequently corroded. This portion of the wire coupon was located near the wall face, just inside the panel access hole and in the open-air gap between the first and second stages of the MSE wall. Photographs showing greater detail of the damaged portions of the wire coupon are provided in Figure 18. The penetration of the rust is relatively shallow with some surface texture becoming apparent. The thickness of the flaking galvanization shown in the pictures is about 3 mil and the corrosion of the steel corresponds to a diametral loss of about 1 mil. The damage and corrosion observed on this coupon highlights the importance of avoiding excessive bending of MSE wall reinforcement elements during pre-installation handling and construction.

Figure 17 Damage and subsequent corrosion of coupon R-351-9-B-10 near panel face of two-stage MSE wall

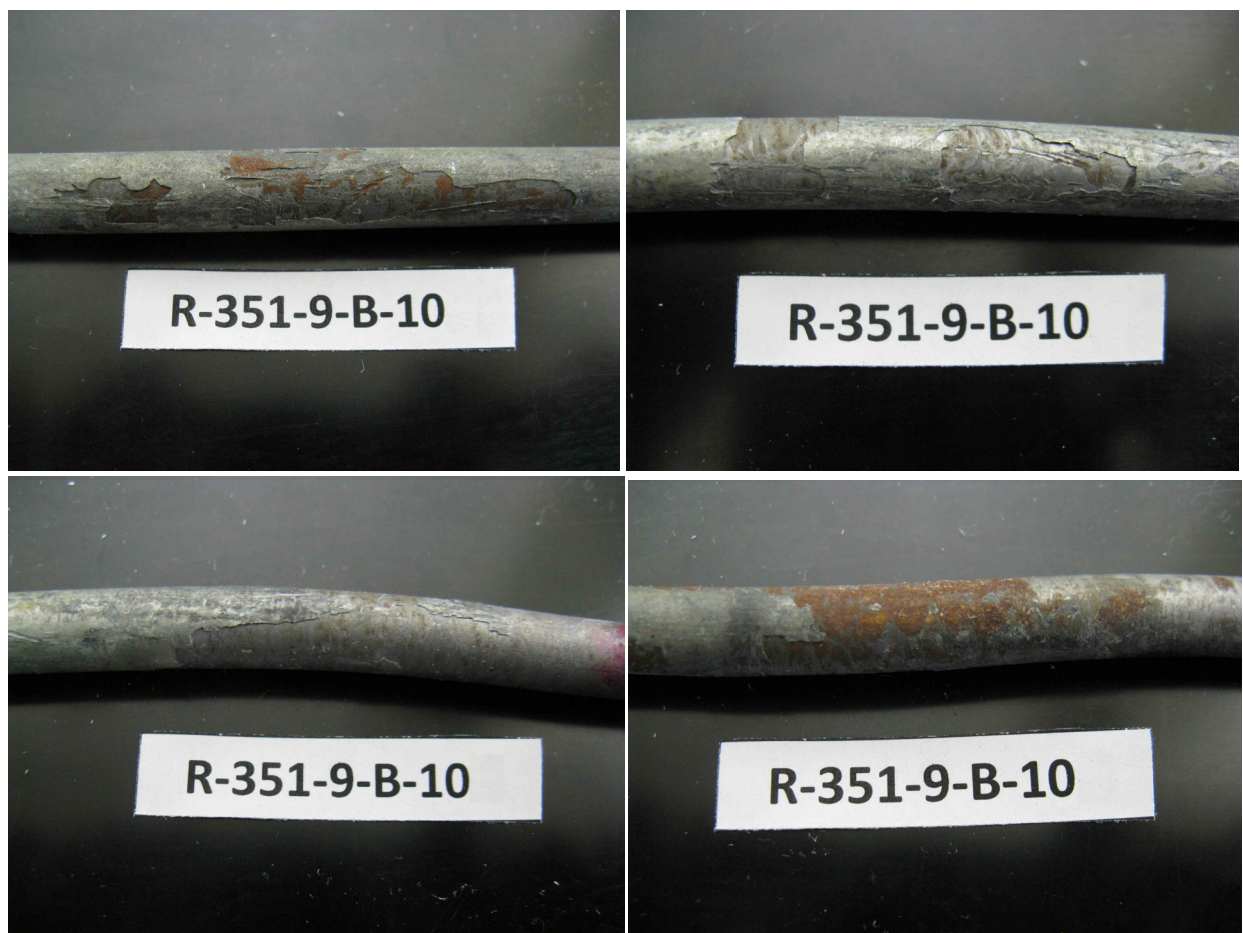
Figure 18 Photographs detailing damage and subsequent corrosion near end of coupon R-351-9-B-10
