1. Report No. FHWA/TX-11/5-5833-01-1		2. Government Accession No.		3. Recipient's Catalog No.	
4. Title and Subtitle IMPLEMENTATION OF TRANSVERSE VARIABLE ASPHALT RATE SEAL COAT PRACTICES IN TEXAS				5. Report Date December 2010 Published: January 2011

IMPLEMENTATION OF TRANSVERSE VARIABLE ASPHALT RATE SEAL COAT PRACTICES IN TEXAS

Report 5-5833-01-1
Project 5-5833-01
Project Title: Statewide Implementation of TVAR Seal Coat Methods

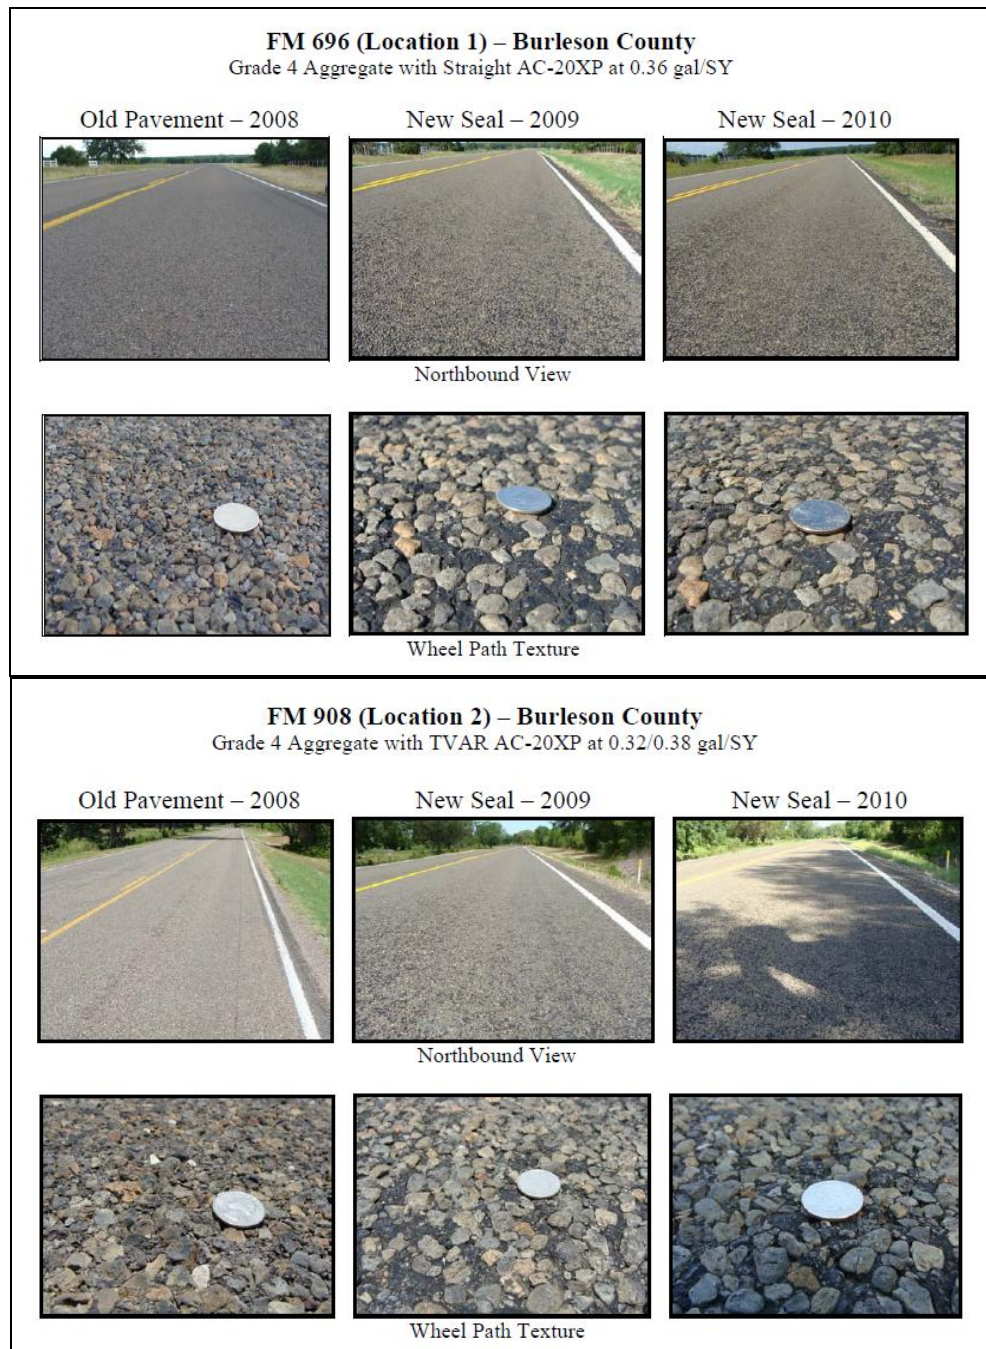
Figure 16. Photographs of FM 908 and FM 696 Textures.

Several pairs of pavements merit individual comparison. The first is a pair of pavement locations in Burleson County. FM 696 and FM 908 are parallel north-south roads which carry similar traffic. FM 696 location 1 and FM 908 location 2 had both been sealed by maintenance the prior year with a fine Grade 4 seal coat. These maintenance seals were short in length, leaving the majority of these pavement surfaces to be sealed in 2008 in an aged condition. The appearance and texture depth test results in 2008 for these two test locations were virtually identical, as seen in Table 11 and Figure 16. However, since the textures of these two pavements otherwise differed, FM 908 location 2 received a TVAR seal coat, with asphalt rates at 0.32 and

Location	TVAR Used	Asphalt Application Rate(s), Gal/SY	Aggregate Grade	2008 Pre-Seal Coat Wheel Path Texture Depth, mm	2009 Wheel Path Texture Depth, mm	2010 Wheel Path Texture Depth, mm
FM 696 #1	No	0.36	4	2.16	1.82	1.28
FM 908 #2	Yes	0.32 and 0.38	4	2.15	2.33	1.67

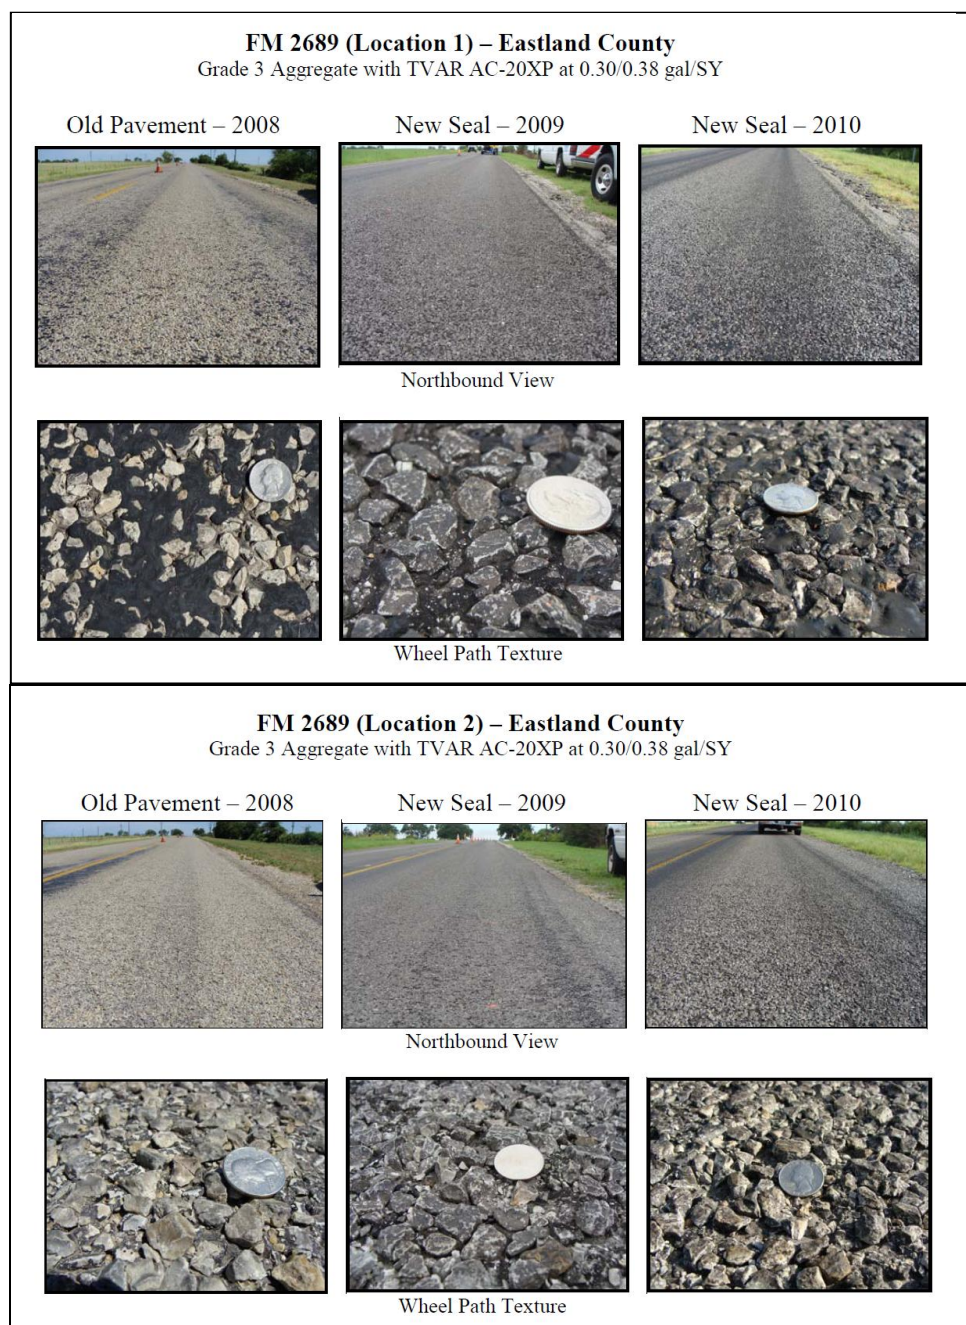
Figure 17. Photographs of FM 2689 Textures.

The second pair of pavement locations was on FM 2689 in Eastland County. They were located in the same lane, within approximately 600 ft of each other, and may be seen in Figure 17. Yet, location 1 had limited pre-existing wheel path texture depth, 1.35 mm, compared to the pre-existing wheel path texture depth of 3.48 mm at location 2. These wheel path texture depths and those found after one year and two years of traffic are shown in Table 12. Both locations received a TVAR seal coat, at asphalt application rates of 0.30 and 0.38 gal/SY, as the bulk of the pavement length called for a TVAR seal coat. Both locations have retained excellent textures over the two-year period of the study. Location 2, which did not require a TVAR method seal coat, has not lost aggregate from the wheel path even though a relatively low asphalt rate was applied.

Location	TVAR Used	Asphalt Application Rate(s), Gal/SY	Aggregate Grade	2008 Pre-Seal Coat Wheel Path Texture Depth, mm	2009 Wheel Path Texture Depth, mm	2010 Wheel Path Texture Depth, mm
FM 2689 # 1	Yes	0.32 and 0.38	3	1.35	3.05	2.74
FM 2689 #2	Yes	0.32 and 0.38	3	3.48	4.74	4.26

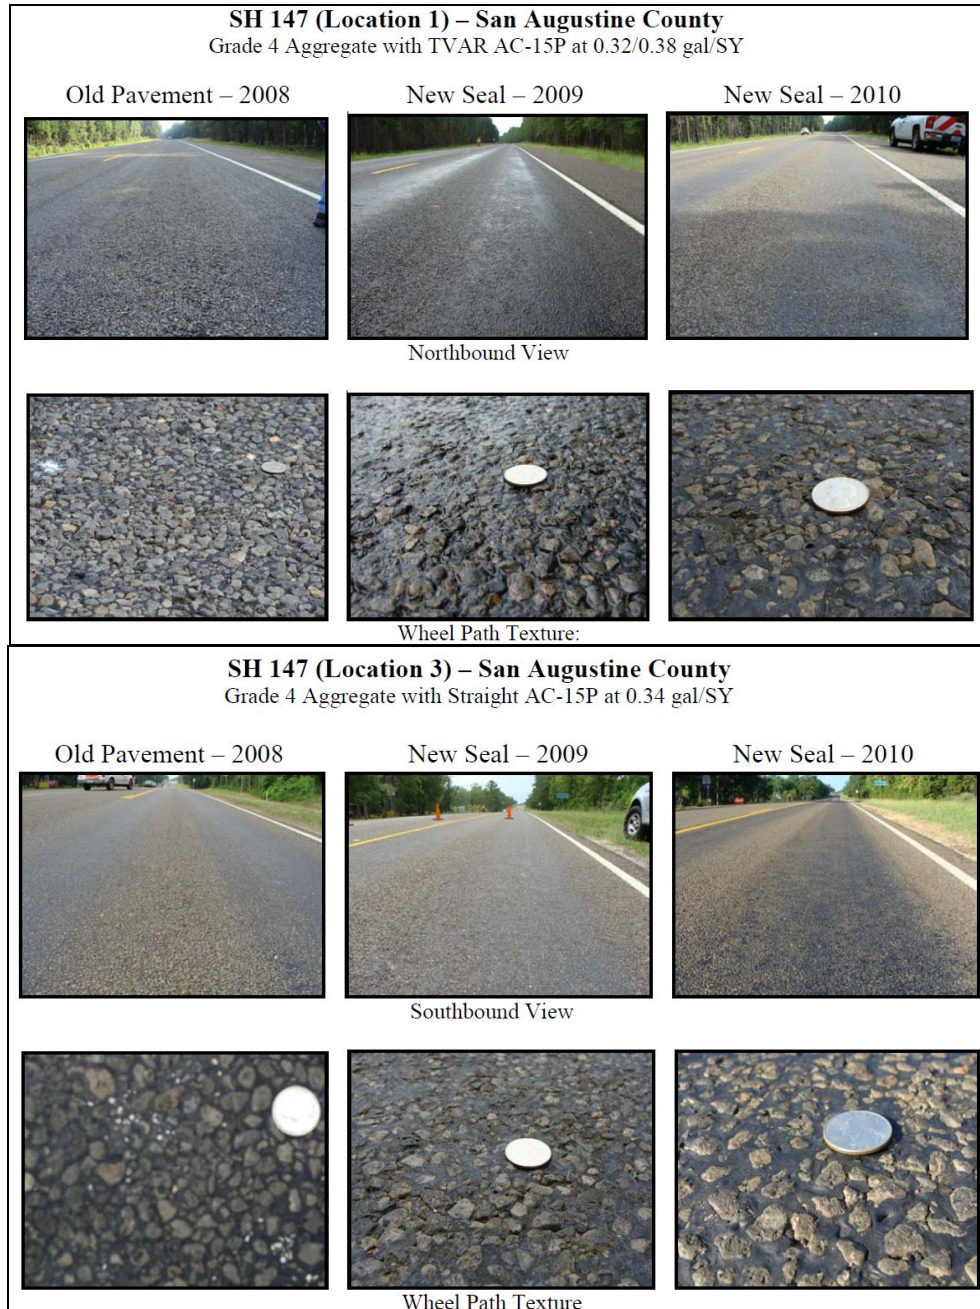
Figure 18. Photographs of SH 147 Textures.

The third pair of locations is on SH 147 in San Augustine County. Location 1 is in the northbound lane and location 3 is in the southbound lane, approximately three miles apart. Because of predominantly differing texture conditions around these test locations, location 1 with reasonably good pre-existing wheel path textures received a TVAR seal coat at 0.32 and 0.38 gal/SY and location 3, which was a considerably flushed wheel path location, received a uniform asphalt application at 0.34 gal/SY. The visual appearances of these locations may be seen in Figure 18, and Table 13 contains pre-existing and post-seal coat wheel path texture depths. Location 3 has lost virtually all texture improvement provided by the new seal coat within two years of construction. Location 1 now has *less* wheel path texture than existed prior to seal coat construction two years prior, although the texture depth is superior to that in location 3. The appearance is that both of these locations still have an excess of asphalt at the surface and both would have benefited from a lesser asphalt application in the wheel paths provided that the lesser asphalt amount would have held the aggregate over the first winter.

Location	TVAR Used	Asphalt Application Rate(s), Gal/SY	Aggregate Grade	2008 Pre-Seal Coat Wheel Path Texture Depth, mm	2009 Wheel Path Texture Depth, mm	2010 Wheel Path Texture Depth, mm
SH 147 #1	Yes	0.32 and 0.38	4	1.93	1.77	1.20
SH 147 #3	No	0.34	4	0.62	1.26	0.88
