Identification and Evaluation of Pavement-Bridge Interface Ride Quality Improvement and Corrective Strategies

Institute for Transportation

Report Number FHWA/OH-2011/1

January 2011

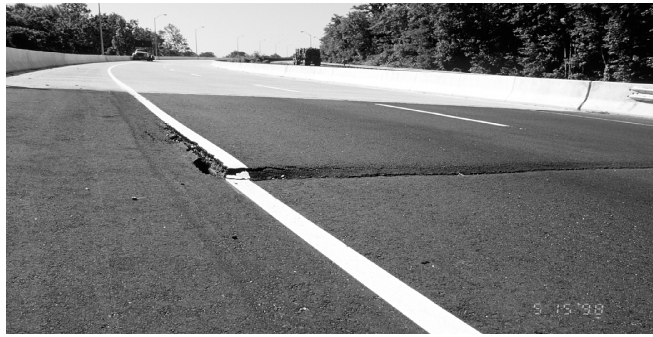
Figure 4.60. Approach slab distress attributable to foundation soil settlement (Route 10 westbound lane over the Appomattox River) (Hoppe, 1999)

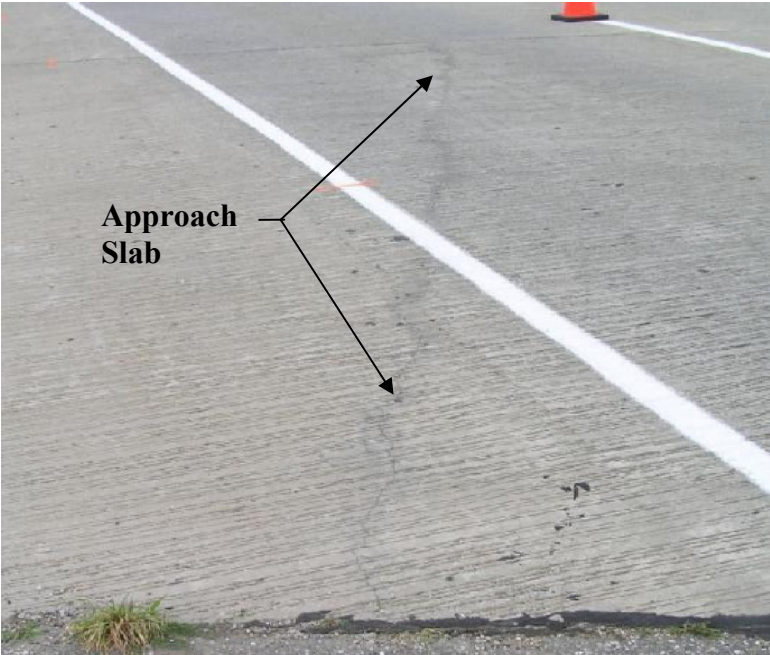
Figure 5.9. FAI 33-14.17 approach slab cracking

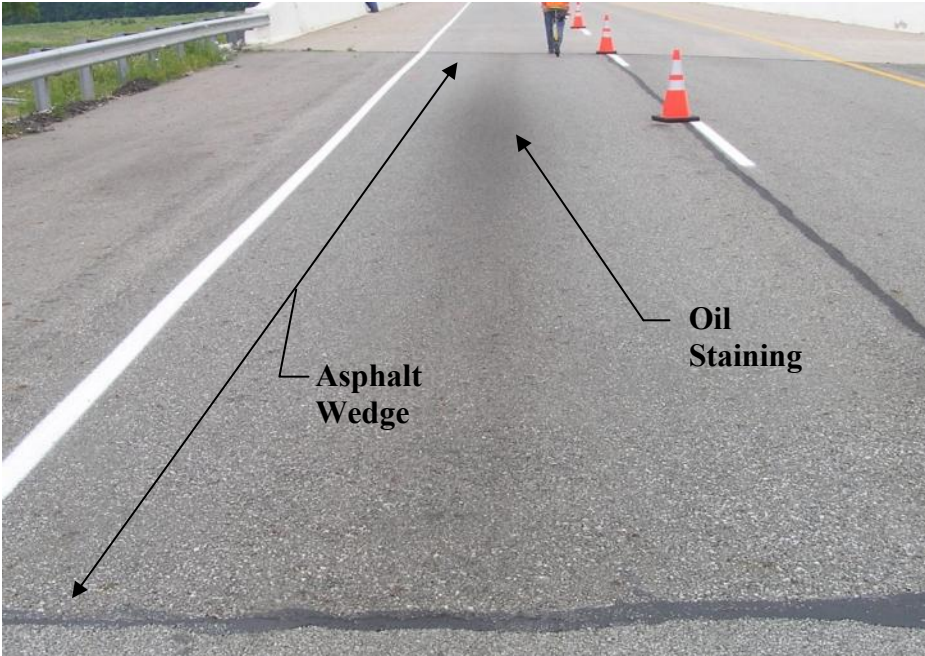
indicates a bump condition just prior to the stain. Oil staining can be caused by the bump exciting the vehicle vertically which in turn causes increased inertial forces on leaking engine oil droplets that then fall to the pavement on the downward portion of the excitation. Figure 5.10 shows the asphalt wedge and oil staining at the exit of the bridge.

Figure 5.10. FAI 33-14.17 asphalt wedge and oil staining located at exit of bridge

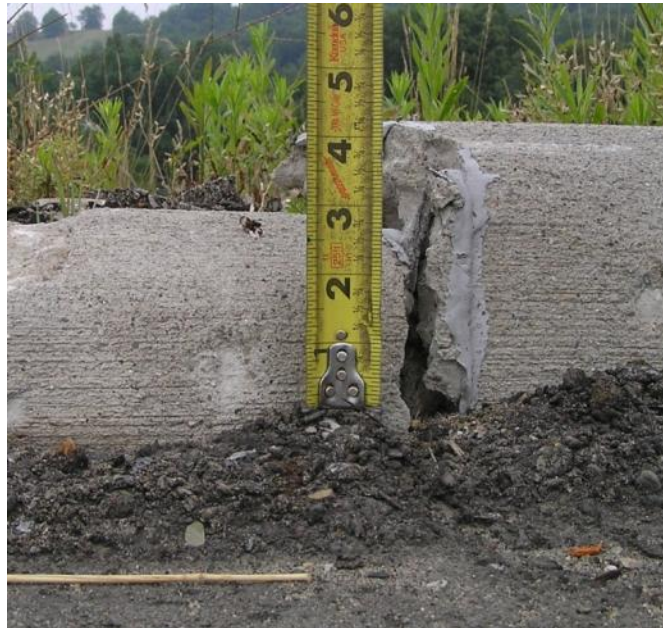
Figure 5.15. MUS 16-7.69 approach slab settlement relative to main line pavement

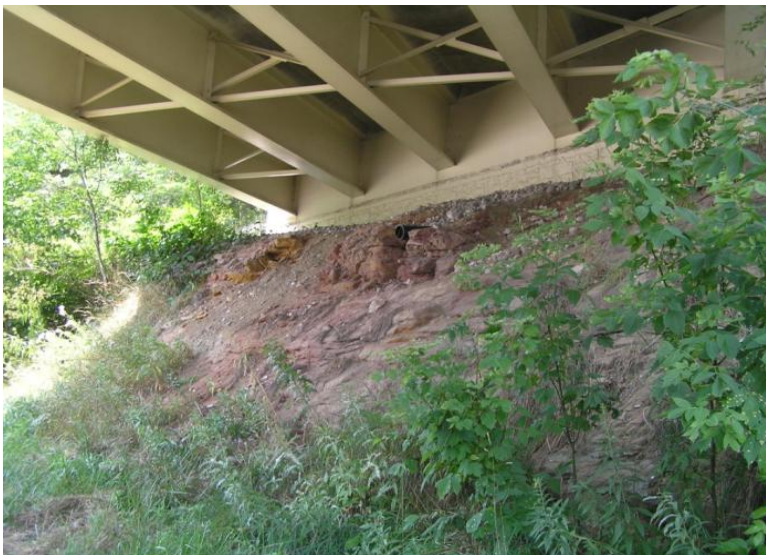
Figure 5.21. Abutment conditions at RIC 430-9.98

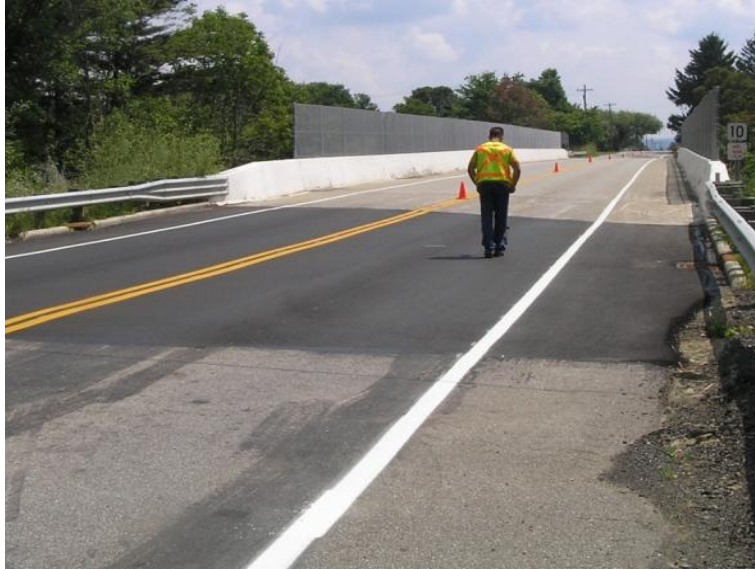
About a month prior to conducting the field test, the bridge approach slabs were mud-jacked, a 50 ft long asphalt wedge was placed on the pavement leading up to the approach slab, and the approach pavement was ground. Figure 5.22 shows the newly surfaced approach on the bridge. Upon investigation, the approach slab has settled causing the parapet's vertical joint at the bridge to be wider at the top than at the bottom, as shown in Figure 5.23. A 20 in. deep void was found between the wing wall and approach slab, as shown in Figure 5.24.

Figure 5.22. RIC 430-9.98 newly placed asphalt wedge and mud-jacked slab

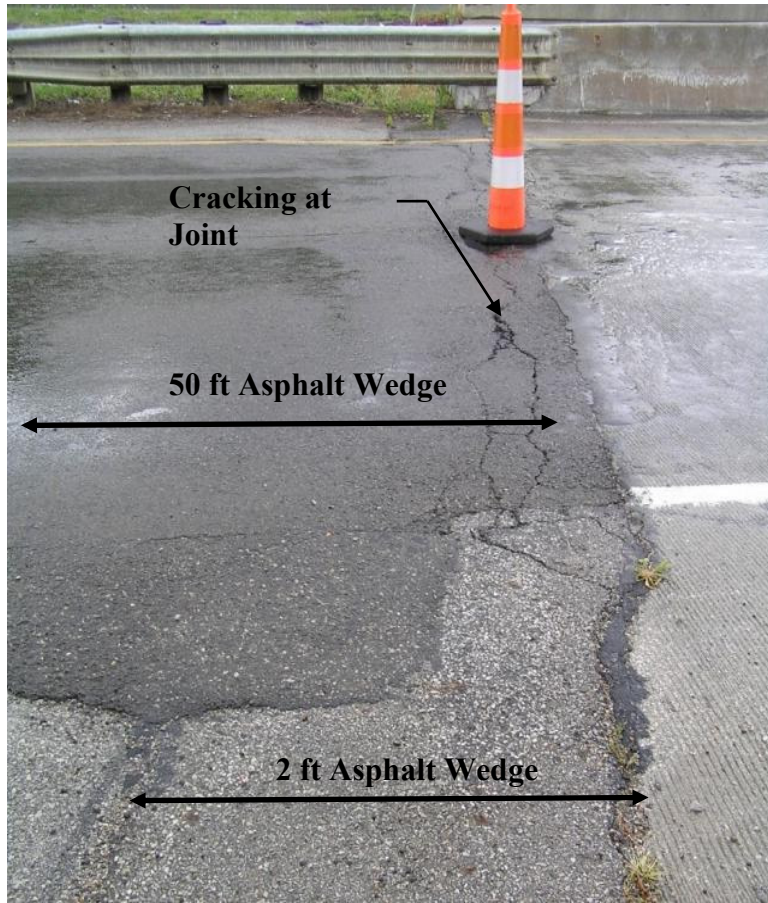
Figure 5.27. Asphalt wedges at bridge abutment

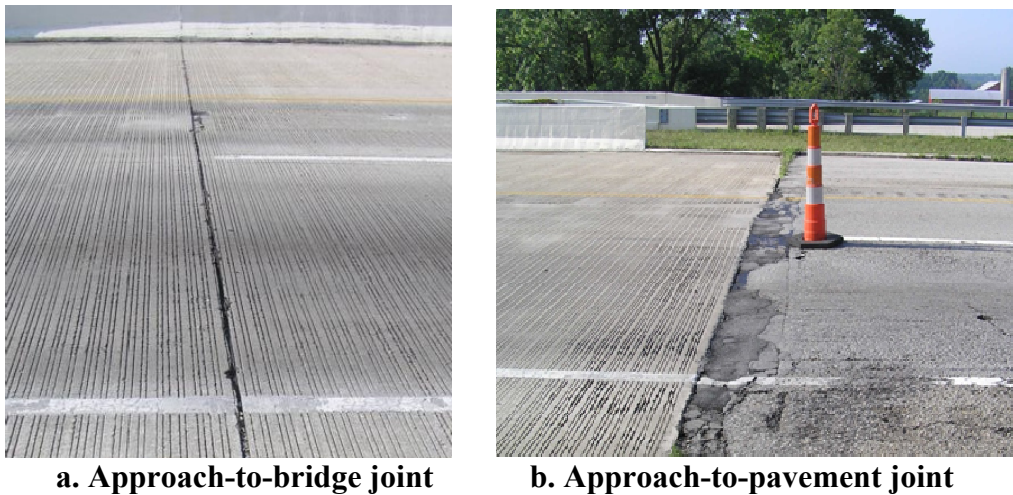
Figure 5.32. Condition of bridge and approach joints

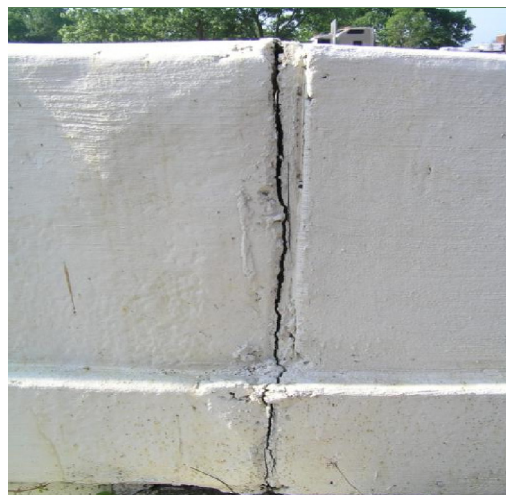
Figure 5.33. Barrier rail joint at approach slab showing settlement of approach slab

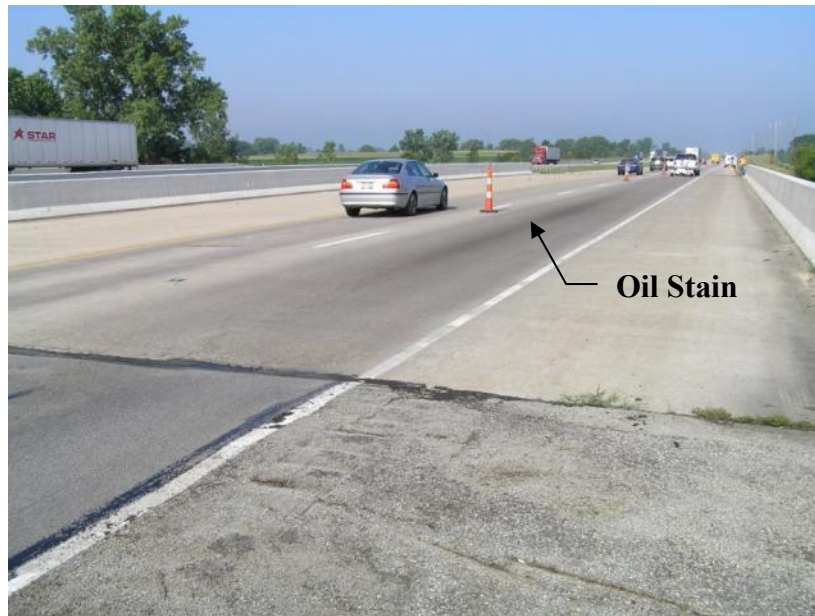
Figure 5.34. Oil staining on bridge surface caused by bump at pavement-to-approach joint

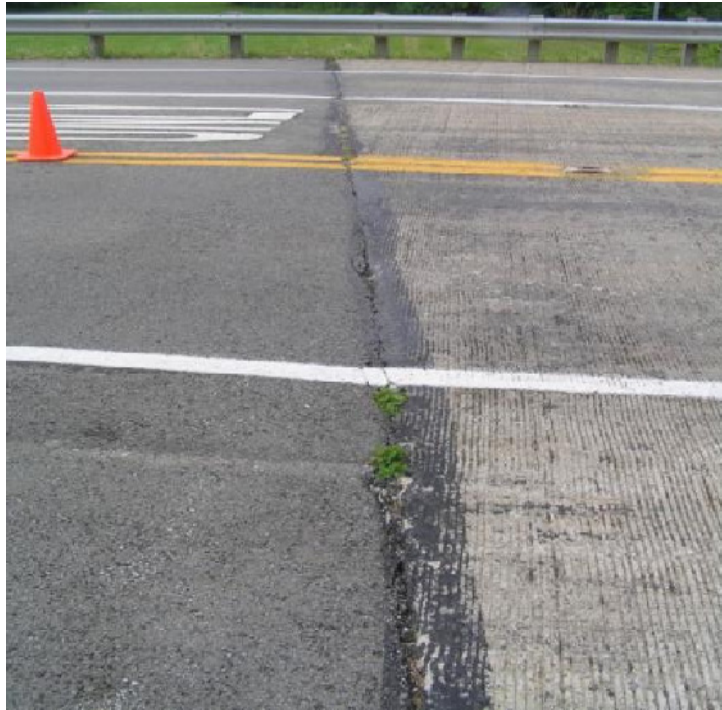
Figure 5.37. Pavement-to-approach joint condition at LIC 40-12.53

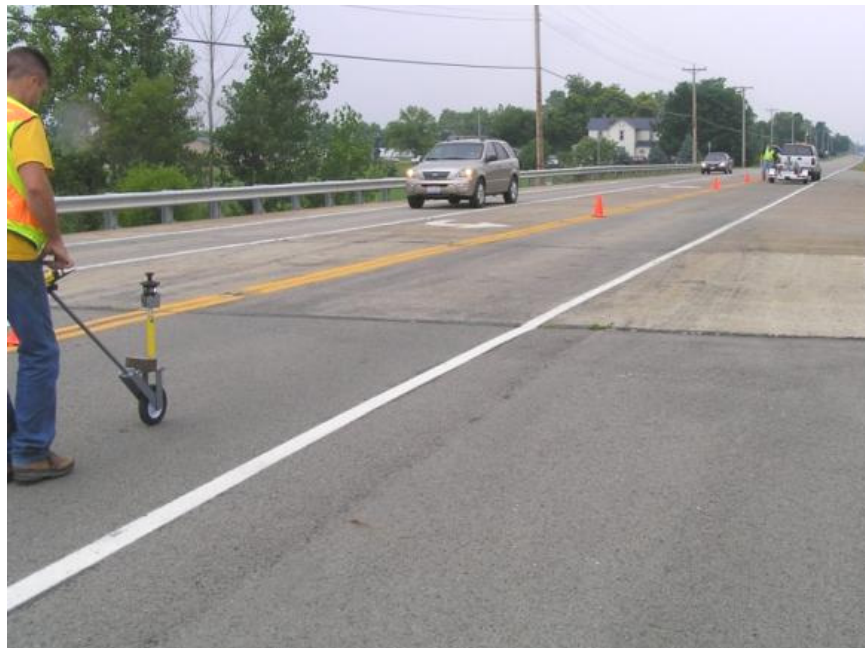
Figure 5.38. Condition of LIC 40-12.53 bridge surface

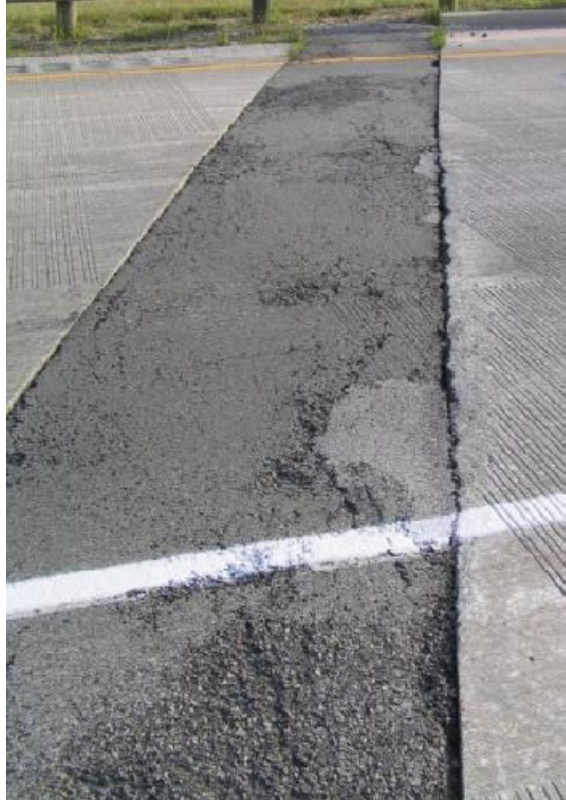
Figure 5.41. WYA 30-22.40 pressure relief joint deterioration

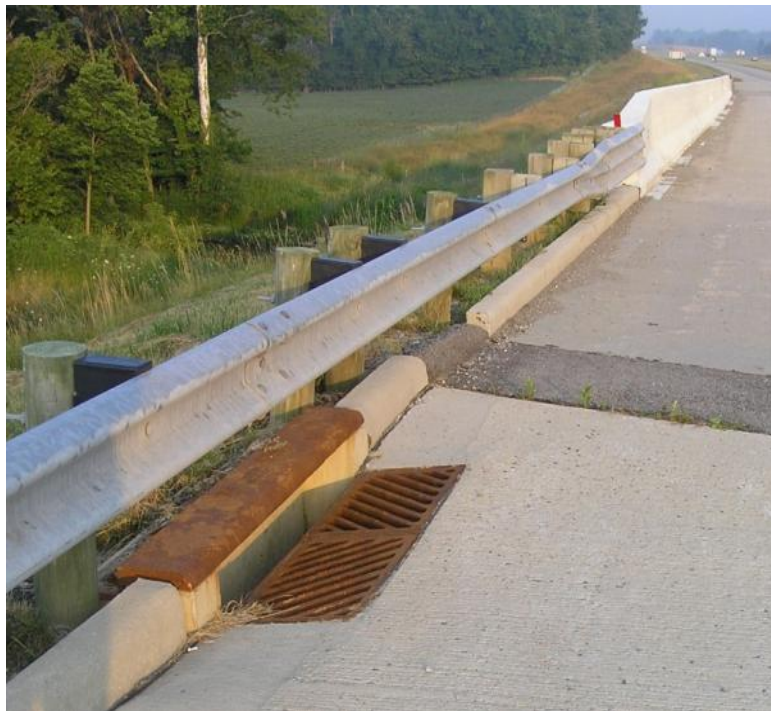
Figure 5.42. Bar grates and curb provide good water drainage and eliminates erosion at the edge of the shoulder

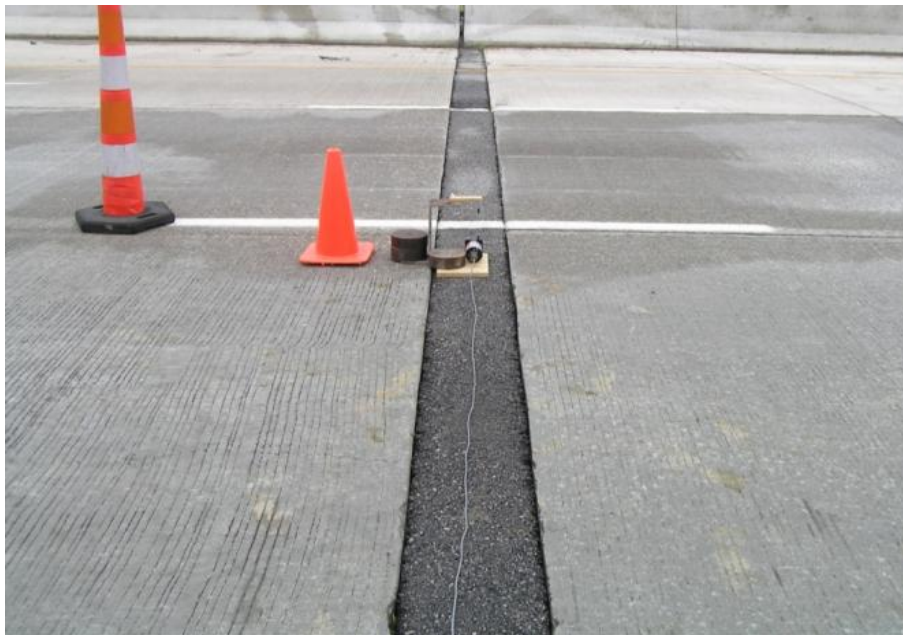
Figure 5.45. 12 in. pressure relief joint condition

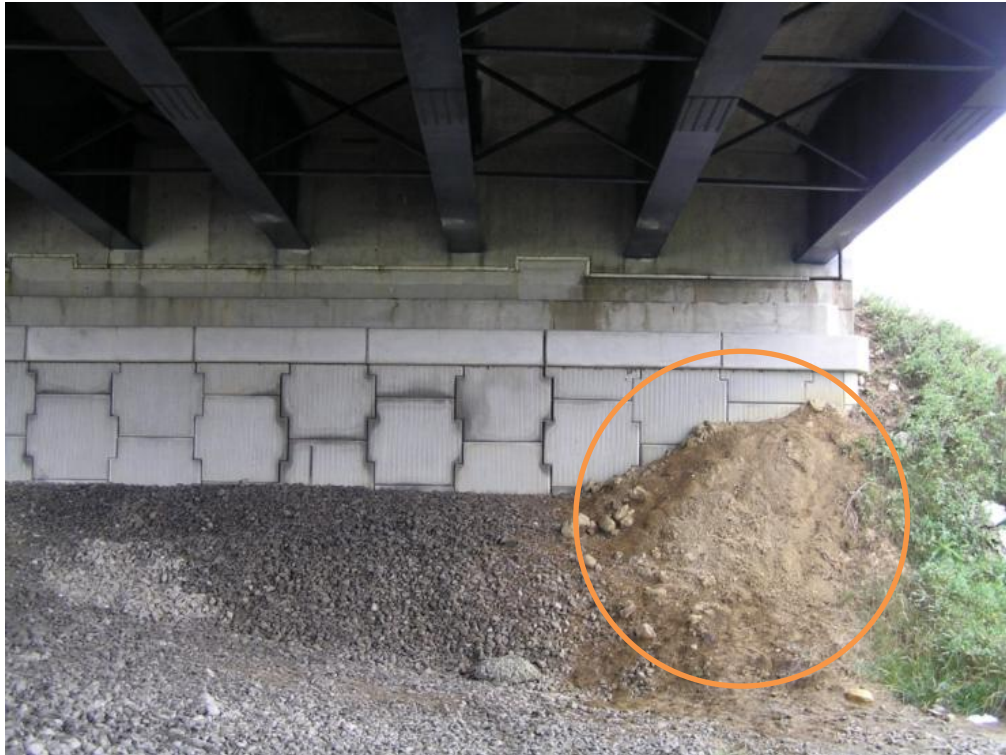
Figure 5.46. Erosion from bridge embankment

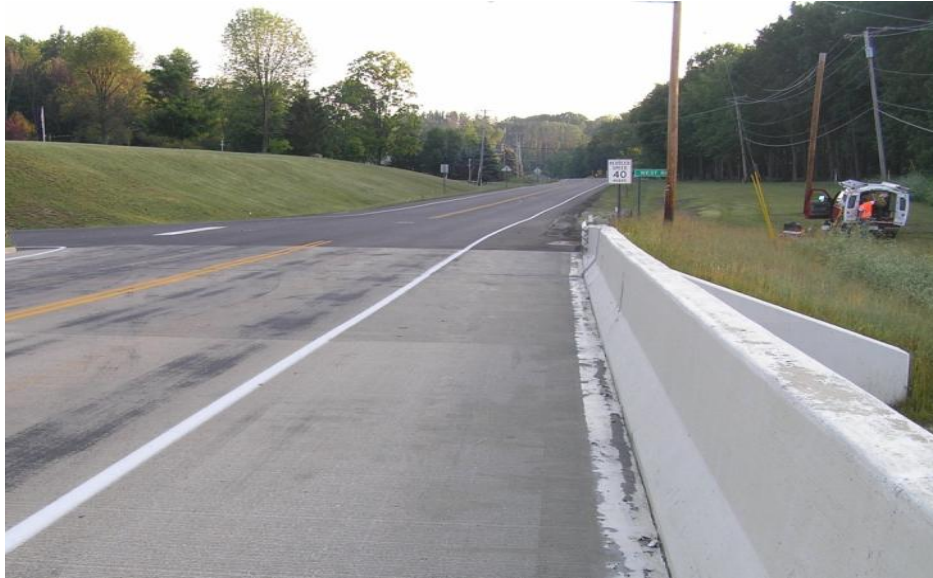
Figure 5.53. New asphalt pavement up to approach slab

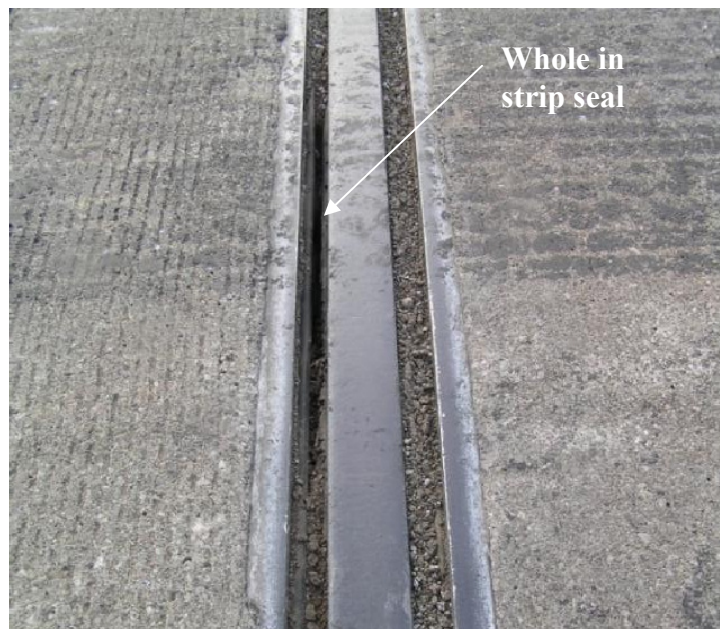
Figure 5.54. Deterioration of strip seal
