Organizational Results Research Report

Experimental Galvanic Anode for Cathodic Protection of Bridge A12112

Final Report

John D. Wenzlick, P.E.
Missouri DOT

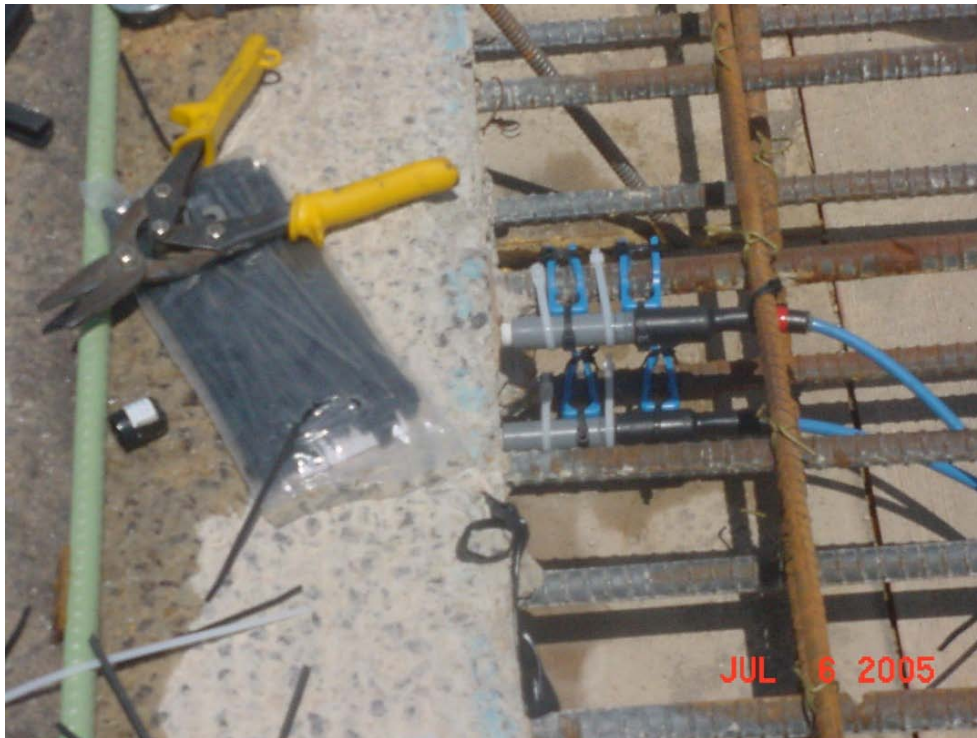
Figure 1: Silver/Silver Chloride Half Cells, one at level of top rebar and one at bottom rebar.

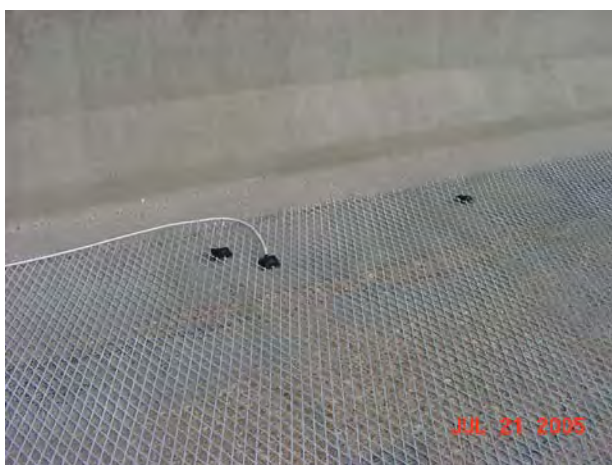
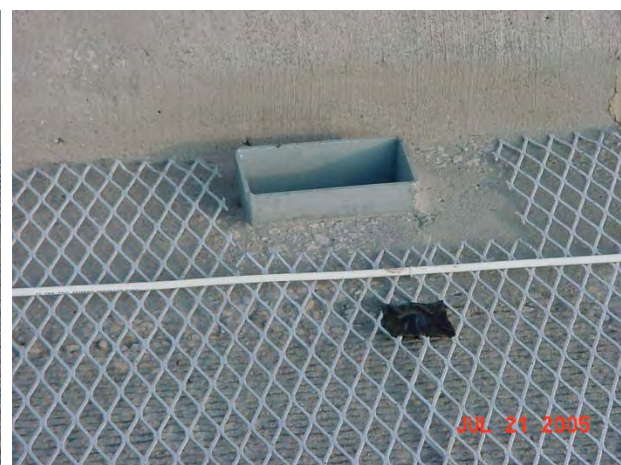
Figure 2 &3: Anode electrically connected to each other with metal clamps at each corner of 4' x 8' sheet. (Black patch is insulation around clamps to keep out concrete during placement.). White anode lead wire is connected to sheet in two locations. Anode was cut to fit around steel deck drains so it won't short out to the rebar.

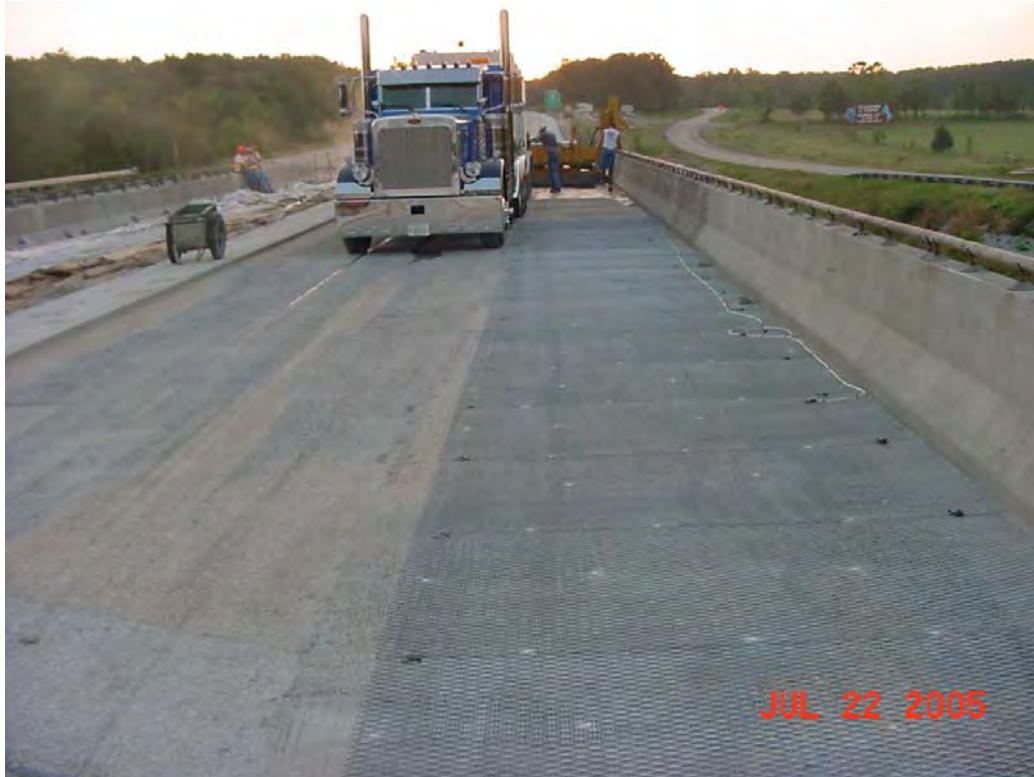
Figure 4: Anode laid out ready for concrete. Note: White spots are plastic anchors to hold sheet in place during concrete placement foreground.

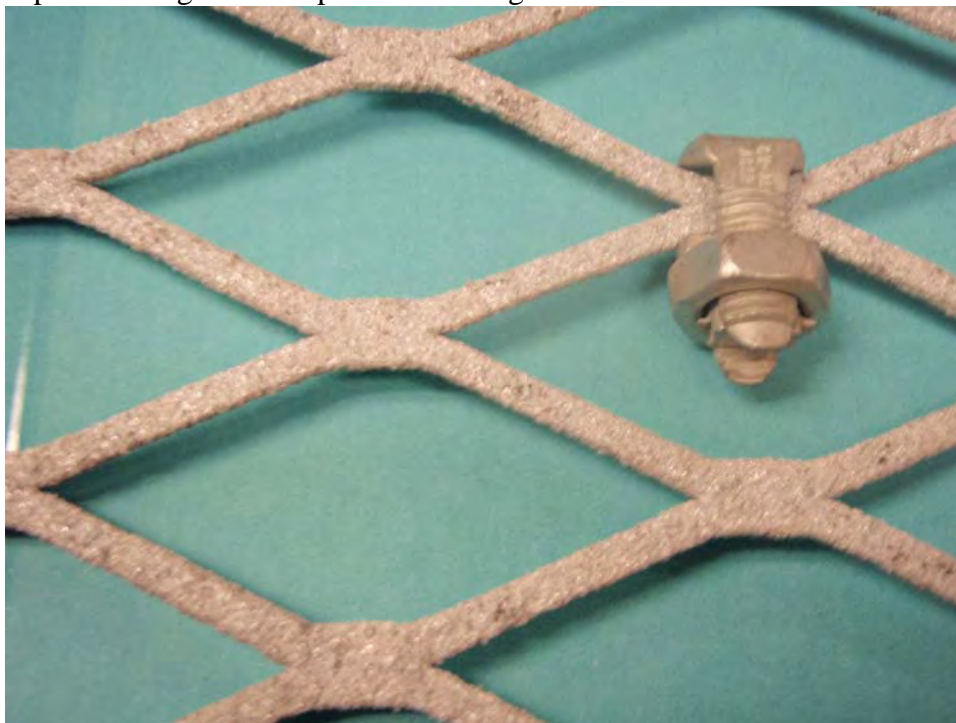
Figure 5: Close up of anode showing grainy texture of arc sprayed on particles of the Al – Zn – In alloy. This increases the surface area of the mesh thousand of times. Also shows clamp as used to attach 4' x 8" sheets together.

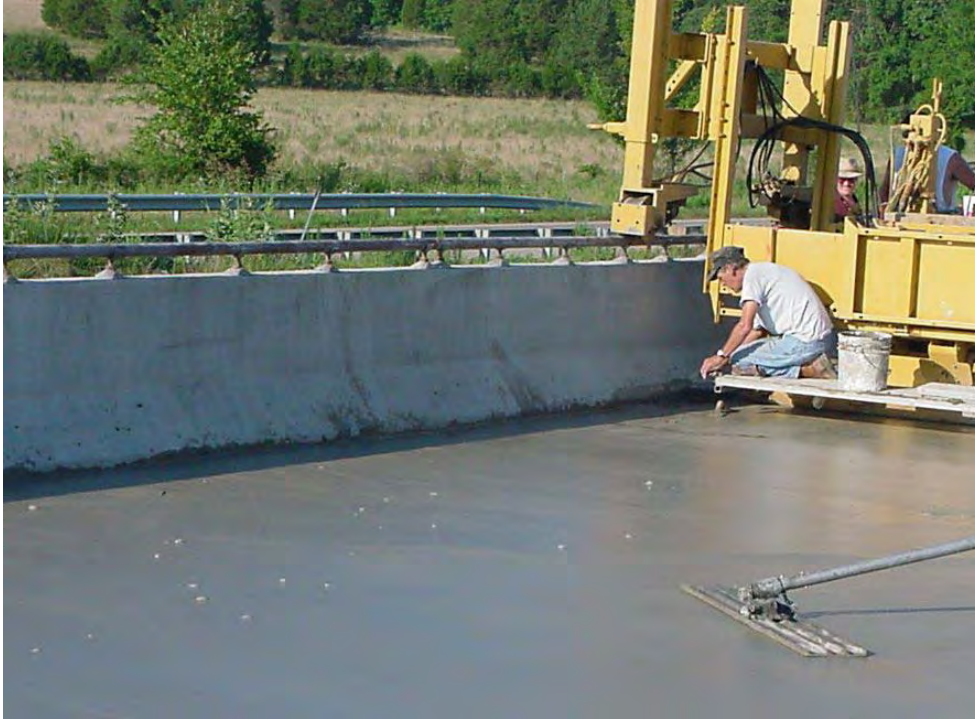
Figure 6: Gas bubbles from cement reacting with Al-Zn-In coating on anode appeared before final finishing of the overlay.

One area of concern is that the anode is very active in the wet concrete and produces gas bubbles from self corrosion. These bubbles ceased after a while and do not appear to extend down to the anode. Missouri DOT used a boiled linseed oil to seal the deck

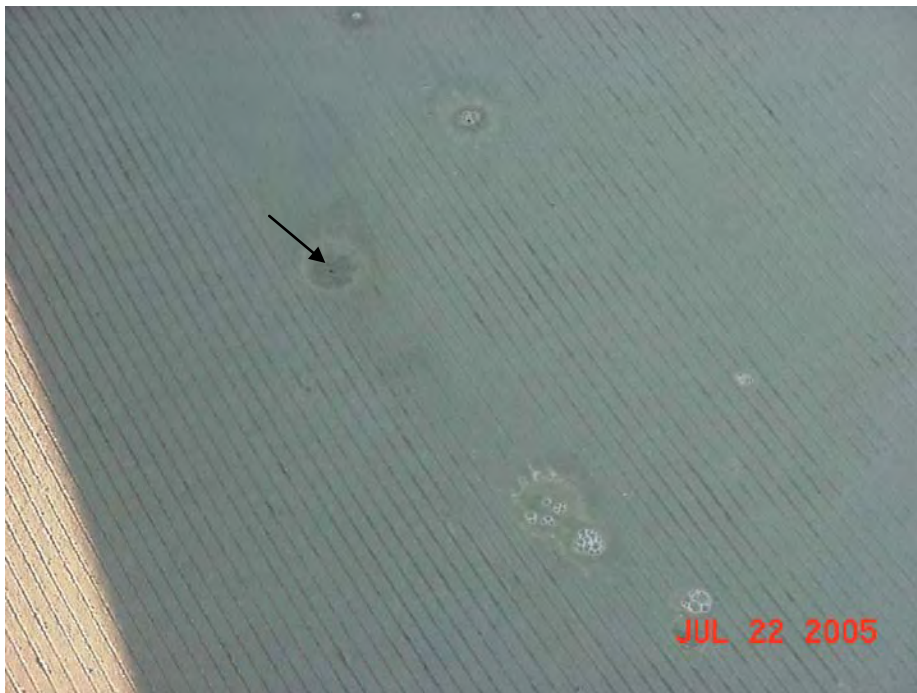
Figure 7: Close up of gas bubbles coming up after surface textured.
Note: one on left in middle has popped and a black pin hole can be seen in its center. Does it go all the way through the 2" thick overlay?

It is MoDOT's opinion that the gas bubbles that made it to the surface of the concrete overlay did leave small holes that went down to the top of the mesh. The linseed oil sealer and later emulsion sealer may have sealed off the holes but that doesn't matter. As shown by the cores taken the gas bubbles that collected around the surface of the anode that were trapped there did cause a problem of keeping the wet concrete overlay from bonding to the mesh surface and to the deck surface below. The subsequent disbondment continued to occur year after year. This was the most detrimental effect of using the thermally sprayed mesh anode.

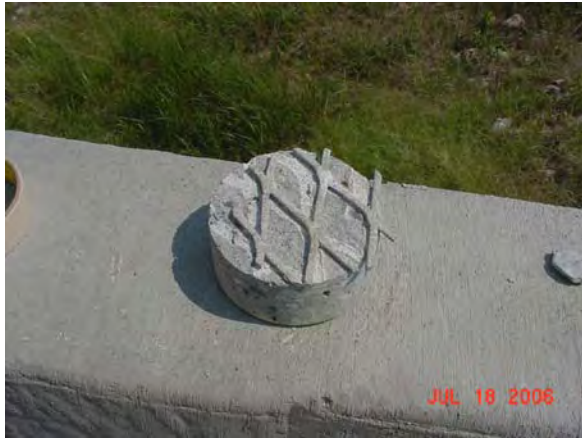
Missouri DOT and Corpro will monitor these to determine if they have any effect on the bridge. Missouri DOT obtained core samples at the one year anniversary of the system. Cores, 4” diameter, were drilled over visible air wholes left in the concrete. Three of the four cores, #1, #2, #4 all had the anodes disbonded from the concrete. Only core #3 had the anode firmly embedded in the overlay.

Figure 8: Core #1 –anode disbonded.

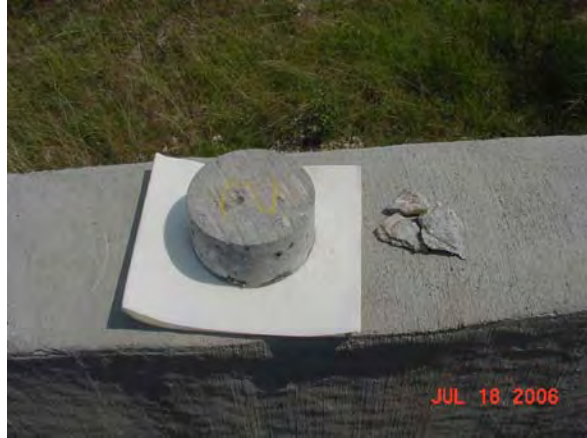
Figure 9: Core #2 – gas bubble hole in center.

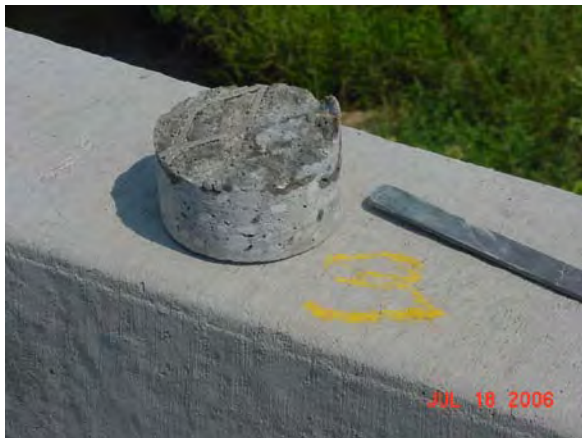
Figure 10: Core 3 – only one with anode imbedded in concrete.

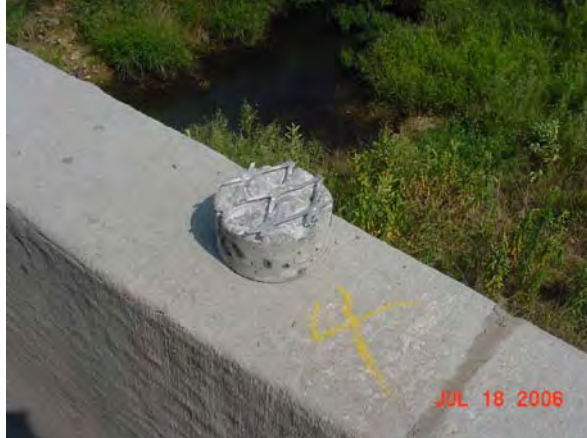
Figure 11: Core 4 – anode disbonded.

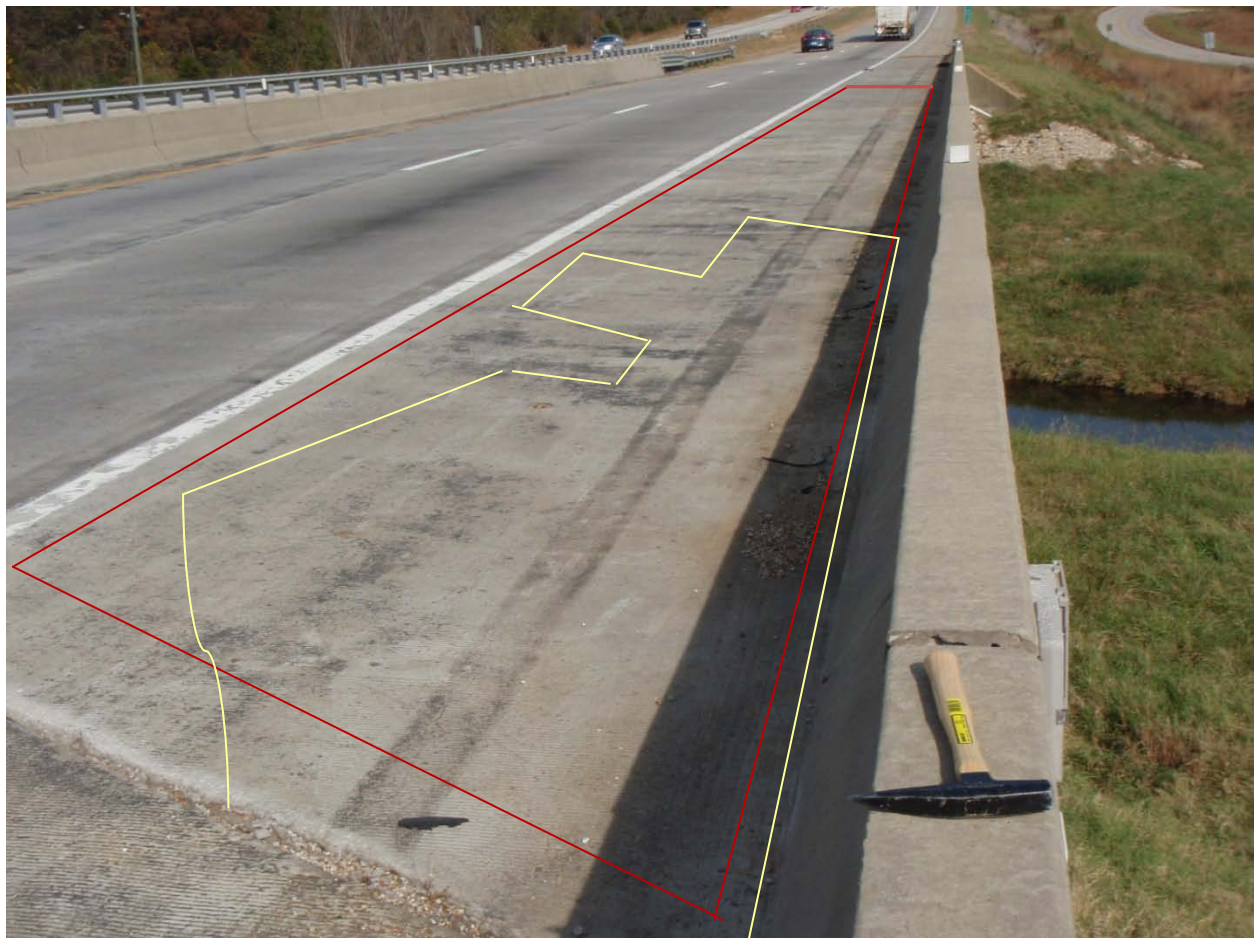
Figure 12: October 2010 photo of concrete deck overlay above the Al-Zn-In anode (outlined in red), five years after installed. There are few cracks and no spalling on the surface but 46% of the concrete overlay is debonded over the anode (outlined in yellow). See maps in Appendix B for additional debonded areas.

As far as bridge A12112, although the outside shoulder has almost half of the overlay debonded on the area over the experimental CP anode, the overlay remains in place with no noticeable distress. Since there is seldom any vehicle loads on it, it could be a long time until any deterioration occurs.

- As any potholes appear they should be cleaned up, the anode removed if necessary and patched in place with an approved patching concrete.
- If cracking appears to worsen the area should be sealed with a crack sealer as per normal bridge maintenance procedures. The bridge has already been sealed with Pavon Indeck once and should be sealed again to keep moisture and salt out of this vulnerable area especially. This overlay is now over five years old and it is expected that it will last the remaining 15 years of its design life until 2025 with some minor patching of the outside shoulder.

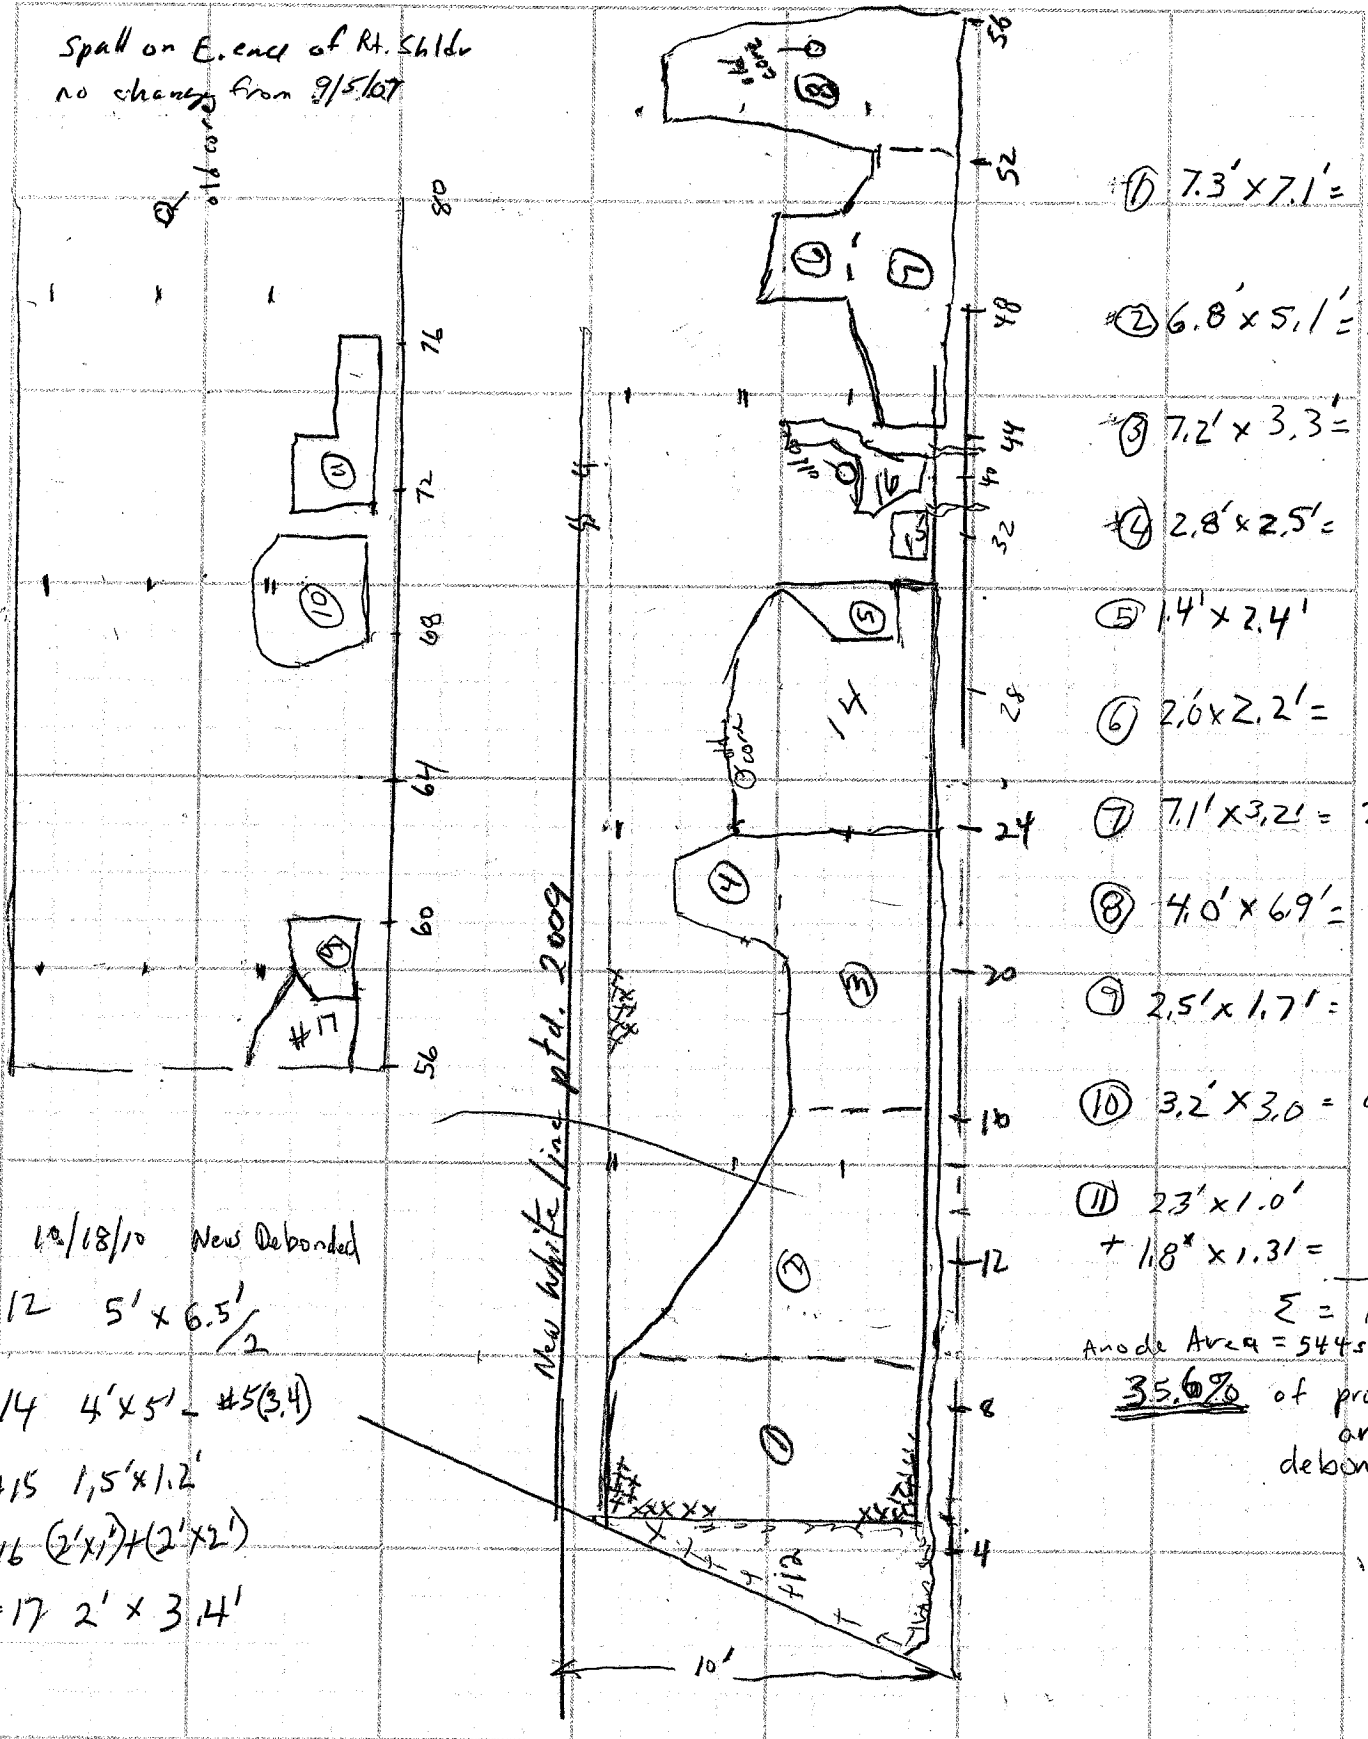
Spall on E. end of Rt. Shldr
no change from 9/5/07

- ① 7.3' x 7.1' = 51.83
- ② 6.8' x 5.1' = 34.68
- ③ 7.2' x 3.3' = 23.8
- ④ 2.8' x 2.5' = 7
- ⑤ 1.4' x 2.4' = 3.4
- ⑥ 2.6' x 2.2' = 4.4
- ⑦ 7.1' x 3.2' = 22.7
- ⑧ 4.0' x 6.9' = 27.6
- ⑨ 2.5' x 1.7' = 4.25
- ⑩ 3.2' x 3.0 = 9.6
- ⑪ 2.3' x 1.0' = 2.3
+ 1.8' x 1.3' = 2.34

$\Sigma = 19880'$
Anode Area = 544sf
35.6% of protected area debanded

- 12/18/10 New Debanded
- #12 5' x 6.5' / 2
 - #14 4' x 5' - #5(3.4)
 - #15 1.5' x 1.2'
 - #16 (2' x 1') + (2' x 2')
 - #17 2' x 3.4'
