FINAL REPORT

GLULAM TIMBER DECK BRIDGES

Virginia Highway & Transportation Research Council
(A Cooperative Organization Sponsored Jointly by the Virginia
Department of Highways & Transportation and
the University of Virginia)

November 1978
VHTRC 79-R26

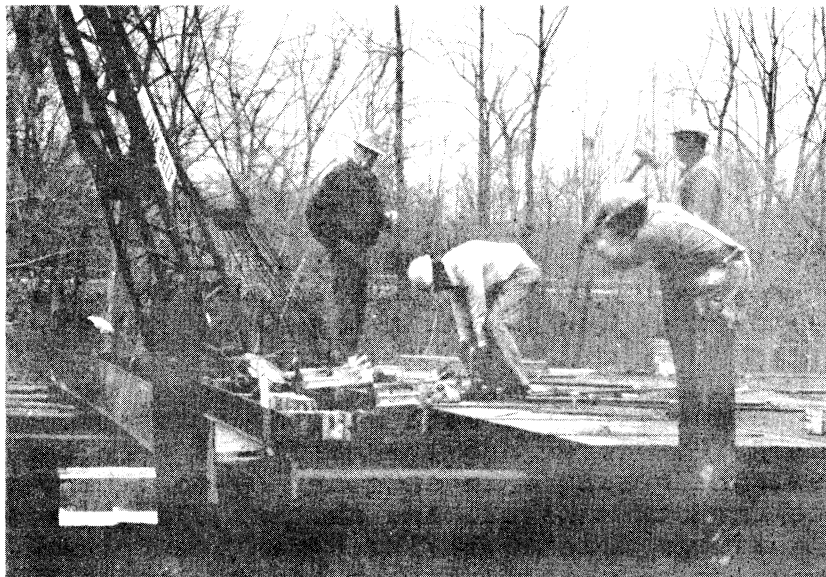
Figure 2. Panels are jacked together on Fairfax County bridge.

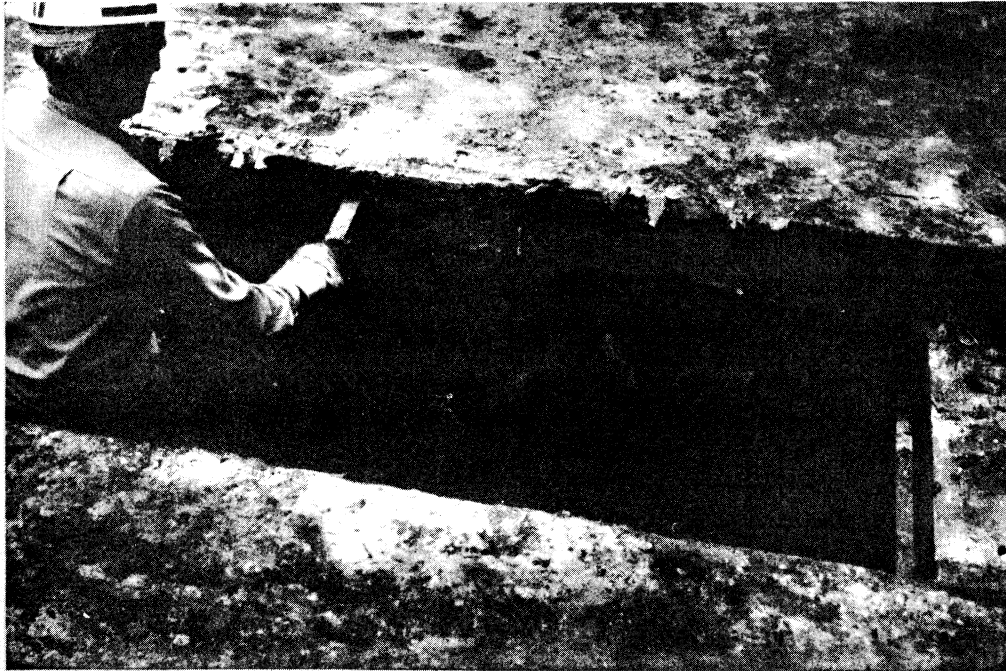
Figure 7. Excess creosote is removed from dowel holes on Henry County bridge.

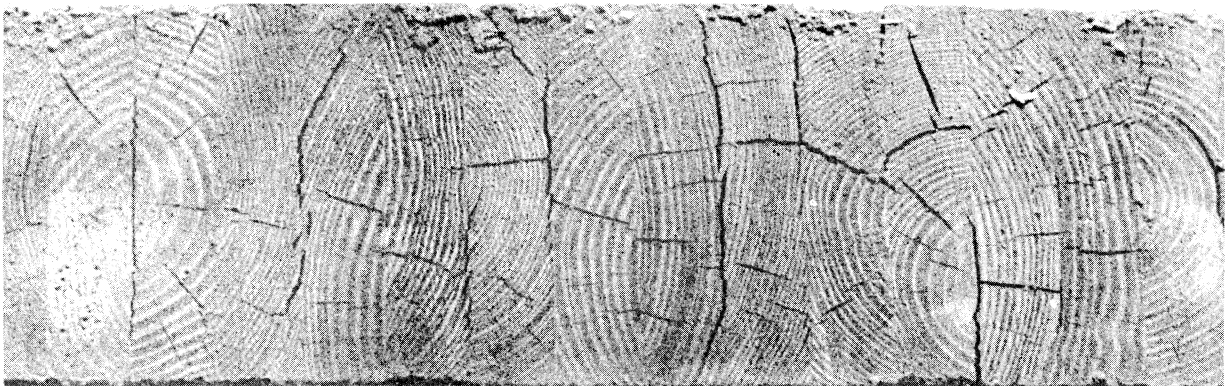
The fact that the total width of the panels on each of the three bridges was greater than specified on the plans has been mentioned earlier. Table 3 gives the dimensional data, an explanation for the excess width, and the corrective measure used to accommodate it. From Table 3 it can be seen that the principal reason for the excess width of the panels on the Fairfax and Patrick County bridges was that many of the panels were wider at the ends than in the center (see Figure 10). On the Henry County bridge several of the panels would not come together because of creosote in the dowel holes. Since the backwalls were cast before the panels were placed on the Fairfax County bridge it was necessary to cut the extra 8-1/2 in. to 11-1/4 in. from the last panel. One or both backwalls were cast after the panels were placed on the Patrick and Henry County bridges and the extra width was accommodated by setting one backwall back several inches. It will be interesting to see if the cracks between the panels will promote deflection cracking in the bituminous overlay.

Figure 10. Cracks in the ends of the Southern pine panels contribute to the increase in the width.

Since the panels for both the Patrick and Fairfax County bridges were wider at the ends than in the middle when installed, one could easily assume that they absorbed moisture and swelled after being fabricated to a uniform width. Since moisture can enter the ends of the panels more readily than the center portion, one would expect that the moisture content and swelling would be greatest on the ends (see Figure 10). As can be seen from Table 5, there was a tendency for the panels to have a higher moisture content at the edges.

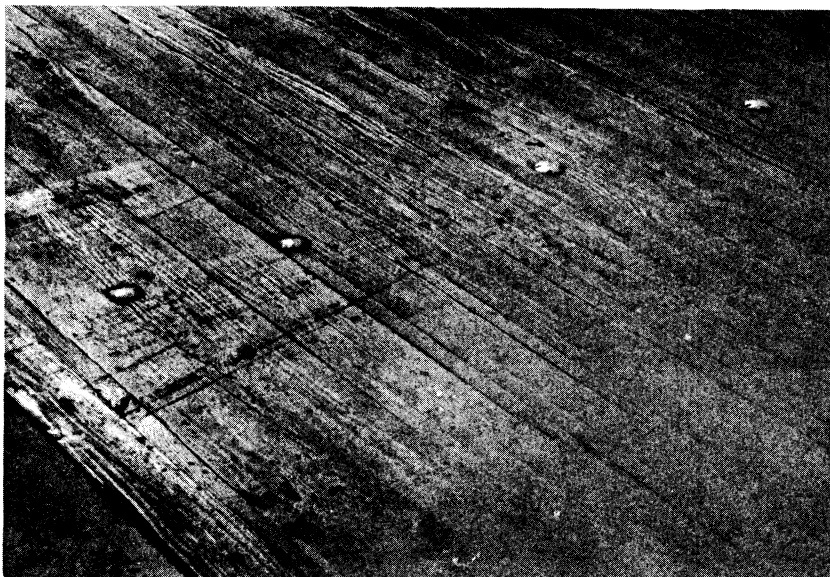
During a field inspection on November 1, a significant number of cracks and splits as shown in Figure 11 were observed in the surface of the panels in the Fairfax County bridge. Consequently, the panels were rated with respect to the number of cracks and splits and the ratings were plotted against the moisture content data, which was collected on the same date. The panels were rated from 1 to 3 with a rating of 3 being assigned to a panel exhibiting a large number of cracks and splits. It's obvious from the data, which are shown in Figure 12, there is a correlation between moisture content and the amount of cracking and splitting in the panels. Panels with few cracks exhibited a low moisture content and panels with many cracks exhibited a high moisture content. It's reasonable to expect that the panels with a high moisture content developed cracks in proportion to the hydrostatic pressure which occurred during the creosote treating process.

Figure 11. Cracks and splits in panels on Fairfax County bridge.

The moisture content data collected to date are interesting and controversial to the point that it is believed these panels should be monitored closely over the next few years. The cracks in the panels should retain water and therefore create a high moisture content environment, which should prove detrimental to the performance of the panels.

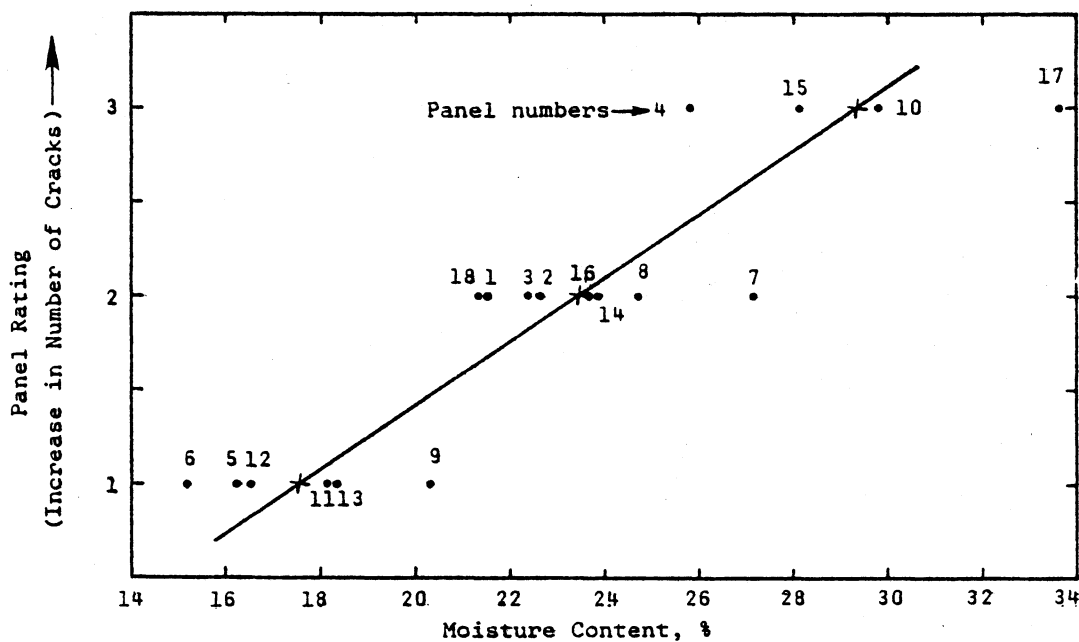
Figure 12. Moisture content versus panel rating for Fairfax County bridge.

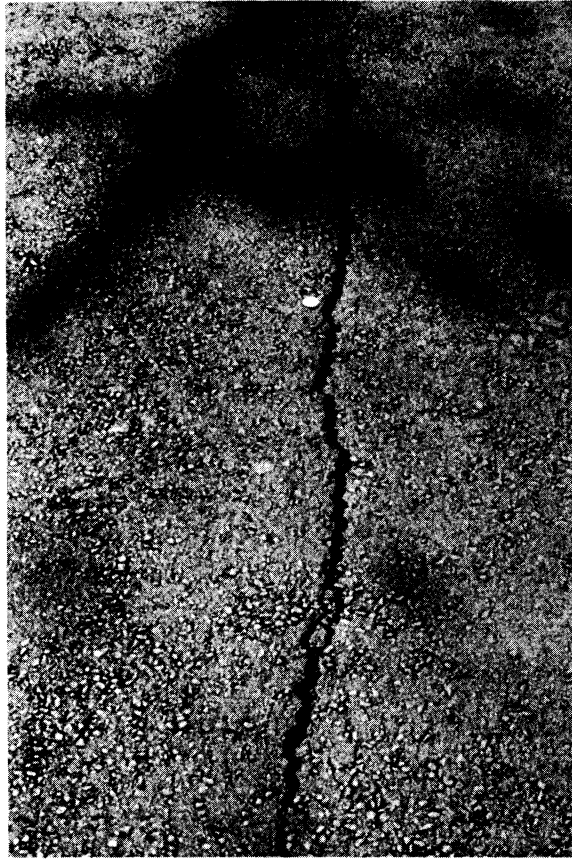
During a field inspection on November 2, just 4 weeks after the wearing surface was installed, cracks were observed in the wearing surface on the Henry County bridge. Most of the cracks were located directly above the joints between the glulam panels but several cracks were also noted in other areas. The cracks differed in width but all ran parallel to the panel joints. Most of the cracks were hairline but a large crack, which is shown in Figure 13, had occurred at midspan. A quarter is shown next to the crack in Figure 13 to provide an indication of the width of the crack.

Figure 13. Crack in overlay on Henry County bridge.

A more reasonable explanation for the cracks is that the tensile strain in the bituminous concrete was excessive. Maupin has shown that the fatigue life of a typical plant mix used in Virginia is a function of the bending strain to which the mix is subjected and that a bending strain of 0.001 can cause failure after 12,500 cycles of loading. (11)

It is anticipated that water will enter the cracks and migrate between the panels and the overlay, and the freezing of the water combined with the traffic loading will cause the overlay to spall in a short time. Filling the cracks with anything other than a very flexible material will result in the formation of new cracks, which will lead to spalling. It is believed that the bituminous concrete overlays as installed will not perform satisfactorily.

On future bridges it might be possible to reduce or eliminate the incidence of cracking in the overlay by installing a fabric between the overlay and the deck panels. The fabric would serve to distribute the strain in the overlay caused by the horizontal movement of the panels at the panel joints. Other measures that should reduce the formation of cracks in the overlay include eliminating the timber bolster and increasing the depth or stiffness of the stringers.

11. To minimize the formation of cracks in the overlay consider using a fabric between the overlay and the panels or increasing the stiffness of the stringers. Because of its inherent self-sealing properties, consider specifying a surface treatment rather than bituminous concrete for the overlay.
