ENGINEERING MEASURES FOR REDUCING WRONG-WAY DRIVING

N. K. Vaswani
Senior Research Scientist

Virginia Highway & Transportation Research Council
(A Cooperative Organization Sponsored Jointly by the Virginia
Department of Highways & Transportation and
the University of Virginia)

September 1975
VHTRC 76-R8

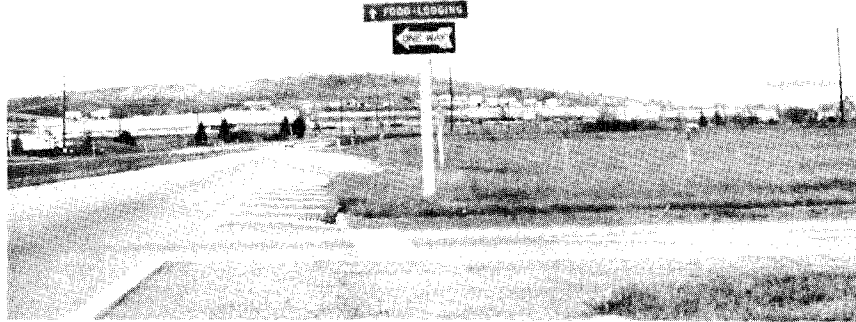
At the request of the traffic and safety engineer, a field survey of these arrows was made by the author and his resultant evaluation is given here. Some arrows were found to be placed for less than 25 ft. (7.5 m) from the stop line. This placement has led to very interesting results, an example of which is shown in Figure 1 (all figures are appended).

Figure 1. Intersection 59 on I-81. Visibility of pavement arrow marking when placed near the stop line.

The author feels that the first arrow on the exit ramp should be very close, say within 5 ft. (1.5 m), of the stop line, such that it will be visible to a wrong-way driver before he enters the exit ramp from the crossroad and will thus discourage him from making the wrong-way entry. The second arrow should be placed approximately 100 ft. (30 m) from the stop line as recommended⁽³⁾ so as to provide a second warning to the wrong-way driver.

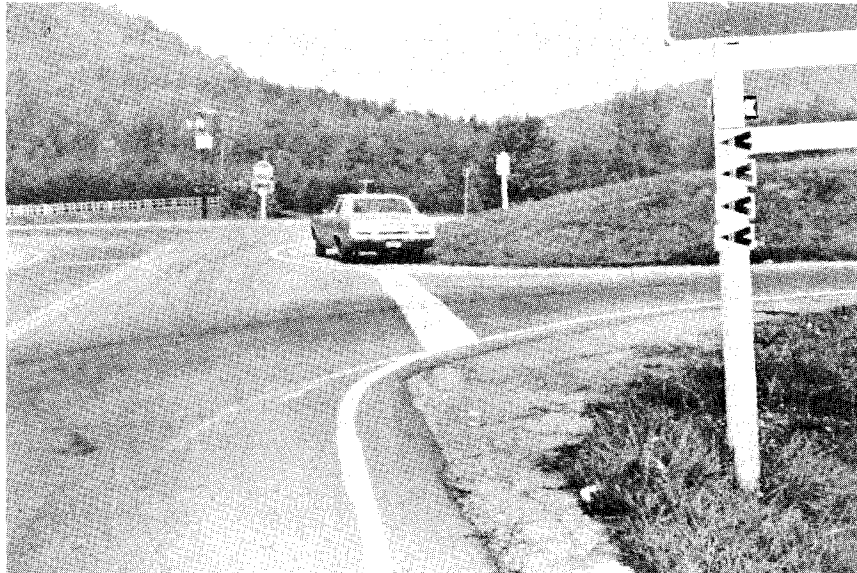
Arrows have been placed as close as 5 ft. (1.5 m) from the stop line on exit ramps. Arrows placed close to the intersection of the crossroad and the exit ramp are visible to the wrong-way driver making either a right-hand or left-hand turn into the exit ramp. Arrows placed more than 25 ft. (7.5 m) from the stop line are not visible to the wrong-way driver as is illustrated in Figure 2, where the first arrow is placed 22 ft. (6.6 m) from the stop line on an exit ramp.

Figure 2. Intersection 43 on I-81 S. Nonvisibility of the pavement arrow marking from the crossroad when placed 22 feet from the stop line.

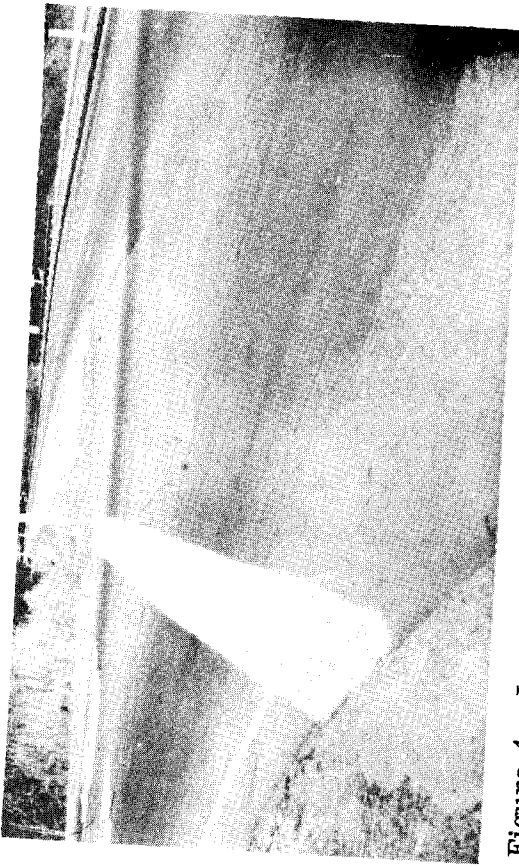
Figure 4. Junction of I-95 South exit ramp and Route 1. The distance of the stop line from the junction of the crossroad and exit ramp is so great that the driver is unable to see the crossroad on his left.

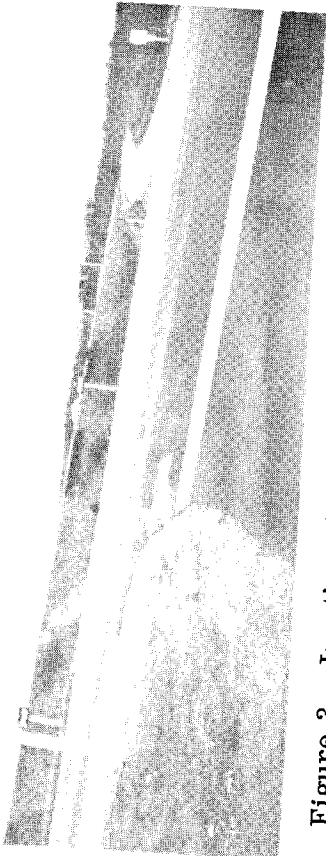
Figure 3 is a photograph showing an unmarked left flare at the I-95 - Rte. 1 intersection during the time it was experiencing wrong-way incidents. This interchange had the highest number of wrong-way incidents of any interchange in Virginia. It had been the scene of six incidents, all by non-drunken* drivers during a two-year survey period ending in May 1973. Figure 4 shows that the location of the stop line at this junction is such that the driver coming from the exit ramp is unable to see the crossroad on his left, if he stops at the stop line. Figure 5 shows the same junction with the flare marked with two right angled lines to create an inexpensive precautionary measure. Since the marking of the flare about 18-months ago no wrong-way incidents have been reported. The marking apparently discourages drivers from quickly turning left on the wrong side of the median and increases the visibility distance. Previously, in approaching the crossroad from the exit ramp all drivers would stop on the stop line. With the introduction of the flare marking, a driver who needs an increased visibility distance crosses the stop line and comes to a stop at the corner of the flare marking as shown in Figure 5.

Figure 3. Junction of I-95 South exit ramp and Route 1 before marking of the left flare.

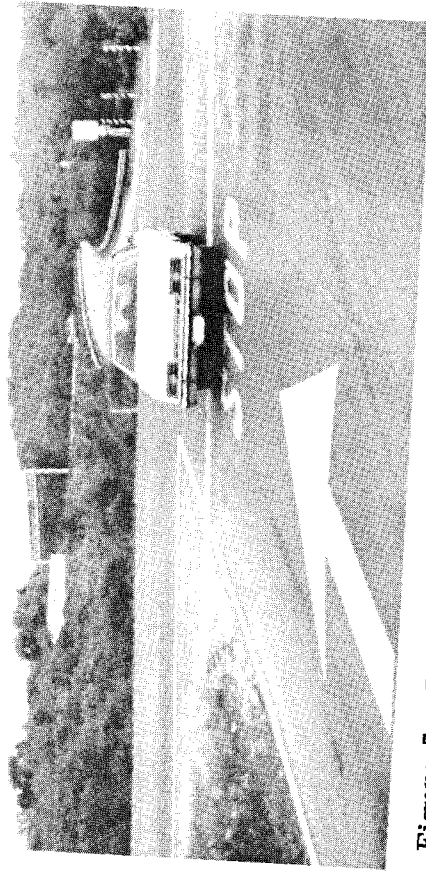
Figure 5. Junction of I-95 South exit ramp and Route 1 after marking of the left flare. Note that the driver ignores the stop line to get a better view of the crossroad.

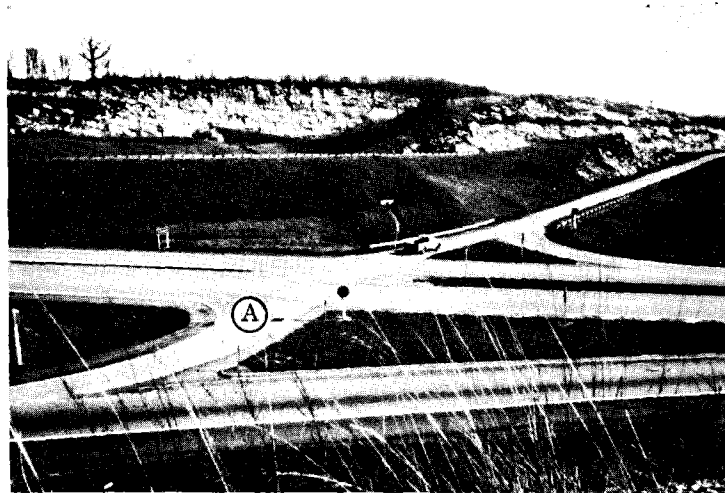
Interchange 53 was the site of two wrong-way incidents, both by non-drunken drivers, during the two-year survey period ending in May 1973, prior to alteration of the flares. Figure 6 shows the junction of the exit ramp and the crossroad with the "A" designating the location of one of the wrong-way incidents. This interchange, like the immediately preceding one, was discussed by the author in a previous report⁽¹⁾ with a recommendation to remove or stripe the flare. The flare was removed about 18-months ago and the interchange appears as shown in Figure 7. No wrong-way incidences have been reported since the change. Another example of recent striping of the flare is at the I-64 and Route 364 interchange, as shown in Figure 8.

Figure 6. Interchange 53 at intersection of I-81 South exit ramp and Route 11. "A" is left flare before marking.

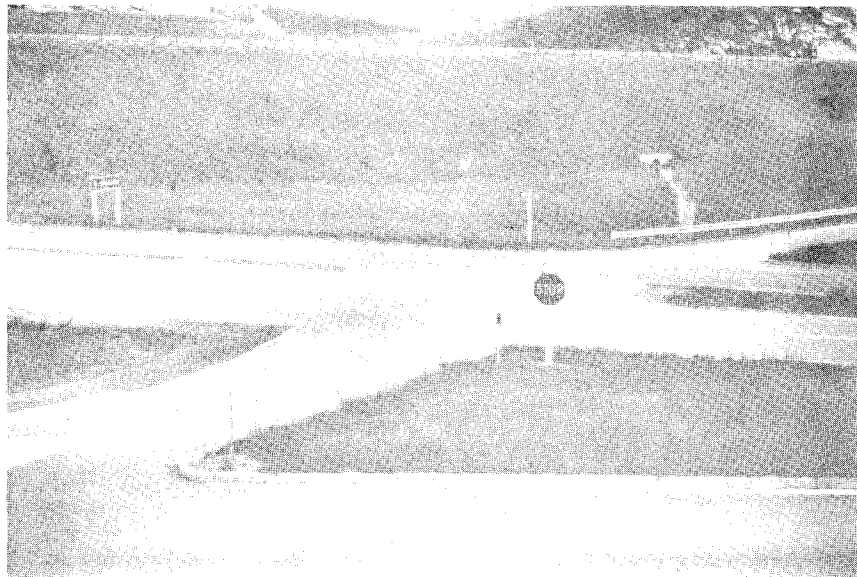
Figure 7. Interchange 53 showing marking of the left flare.

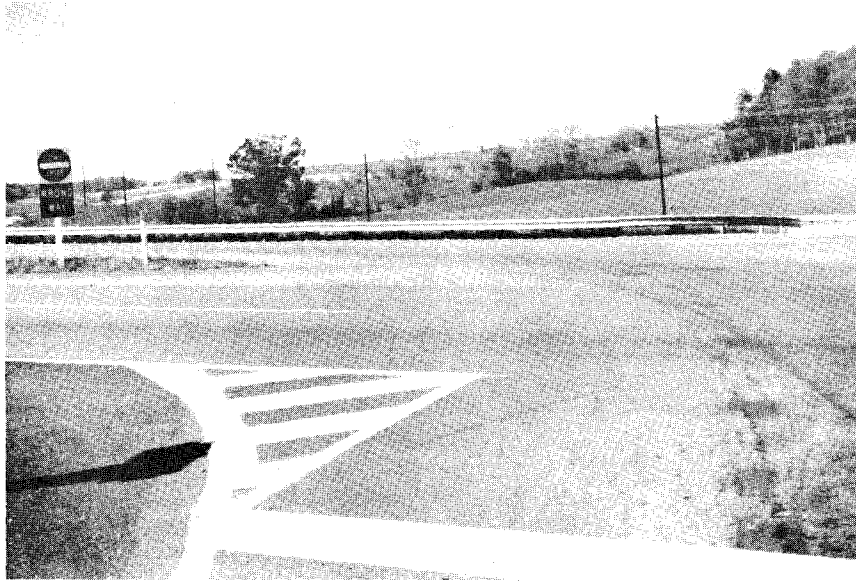
Figure 8. Junction of I-64 W exit ramp and Route 364 showing recently striped flare.

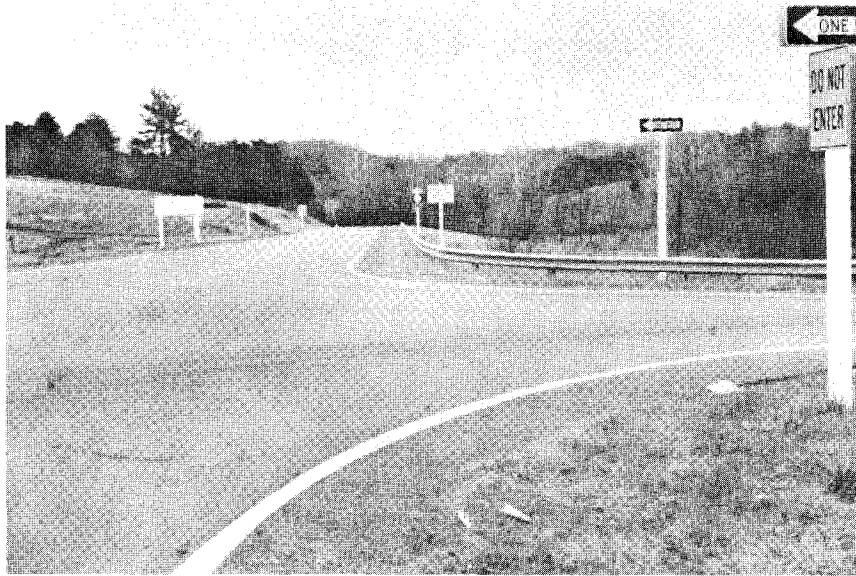
It is the author's belief that flared entrance and exit ramps will continue to contribute to wrong-way incidents on interstate and divided highways. An example of a recent such incident was by a wrong-way entry on a flared ramp during November 1974 on I-64 at Ivy by a drunken driver. This ramp has very wide flares. Figure 9 shows the flares where the driver entered the wrong-way.

Figure 9. Intersection of I-64 at Ivy showing flared end of exit ramp. Intersection was scene of wrong-way entry that led to accident resulting in three fatalities.

Recent investigations by Shepard⁽⁴⁾ at this interchange also concluded that the flares should be removed. Scrifes⁽⁵⁾ in his report of February 1974 about wrong-way driving in Illinois, has also recommended the removal of flares. There is therefore a great need for making the striping or removal of left flares of exit ramps mandatory. It is desirable that the right flare also be so treated where the traffic volume is low.

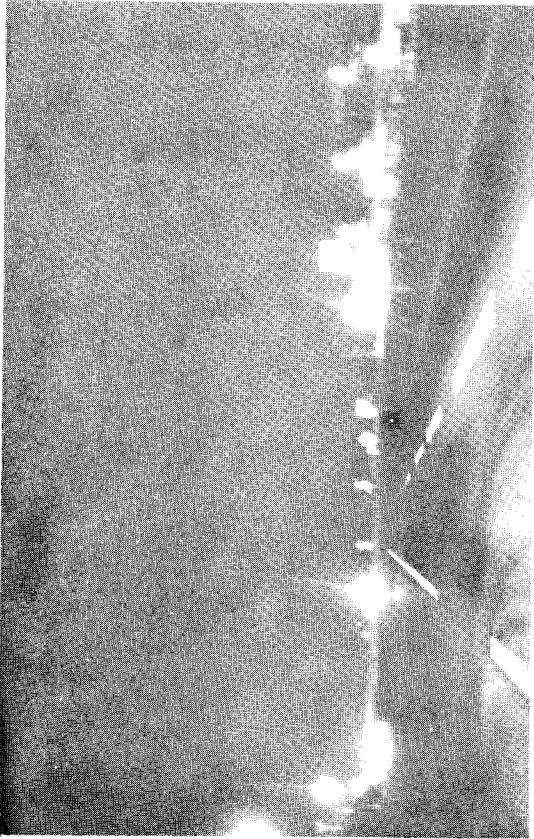
Figure 10 is a night photograph of a crossroad opposite an exit ramp from I-81 to Route 250, the site of a wrong-way maneuver at night, due to deceptive pavement edge marking. A driver looking for an entrance ramp from the passing lane entered this exit ramp, probably after seeing an opening in the pavement edge line.

Figure 10. Interchange 57 at I-81 North and Route 250. Opening in the pavement edge line which probably encouraged a wrong-way driver to enter the exit ramp.

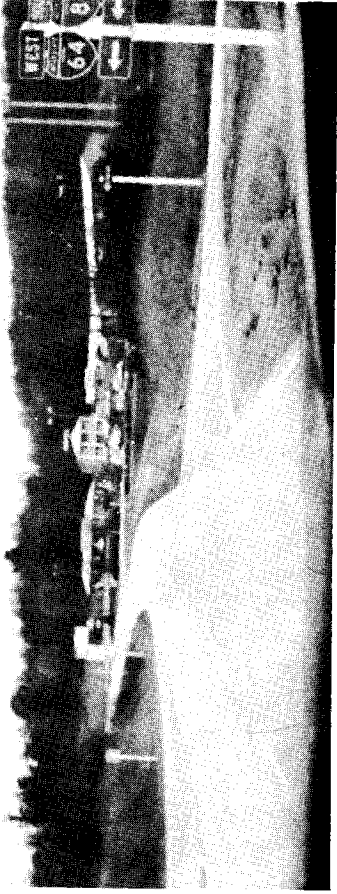
Figure 11. Interchange 55-A at I-81 exit ramp and Route 654 in daylight photograph showing one-way arrow and stop line.

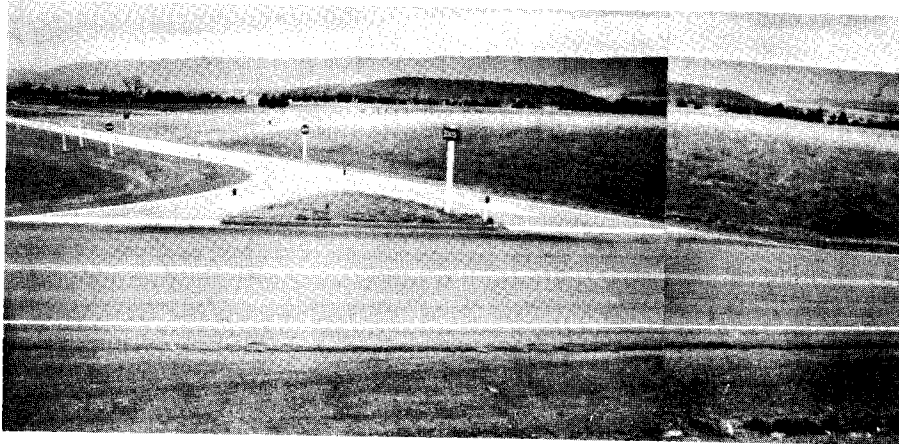
Figure 15. Example of continuous yellow double lines opposite an exit ramp.

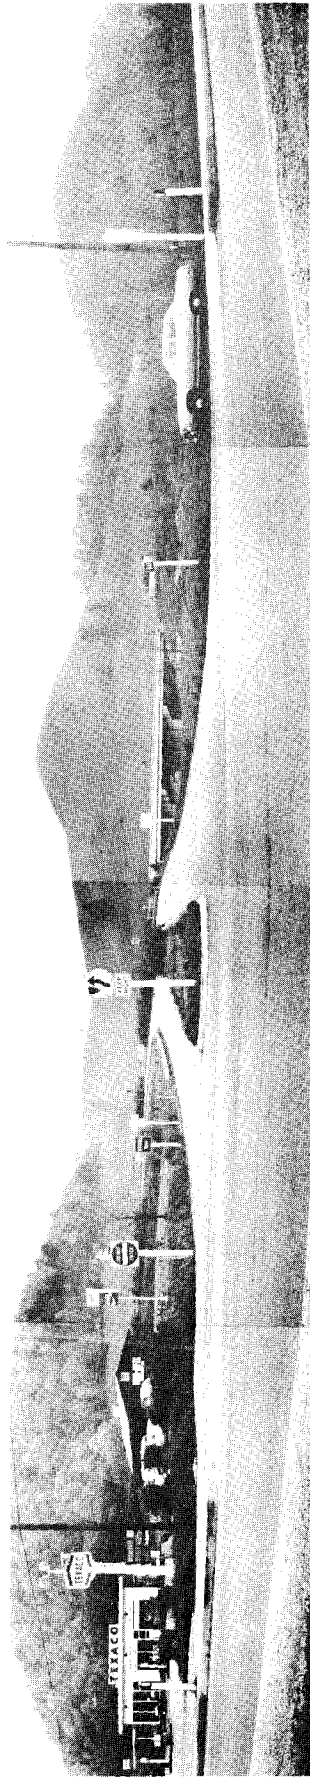
Figure 16. Parco interchange No. 65 on I-81. Very wide crossover even after extension of the medians.

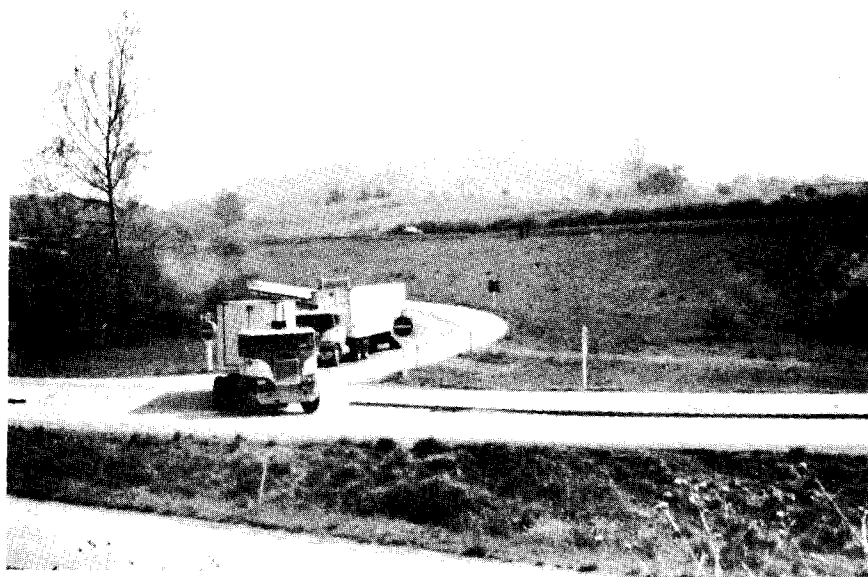
Another location at which the nose of the median was recently extended is shown in Figure 17. This interchange was also the scene of a wrong-way entry. The nose of the median is now in line with the edge of the exit ramp, but does not cover the exit ramp. This photograph shows the path traveled by a semitrailer combination. Notice the gap between the wheel path and the newly extended nose of the median on the left. As is evident, the left nose of the median could have been easily extended to cover more than half the width of the exit lane to provide required channelization.

Figure 17. Interchange on I-81. Even after extension of nose of median, there is ample gap between nose and biggest trailer truck.

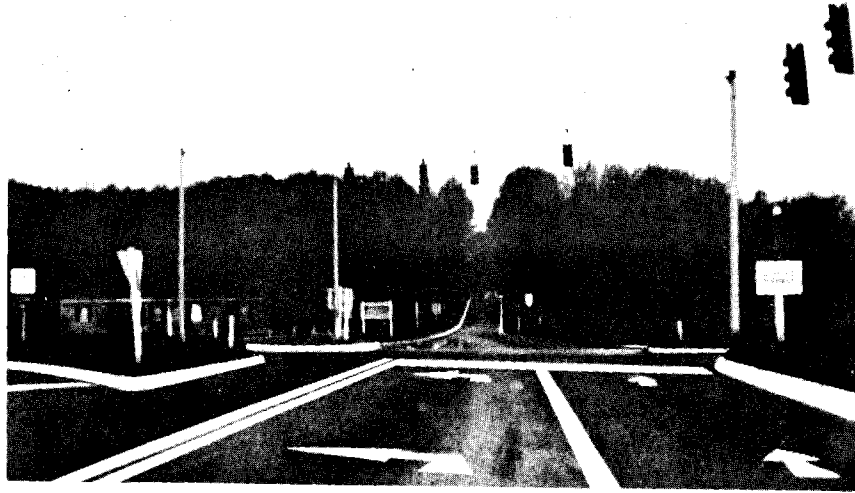
1. Figure 26 is a photograph of a lighted intersection of Routes 301 and 206 at Dahlgren where a wrong-way incident occurred at night. This photograph was taken at the point from which the driver made a wrong turn. During the night investigation of this site, the author saw a wrong-way entry being made. On inquiry the driver (a local resident) said that he did not see the other lane before making a left turn. This is a level intersection and unless a person is very careful he is unable to see the other side of the median. This intersection, as seen from the photograph, is provided with a DIVIDED HIGHWAY sign. This sign is located on the right-hand side of the lane which is for vehicles going straight only. This sign should therefore be moved onto the left nose of the crossover, and should preferably be changed to a suitable diagrammatic sign, to enable drivers turning left to see it and turn around the nose instead of turning before it.

Figure 26. Intersection showing poor visibility of the lanes across the median.

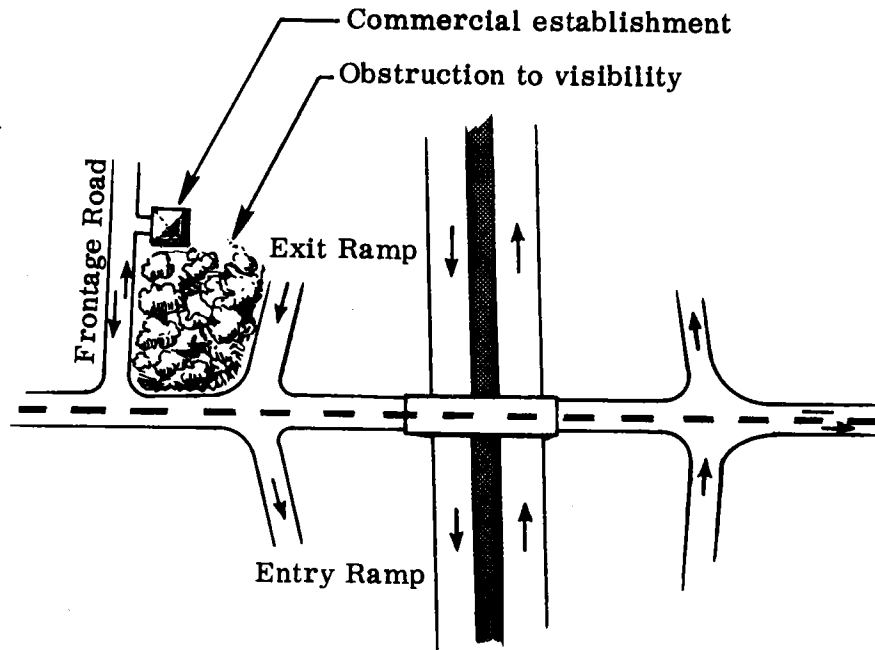
Figure 27. Frontage road with access obstructed from view led to wrong-way entry into the exit ramp from I-95 onto Route 630.

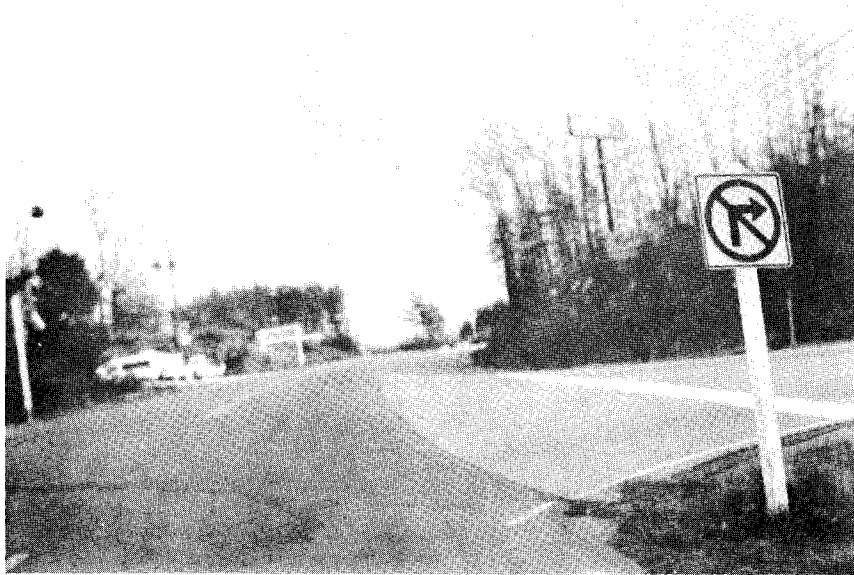
2. Figure 27 is a typical example of drivers heading for a frontage road but turning prematurely into the exit ramp. Figure 28 is a photograph of an optical illusion where, as seen in the photograph the frontage road is hidden from the driver's vision by raised land and trees, the driver made a wrong-way entry into the exit lane at night. Night studies showed that a driver driving towards the exit ramp on the crossroad could see only this tiny "no right turn" diagrammatic sign and the black topped road ahead. He could not see the stop line. The least expensive remedy is either to bring the stop line within 0 to 4 ft. (0 to 1.2 m) of the junction of the exit ramp and the crossroad or to continue the pavement edge line of the undivided crossroad. Another recommendation is to increase the size of the sign.

Figure 28. Day photograph of exit ramp in Figure 27. Driver made wrong-way entry at right. Access to frontage road is not visible.
