FINAL REPORT

MINIMIZATION OF REFLECTION CRACKS IN FLEXIBLE PAVEMENTS

July 1977

VHTRC 78-R5

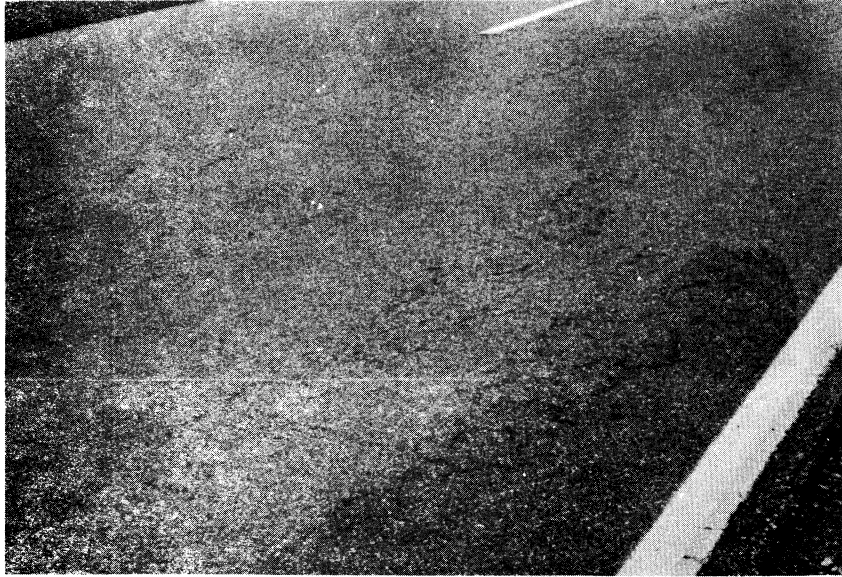
After six years the Petromat section is performing very well. The surface is slightly dry, but no longitudinal cracks are apparent. In contrast, the control section has developed longitudinal cracking (Figure 1*) and should require an overlay before one is needed on the Petromat section.

Figure 1. Cracking in the control section on Route 33.

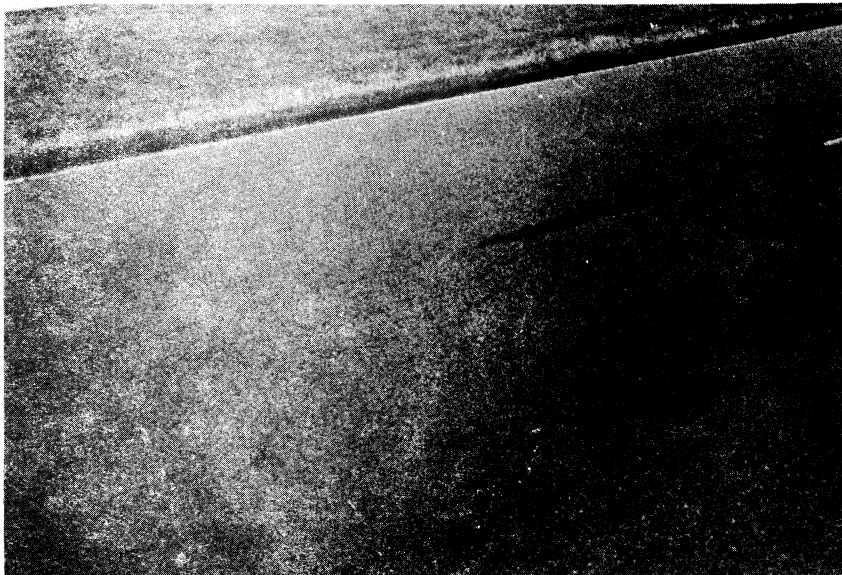
After six years this Petromat section is performing adequately; however, a few longitudinal cracks are starting to show (Figure 2). The control section exhibits more cracking (Figure 3) than the test section and should be the first to require an overlay.

Figure 2. Cracking in Petromat section on Route 29 at Chatham.

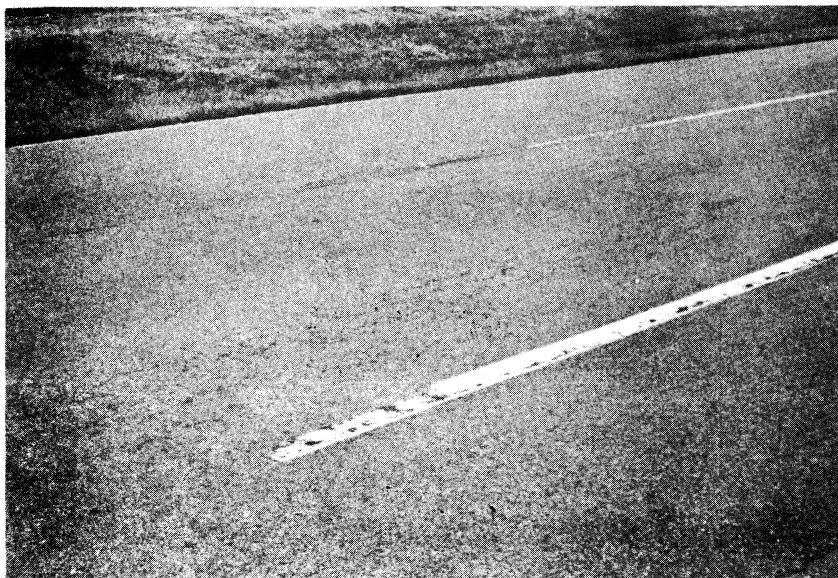
Figure 3. Cracking in control section on Route 29 at Chatham.

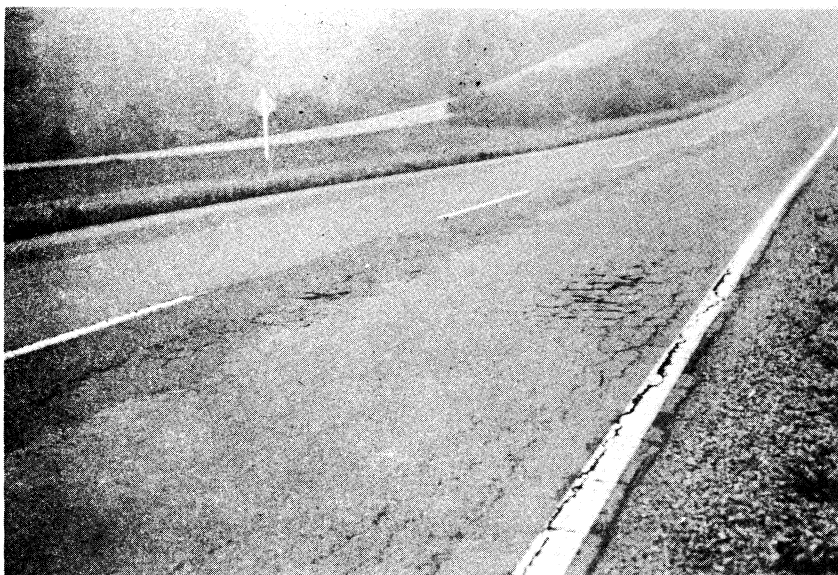
This pavement surface is five years old and is badly cracked in both the Petromat (Figure 4) and control (Figure 5) sections. A previous investigation had shown that the infiltration of water beneath the Petromat and overlay had weakened the underlying layers and was responsible for the early failure.

Figure 4. Cracking in Petromat section on Route 29 at Charlottesville (NBL).

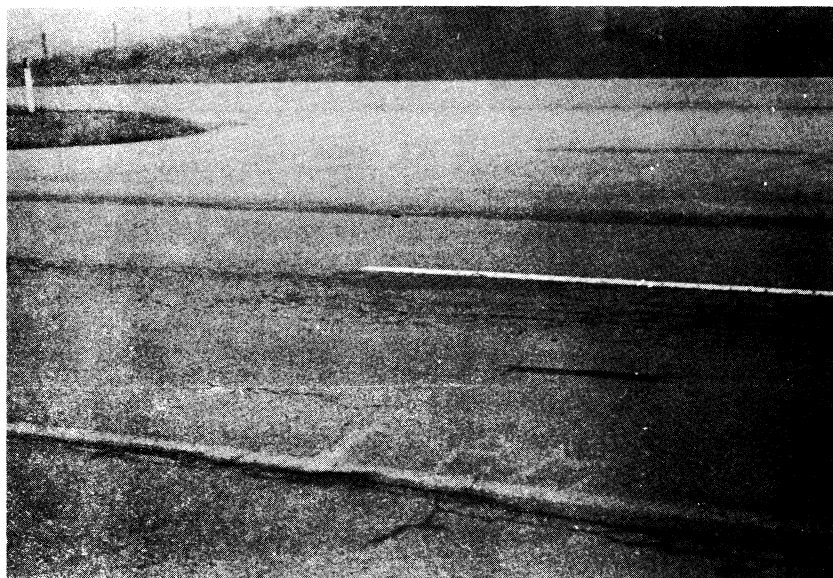
Figure 5. Cracking in control — Petromat interface on Route 29 at Charlottesville (NBL).

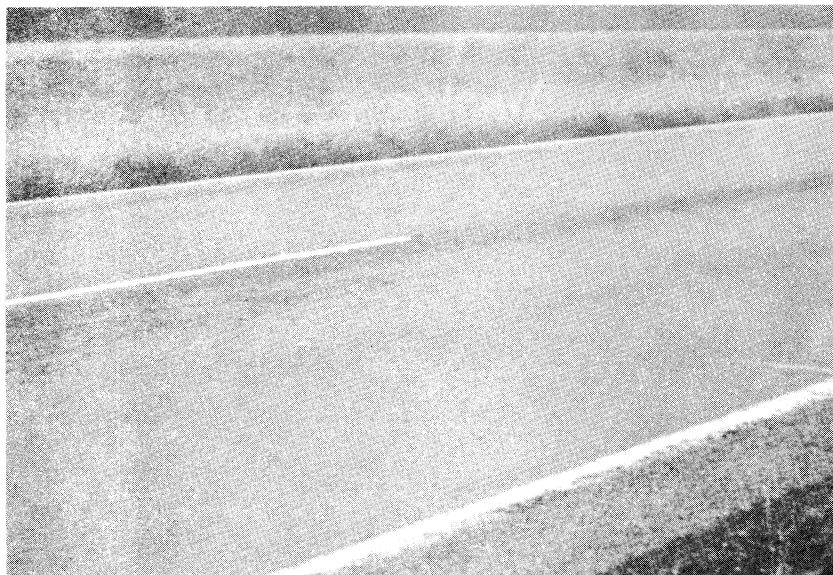
This installation is four years old and contains both Petromat and Burlington glass fabric, in addition to the control section. The Petromat is showing a slight amount of longitudinal cracking (Figure 6) and the glass fabric has a large amount of edge cracking (Figure 7). The control section is showing alligator cracking and pumping (Figure 8).

Figure 6. Cracking essentially stops at Petromat on Route 29 at Charlottesville (SBL).

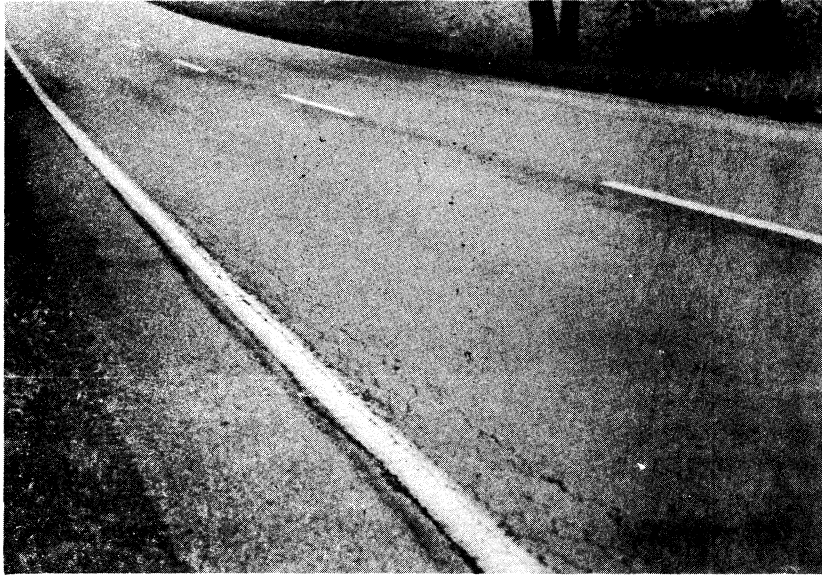
Figure 7. Edge cracking in Burlington glass fabric section of Route 29 at Charlottesville (SBL).

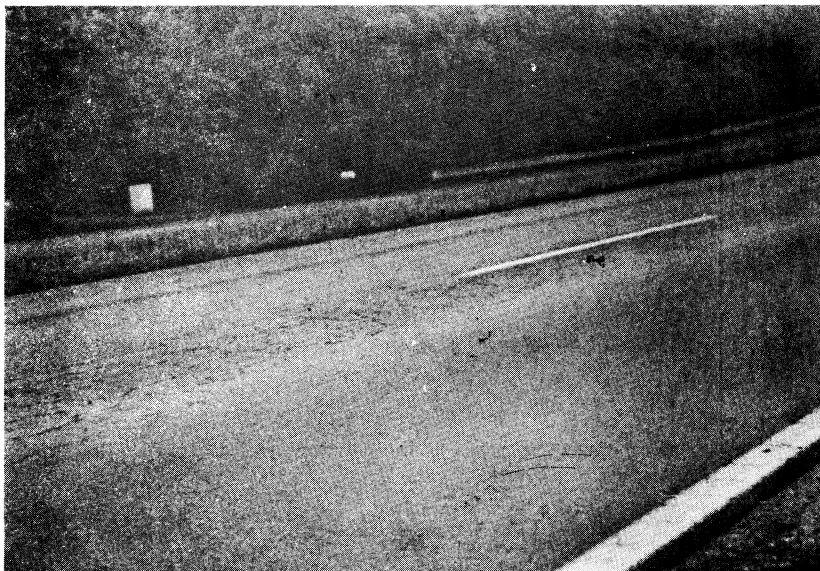
Figure 8. Cracking and pumping in control section on Route 29 at Charlottesville (SBL).
