EVALUATION OF THE ON-FLEX EXPANSION JOINT
SEALING SYSTEM FOR BRIDGE DECKS

Marvin H. Hilton
Senior Research Scientist

Virginia Highway & Transportation Research Council
(A Cooperative Organization Sponsored Jointly by the Virginia
Department of Highways & Transportation and
the University of Virginia)

January 1984
VHTRC 84-R22

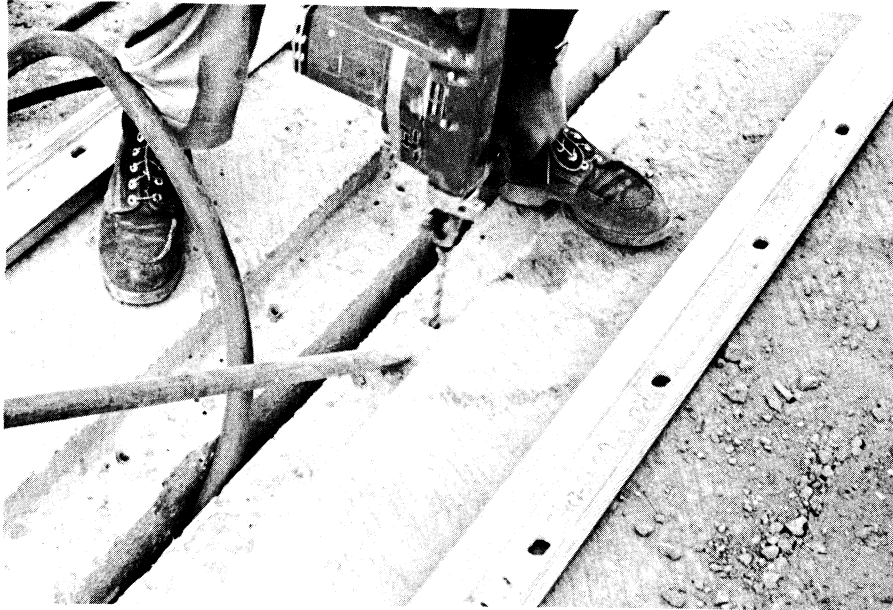
During drilling of the holes in the concrete deck, the reinforcing steel was hit in a number of instances. When this happened, the hole was abandoned and a hole was drilled approximately 2 in. (5.08 cm) on each side of the original. As a result, a large number of extra holes were drilled into the deck in order to ensure the minimum original spacing of 1 ft. (30.5-cm) between anchor bolts. Thus, the bolt spacing in several areas appeared as shown in Figure 4, as opposed to the planned 1-ft. (30.5-cm) spacing along the length of the joint.

Figure 3. Drilling anchor bolt holes for an ON-FLEX joint.

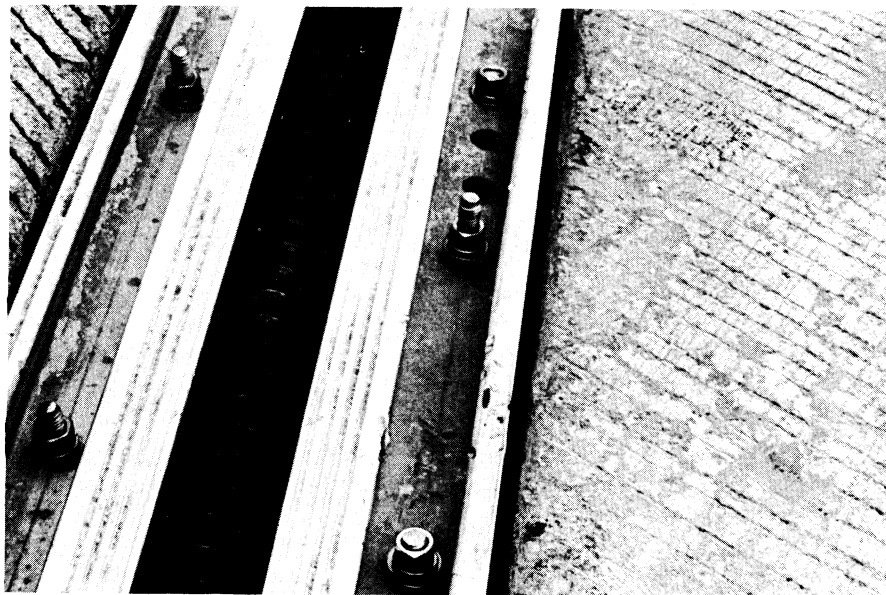
Figure 4. View showing irregular anchor bolt spacing required when reinforcing steel in the concrete prevented hole drilling at the planned location. Note also, at the center of the photograph, the extra washers used to elevate the nut after pullout of some of the anchor bolts occurred during tightening.

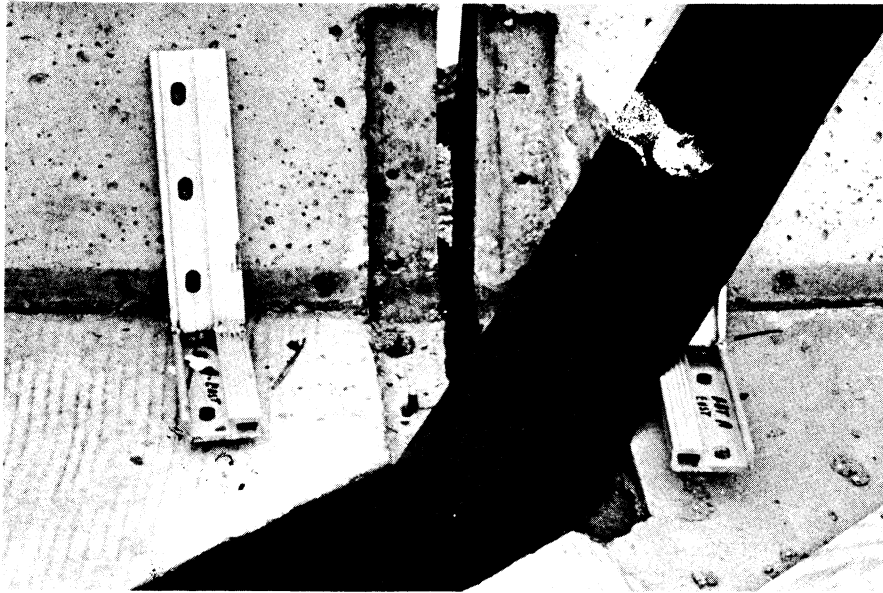
The elastomeric membranes were delivered to the sites with the parapet wall sections vulcanized to the main sections of the material. In most all cases the material was vulcanized at the wrong skew angle and did not fit into the parapet wall joint trough. A typical misfit of the membrane as delivered to one of the three bridge sites in Henrico County is shown in Figure 6. This problem caused considerable delay in the installation of the joints, since the material was sent back to be corrected. On one of the structures the material was returned several times because it was either the wrong size or the skew angle for the parapet wall was incorrect.

Figure 6. A view of the misfit of the elastomeric membrane at the parapet wall on one of the three Henrico County bridges.

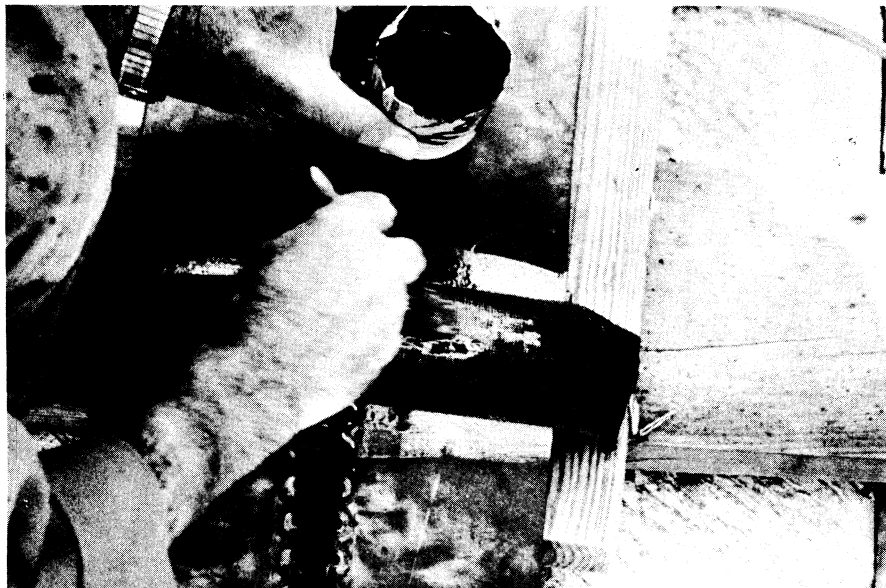
On the NBL of Route 95 connection bridge the neoprene material for the south joint was too long. In this case the material was cut to the desired length, spliced, and vulcanizing chemicals applied on the job site (Figure 7). On the north joint of the same bridge the skew angle was spliced and vulcanized in the field to correct the error.

Figure 7. Application of sealing materials to complete the splicing of two sections of neoprene.

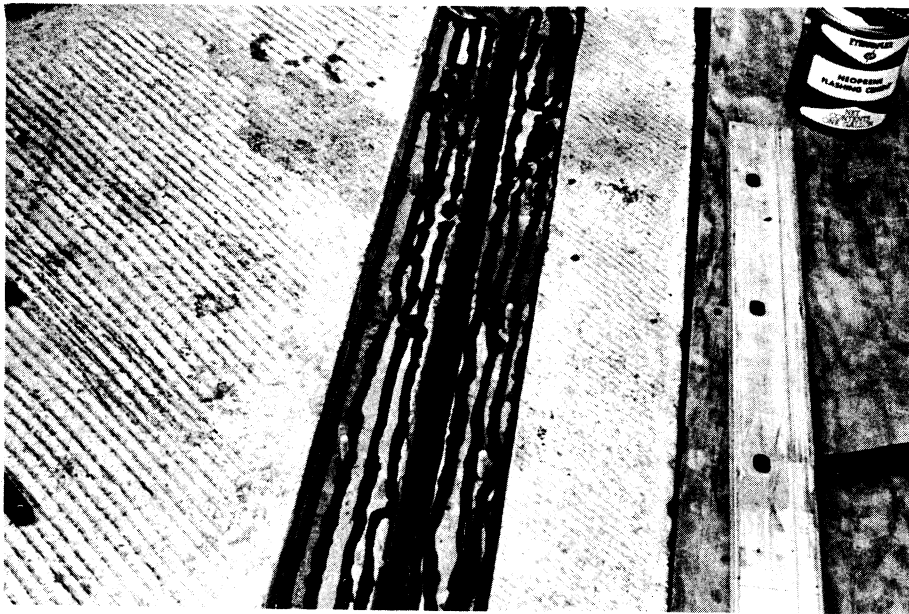
Prior to installing the neoprene, the joint trough is cleaned, holes are punched in the material at each anchor bolt location, and a sealant material placed in the trough. At first, a considerable amount of sealant material was placed in the trough, as shown in Figure 8. This was later reduced because it was thought that some of the difficulty in obtaining the specified torque on the anchor bolts was due to the heavy application of sealant. The reduced amount of sealant used on a subsequent installation can be seen in Figure 9, which also shows the elastomeric membrane being installed.

Figure 8. Heavy application of joint sealant material in joint trough.

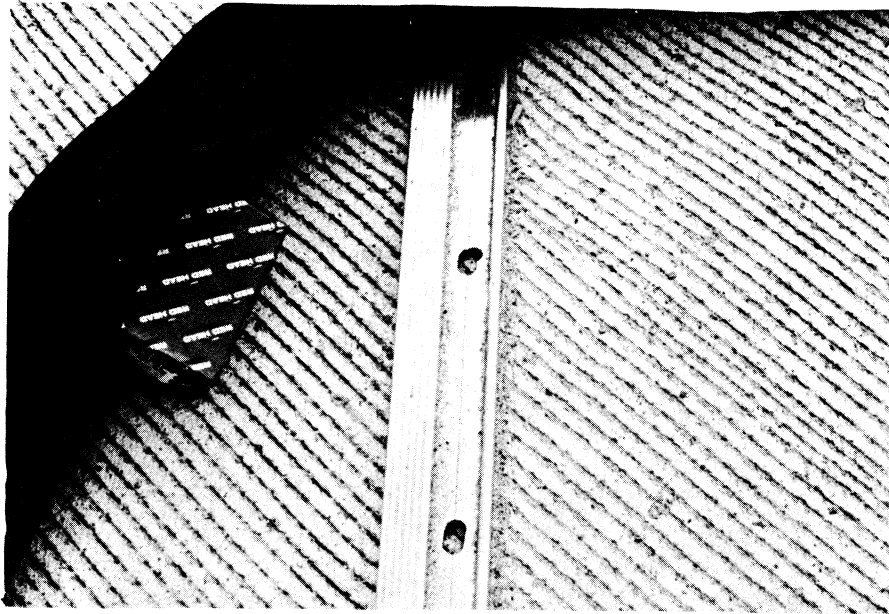
The hold-down channels can be placed rather rapidly, if all the holes are drilled in the proper location to fit the anchor bolts. In some instances, however, the holes had to be enlarged (Figure 10) to fit the anchor bolts.

Figure 10. View of hold-down channel with enlarged holes.

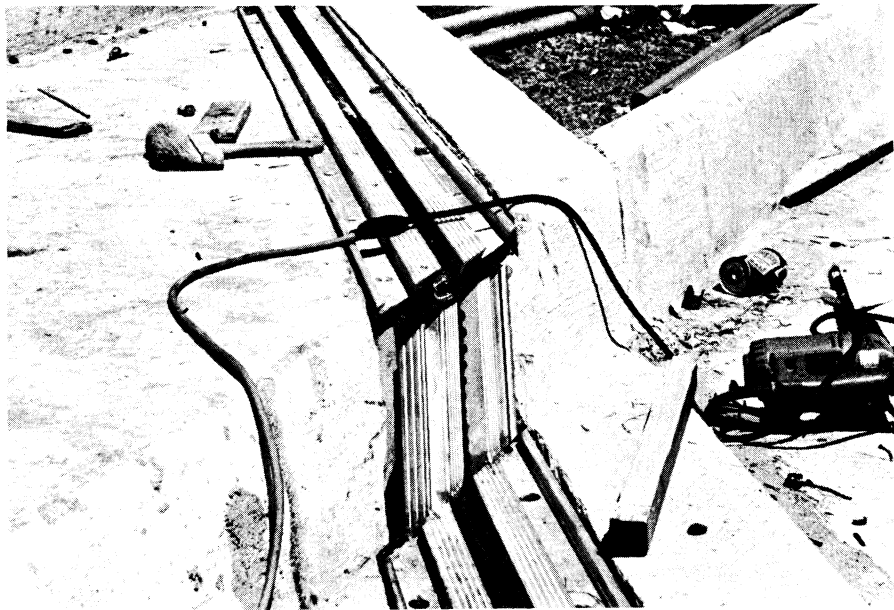
Fitting the joint materials to vertical faces such as curbs and parapets was a problem on all four bridges. The neoprene was cut and re-spliced to fit on several occasions. On the Duke Street bridge, the last of the four bridges to be completed, the hold-down channels did not fit well at the curbs and median strip. Because of the skew and the difficult fit, sharp edges of the channels protruded at the top of the curb of the sidewalk (Figure 12) and the median strip (Figure 13). A special plate was later installed to cover these edges and to improve the appearance of the joint.

Figure 12. Appearance of the joint at the face of a sidewalk curb on the Duke Street bridge.

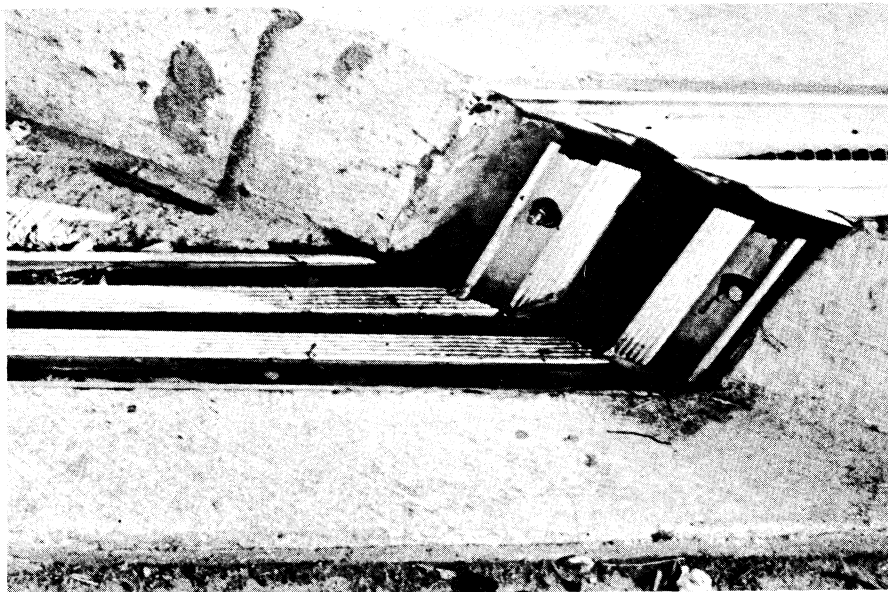
Figure 13. Appearance of the joint at the face of the median strip on the Duke Street bridge.

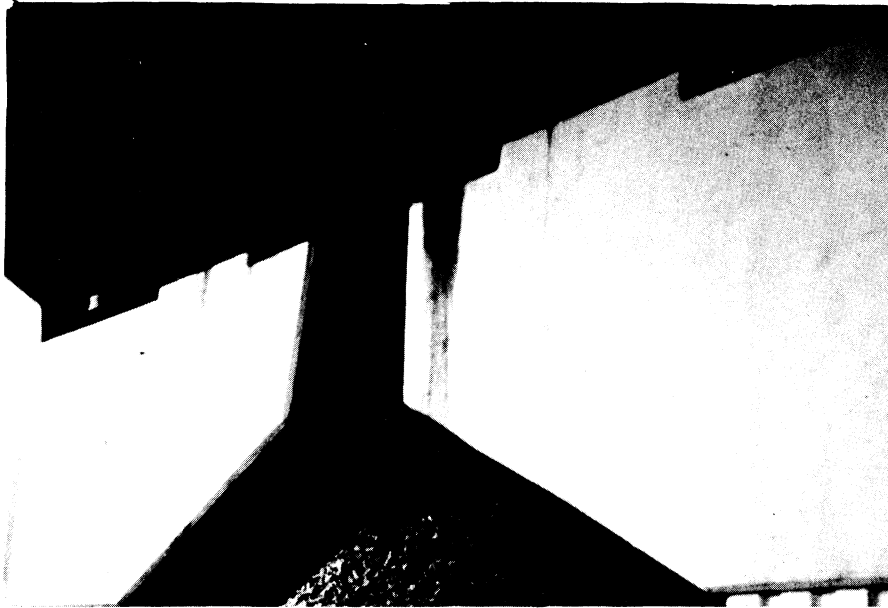
The only serious leak found was at the south joint over a pier on the connection "NN" bridge. The water comes through the joint in an area about 18 to 24 ft. (5.5 to 7.3 m) from the face of the east parapet wall and drains down on the south end of the center pier of a three-pier design (Figure 14). It should be noted that during the installation of the joint there was trouble tightening the nuts on the wedge type anchor bolts in this area. Also, some grinding of the concrete in the trough had been necessary during construction. While the joint did not appear to be loose under the impact of the traffic, the problems discussed earlier concerning the installation of the anchor bolts could be directly related to the leak.

Figure 14. Stained pier cap caused by leakage through the south joint on the Route 195 connection "NN" bridge.
