FINAL REPORT

FIELD STUDY OF A PEDESTRIAN BRIDGE OF REINFORCED PLASTIC

December 1985
VHTRC 86-R21

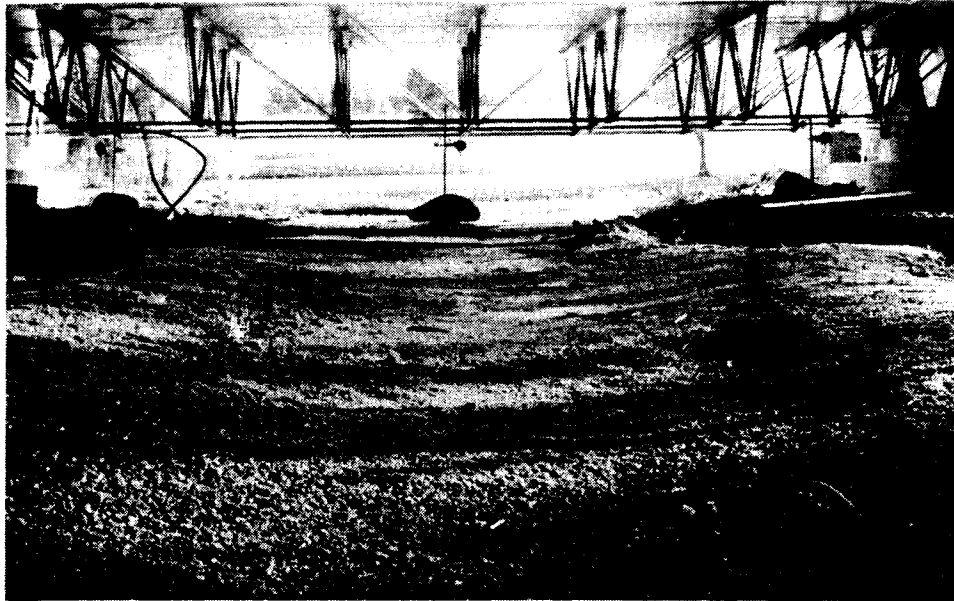
The site chosen for the field study was in Pen Park, one of the municipal recreational areas of Charlottesville, Virginia. The bridge was located across the overflow channel of the primary irrigation pond for a golf course in the park as shown in Figure 1. The principal use of the bridge was for pedestrians and golfers using electric carts weighing approximately 1,000 lb fully loaded. The superstructure was erected on March 29, 1985, as will be described later. A wearing course was applied from April 3 to April 5 and the load test initiated on April 17. On May 24, a heavy rainfall in the park caused severe erosion of the region adjacent to the bridge foundation. Because of anticipated

Figure 1. Pedestrian bridge in place over the discharge channel of an irrigation pond at Pen Park.

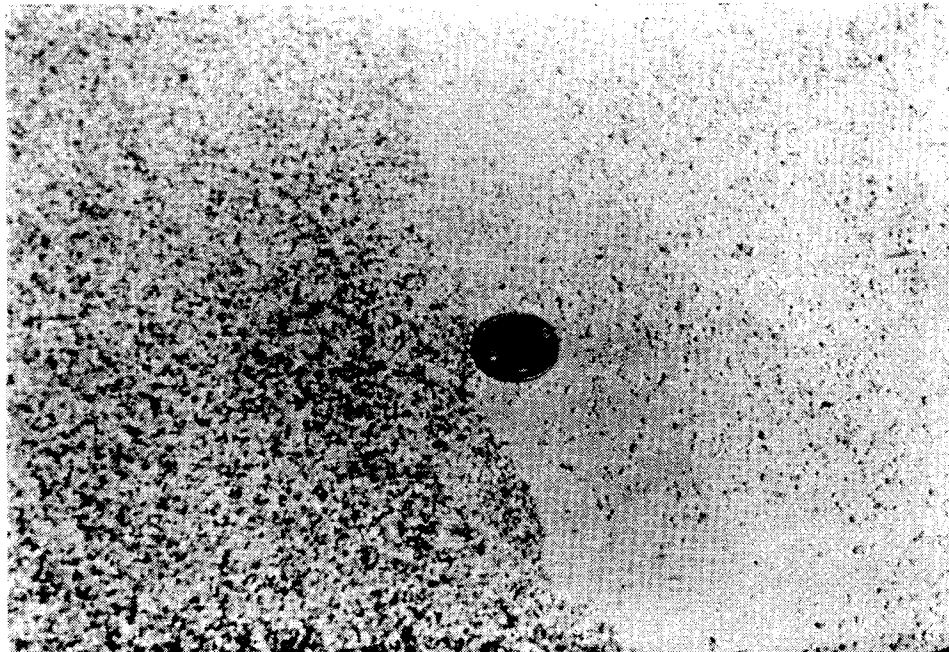
Figure 7. Texture of the surface of the cured polymer concrete compared with an uncoated surface of the GRP cover plate. Note loose particles of sand on cover plate.

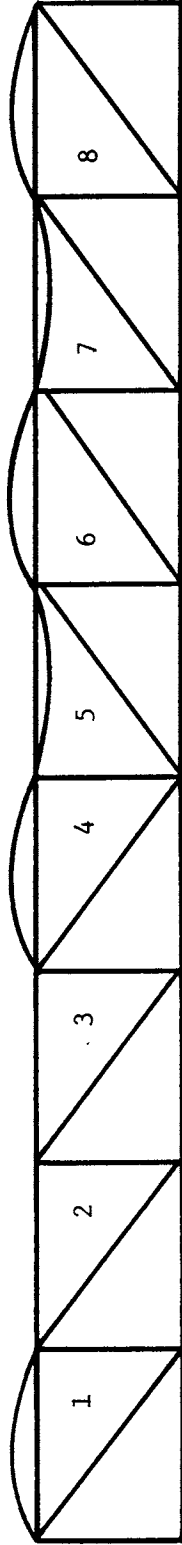
(b) Exterior girder on west side

Early evidence of excessive compressive stresses in the flanges was manifested in a slight buckling of the flanges as sketched in Figure 9. The directions of the plate displacements were determined visually with the aid of a straightedge. No quantitative measurement of the displacements was attempted since most amplitudes were very slight. The maximum amplitude was estimated at 0.10 in and occurred in panel 8 in both outside girders. No assessment of buckling was attempted in the interior girder, but it is quite likely that the behavior was similar to that of the exterior girders. As shown in Figure 9(c), the transverse stiffeners typically were bowed downward at the center of the bridge. There was concern that the displacements of the flanges would grow and possibly result in a catastrophic failure of the bridge as the ambient temperature increased during the summer months and thereby reduced the effective modulus of the flange and deck material. Consequently, on April 23, two drums of water were removed from panel 3 and from panel 6 (Figure 8) to reduce the live load to 6,000 lb. This load remained undisturbed on the structure throughout the remaining creep test period of 55 days.

Figure 9. Exaggerated representation of elastic buckling and displacement of deck assembly due to live load application of 8,000 lb. Maximum amplitude estimated at 0.10 in.

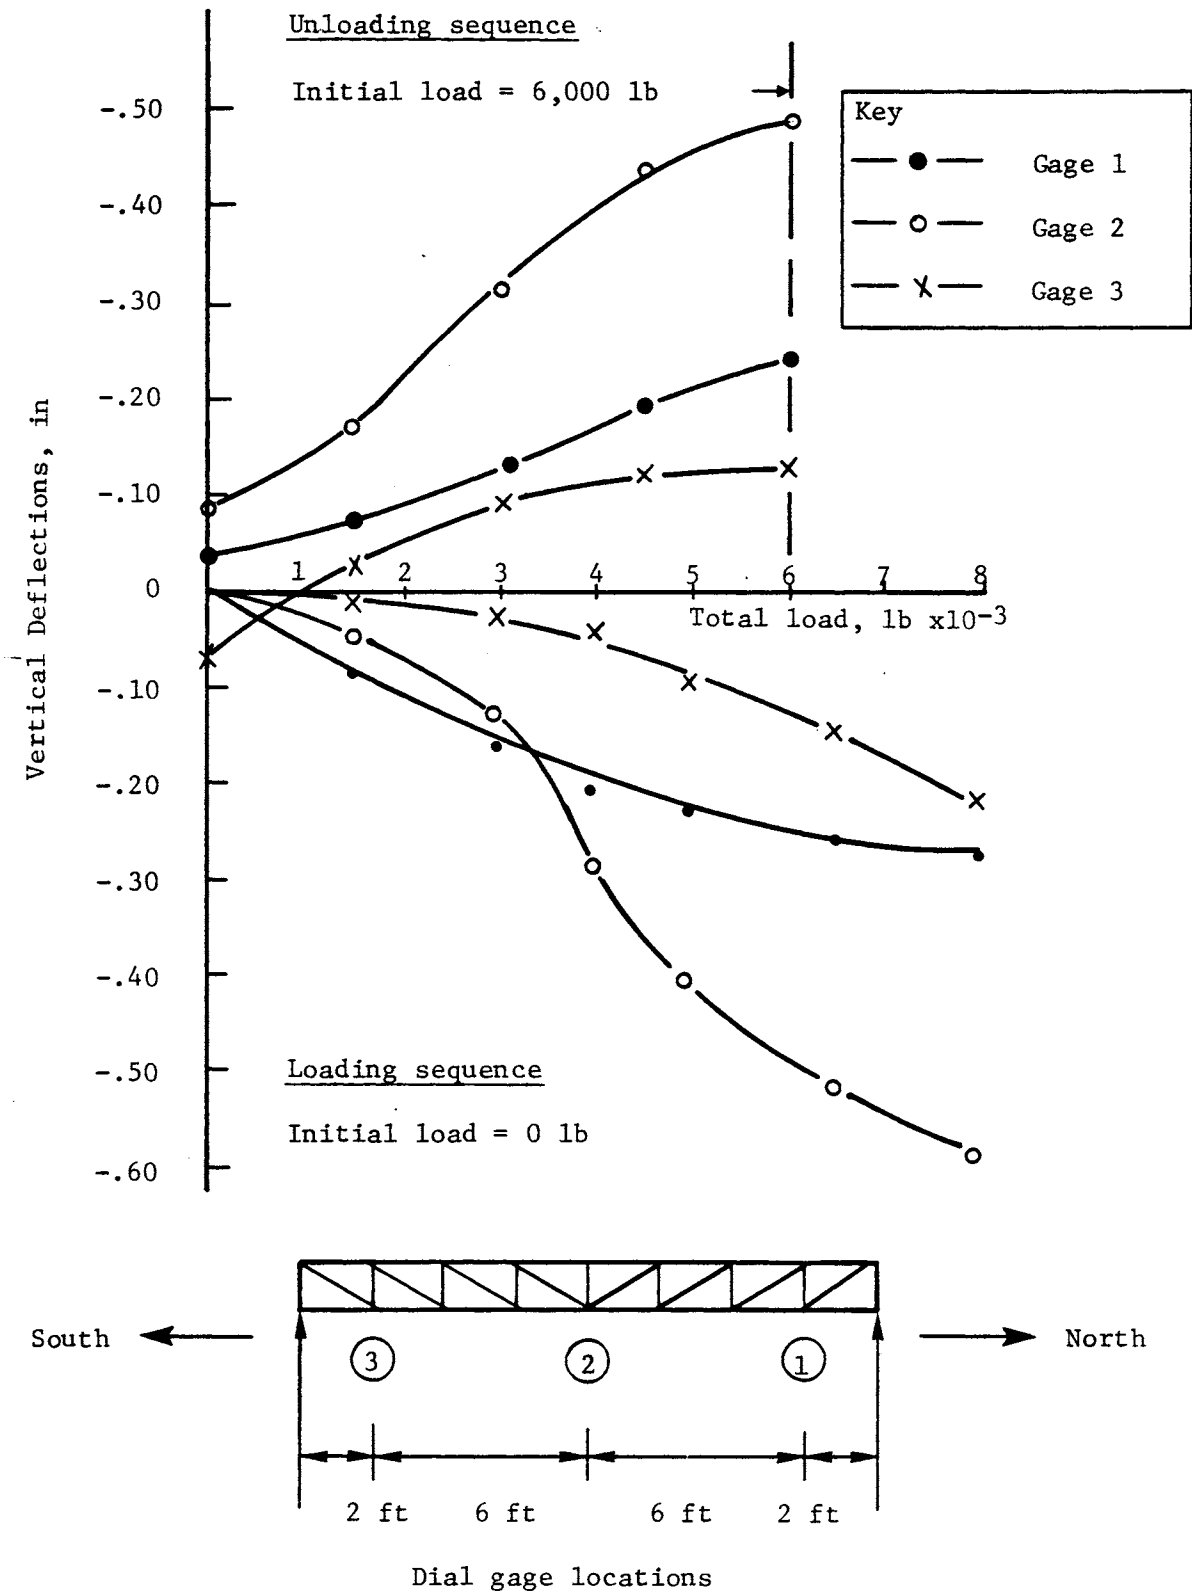
It was expected that the deflection at gage 3 would reach that of gage 1 when the full load was applied, since an effort was made to distribute the filled drums symmetrically about mid-span. However, a check of the positions of the drums on the deck after they were filled indicated that the loads on the southern half of the bridge were approximately 4 in closer to the center of the bridge than were loads on the northern half. Thus, it is believed that the off-center loading, plus probable differences in the settlement characteristics of the supports, completely explains the difference of 0.06 in in the measured deflections.

The difference between the average measured deflections of the end gages (1 and 3) and gage 2 was 0.324 in for the full load of 8,000 lb. If it is assumed that approximately half (0.12 in) of the average deflection of the end panels (0.24 in) was caused by the settlement of the bearing pads and support stiffeners, the centerline deflection of the girder due to flexural action would be 0.44 in. The estimated center deflection of 0.44 in results in an L/S value of 435 for a span of 16 ft. This is approximately twice the AASHTO limit for pedestrian bridges. The deflection of 0.44 in compares with a range of values from 0.25 to 0.30 in computed from a theoretical analysis of the bridge.* The computations for the range of values will be discussed later.

Figure 12. Deflections of the lower chord of the center girder as a function of live load.

Deflections measured during the unloading cycle of the test mirrored the pattern observed during the loading cycle. Both gages 1 and 2 indicated a residual net deflection, while gage 3 showed a greater elastic recovery than that measured during the loading cycle. The residual deflection values recorded when the load had been removed were somewhat arbitrary, since the starting values (indicated as 6,000 lb in Figure 12) were selected as equal to those measured at 6,000 lb during the loading cycle. The actual deflected positions of the gage reference points were due to the creep of the bearing pads, temperature induced distortions, and creep of the trussed girders during the period of loading. The differential deflections between gage 2 and the average values of gages 1 and 3 would be affected less by these variables than were the direct readings from the individual gages. A calculation at zero load for the differential residual deflection indicates a value of 0.11 in. While the exact value of the residual deflection is uncertain, the computed value of 0.11 in should be an indication of the magnitude of the nonelastic deflection which occurred over the test period. Some of the nonelastic deflection is recoverable, however, as discussed in the following section.

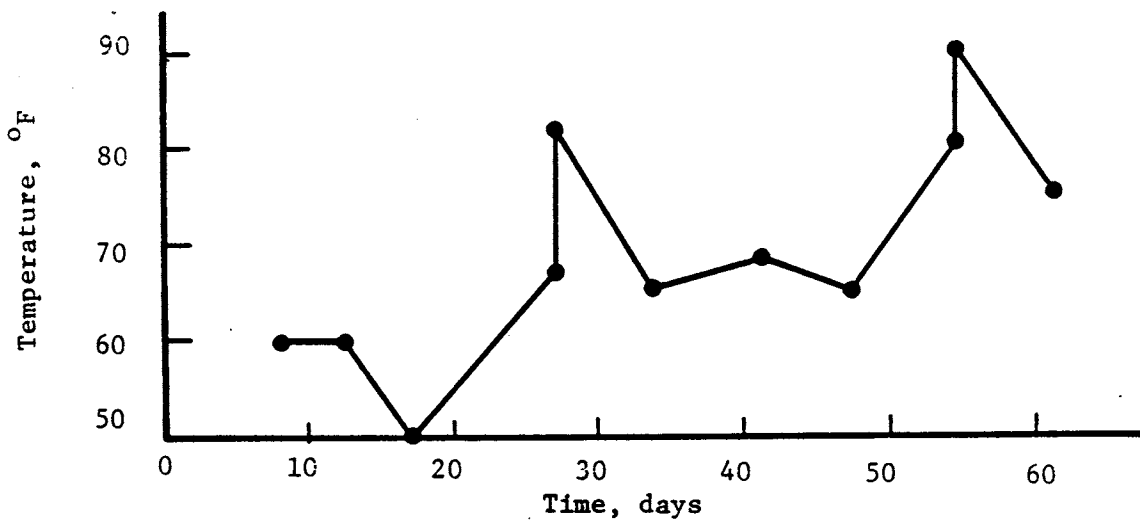
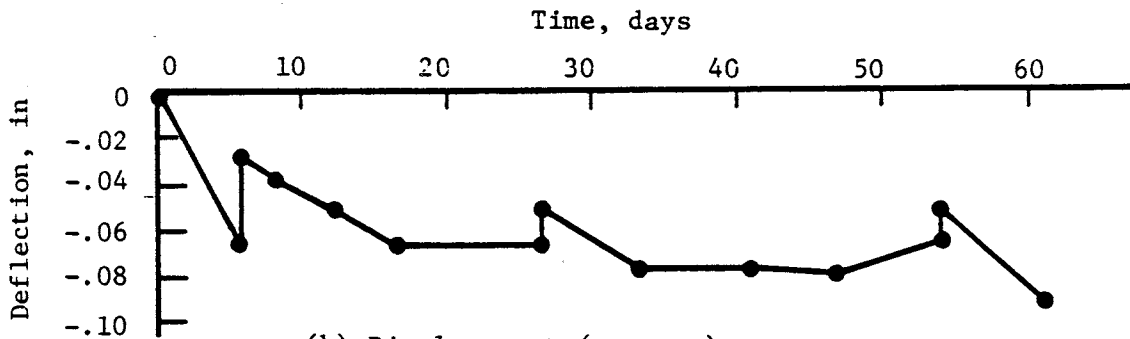
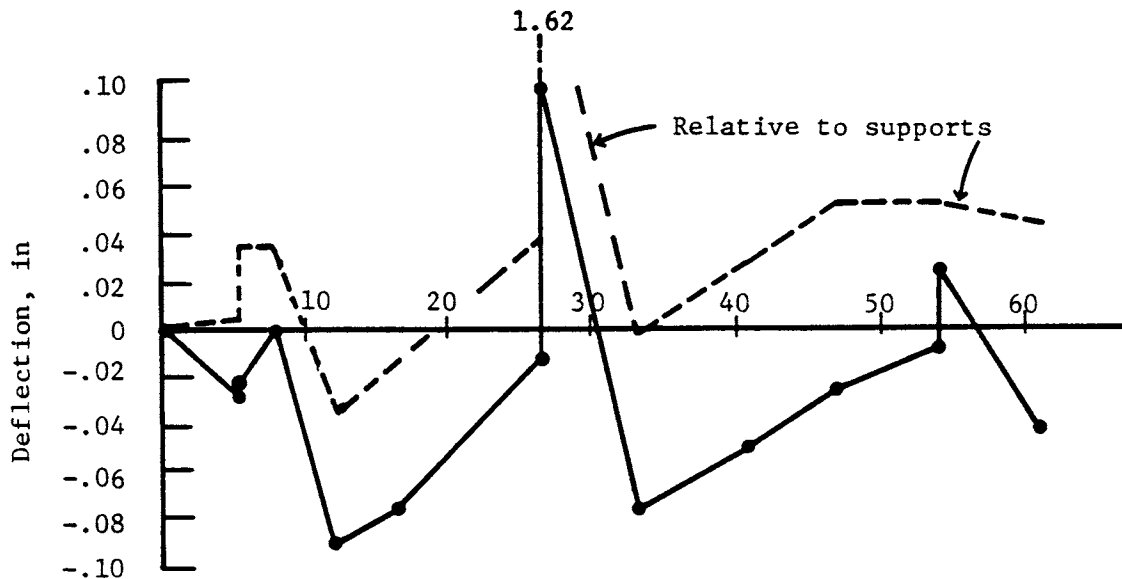
Initial creep readings were taken within 30 minutes after the final load increment was applied and correspond to the zero deflection value at time zero in Figure 14(b) and (c). Since reference points 1 and 7 were located very close to the supports, the deflections shown in Figure 14(b) may be attributed principally to the distortion of the elastomeric bearing pads beneath the supports. The data of Figure 14(c) are plotted as movements of the center span with reference to the benchmarks (solid lines) and also with reference to the supports (dashed lines). Dual data points shown on three different days reflect the reduction of load from 8,000 to 6,000 lb on day 6 and readings taken in early morning and late evening for temperature fluctuation effects on days 26 and 54.

Figure 14. Air temperature fluctuation (a) and deflections of the deck at the supports (b) and at the mid-span of the bridge (c).

In general, the deflection data of the supports and the center span clearly follow the ambient temperature fluctuations -- when the temperature increased, the deck rose; when the temperature decreased, the deck fell. As may be expected, the movement of the mid-span was more pronounced than the movement of the supports. The supports were shaded from direct sunlight by the bridge superstructure and the abutments but the deck surface was exposed to heating from the sun during the day and rapid cooling during the night. Because of the continual movement of the deck, it was difficult to determine from the available data whether any viscoelastic creep occurred in the superstructure, but if so, it was not detectable during the 61 day test period.

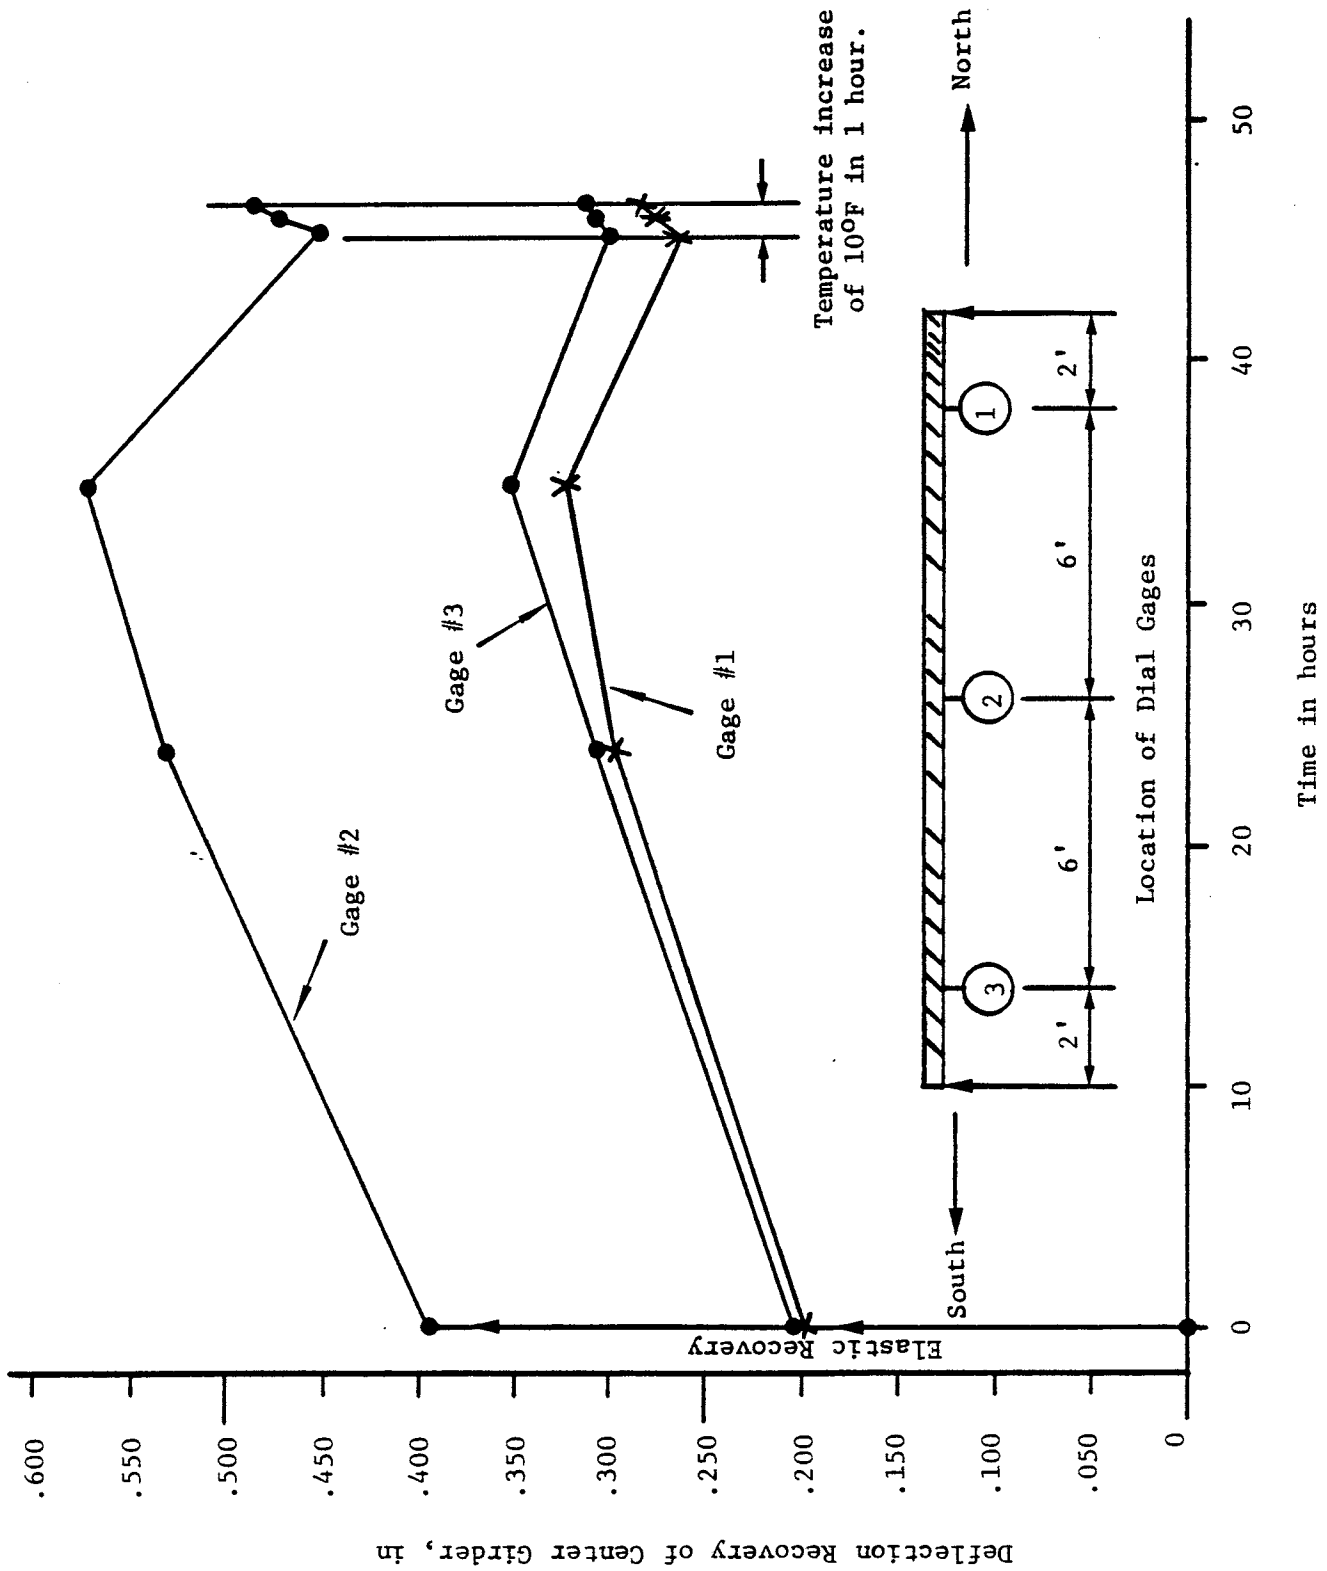
Figure 15 charts the creep recovery (sometimes referred to as an "elastic after effect") of the bridge following removal of the live load. Also indicated is the considerable influence of ambient temperature variations on the deflected position of the lower chord of the bridge. The plotted points indicate gage readings at times of zero, 24.0, 37.0, 45.5, 46.0 and 46.5 hours. Lines connecting the points are not intended to represent the variation in readings, except for the period from 45.5 to 46.5 hours, when the gages were monitored continuously. Two phenomena were at work to influence the deflection measurements: creep recovery and temperature variation. Regrettably, a careful record of the ambient temperature was not maintained during the test period, principally because temperature changes were not considered to be such an influential factor as they (in hindsight) apparently were. The temperature values shown were recorded from thermometer readings at the site or from the readings made in the Charlottesville area. The effect of temperature was clearly demonstrated by the increased deflection (an upward movement of the lower chord) over a period of 1 hour (from 7 to 8 a.m. on June 19, 1985), during which time the ambient temperature increased from 60° to 70°F. Values of 0.02, 0.03 and 0.01 in occurred at gages 1, 2 and 3, respectively, during that period of time. The movement due to temperature in 1 hour represents approximately 15% of the maximum creep recovery measured in 37 hours. While the change in geometry of the structure due to temperature variation is not completely understood, it is believed that the heat absorbed by the deck material when exposed to the sun was the predominating factor for change.

Analyses of the measurements for deflection recovery indicated that essentially all of the movement of the structure occurred at the supports. That is, after allowing for temperature fluctuations, the movement of gage 2 relative to gages 1 and 3 was nearly equal over the observation period of 46.5 hours. Therefore, it appears that little, if any, viscoelastic creep occurred in the bridge itself and that the measured "rebound" of the structure was due to the recovery of the elastomeric bearing pads. A similar observation was made in the creep study of a single girder over a period of 3 months as reported in reference 1.

Figure 15. Deflection recovery of the bridge following load removal. The effect of a temperature increase is shown for a period of 1 hour.

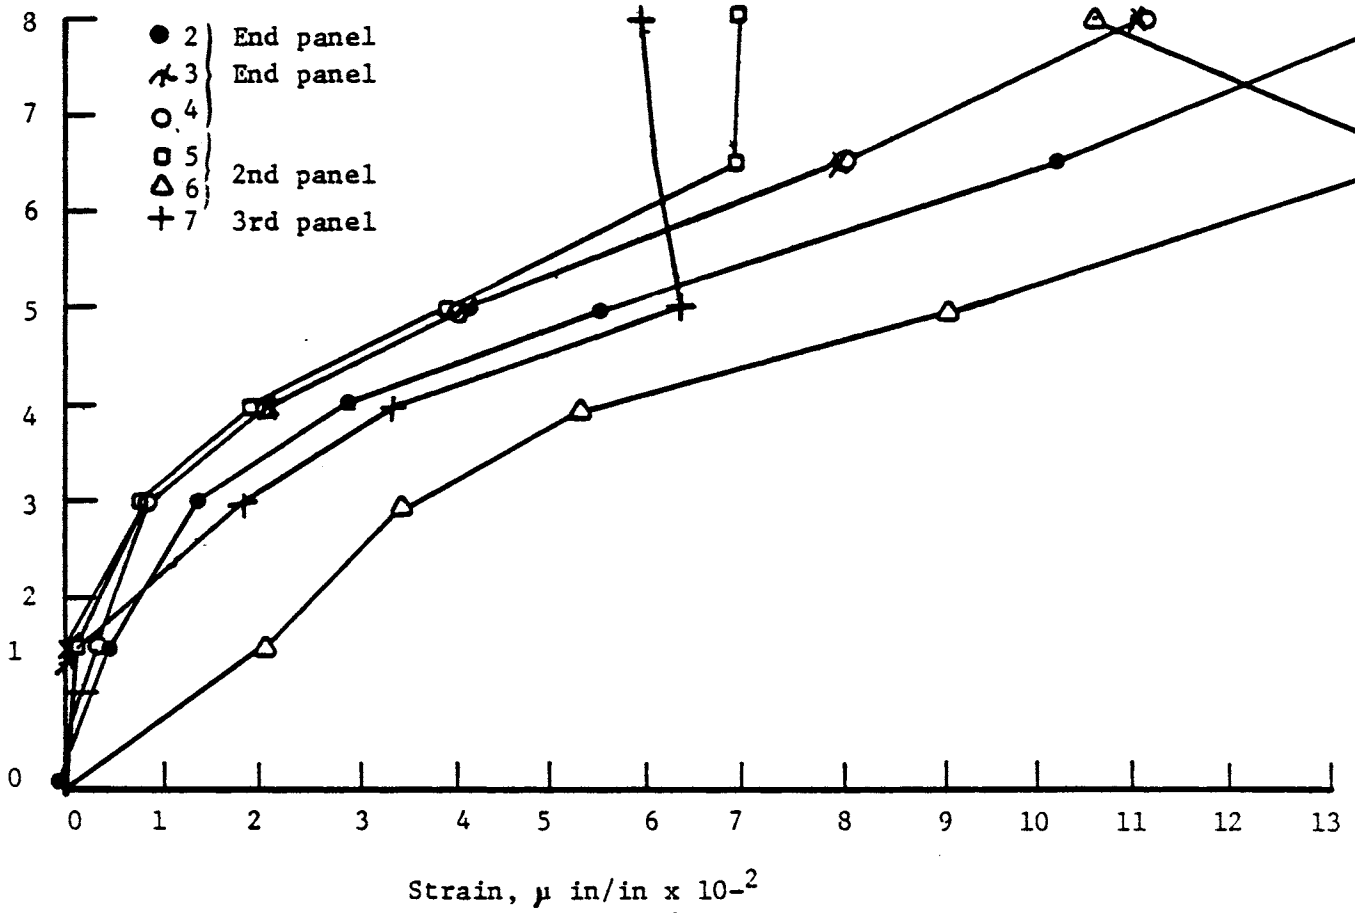
Figure 17 presents data from six gages mounted on the inclined web elements. Gages 2, 3, and 4 in the southern end panel tracked each other closely during the period of loading and ranged from 11,000 to 14,000 $\mu\text{in}/\text{in}$ when the total load was applied. These three gages indicated no reversal of strain increase in the end panel. The difference in strains between gages 2 and 3 is indicative of a possible load-carrying discrepancy between one of the outside girders and the inside girder, whereas the data from gages 3 and 4 indicate very similar load distributions between the center girder and the other outside girder. Gages 5, 6, and 7 in the second and third panels from the southern end indicated approximately the same increased rate of strain with the application of the load as did gages 2, 3, and 4 until loads were applied directly to their respective panels. At that time, the strains reversed direction. This change in direction reflected the change in magnitude of the negative shearing force in the interior panels as the load was increased and more uniformly distributed along the length of the bridge.

Using a tensile elastic modulus value of 7×10^6 lbf/in² for the lower chord and web elements as reported in reference 4, the strains shown in Figures 17 and 18 may be converted to axial tensile stress in the elements. The inclined web elements, therefore, developed stresses ranging from 4,200 to 9,800 lbf/in². Similarly, the lower chord stresses ranged from 3,150 to 6,650 lbf/in². With a conservative ultimate strength value for the tensile strands exceeding 50,000 lbf/in², the safety factors against tensile failure of the material exceed 5. Obviously, the design limitation of the GRP material system is the deflection of the structure due to the (low) modulus of the composite or the shear strength of the connections.

Figure 17. Elastic strain in inclined web elements in the girders due to application of loads.

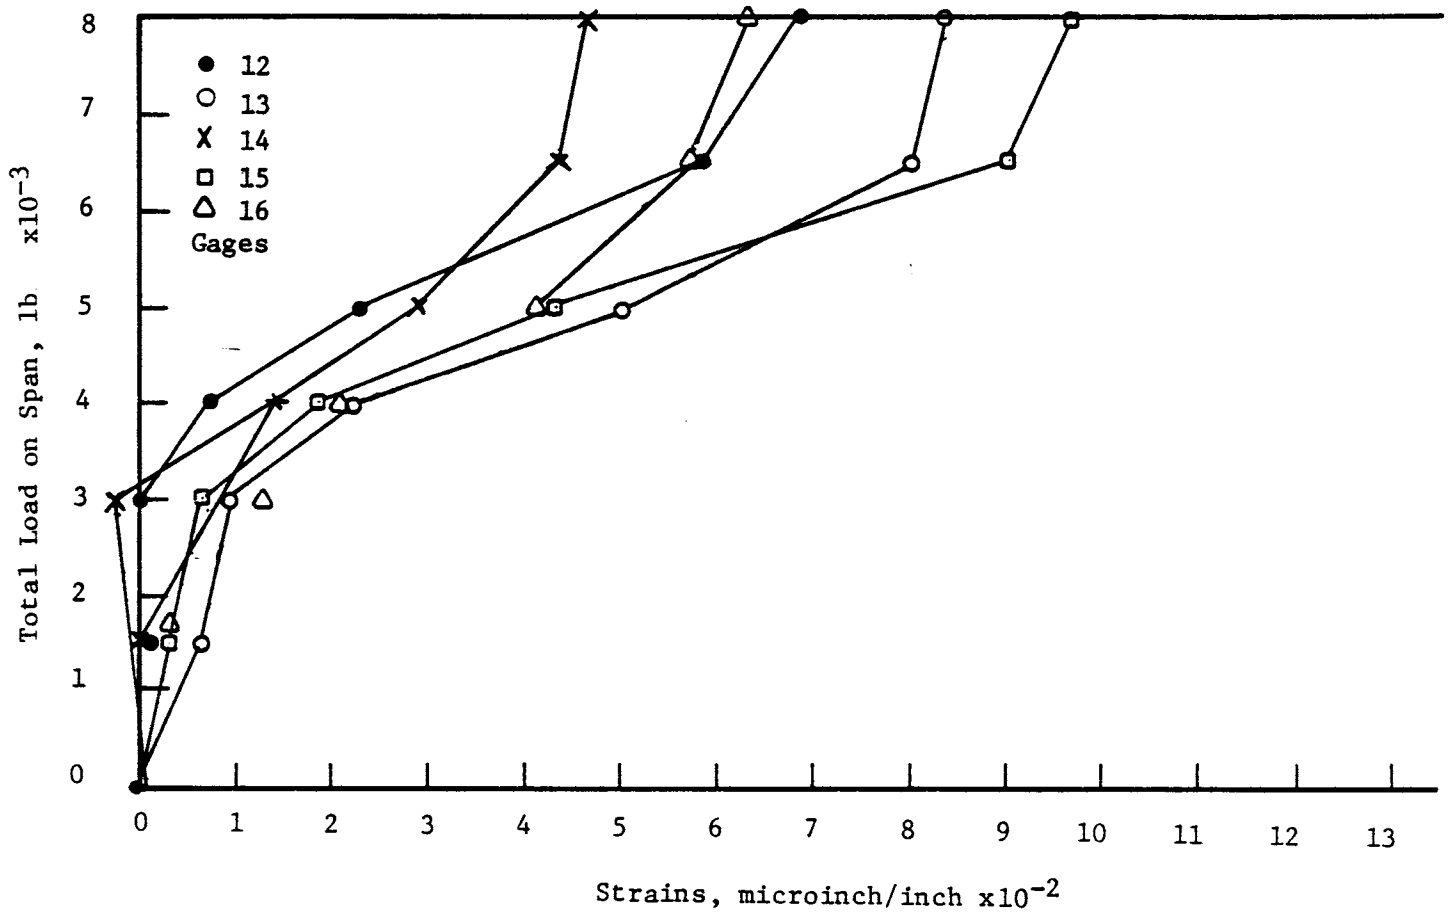
Figure 18 presents strain data from five gages mounted on the lower chords. All gages indicated increasing strain values as the load was increased on the bridge. As expected, a sharp reduction in the strain rate in all five gages was noted with the application of the last increment of load. As noted previously, the last load increment was applied in the southern end panel and, therefore, should not have affected the flexural stresses in the girders as much as the prior load increments had. It is seen from Figure 18 that a relatively narrow range of strains was measured throughout the four panels and two girders monitored by the gages -- particularly through the application of the first 5,000 lb of load. The narrow range of strain values indicates that the lower chord elements were stressed as uniformly as might be expected with the nonuniform arrangement of the test load. The relative

uniformity of stress indicates that the design procedure used to dimension the chord elements produced an efficient structural configuration. Also, the lateral transfer of the load and the interaction between girders during the load test appeared to be satisfactory as indicated by the random variation in strain values in the chords of the inside and outside girders.

Figure 18. Elastic strain in lower chord elements in the girder due to application of loads.

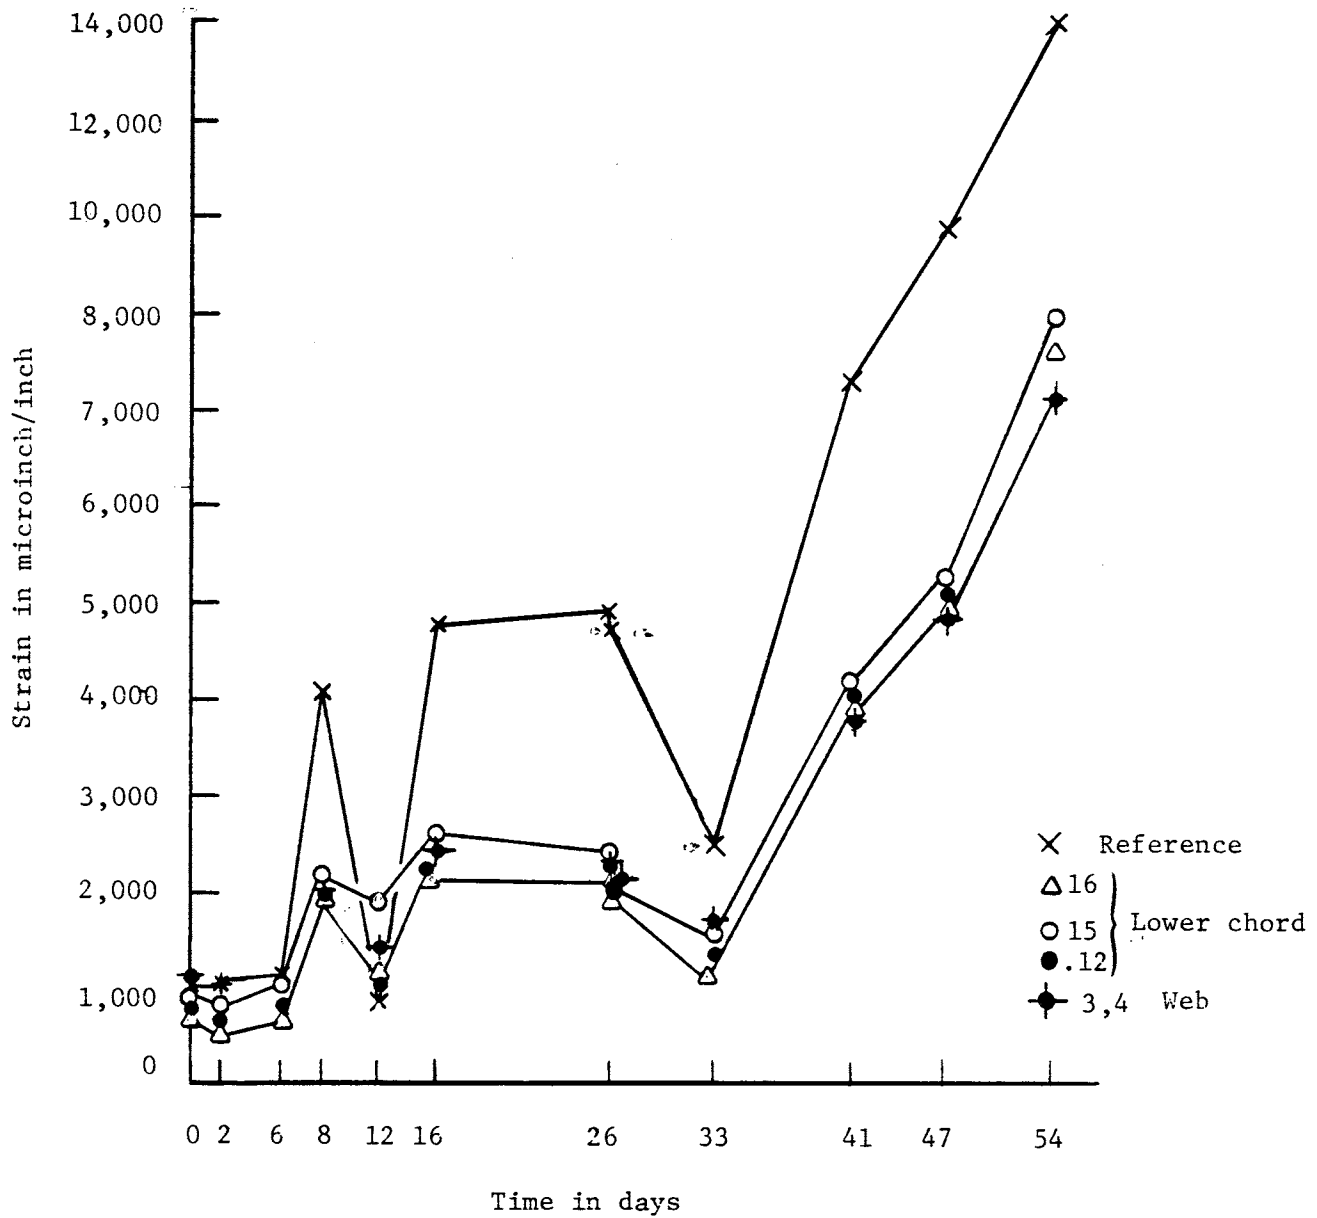
Figure 19 presents representative strain data from five active strain gages and a fixed reference circuit over the period of the creep test. The reference circuit was fixed at 1,000 $\mu\text{in}/\text{in}$ as a check on the stability of the measuring indicator. As can be seen in Figure 19, the reference circuit remained essentially unchanged for the first 6 days of the creep test. Thereafter, wide fluctuations appeared in the data until, finally, the drift in the reference circuit exceeded the range of the indicator. Also, note that the magnitude of variations in the reference considerably exceeded those of the measuring circuits, even though the directions of the deviations were the same. Efforts were made to correct the obvious malfunction of the instrument as soon as the deviations were noted, but to no avail. Apparently, moisture penetrated the switching units and altered an internal resistance common to all of the gage circuits to produce the results obtained. The measurements were discontinued after 54 days.

It is not believed that the fluctuations of the measuring instrument were due to changes in the ambient temperature. The comparison of the strain deviations with the temperature fluctuations shown in Figure 15 indicates little to no correlation. Because of the gross deviations of the measurements, the data are worthless for quantitative use. However, it is quite evident that all of the gages underwent the same magnitude of creep strain, whatever it was. If the first 6 days of the creep strain readings might be considered reliable, it appears that no measurable creep occurred in the three lower chord and two web elements shown in Figure 19. The absence of detectable creep strain in the individual elements of the girders corresponds with the deflection measurements of the lower chord and the deck as discussed previously. The relatively low stresses developed in the elements due to the full live load would account for the absence of creep in the composite material.

Figure 19. Strain in selected elements vs time with full live load applied to bridge.

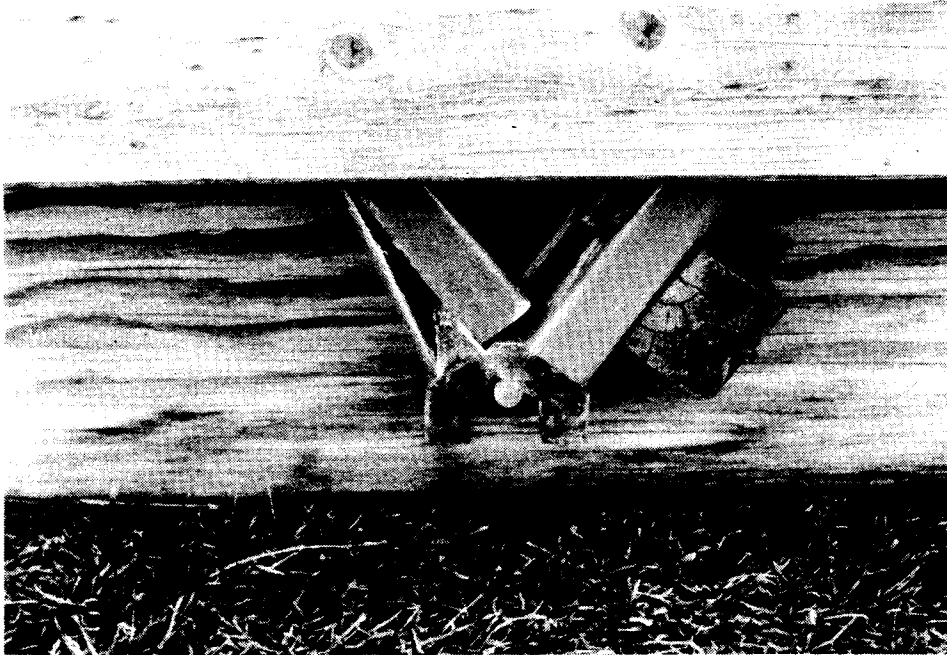
Unexpected but valuable information was obtained when the superstructure was moved to the test site. On March 11, 1985, personnel from the Parks and Recreation Department of the city of Charlottesville moved the bridge from a storage yard to the erection site in Pen Park. The handling and transporting of the bridge were completed without benefit of procedural instructions from the project director. Being unaware of the fragile nature of the material in the bridge and unfamiliar with special support requirements, the persons moving the structure took few precautions to avoid damaging it. Consequently, a heavy chain was simply wrapped around the bridge longitudinally and attached to a front-end loader for lifting the structure onto a lowboy trailer. Fortunately, the temporary wooden crating attached to the end stiffeners for support during storage also served well as end supports while the bridge was transported approximately 8 miles to the erection site. The bridge was unloaded from the lowboy in the same manner as it had been loaded. During the handling, the outside stiffeners at both ends of the center girder were broken where the lifting chain made contact. The extent of the damage to a stiffener may be seen in Figure 20. Aside from some abrasion on the edge of the cover plate on the deck, no other damage to any of the structural elements was observed. The displaced stiffeners were realigned manually with the lower chord connector and reinforced by cutting and bonding a pultruded GRP plate 1/2 in thick to the mating stiffeners as shown in Figure 21.

While improper handling of the bridge may have been disastrous, the episode just described turned out to be quite valuable because it provided a test of the toughness of the structure which would not have been conducted intentionally for fear of irreparable damage to the joints and elements.

Figure 20. Damaged web stiffener at the end of the center girder.

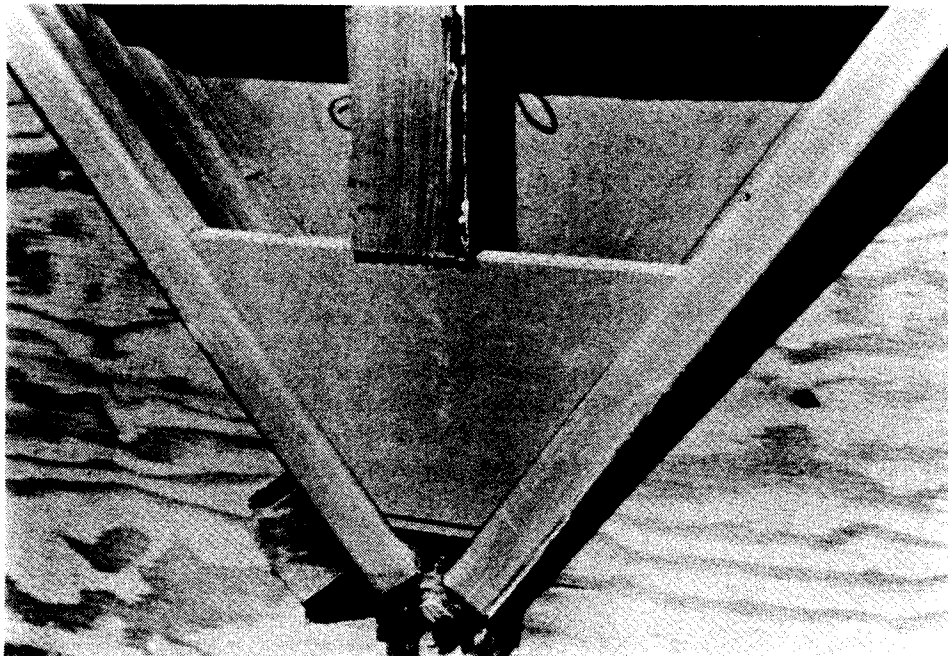
Figure 21. Joint shown in Figure 20 after repair by bonding plate to the stiffeners.

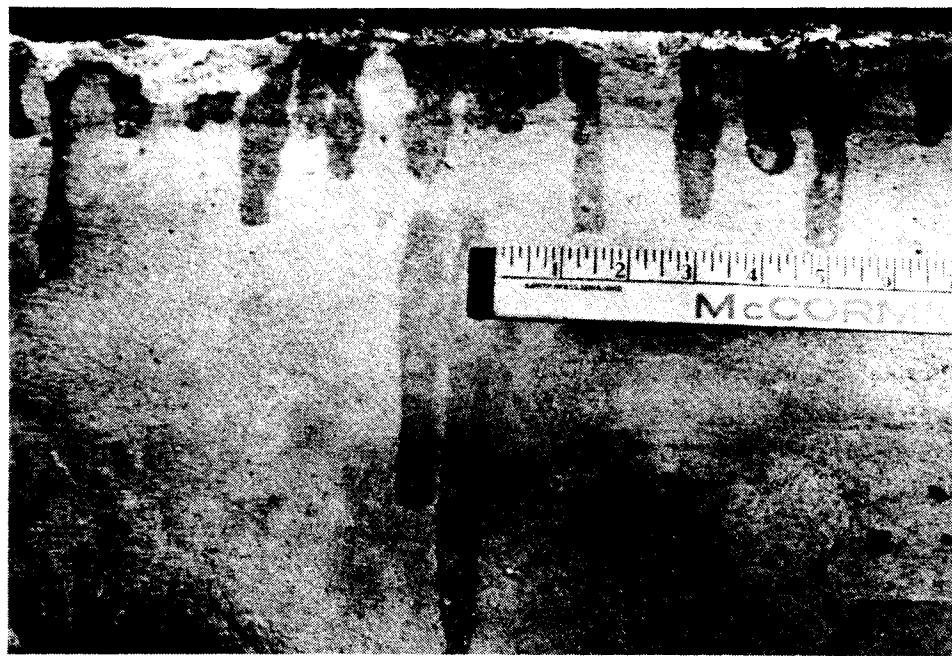
Upon removal of the superstructure from the concrete seats, it was determined that the northern end of the bridge had resisted removal because of the wedge action of the bearing pads on the support elements. However, the southern end had been bonded to the concrete abutments by small quantities of polyester resin which had drained from the end of the deck plate during the application of the polymer concrete wearing course. Figure 25 shows the principal area on the surface of the concrete backwall over which the polyester resin drained. Apparently the clearance between the top transverse stiffener and the backwall of the abutment was small enough to trap a quantity of the resin, which cured and bonded the two mating surfaces securely. The forces and efforts required to break the polyester from the abutment attest to the strength of the binder, and they explain why the deck assembly could be drastically distorted without spalling the layer of polymer concrete from the pultruded deck plate.

Figure 25. Polyester resin on the surface of the concrete abutment at the southern end of the bridge.

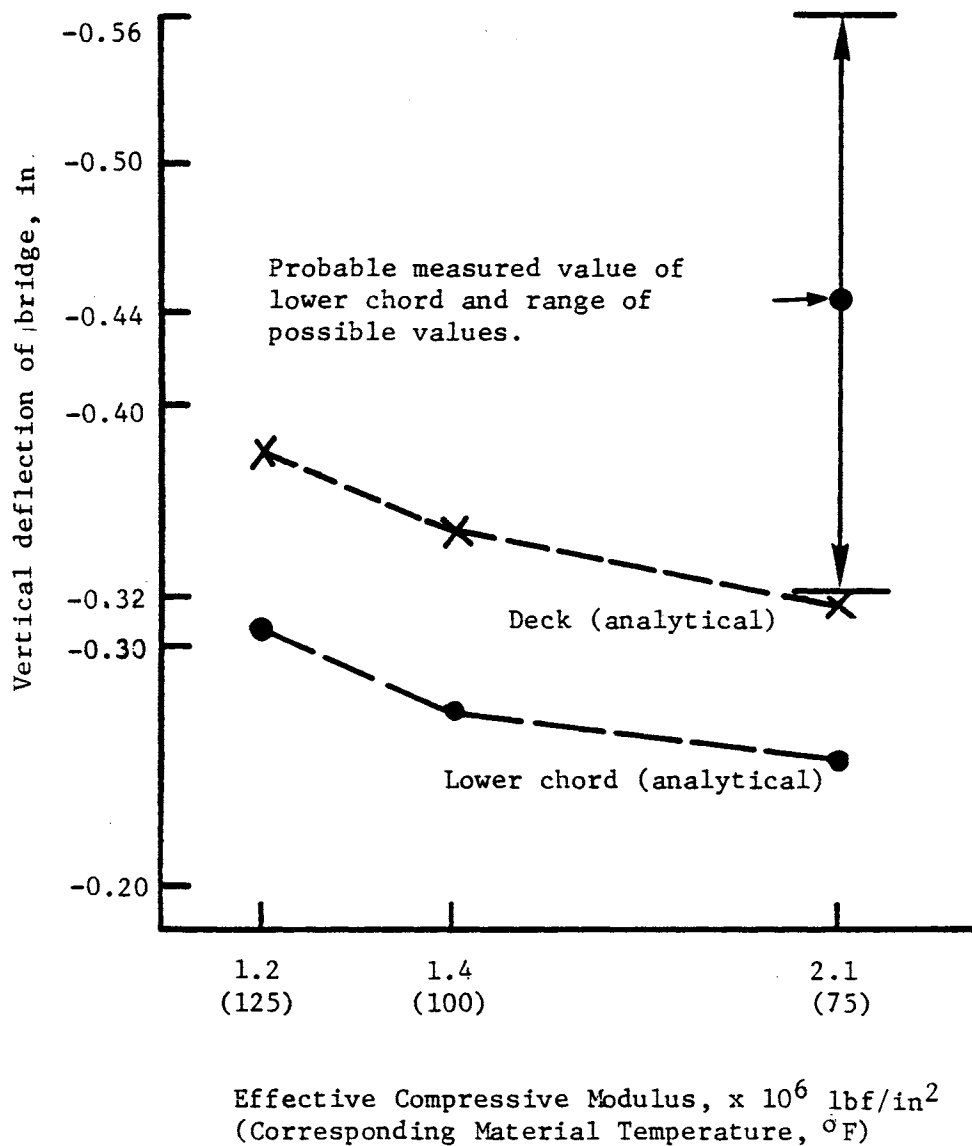
Figure 27 presents the results of an analytical solution for the deflection of the deck surface and the lower chord at the center point of the bridge with full live load applied and with various values for the effective compressive modulus for the deck and girder flanges. The measured values for the same deflections are plotted in the figure for comparison. From this comparison, it is apparent that the analytical model used to compute the deflections in the structure provides a conservative estimate at the test temperature of 75°F. The difference between the measured and computed deflections diminishes as the test temperature increases. While the difference between the measured value of 0.44 in and the analytical value of 0.25 in appears large, it should be noted that the analytical model does not include known secondary conditions which contributed to the actual deflection of the structure. These variables include bending in the two-force elements, joint and general geometric distortions, deck-plate warping, shear deflections in

all of the elements and other synergistic effects between elements and joints. The relative contributions of these secondary conditions to the overall measured deflections are unknown. Certainly, some of the variables cited are more significant than others. It is, therefore, difficult to include a meaningful modifying value in the analytical solution for each affected component to achieve better agreement between the measured and computed values for deflections. Further testing of the structure under conditions more carefully controlled than those for the recently completed field load test should provide some estimate as to which of the variables are significant and to what degree.

Figure 27. Elastic deflection of center point of bridge at deck and lower chord elements as a function of temperature and material modulus variation for a live load of 8,000 lb.
