FINAL REPORT

EVALUATION OF A BRIDGE DECK EXPANSION JOINT

June 1986  
VHTRC 86-R44

A particular type of proprietary joint, the Royston Unidam Type LK-120, was installed in 1980 as an experimental feature on the eastbound lane (EBL) of the Rte. 50 bridge over the Shenandoah River in Clarke County, Virginia. This report includes a review of the installation of that expansion joint and an evaluation of its performance after five years in service.

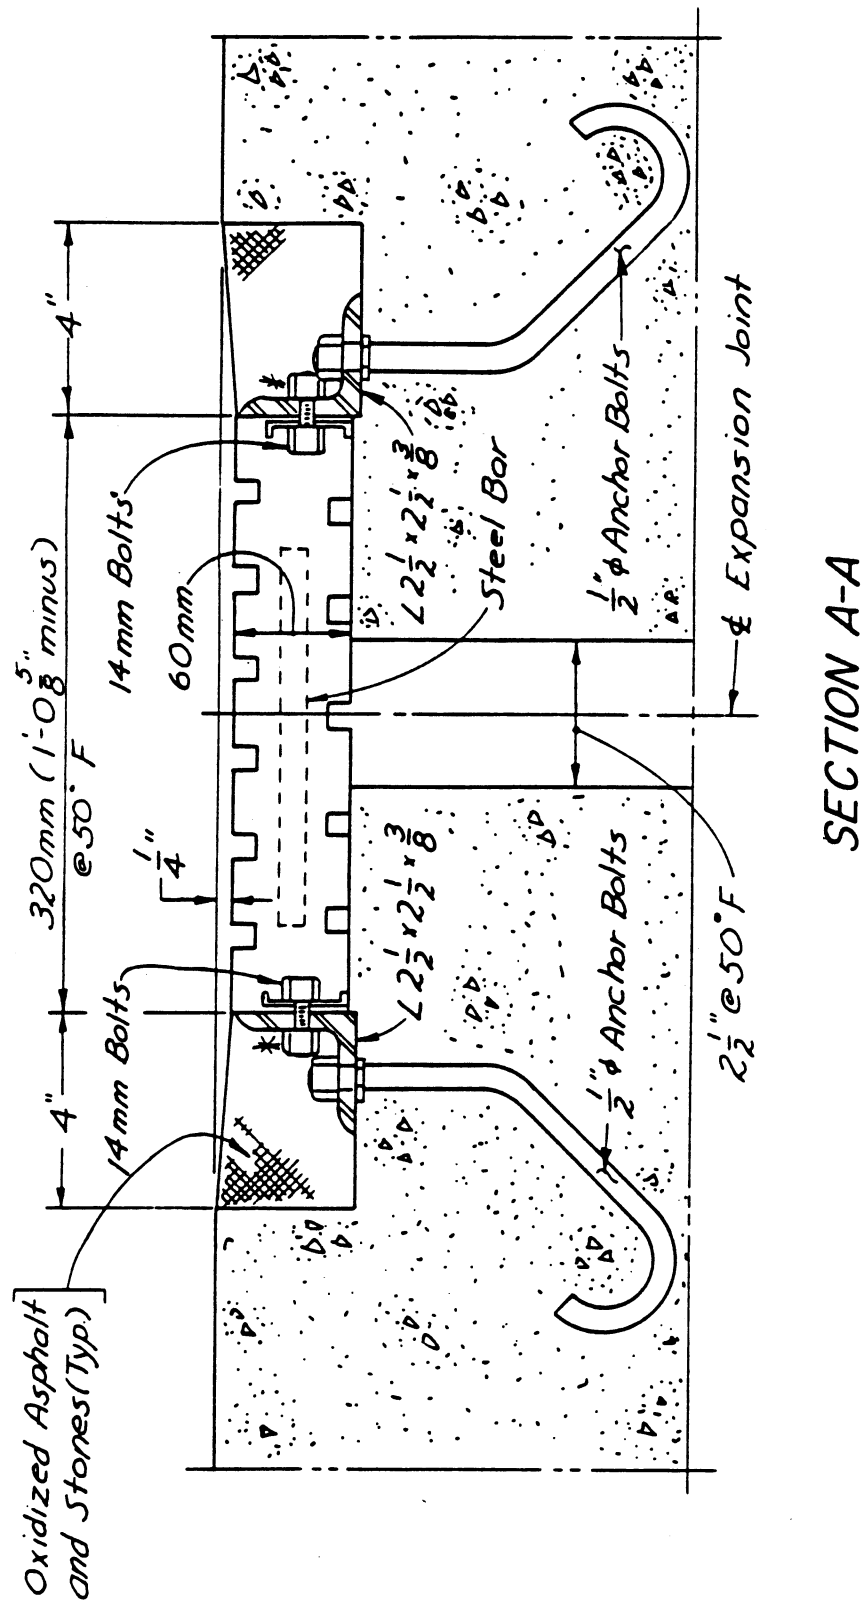
Figure 2. A typical transverse section of the Royston joint.

The requirement that the horizontal clearance between the two hold-down angles be 320 mm at 50°F (Figure 2) is, from a practical viewpoint, difficult to meet. Because of the time required to install the supporting form work and the anchorage and hold-down angle assembly it is virtually impossible to position it precisely. Even if it were possible to install the second angle in such a manner that it could be adjusted in a short period of time prior to placement of the deck concrete, the final position would likely still not be correct. The reasons for this are simply that time, thermal changes, rotations due to deflections, and changing inertial properties all simultaneously vary during the placement of the deck concrete. These factors, added to the pressures, impact, and jolting that usually occur during concrete placement, produce a highly complex situation. On each of the joints placed on the bridge, the final distance between the two vertical legs of the hold-down angle was in error; one on the order of 1/4 in, the other on the order of 1/2 in. Viewed in retrospect, this result probably should have been expected. It is, therefore, very likely that the extra cost of providing shims or making other width adjustments would often be associated with the use of this bridge deck expansion joint.

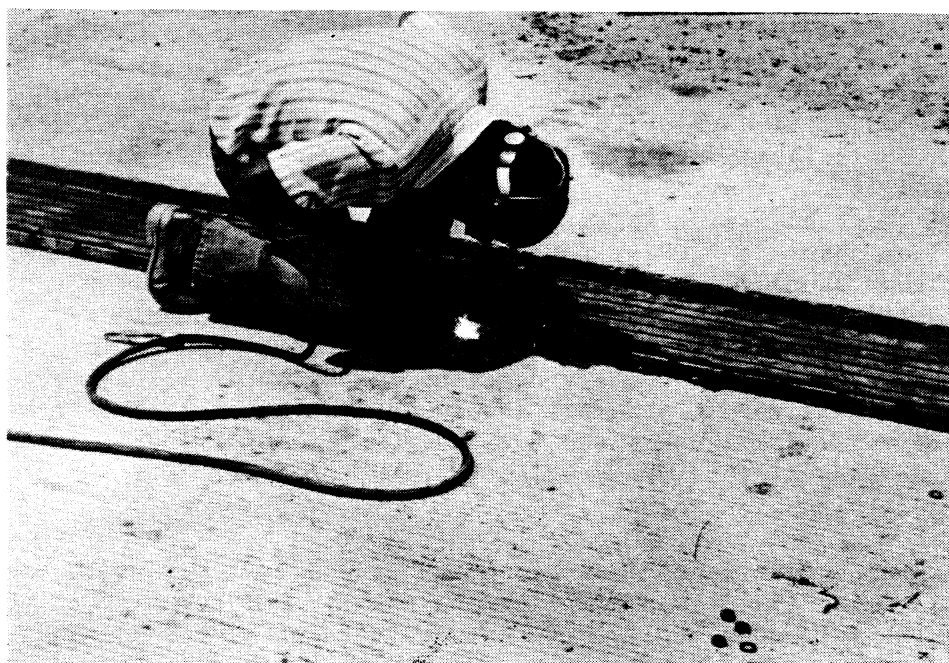
Figure 6. Anchor bolt nuts being welded to vertical leg of anchorage angle.

Because the horizontal anchor bolts tended to twist within the elastomer material, it was difficult to tighten the anchor bolt nuts against the hold-down angles. To ensure that the anchor bolts would not loosen after the bridge was placed in service, the nuts were welded to the vertical leg of the hold-down angles. While this appears to be a necessary procedure, the field welding adds to the time and cost of installing the joint material.

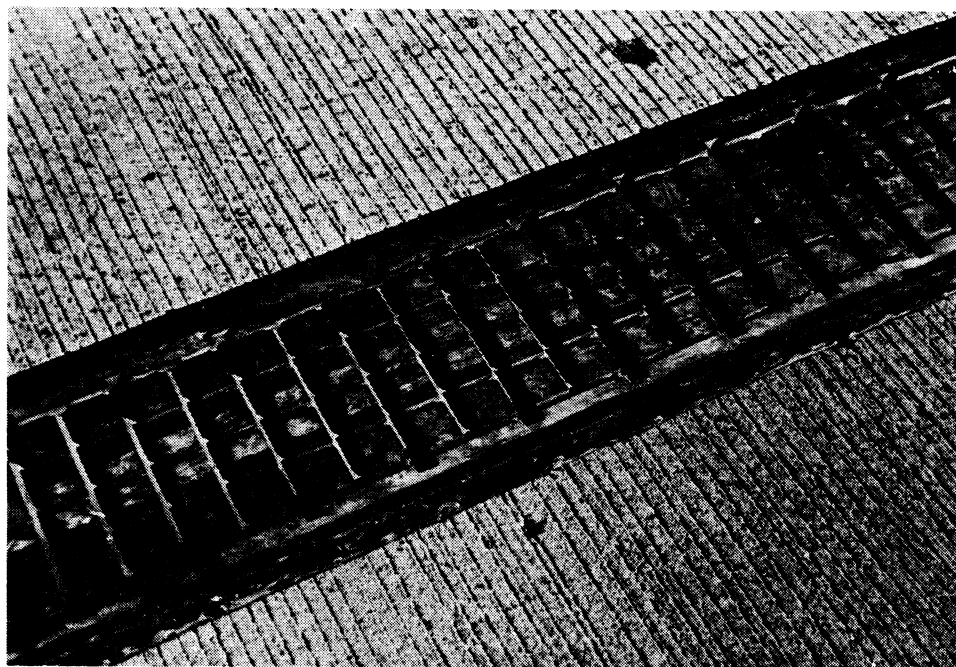
After one year of service the west joint elastomer was removed. A view of the bottom side of this elastomer is shown in Figure 8. The rust stains evident suggest that water may have gotten through the joint, thus allowing rust stains from the steel angles, anchor bolts, or the inserted steel rods to be deposited on the bottom of the elastomer and in the trough area. Other than these stains, no other deterioration of the west joint was apparent after one year of service. No deterioration of the east joint was evident after the first year of service.

Figure 8. Underside of elastomer removed from west joint after approximately one year of service. Rust stains on the elastomer were evident.

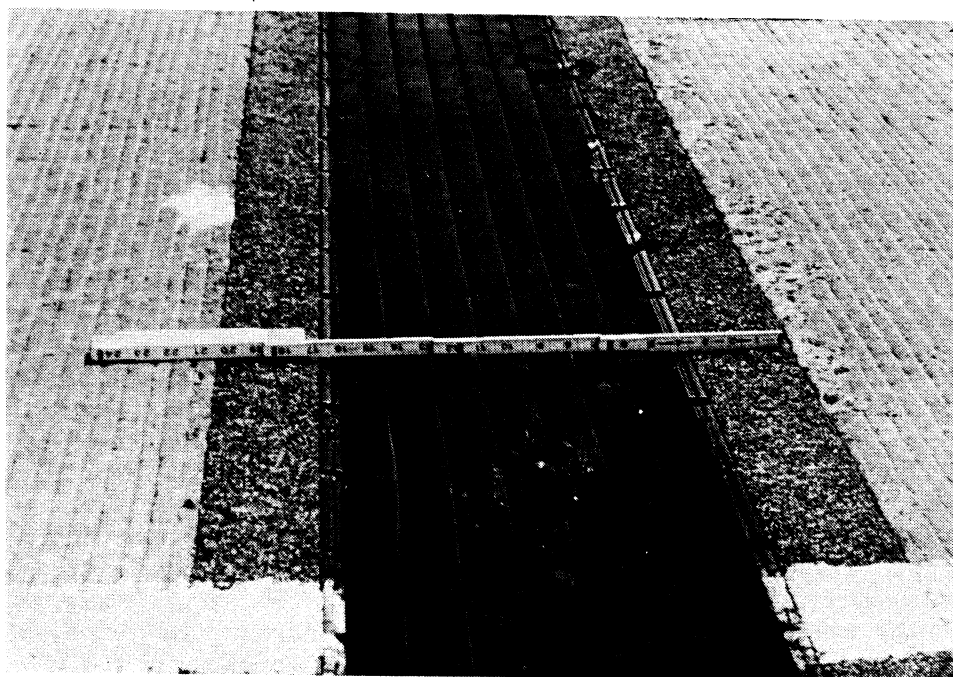
After five years of service the east joint had either collapsed or compressed considerably beyond the 1/4-in depression with respect to the adjacent concrete deck as originally installed (see Figure 2). The collapse of the neoprene is clearly indicated in Figure 9 by the ruler lying across the joint near the right wheel path of the right-hand lane. At the center of the joint the elastomer had sagged by approximately 1 in, suggesting at least a partial failure of the material to maintain its initial structural shape. Some degree of sag in the elastomer beyond that of its original position was noted. However, the right-hand lane, in general, exhibited more sag than the left-hand lane.

Figure 9. Excessive sagging of the elastomer of the east joint suggests partial failure of the material.

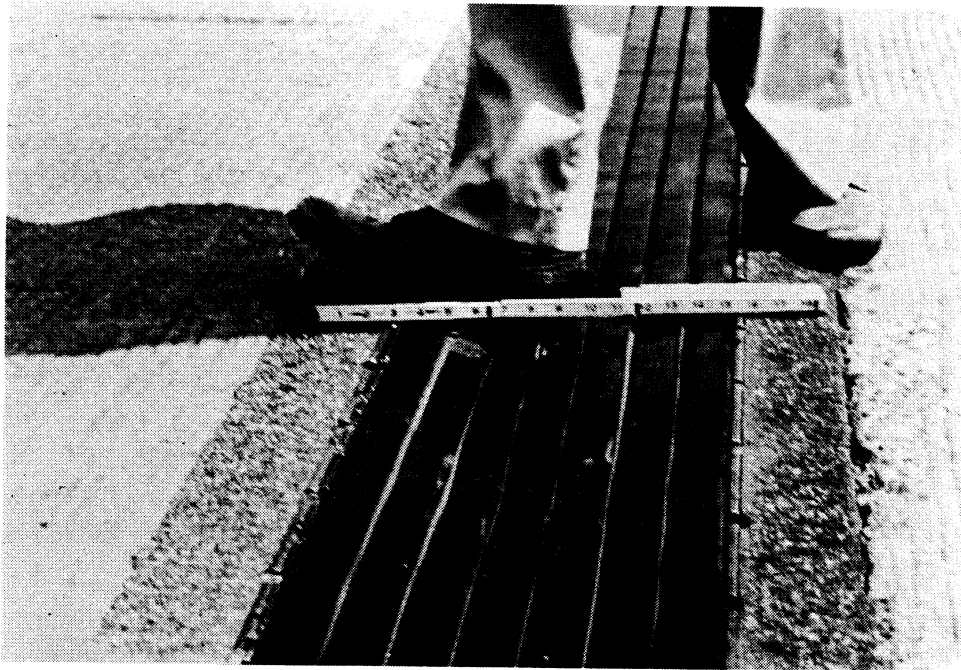
The elastomer in the west joint, which had been in service for only four years at the time of the evaluation, exhibited more severe sagging in the right-hand lane than did the east joint. In the area of the right-hand wheel path of the right-hand lane the elastomer had failed. As shown in Figure 10, the elastomer could be deflected several inches under only modest pressure. This failure extended over approximately 3 ft of the joint at the time of the inspection. Without removing the elastomer, it was not possible to identify the exact cause of the failure. However, the failure appeared to be in the structural integrity of the elastomeric material itself. As a result of the failure in the right-hand wheel path of the west joint and the excessive sag in other areas of both joints, the riding quality over the joints had been impaired and the noise resulting from traffic impact had increased.

Figure 10. Apparent failure of elastomer in the right-hand wheel path of the right-hand lane (west joint).

3. The design of the joint material prevents debris and other solids from entering the joint opening.
4. The elastomer of one of the two joints had failed over an approximately 3-ft length in the right wheel path of the right-hand lane. Considerable sagging in the elastomer of both joints suggests that failure of the material may become more widespread with time. Due to this problem, the riding quality over the joints has been impaired and the noise resulting from traffic impact has increased.

Based on the observations discussed in this report and the performance of the joint material over a five-year period, and considering its high initial cost, use of this bridge deck expansion joint is not recommended.

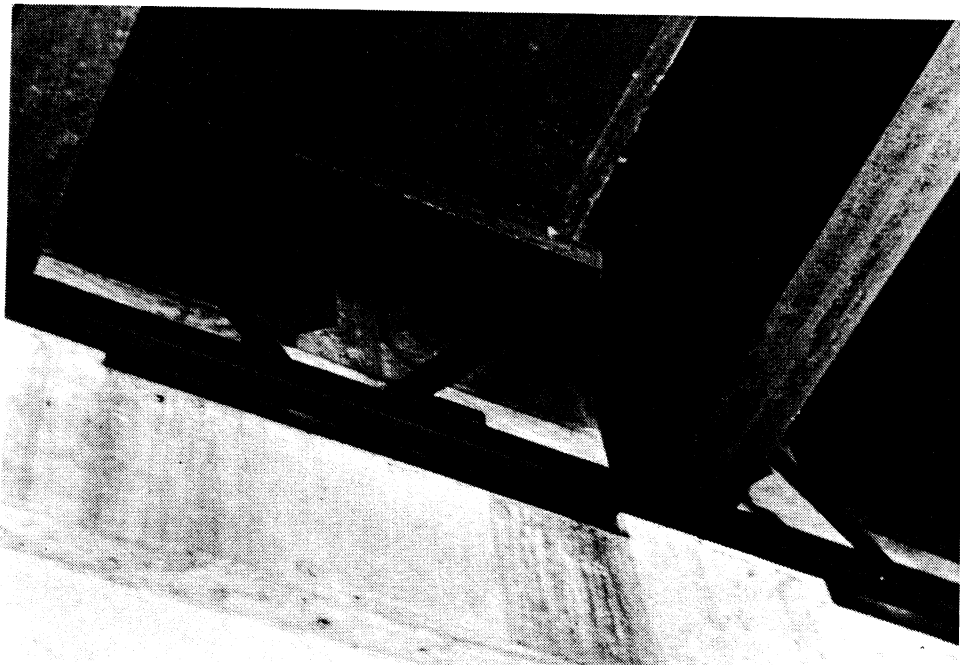
Inspection on the underside of the bridge revealed considerable streak staining on the pier caps, which suggested that leakage of water through the joints had occurred. The greatest amount of pier staining was below the right wheel path of the right-hand lane of the west joint (Figure 11). A lesser amount of staining was evident below the area of the left wheel path. The evidence of the heaviest leakage through the joint, therefore, appeared to coincide with the severity of the failure of the elastomer. Some streak staining of the pier cap below the east joint suggested that some leakage was occurring there as well.

Figure 11. Streak staining on the pier cap below the west joint.

2. The evidence of streak staining on the pier caps indicated that the joints were not completely waterproof. This was particularly true under a section of one of the joints where the elastomer had undergone some degree of failure.
