1. Report No. VTRC 91-R7	2. Government Accession No.	3. Recipient's Catalog No.	
4. Title and Subtitle Installation and Performance Evaluation of the Wabocrete FMV Joint System for Bridge Decks		5. Report Date August 1990

August 1990
VTRC 91-R7

**INSTALLATION AND PERFORMANCE EVALUATION
OF THE WABOCRETE FMV JOINT SYSTEM FOR BRIDGE DECKS**

Marvin H. Hilton

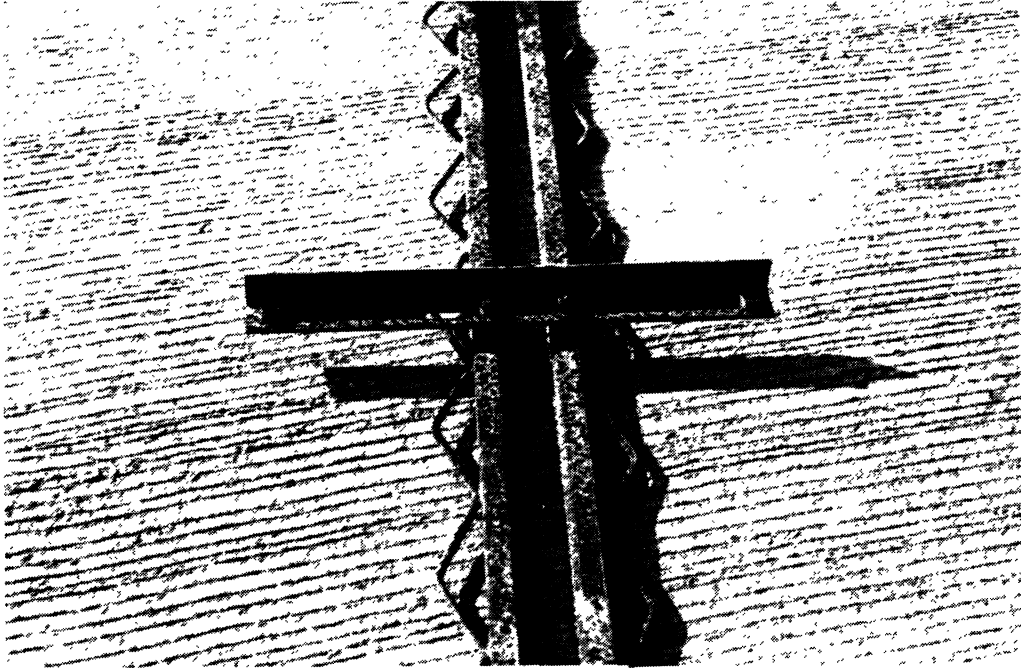
All of the components of the joint system were delivered to the bridge site approximately two years prior to its actual installation. When the steel extrusion-sinusoidal anchorage system was inspected on November 4, 1986, it was badly corroded (see Figures 2 and 3). The remaining elements of the system that were on the job site were ten 44-lb bags of premixed aggregate materials and several containers of the two-component Wabocrete FMV binder. In order to test the binder materials, small samples of each component were mixed by the joint manufacturer's representative and allowed to set overnight. The mixture hardened normally; thus, it was concluded that the materials on hand could be used for the joint installation.

Figure 2. View of the rusted steel extrusion-sinusoidal anchorage unit.

Prior to beginning the joint installation on November 6, 1986, the contractor sand-blasted the steel extrusion-sinusoidal anchorage system. In Figure 4, the cleaned unit is shown lying parallel to the bridge joint opening. Since there did not appear to be any ill effects from the corrosion of the unit or from the cleaning operation, the unit was approved for installation on the bridge.

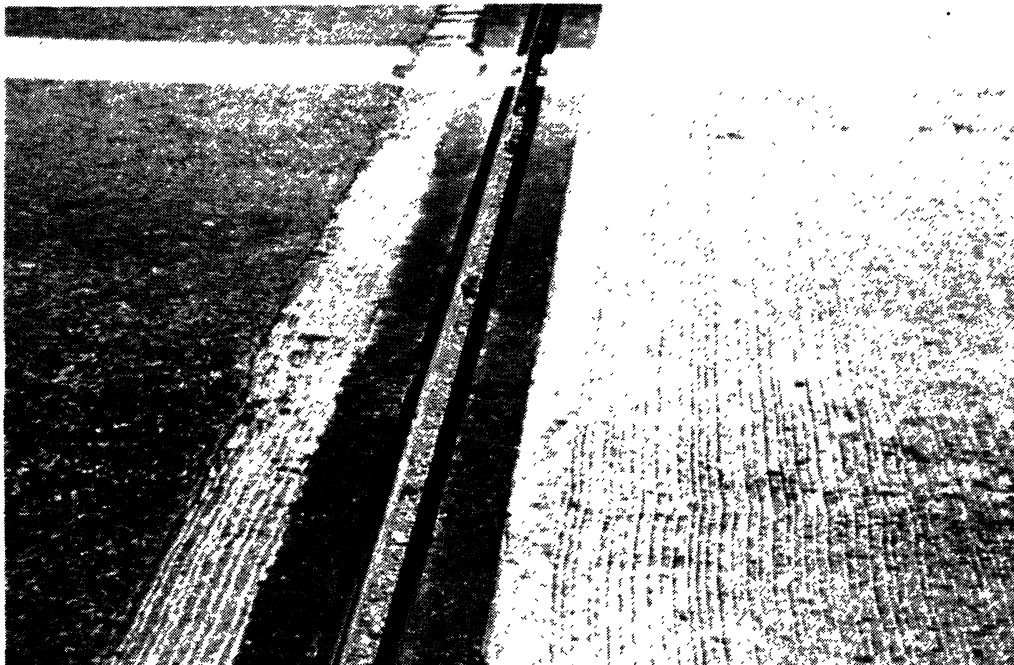
- No evidence of joint system leakage was detected.
- No evidence of debonding of the Wabocrete FMV material was detected.
- Sand and gravel (and possibly other debris) tend to accumulate in the trough of the neoprene strip seal.

Figure 8 shows a view of approximately half the length of the joint as it appeared at the last inspection. Considerable debris can be seen in the trough of the strip seal. Further accumulation of sand at the face of the parapet wall is shown in Figure 9. The appearance of the joint on the inclined face of the parapet, as discussed earlier, can also be noted.

Figure 8. Partial view of the joint, showing debris in the trough of the neoprene strip seal.

- Based on the performance of the system to date, routine maintenance should be minimal. However, debris should be removed from the neoprene strip seal periodically to prevent potential damage.

Because of the tendency of this joint to accumulate debris in the trough of the neoprene strip seal, it should be routinely cleaned—perhaps semi-annually or as necessary.

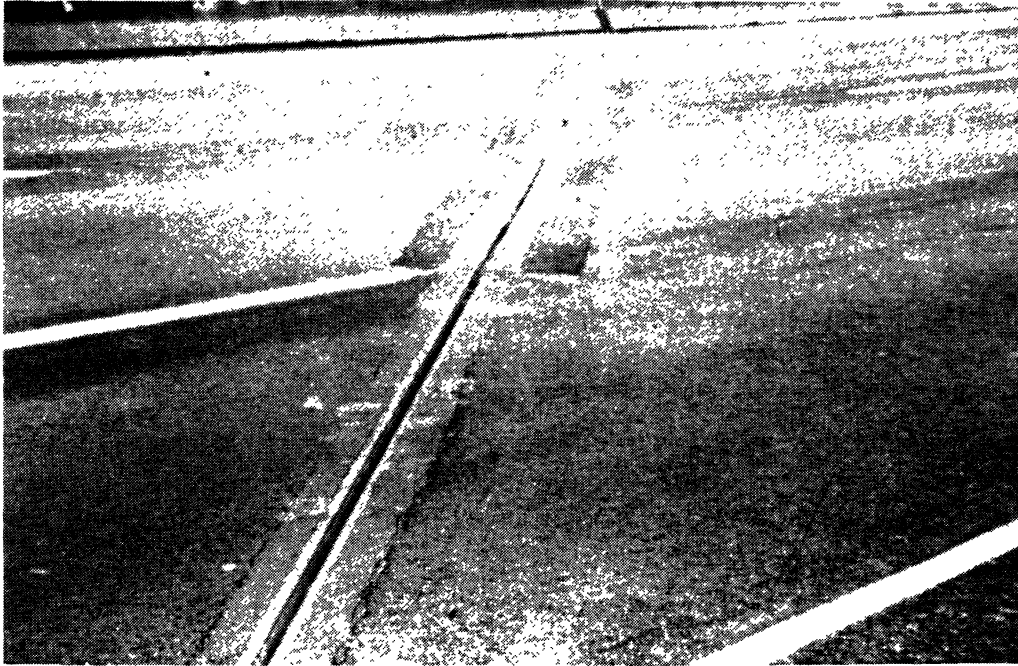
Photographs of two of the joint installations at the RF&P Railroad overpass site are shown in Figures 10 and 11. It can be noted from Figure 10, that the asphaltic overlay adjacent to the joint had failed and had been repaired. In addition, the Wabocrete FMV and asphaltic overlay had separated at their vertical interfaces as can be noted from both photographs. The joints were reported to be leaking and collecting debris (see Figure 11).

- On at least some of the joints at the two bridge sites, the Wabocrete FMV joint system was installed over existing steel armor joints. Apparently, the bond between these two materials was inadequate.

- There is evidence that there was a lack of support beneath some portions of the steel extrusions of the Wabocrete FMV system. On an 8-ft section of one joint, the steel extension had broken away from the sinusoidal anchor bar, which led to the failure of the anchorage system.

- Inconsistency in the bonding surface of the existing bridge deck material resulting from miscellaneous contaminants, such as water-proofing materials (possibly used earlier) etc., could have contributed to the bond failure.

- As suggested by the bond failure at the vertical interface, the Wabocrete FMV material does not appear to bond well to the flexible asphaltic concrete.

- The high traffic volume on the Capital Beltway, which is approximately 200,000 vehicles per day, made the installation of the joints difficult. They were also subsequently subjected to high numbers of impacts every day.

Figure 10. View of a Wabocrete FMV retrofit installation on a Capital Beltway bridge deck.

The use of the Wabocrete FMV and similar systems as retrofit on older bridges should be approached with caution. Furthermore, these systems should probably not be used in retrofit situations in conjunction with adjacent asphaltic overlays.

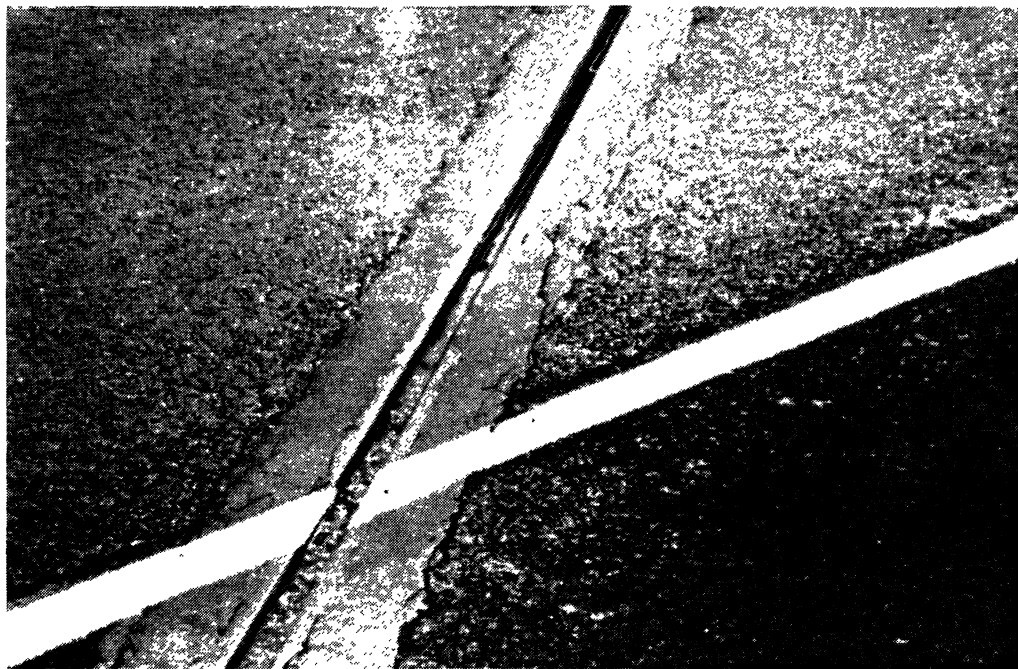
Figure 11. Separation at the interface between the joint and adjacent asphalt overlay.
