INSTALLATION REPORT
THE USE OF FABRIC REINFORCED OVERLAYS
TO CONTROL REFLECTION CRACKING OF
COMPOSITE PAVEMENTS

K. H. McGhee
Highway Research Engineer
and
C. S. Hughes
Senior Highway Research Scientist

Virginia Highway Research Council
(A Cooperative Organization Sponsored Jointly by the Virginia
Department of Highways and the University of Virginia)

February 1973
VHRC 72-R27

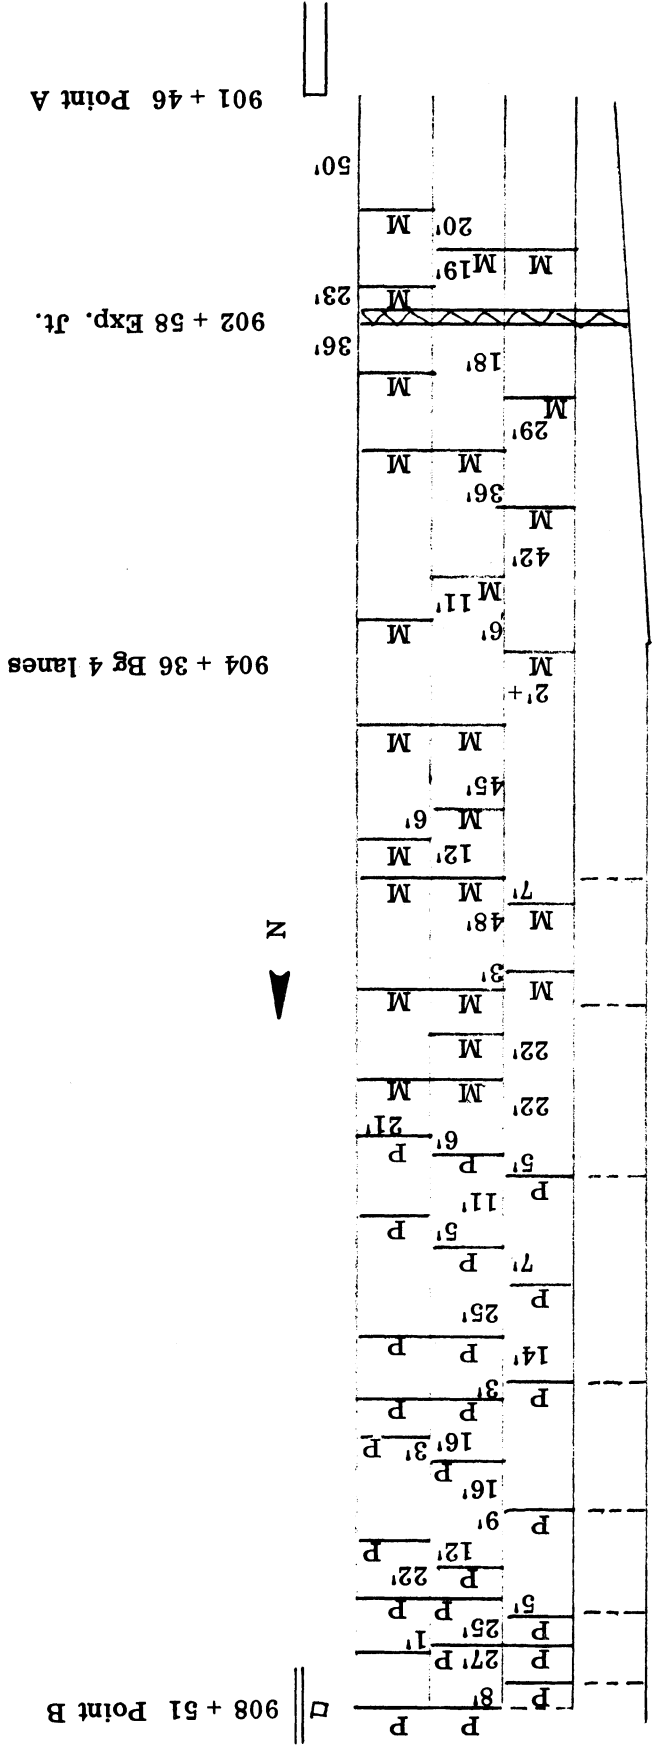
Figure 5. Site #4 - Southbound I-95. (Not to scale.)

M indicates crack covered with Monsanto. Total = 25

P indicates crack covered with Petromat. Total = 25.

Dashed line indicates uncovered crack. Total = 8.

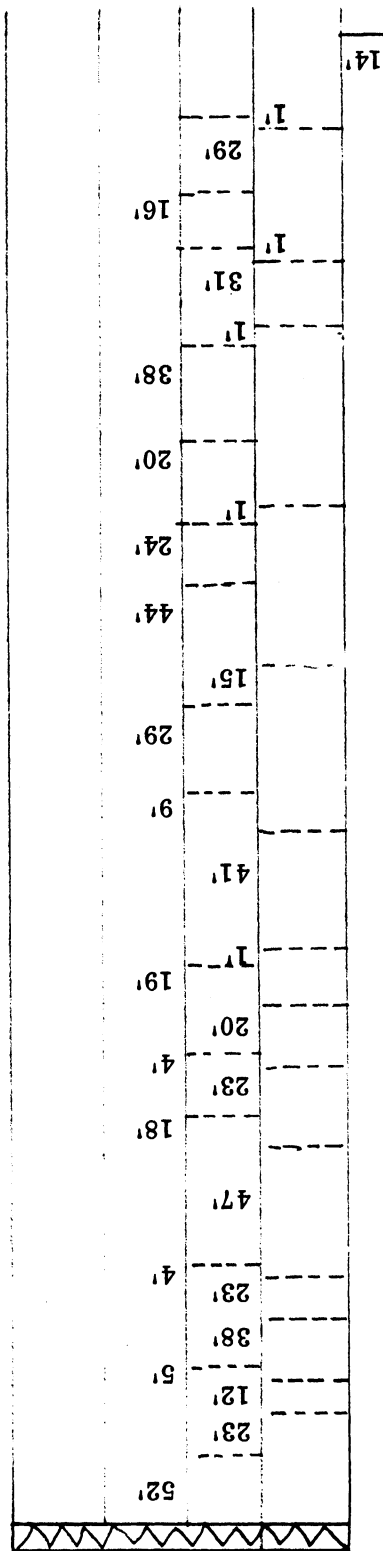
Figure 6. Site #5 - Southbound I-95. (Not to scale.)

Dashed line indicates uncovered crack. Total cracks = 29
