DEMONSTRATION PROJECT NO. 37

Use of Discarded Tires in Highway Construction

October 1980
VHTRC 81-R24

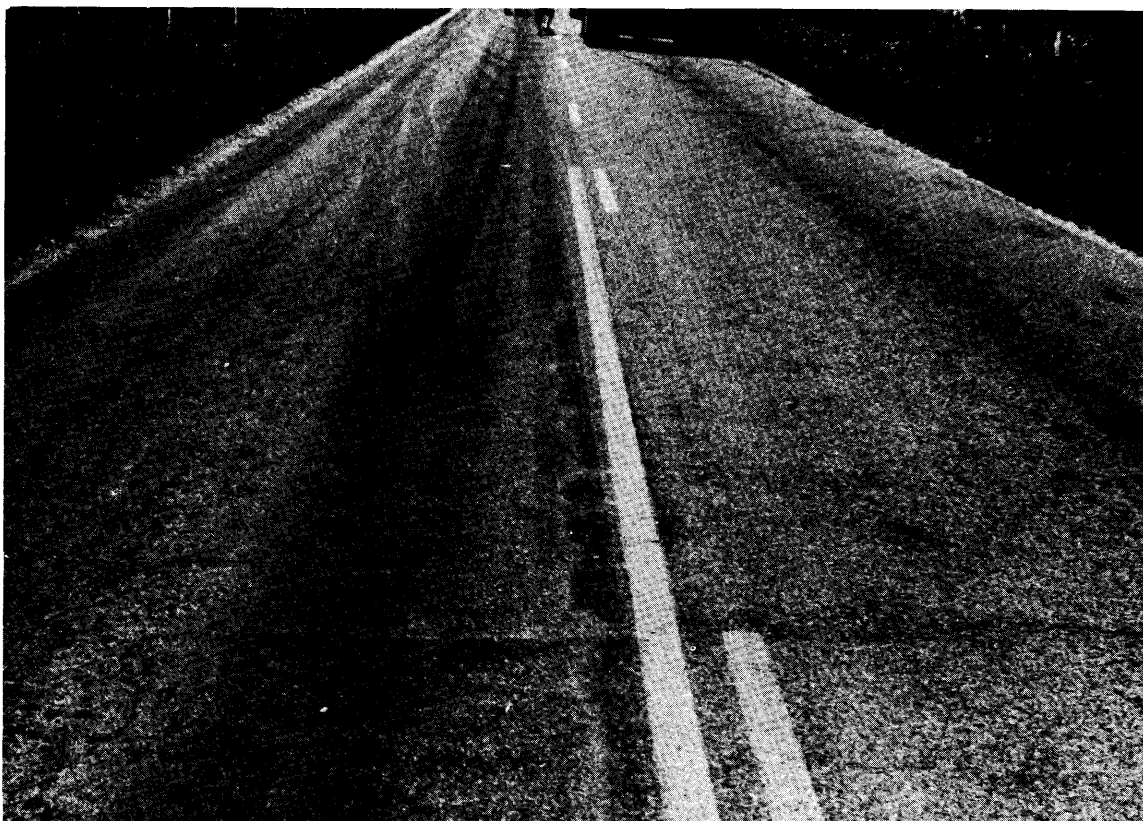
The first 0.15 mile of Route 684 after leaving Route 1 was not treated. Figures 1 and 2 are photographs of this untreated pavement. It can be seen in Figure 1 that the eastbound (loaded truck) lane, on the left in the photograph, showed cracking and distortion in 1978. Figure 2, a photograph taken two years later, shows how much the condition worsened.

Figure 1. Untreated pavement in August 1978.

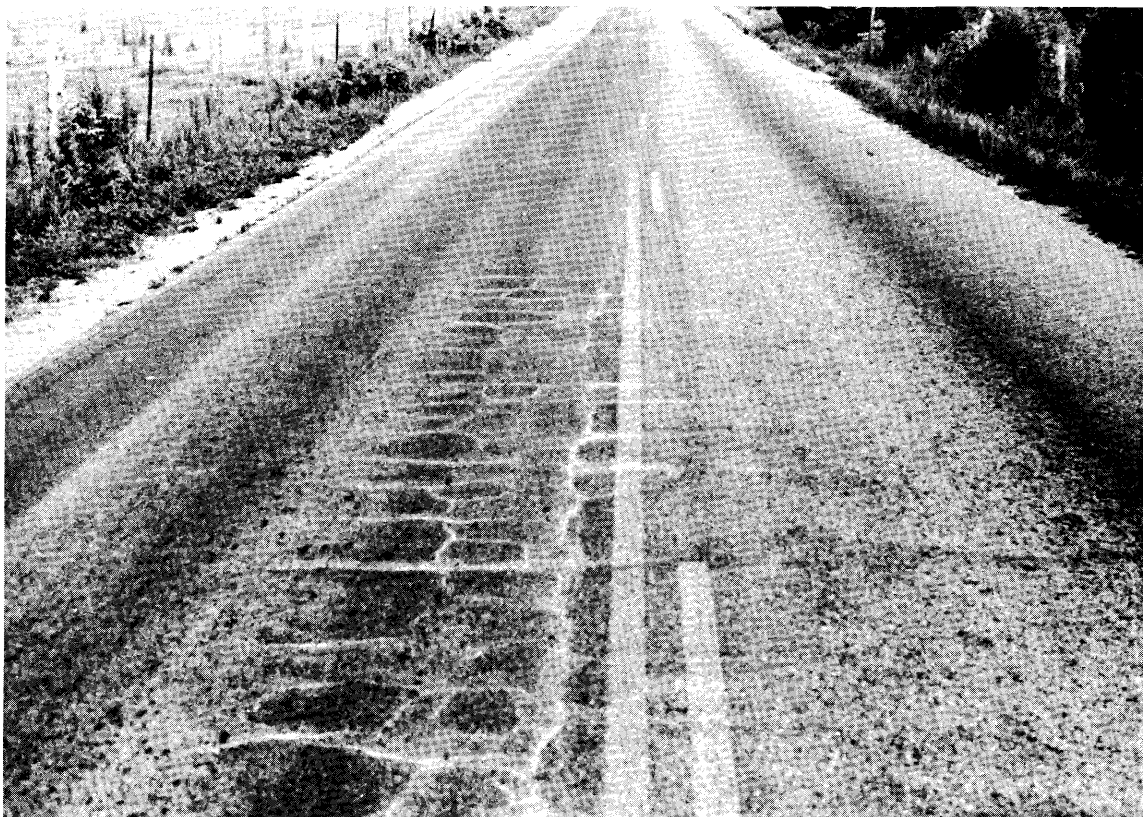
Figure 2. Same untreated pavement in August 1980.

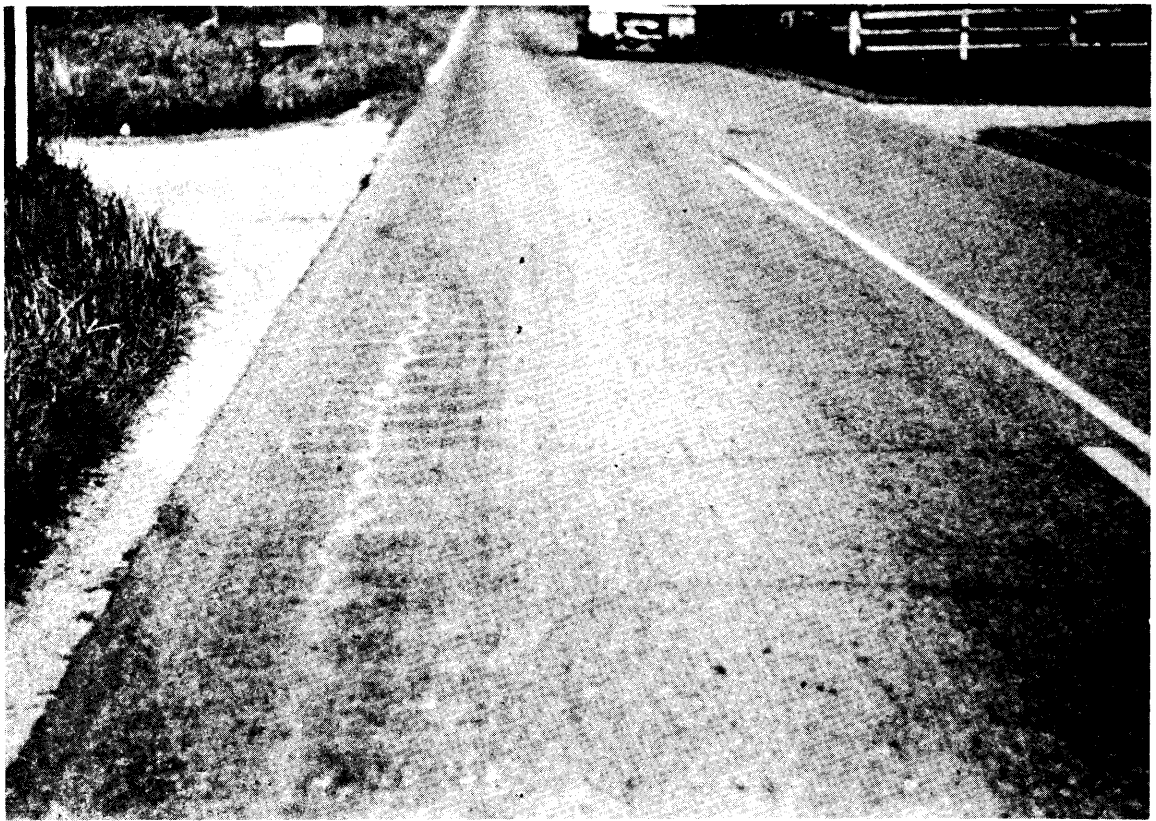
Figures 3 and 4 are photographs of the eastbound lane in an area covered by the rubberized asphalt treatment. While it can be seen that the edge of the pavement was skin patched sometime during the two years between the times the pavement was photographed, it is obvious that the surface treatment arrested the cracking.

Figure 3. Pavement before treatment in August 1978.

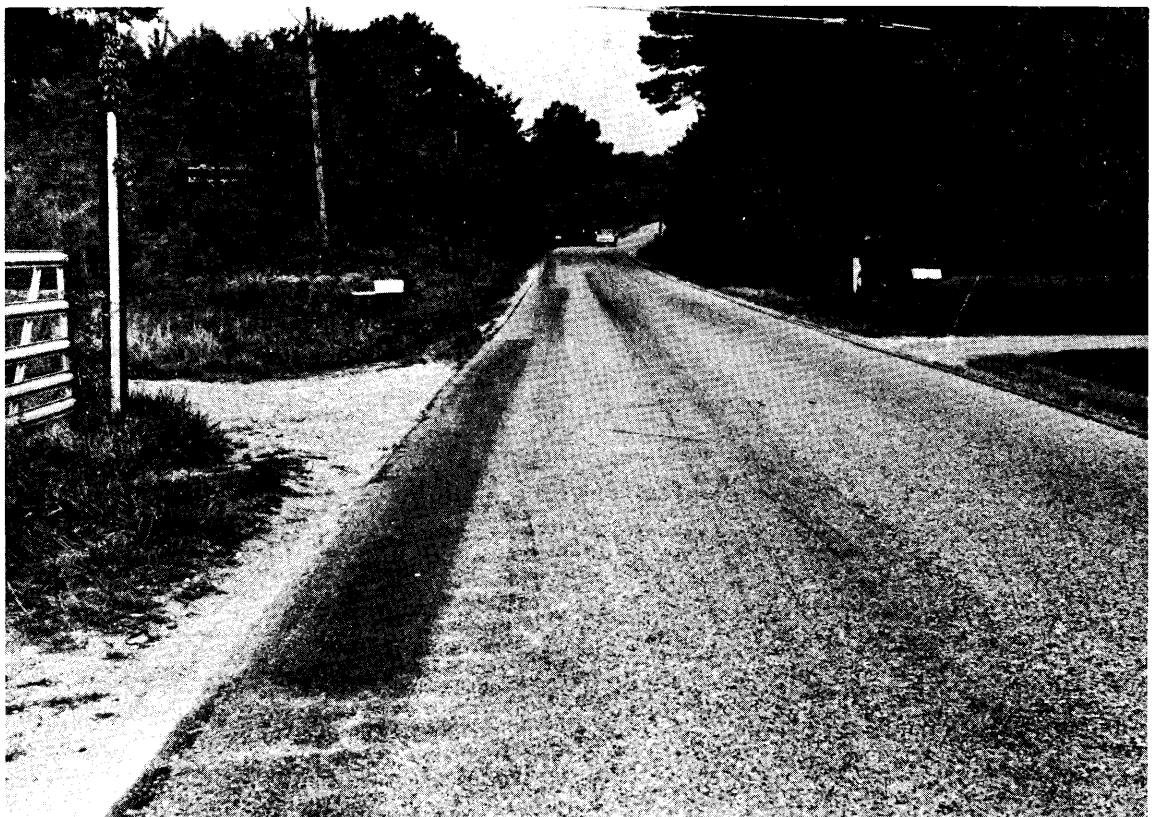
Figure 4. Same pavement two years after surface treatment.

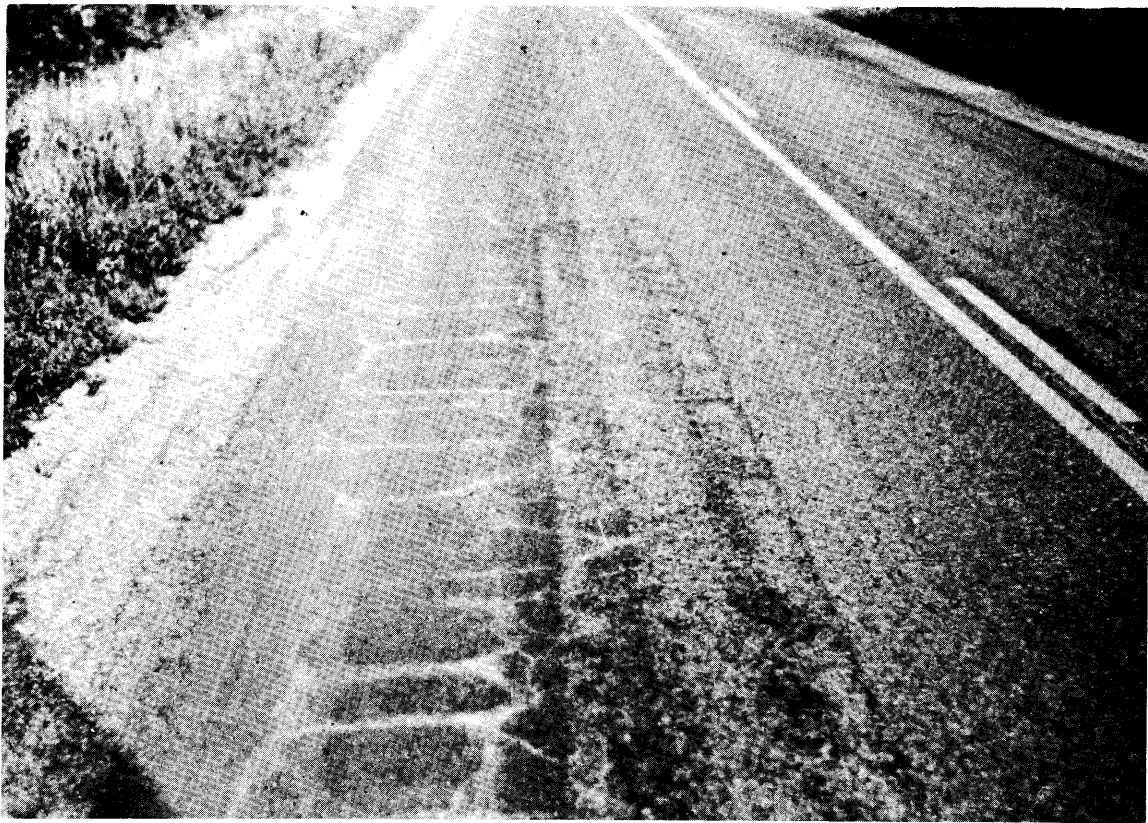
Figures 5 and 6, also photographs of the eastbound lane, vividly show the effectiveness of the surface treatment in sealing cracks and arresting deterioration.

Figure 5. Before rubberized surface treatment in August 1978.

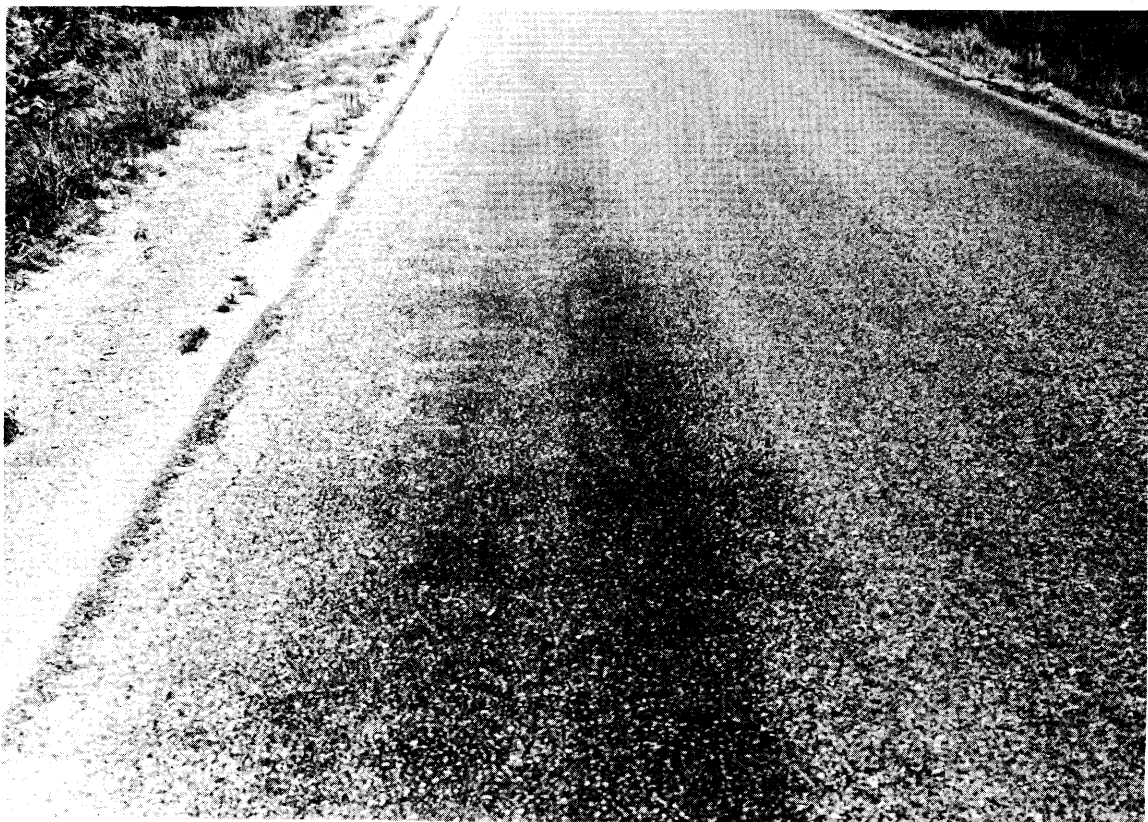
Figure 6. Same pavement two years after surface treatment.

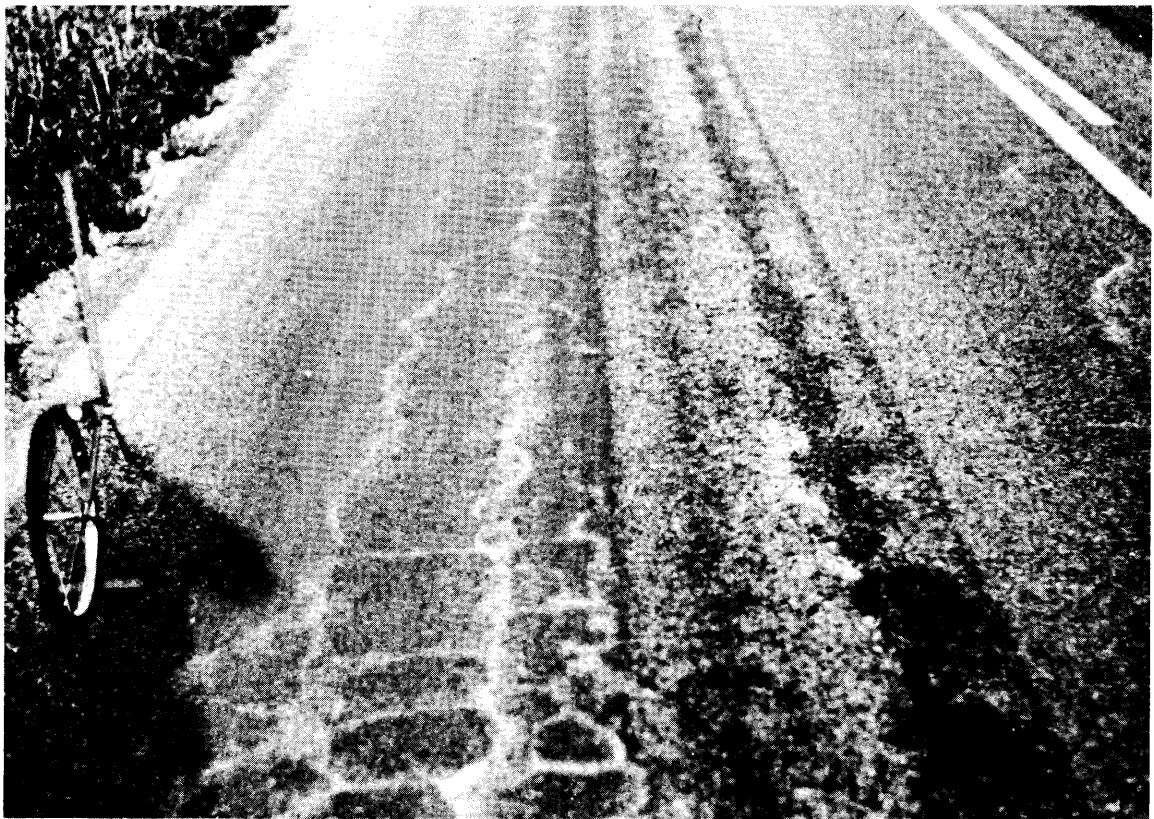
Similar examples are shown in the pairs of photographs in Figures 7 and 8, 9 and 10, and 11 and 12. These photographs clearly show that the rubberized asphalt treatment effectively arrested the pavement cracking and partially healed the pavement distortion. The mechanism by which the distorted areas were partially healed is not known. It is speculated that the treatment sealed the surface to prevent the entry of moisture into the base, while the moisture already present was sufficient to permit gradual compaction and rearrangement of the base by traffic.

Figure 7. Pavement section before surface treatment in August 1978.

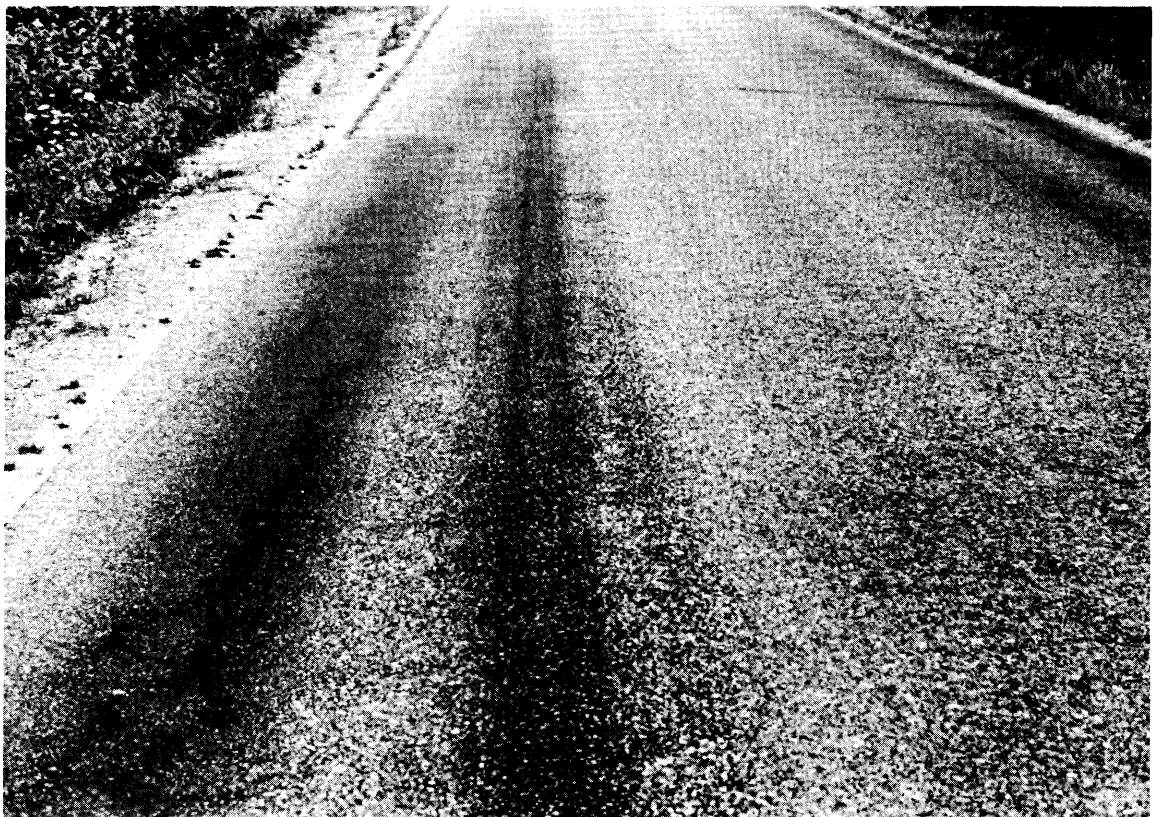
Figure 8. Same pavement two years after treatment.

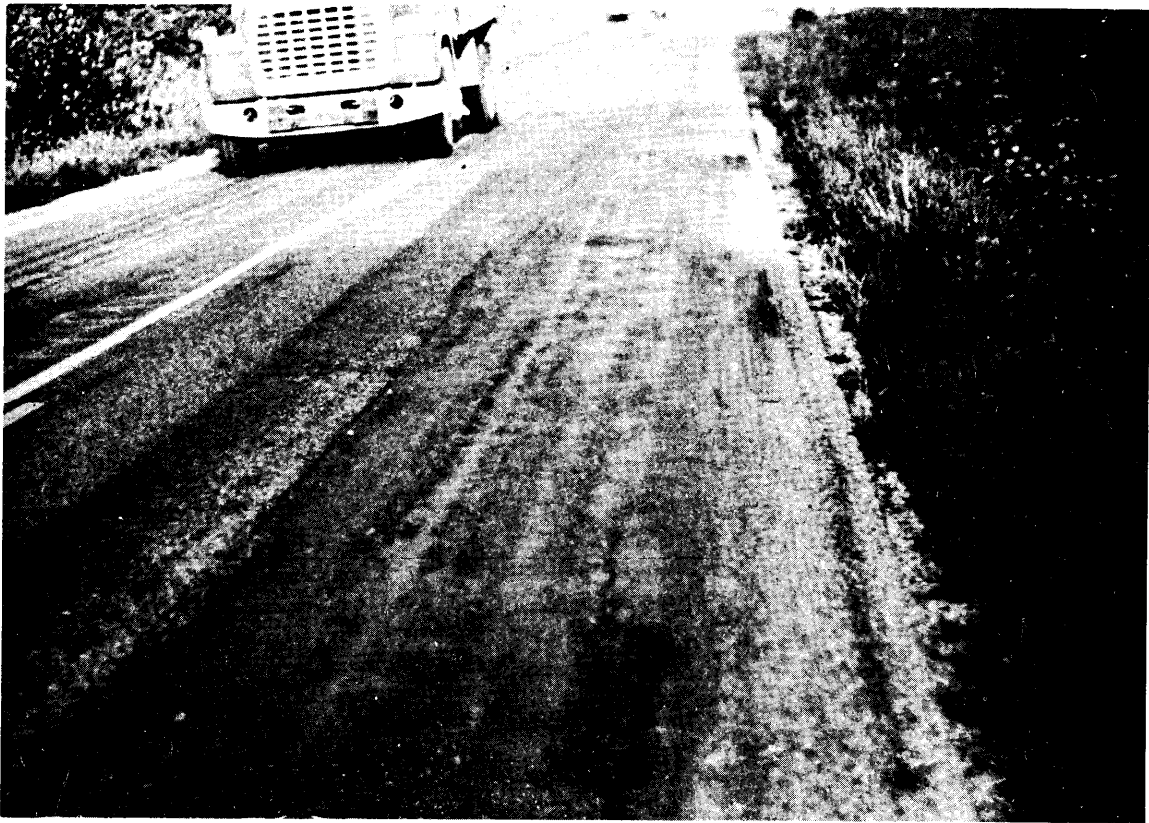
Figure 9. Before treatment in August 1978.

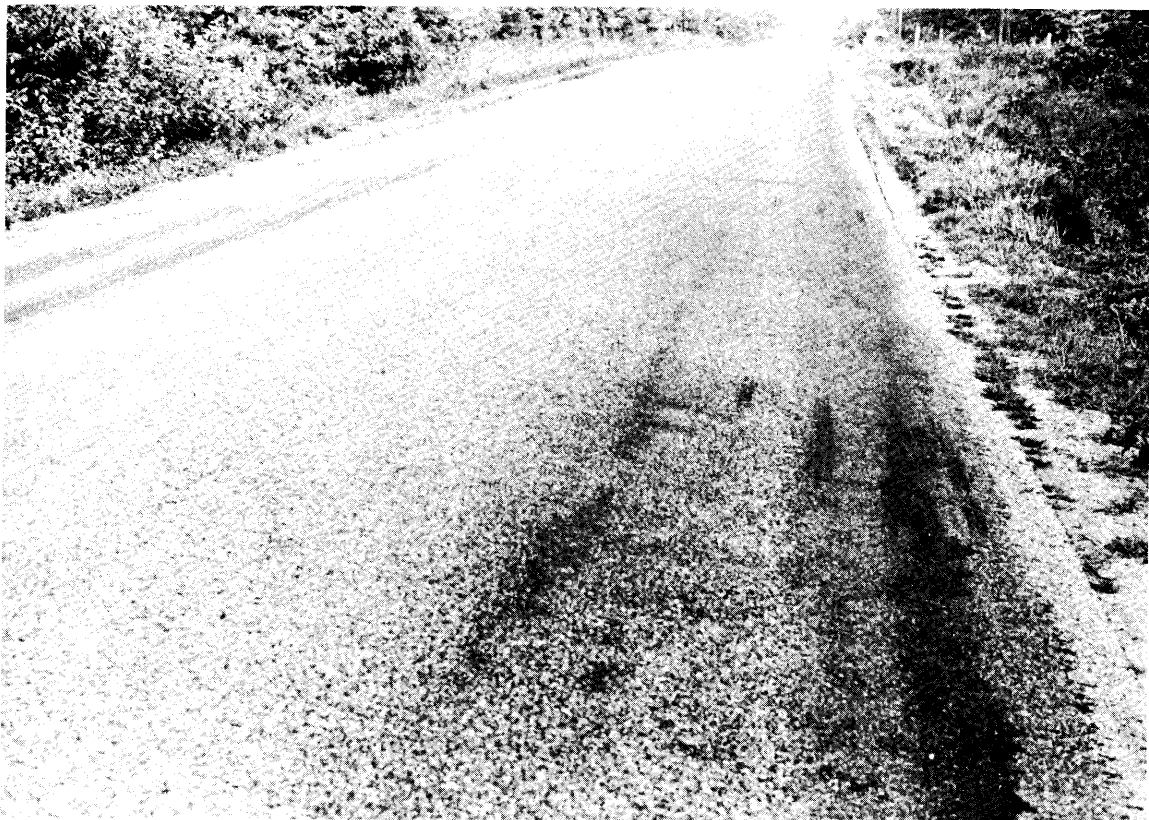
Figure 10. Two years later.

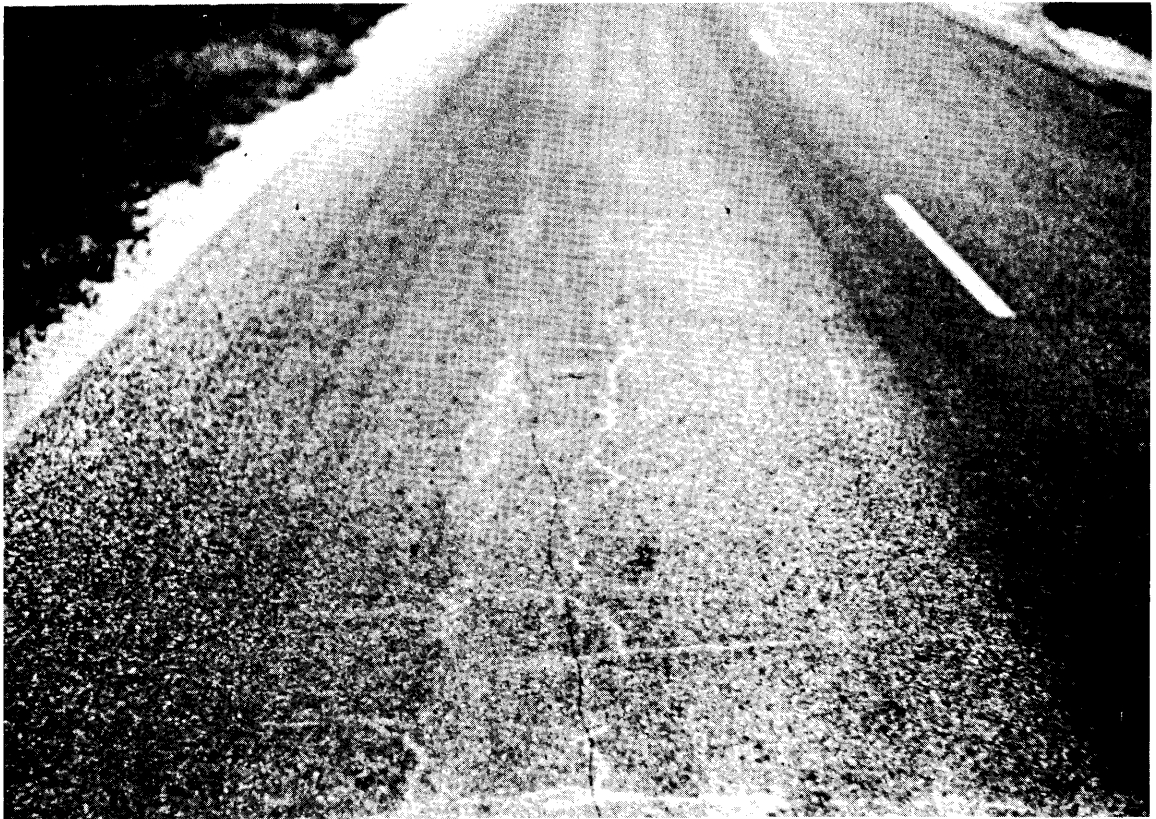
Figure 11. Before treatment in August 1978.

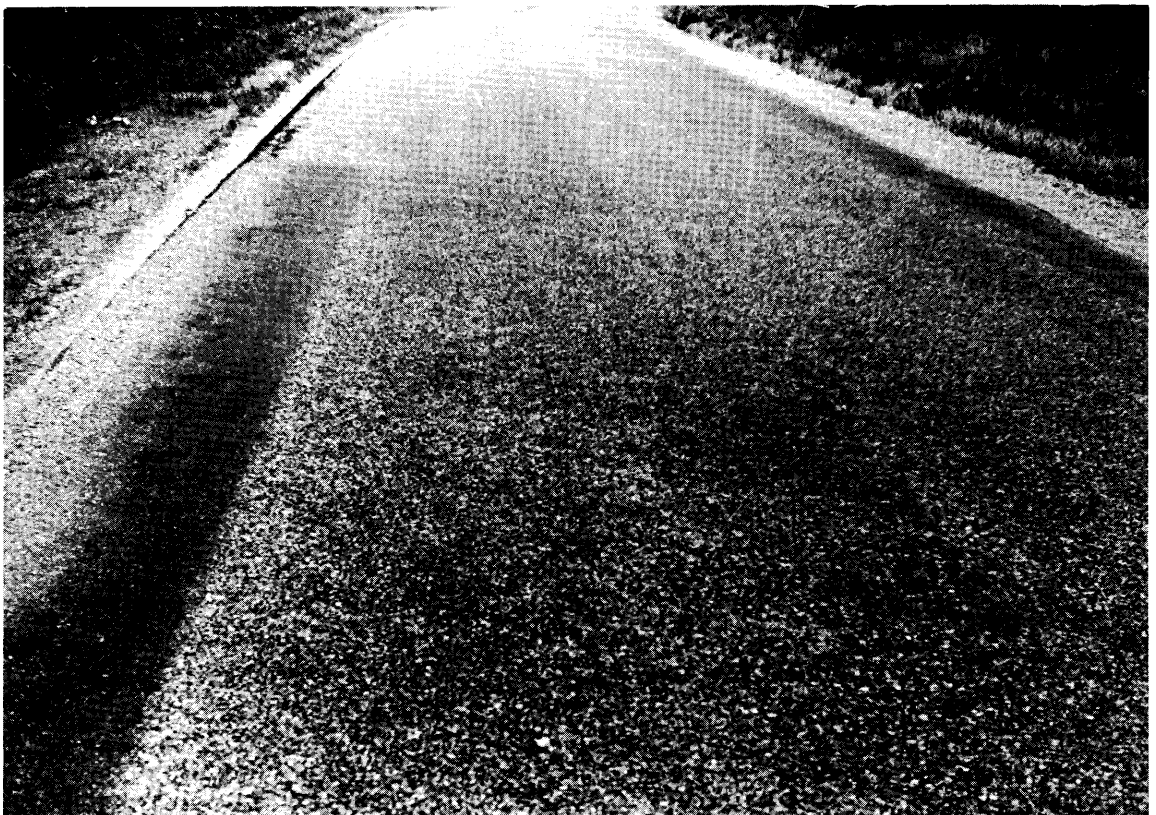
Figure 12. Two years later.

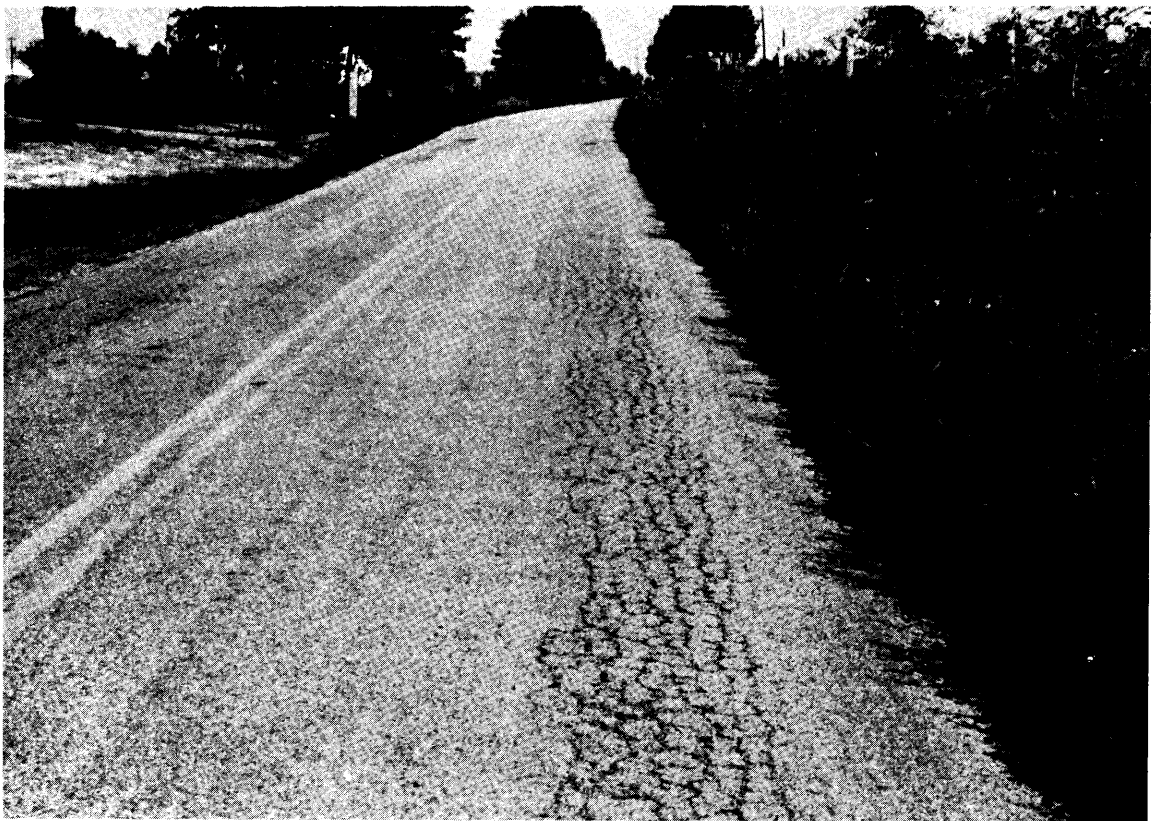
As previously mentioned, at the site of the experiment, Route 738 is a lower class road than Route 684. It has a lot of curves and a poor cross section, and is shaded a great deal of the time. These conditions, coupled with the fact that the rubberized binder is more viscous than regular asphalt, led to the loss of a great deal of the cover stone. Since the viscosity of the binder in shaded areas rises more rapidly than that of the binder subjected to the sun's rays, it would be prudent to employ special precautions when using the rubberized binder in the shade. Figures 13 and 14 are photographs of an area before treatment and two years afterwards. The type of cracking is different from that shown in the photographs of Route 684, but the treatment was just as effective, even with the loss of cover stone. Mention should be made that although much of the cover stone was lost from this road within several days, the rubberized asphalt did not flow and become tacky as regular asphalt does, even in the very hot weather.

Figure 13. Before treatment in August 1978.

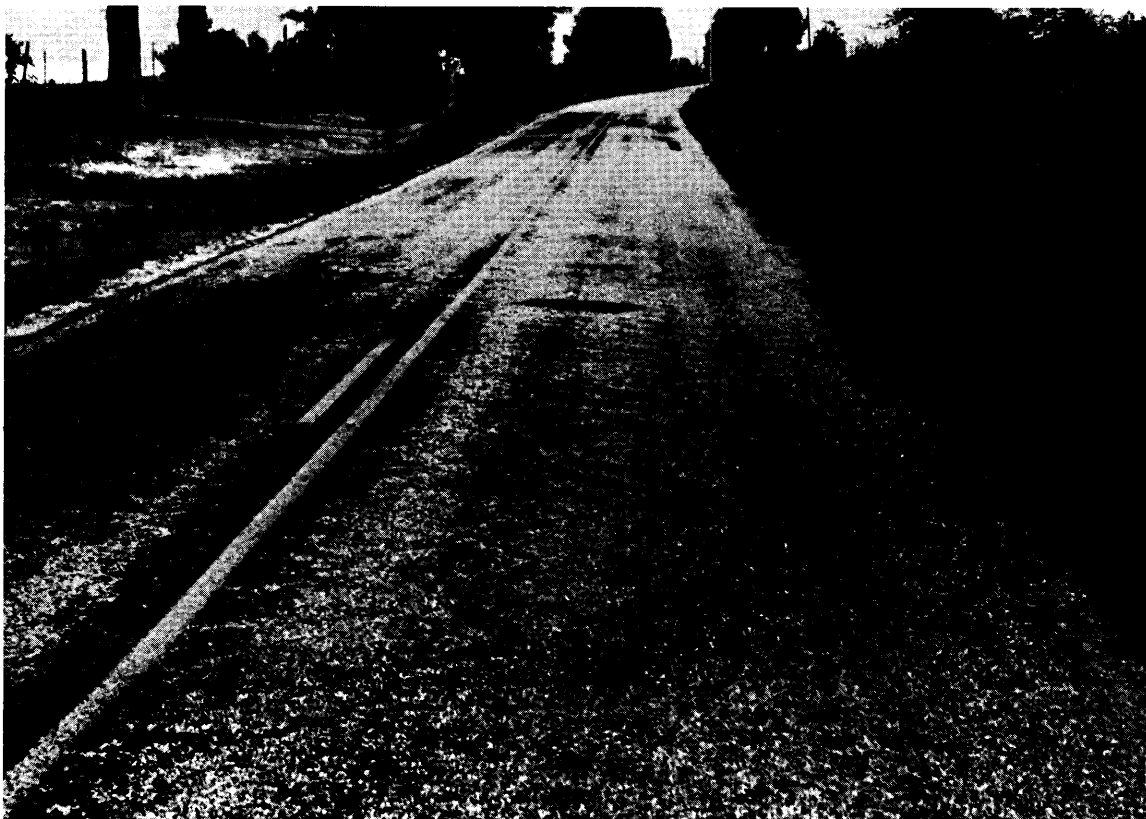
Figure 14. Two years afterwards.

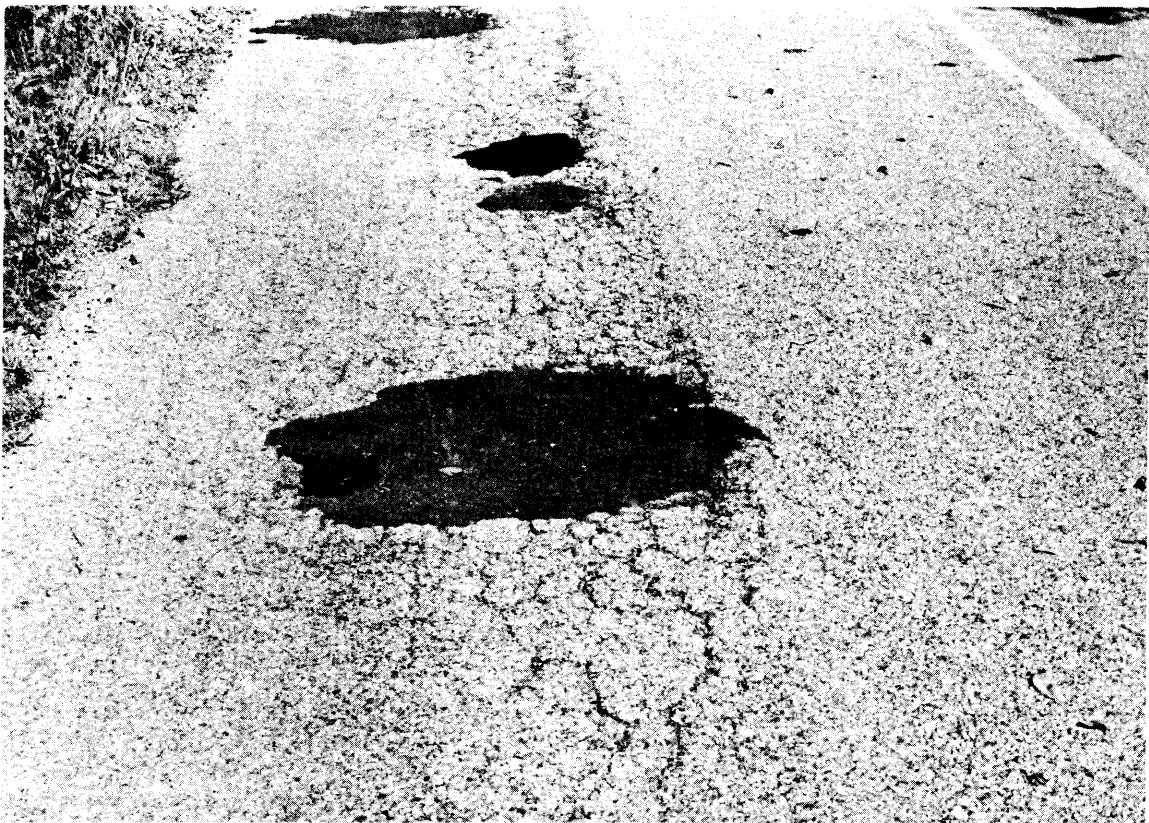
Figures 15 and 16 also show the effectiveness of the binder in sealing cracks.

Figure 15. Before treatment in August 1978.

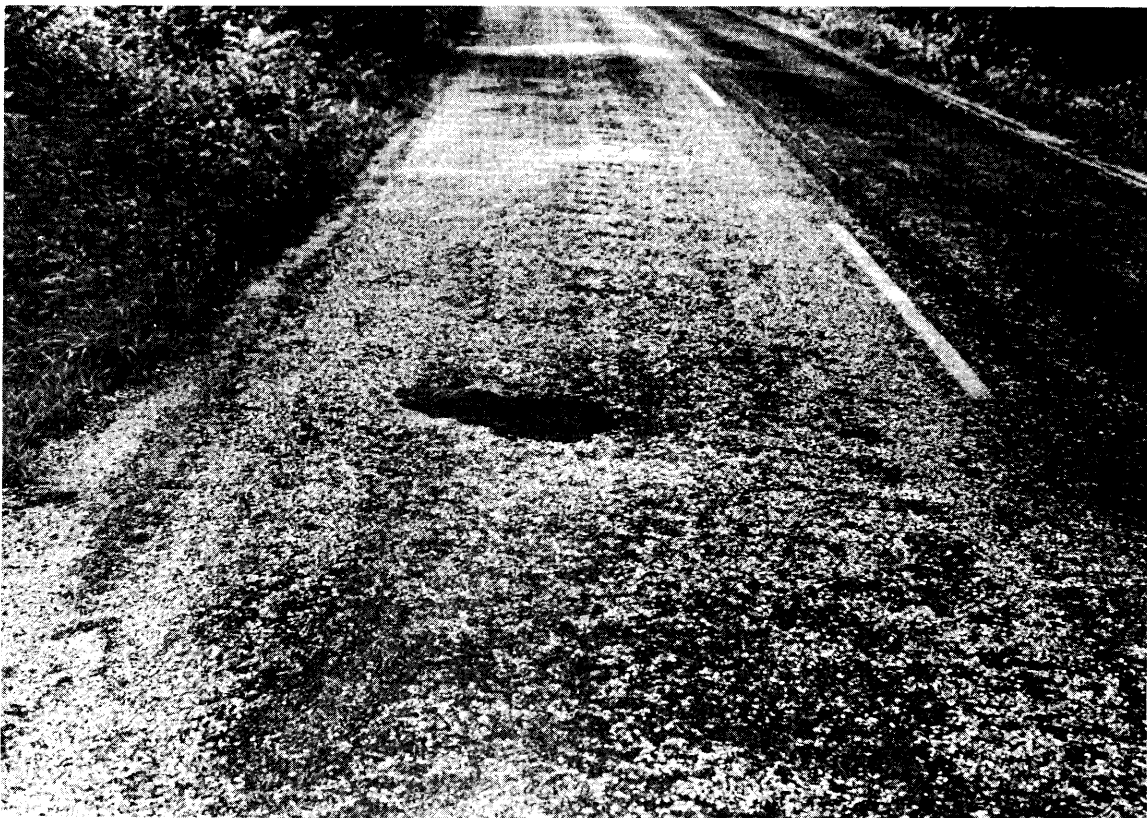
Figure 16. Two years afterwards.
