MEMORANDUM REPORT

AN EVALUATION OF TWO BRIDGE DECK OVERLAY
SYSTEMS ON THE RTE. 85 BRIDGES OVER THE ROANOKE RIVER

October 1971
VHRC 71-R11

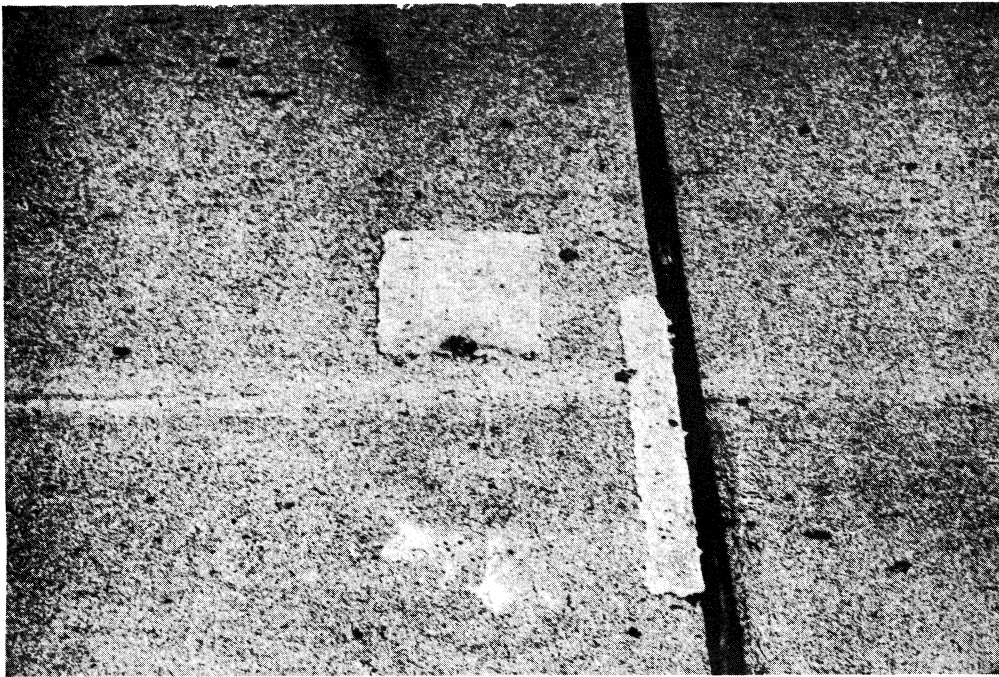
After the first winter, the epoxy overlay performed satisfactorily; but by the fall of 1970 signs of impending failure were apparent. Failures in the bond between the deck and the overlay occurred at several locations during the latter part of 1970 — requiring patches of from less than one square foot to several square feet in area (Figure 1). Since all material necessary for repairs was to be supplied by the Shell Oil Company for a period of two years, a field inspection was held in April 1971. Additional patching, which was required at a half dozen locations, was installed several weeks after the field inspection. Subsequently, on

Figure 1. Typical areas requiring patches after slightly more than a year's service. (Guardkote 250 epoxy mortar overlay, SBL Rte. 85 bridge over the Roanoke River.)

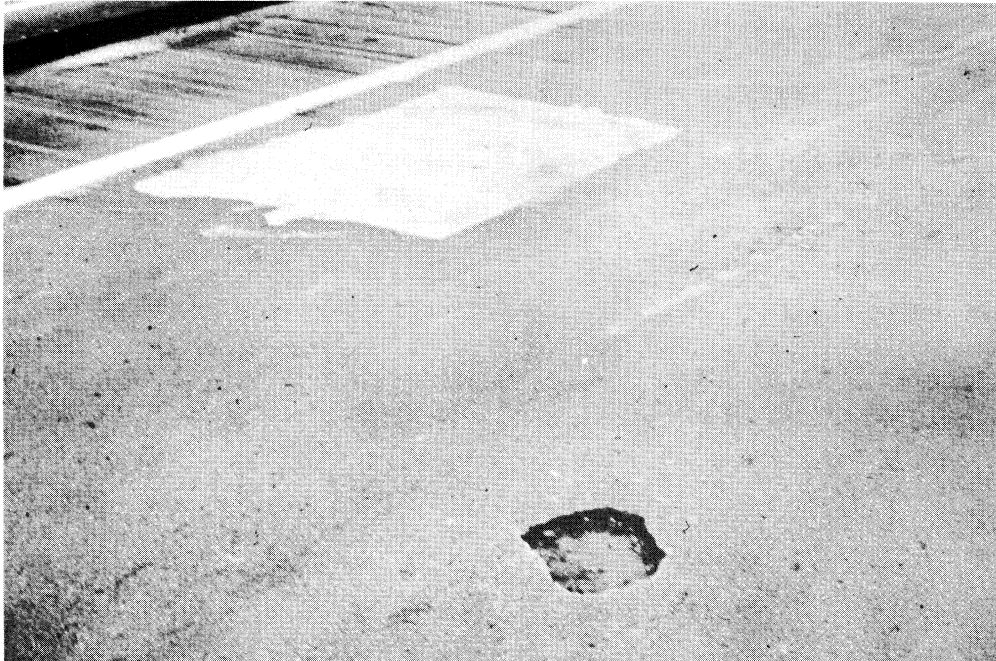
September 21, a new failure on one span was noted as shown in Figure 2. Several other spans have small areas where failure in bond has occurred but the unbonded area has not broken out from the overlay. It is apparent that the overlay will be a continuous maintenance problem.

Figure 2. A failure (foreground) which developed three months after the repair shown in the background. (Guardkote 250 epoxy mortar overlay after two years' service, SBL, Rte. 85 bridge over the Roanoke River.)

1. The Guardkote 250 epoxy mortar overlay as used for bridge deck repairs is a failure and no further use of the material is recommended.
2. While the performance of the SM-100 latex modified mortar has been satisfactory to date, it is recommended that widespread use of the material for repairing bridge decks await the outcome of a laboratory analysis of sample cores to be taken from the study overlay. In the interim, where urgent repairs of deteriorated bridge decks are necessary, a latex mortar overlay is a better alternative than a Guardkote 250 epoxy mortar overlay.

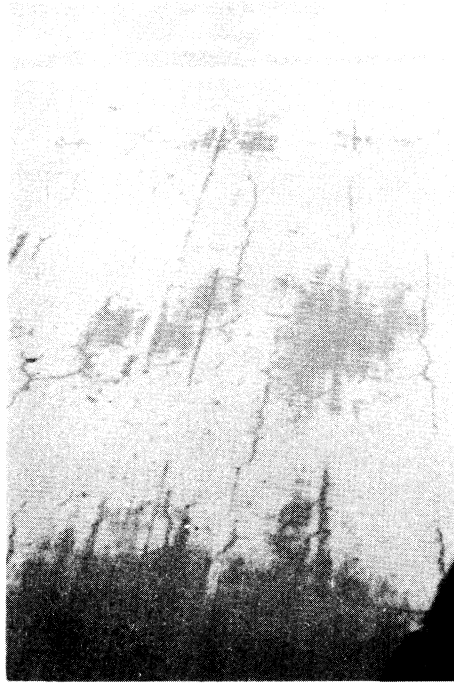
After two years of service the DOW SM-100 overlay is performing satisfactorily. No failures in bond to the concrete deck have been observed to date and no maintenance repair work has been required. A network of hairline cracks, however, has developed throughout the overlay. As shown in Figure 3, the crack patterns can be easily detected as water evaporates from a wetted deck surface. The cracking is the most extensive in the transverse direction; but shorter length longitudinal cracking, propagating outward from the transverse cracks, is present also. The longitudinal cracking is more random and of shorter length than the transverse cracking, but often spans the distance between transverse cracks. While in some areas the cracking is beginning to resemble a fine pattern type cracking, it can best be described at this time as fine transverse cracking as defined and illustrated in the ACI guide for concrete condition surveys⁶.

Figure 3. Typical fine transverse cracking in the DOW SM-100 latex modified mortar overlay. (NBL Interstate Rte. 85 bridge over the Roanoke River.)

was not considered to be detrimental to the bond between the old concrete and the latex mortar, but an evaluation of the long-term durability of the overlays had not been made. While bond does not appear to be a problem on the Rte. 85 NBL study bridge at this time, the origin, degree, and effects of the cracking should be investigated further. Accordingly, sample cores will be taken from some randomly selected cracked and non-cracked areas of the deck and examined petrographically in the laboratory.
