AN INVESTIGATION OF STREAKING ON HIGHWAY TRAFFIC SIGNS

R. N. Robertson
Highway Research Engineer

Virginia Highway Research Council
(A Cooperative Organization Sponsored Jointly by the Virginia
Department of Highways and the University of Virginia)

May 1974
VHRC 73-R48

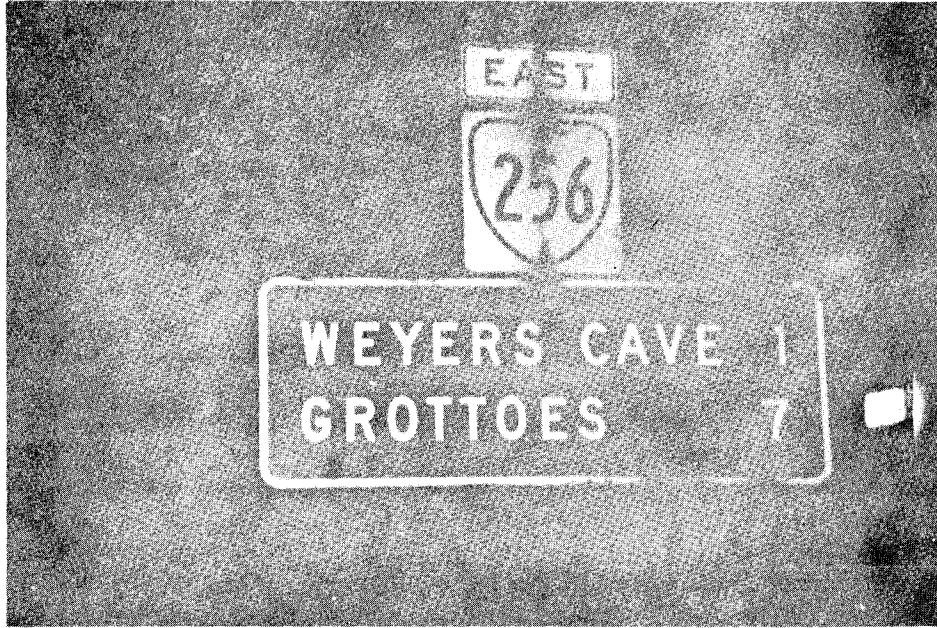
For a sign to be effective, it should not only be properly installed, but it must be legible at all times. The Virginia Department of Highways requires that all signs be inspected at least twice a year to make certain they are kept in proper position, clean, and legible. During a nighttime sign inspection, dark streaks were observed on the faces of many reflectorized signs. Generally, the streaks were in line with the bolts that secured the signs to the posts. The streaks adversely affected the retroreflective characteristics of the reflective material, thereby reducing the brightness of the sign as shown in Figure 1. During daylight, the streaks were not visible (Figure 2).

Figure 1. Streaked sign — nighttime.

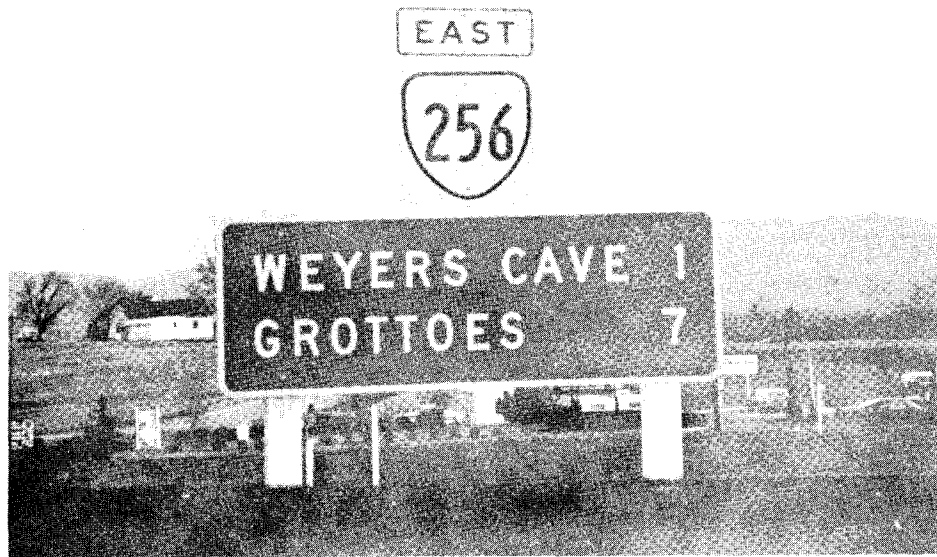
Figure 2. Streaked sign — daytime.

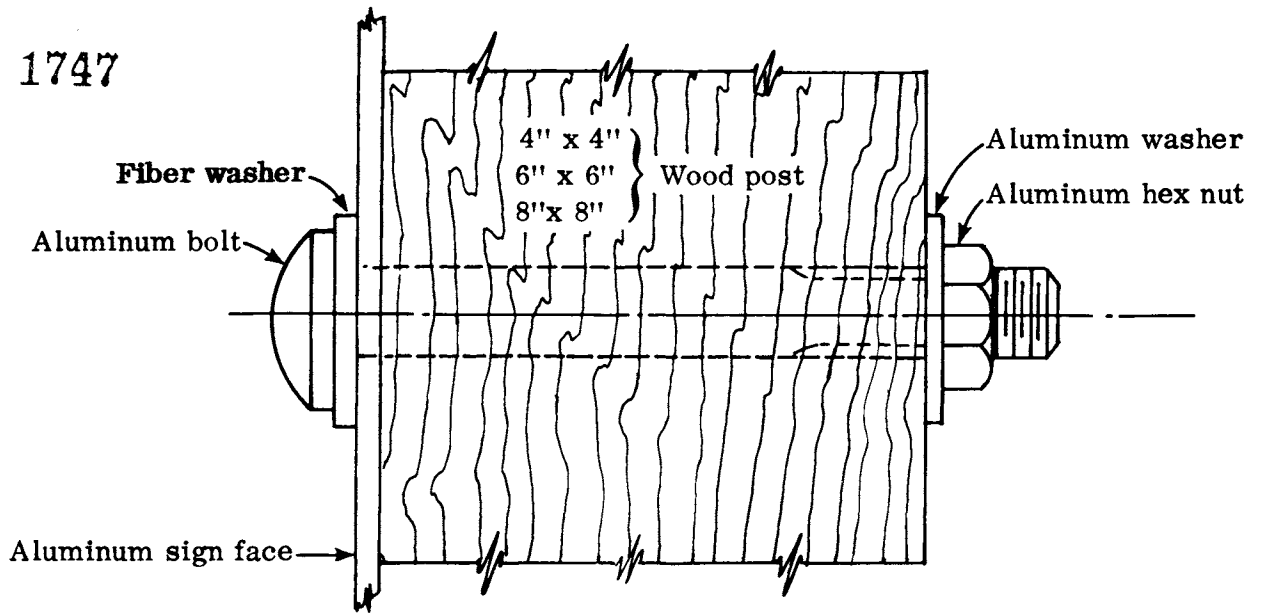
Figure 4. Sign attachment details.

Preliminary investigations indicated that the streaks were caused by a residue from the painted posts and/or the mounting hardware. All test signs, except the Route 687 sign, were mounted to the wooden posts with aluminum bolts and nuts, with fiber washers installed between the bolt heads and faces of the signs. The attachment details are shown in Figure 4.

Field observations revealed the fiber washer had deteriorated and thus the sign panel was not attached firmly against the post. However, the washers were determined not to be a source of the streaks as they were not used on the streaked Route 687 sign. Through an elimination process, the cause of the streaks was traced to the paint on the post, and the 3M Company agreed to conduct a chemical analysis of the paint residue on the test signs.

1. The streaks were caused by a residue of titanium dioxide, the white pigment in paint, which was transported down the sign face by rain. The deposit reduced the reflective characteristics of the sheeting and thereby adversely affected the brightness of the sign.
2. The fiber washers used between the bolt heads and the sign face deteriorated with age. This allowed the sign panel to come loose from the post and thus, provided an opening through which the titanium dioxide residue was transported to the sign face.

1. It is recommended that the use of fiber washers be discontinued. The deterioration of these washers contributes to the streaking problem. It is suggested that instead the Department use washers made from a non-biodegradable material, such as the nylon washers supplied with high intensity reflective sheeting. Furthermore, nylon washers may be used universally as they do not create a chemical reaction with either galvanized steel, aluminum, or paint.
2. Although the paints (oil base and latex) used by the Department are acceptable, an evaluation should be conducted to determine which one has the superior performance characteristics. In recent years latex paints have increased in popularity, however, there are no data to substantiate their effectiveness on signposts.

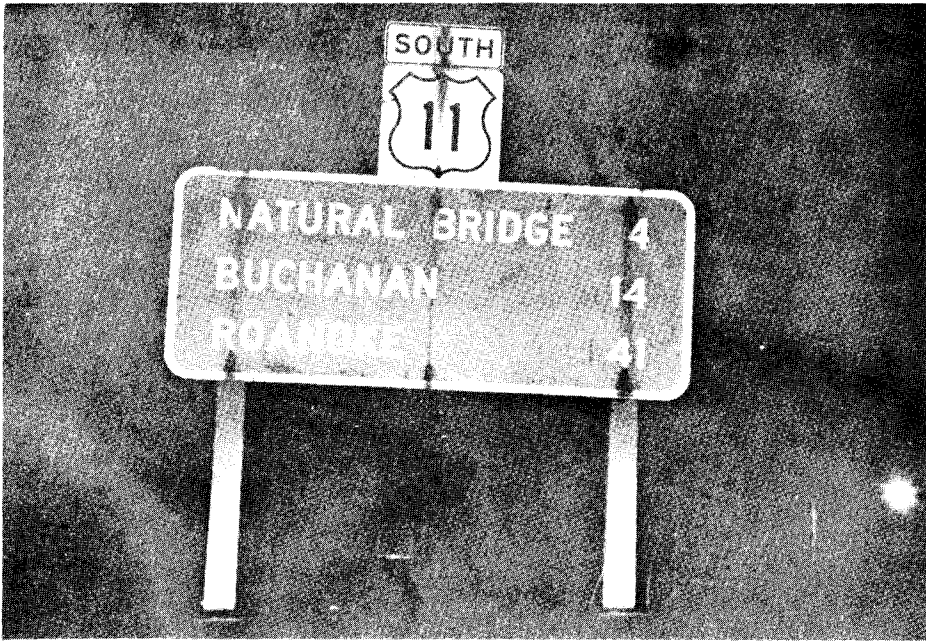
Figure 6. Test sign — "original" condition.

A comparison of Figures 6 and 7 reveals that washing did not improve the appearance of the sign (center section), however, the clear coating removed the streaks and restored the reflectivity (left section).

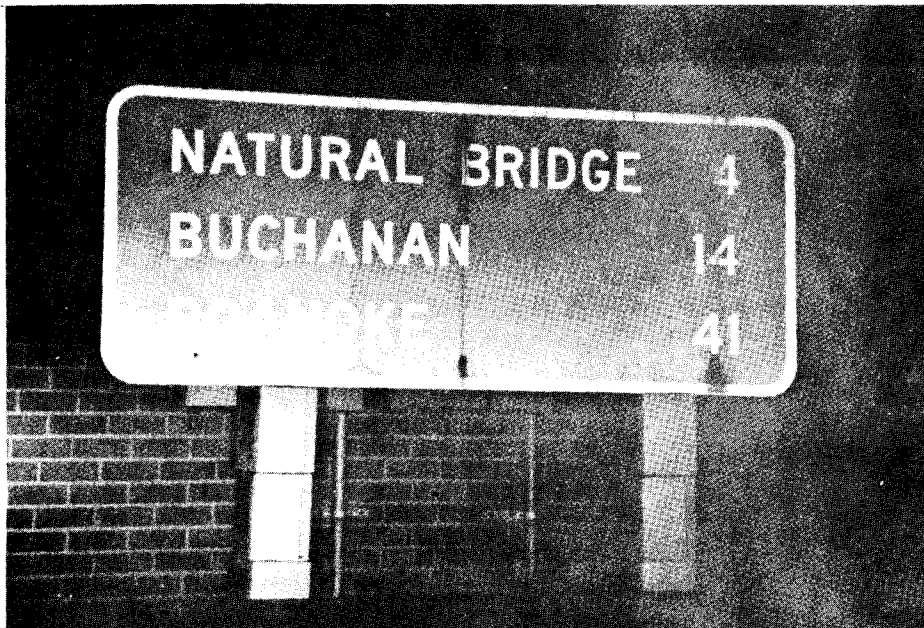
Figure 7. Test sign — "after" condition.

As shown in Table 1, there was a statistical difference in the retroreflective characteristics of the clear coated section of the sign when compared to the original condition; however, washing did not "statistically" restore the brightness.

3. In order to remove the streaks and restore the brightness, it is recommended that the existing signs be clear coated in accordance with the reflective sheeting manufacturer's instructions.

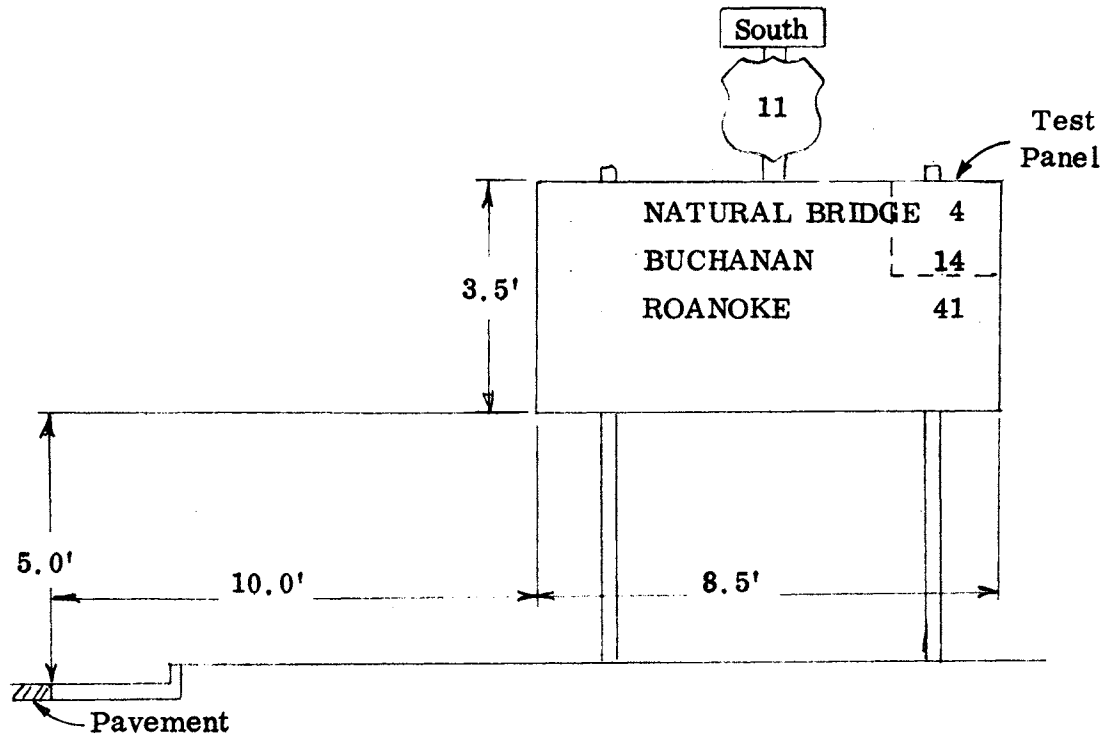
TEST SIGN NUMBER 1

Mounting — On wooden post with aluminum bolts and nuts and fiber washers.

Characteristics — Dark streaks showed on the sign in line with the bolts during nighttime. These streaks were not visible during the day.

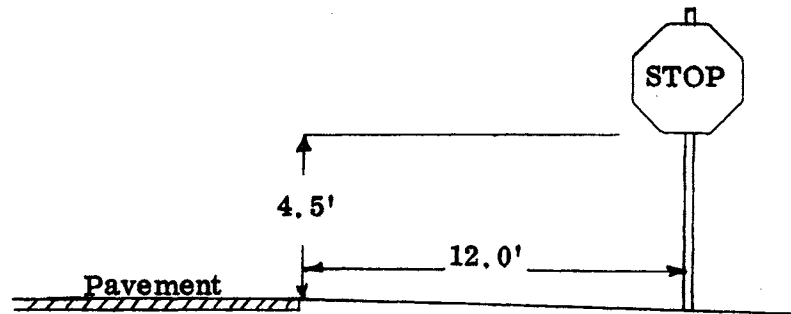
TEST SIGN NUMBER 2

Mounting — On wooden post with aluminum bolts and nuts and fiber washers.

Characteristics — A dark streak showed on the sign in line with the bolts during the hours of darkness. During the day it was not visible except for a small spot under the lower bolt where the transparent red paint had deteriorated.

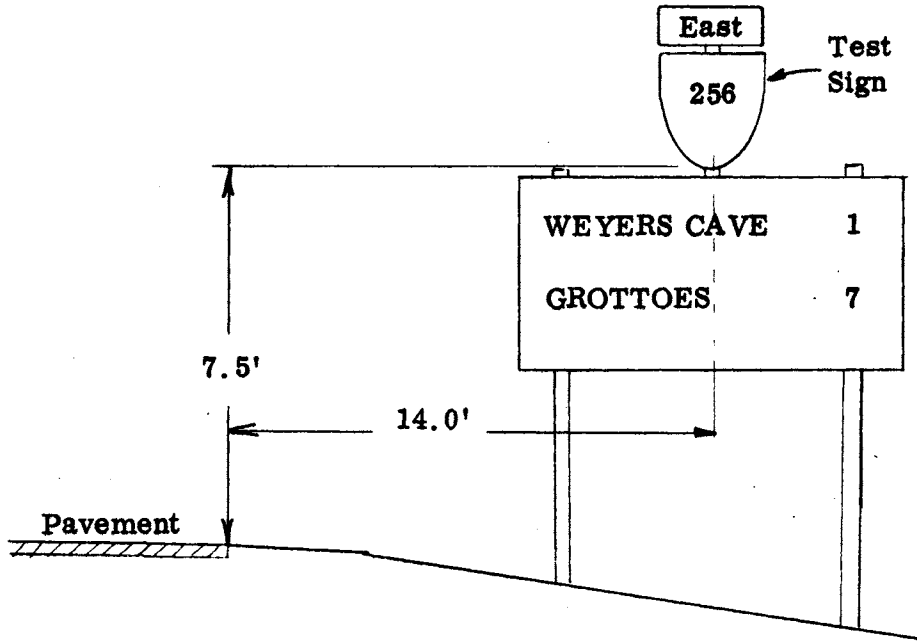
Mounting — On wooden post with aluminum bolts and nuts and fiber washers.

Characteristics — A dark streak showed on the sign in line with the bolts during the hours of darkness. However, during the day the streak was not visible.

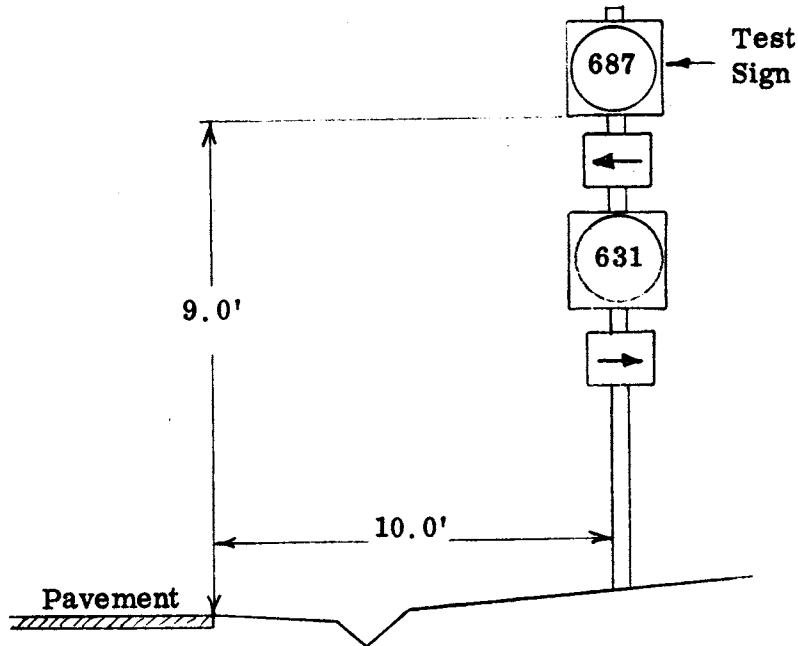
TEST SIGN NUMBER 4

Mounting — On wooden post with galvanized lag bolts (no washers).

Characteristics — During the hours of darkness there was a dark streak, approximately the width of the post, beginning at the top and continuing down the face of the sign. The streak was not visible in daylight.
