SIDEWALK UNDERMINING STUDIES

Phase III - Field and Model Studies

April 1979
VHTRC 79-R35

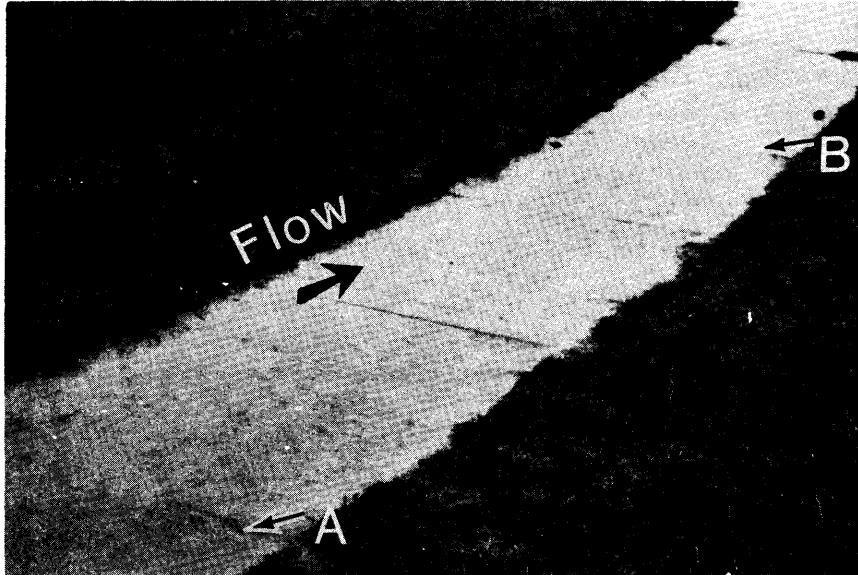
Undermining of a sidewalk typically is evidenced by dislocation of the joints and distortion or rotation of the slabs in either or both the longitudinal and transverse directions. However, undermining may be present where there is little or no distortion of the sidewalk. The severity of distortion that may materialize is exemplified in Figure 2. The soil eroded from underneath the sidewalk is usually deposited at the low point of the vertical curvature, although it may accumulate at intermittent joints or points along the edges of the sidewalk. After a heavy rainstorm soil particles are present on the sidewalk in very noticeable amounts, even though most of the eroded material is transported into the storm drain system. The soil particles on the sidewalk are an excellent indication of undermining, especially the early stages of undermining when distortion is not very evident. The depth of the voids under the sidewalks ranges from just a few inches to a couple of feet (see Figure 3).

Figure 1. Undermining of sidewalk.

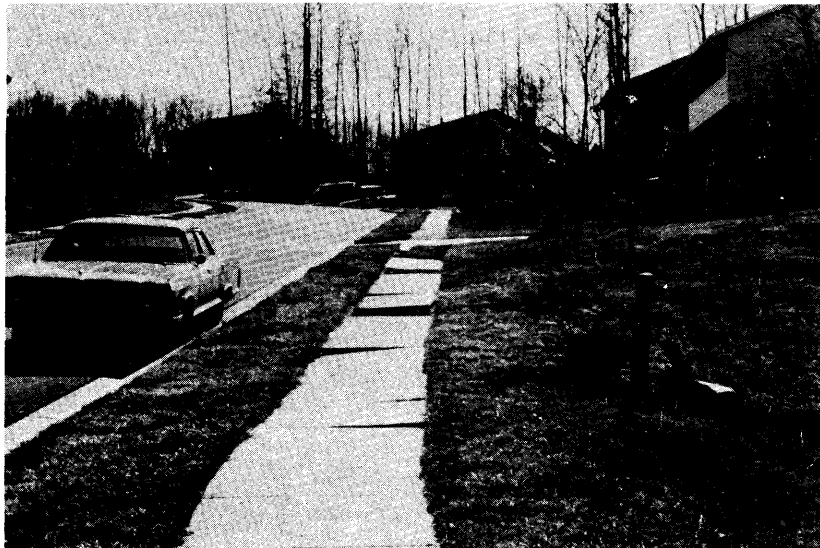
Figure 2. Severe distortion of sidewalk due to undermining.

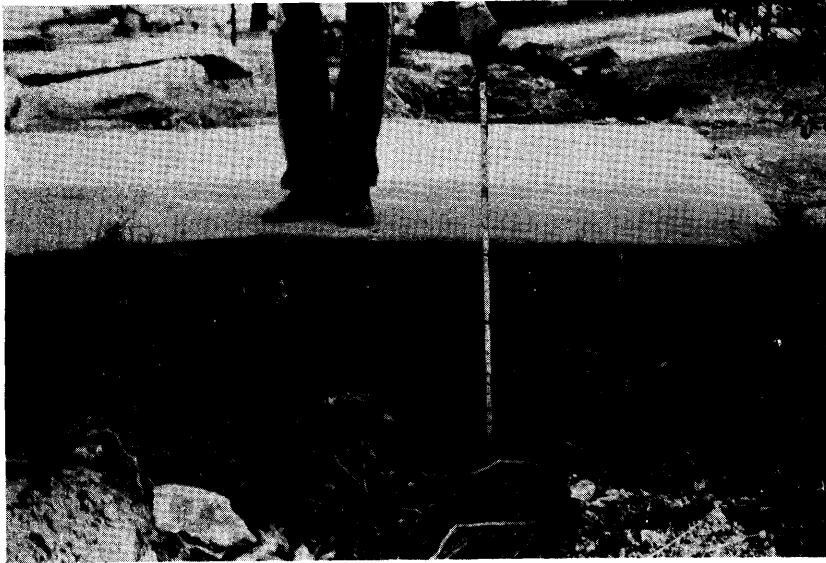
Figure 3. Severe undermining of entrance to driveway.

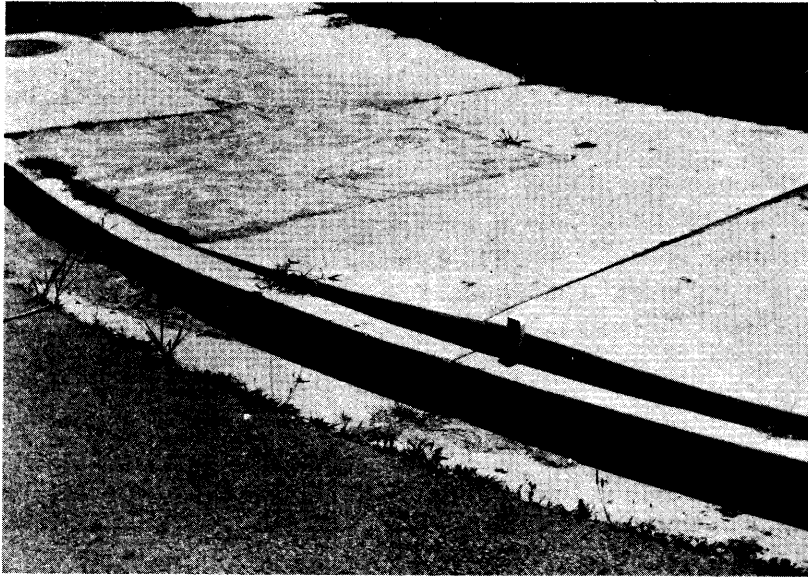
As noted before, the soil eroded from underneath a sidewalk usually is deposited at the low point of the vertical curve. In innumerable cases this low point occurs either at or near the fillet, as illustrated in Figure 12. From the photograph it is obvious that part of the soil eroded upgrade has been deposited under the fillet and forced the sidewalk slabs upward. An additional portion of the eroded soil has been washed out through an opening in the sidewalk or an opening at the interface of the sidewalk and the back face of the combination curb and gutter, as is obvious in the foreground. The remaining portion of eroded soil probably was carried to the storm sewer system. The hypothesized "blocking off" effect, which was the reason for closing off the lower end of the trough in the model, occurs because the back face of the combination curb and gutter is 330 mm (13") high while the abutting sidewalk is only 100 mm (4") deep.

Figure 12. Typical fillet of sidewalk forced upward by undermining upgrade.

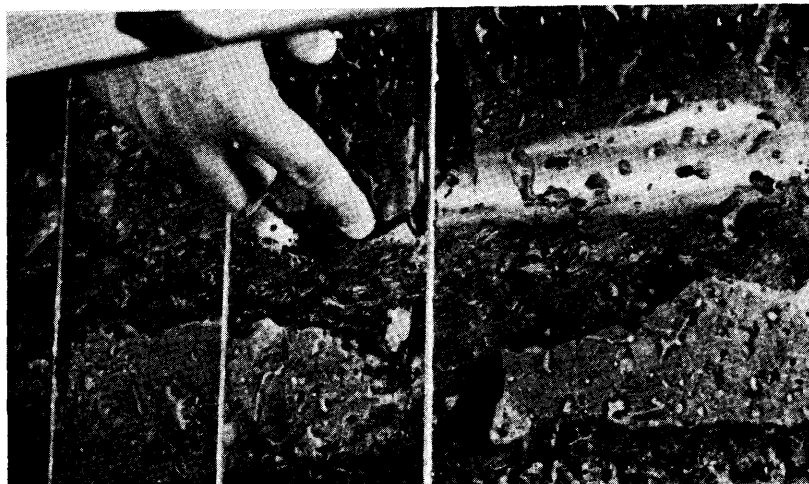
As evidenced by Figure 14, a definite erosion channel was formed underneath the plexiglass sidewalk by the initial simulated rainstorm in the tests on this control setup of the model. Observations made during this initial rainstorm were as follows:

1. The seams at abutting plexiglass slabs which simulated cracks did allow a substantial amount of water to gain entry to the underlying soil;
2. the openings in the plexiglass sidewalk allowed a large amount of water access to the subgrade soil;
3. even though care had been taken to obtain a smooth, even subgrade, the slightest imperfection of the subgrade enabled a small amount of water to flow underneath the plexiglass sidewalk at the beginning of the rainstorm, to erode the soil, and, eventually, to establish an erosion channel; and
4. until the erosion channel was established, the water seemed to "boil" at the openings in the plexiglass sidewalk and in doing so eroded some soil particles.

Figure 14. Erosion channel developed by initial simulated rainstorm with soil compacted to 78% maximum dry density.

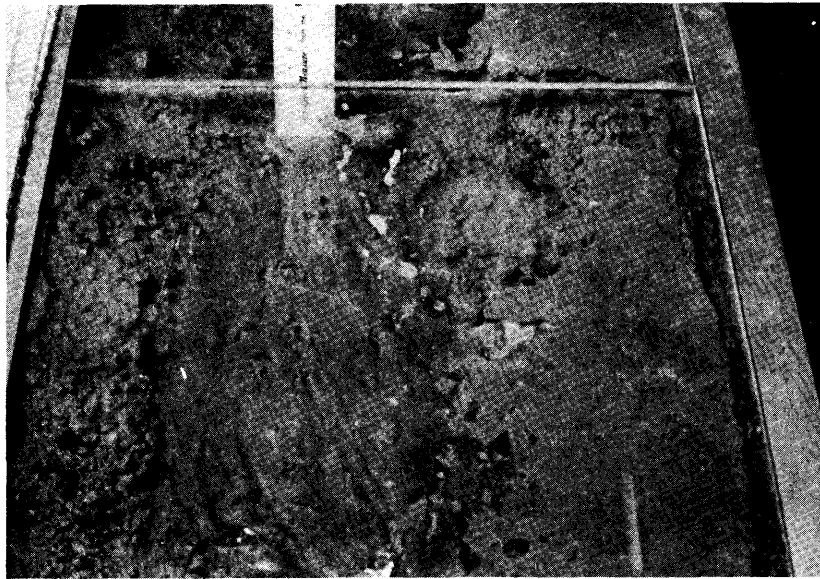
At 24-hour intervals, three additional simulated rainstorms were run with this setup of the model. These caused the erosion channel formed during the first rainstorm to widen and deepen, but resulted in no additional channel being established. Figure 15 evidences the undermining caused by the four simulated rainstorms. The only supplementary observation made during the last three rainstorms was that, due to surface tension, some of the water flowed on the underside of the plexiglass sidewalk instead of along the subgrade. This phenomenon resulted in less soil being eroded from the model.

Figure 15. Erosion channel developed by four simulated rainstorms on control setup of model.

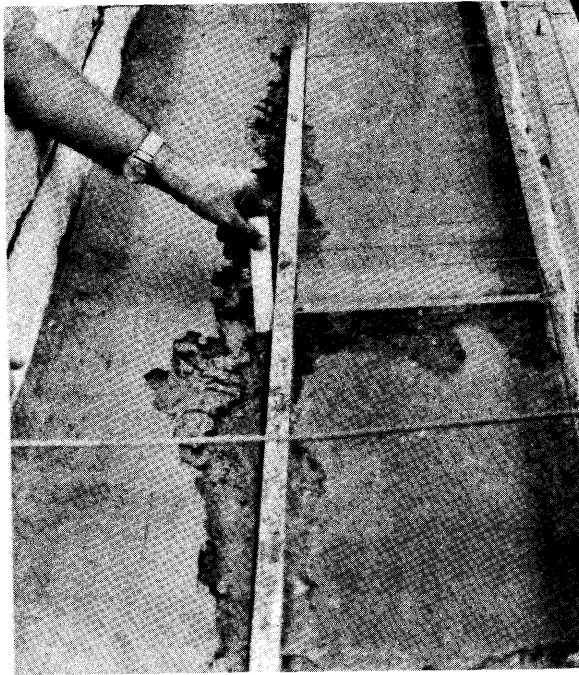
Figure 16 illustrates the undermining that resulted from the eight rainstorms. A small amount of erosion of the simulated yard slope is noticeable in the upper portion of the figure. This was caused by one particular stream of water hitting the vertical side of the trough and flowing underneath the fabric, and it is obviously negligible as compared to the amount of soil eroded along the edge of the plexiglass sidewalk. Even though the location of the undermining in the model is not representative of that normally observed in the field, it was concluded that the undermining in the model was caused by flowing water and not the impact of the simulated rainstorm. Therefore, a comparison could be drawn between the results from this setup and those from the control setup.

Figure 16. Erosion channel developed by eight simulated rainstorms on soil compacted to 98% maximum density.

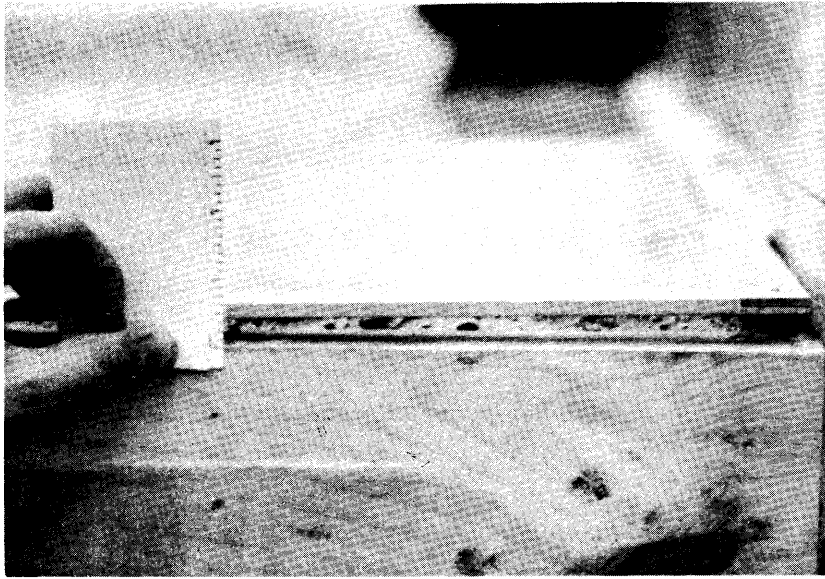
Many of the observations made with the control setup were also noted for this setup. Additionally, there was a large amount of swell of the soil, about 9-1/2%, as can be noted in Figure 17. The soil swell also promoted the buckling of some of the plexiglass "slabs" as demonstrated in Figure 18. A CBR test performed on a sample of the soil soaked for four days at this time resulted in a swell of approximately 1-1/2%. The difference in these values are reasonable when one considers that the plexiglass weighs much less than the 56 N (12-1/2 pounds) of weight placed on a CBR specimen during the soaking period. Nevertheless, it is conceivable that the same swell pressure was present in each case.

Figure 17. Swell of subgrade soil after eight simulated rainstorms with soil compacted to 98% maximum density.

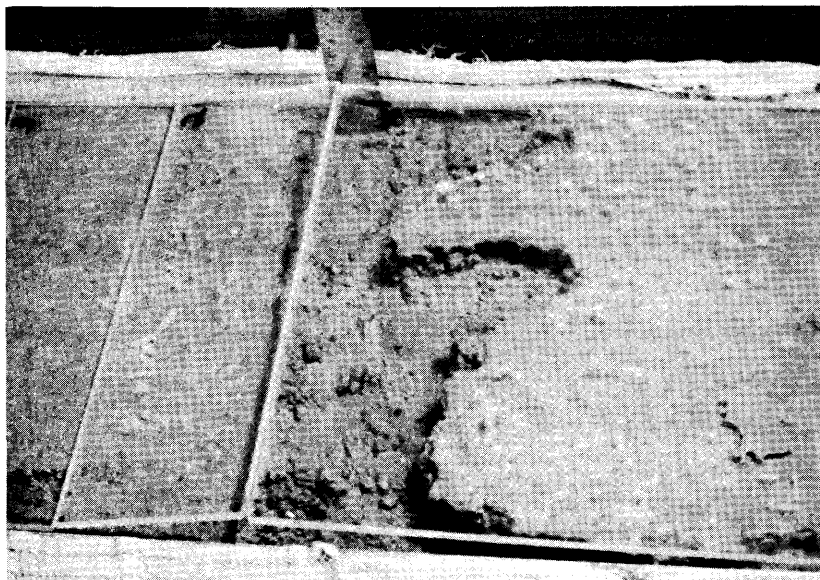
Figure 18. Buckling of plexiglass slabs developed under eight simulated rainstorms with soil at 98% maximum density.

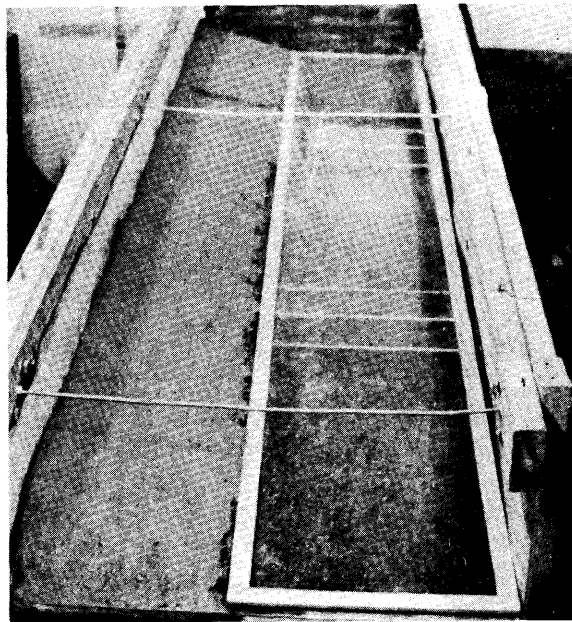
Figure 19. Negligible erosion after eight simulated rainstorms on model setup incorporating #21-A stone subbase.

A very minimal amount of soil was eroded along the inside edge of the plexiglass sidewalk, but no undermining of the sidewalk occurred. Again, a small amount of erosion of the simulated yard slope was noted at the same location and for the same reason as before, but in this setup the eroded material was retained in the stone subbase. Additionally, the vast majority of the material by weight, eroded during this model setup was formed by the finer particles of the stone subbase and not by the soil particles.

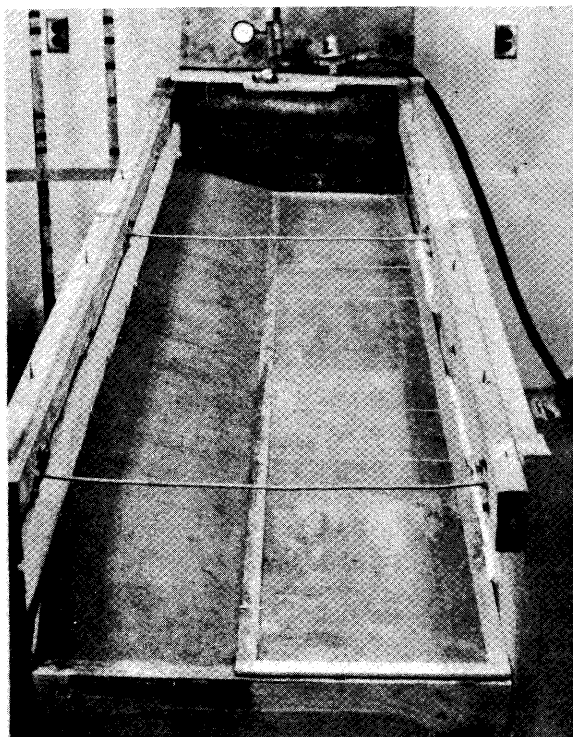
After the 3-day curing time the model setup was subjected to the established eight-rainstorm sequence. The final result is shown in Figure 20. Obviously, there was no substantial erosion of the soil with this setup. In the author's opinion the undermining was prevented by the increased strength and bonding of the soil resulting from the addition of lime.

Figure 20. Essentially no erosion after eight simulated rainstorms with lime-modified soil.

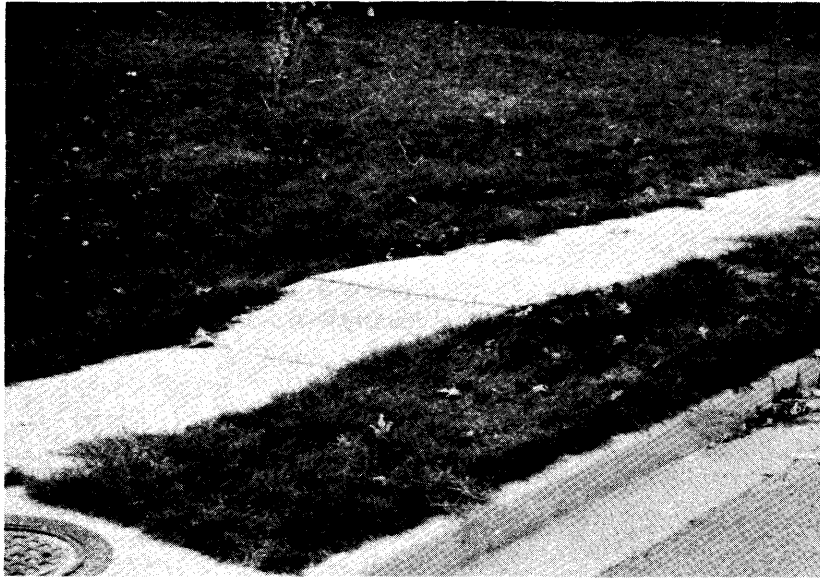
The fact that no undermining was found at any of the sites should not be taken to mean that the operations tested are totally successful in preventing undermining. The site of Test Area #1 built under normal construction (i.e., with compaction of the subgrade and cut-off walls) has the most severe geometric conditions of all the test sites. When this site was inspected in May 1976 the only indication of undermining was that some soil particles were visible on the sidewalk. There was no noticeable distortion of the sidewalk at that time. But in November 1977, when this site was revisited, the evidence of undermining was overwhelming. There was a considerable amount of uplift of the sidewalk slabs at the lower part of the section as is shown in Figure 22. Additionally, some undermined slabs upgrade of the paint pictured had collapsed and had been filled in with bituminous material, and there were many holes along the edge of the sidewalk. Since this section represented the severest geometric conditions and took from 5 to 6 years for unmistakable undermining to develop, and since any procedure would logically delay sidewalk undermining a little, there is a strong possibility that in the case of the other test sections not enough time has elapsed for undermining to develop. Future inspections of the test sites will reveal the validity of this suspicion.

Figure 22. Uplift of sidewalk at lower end of section at Test Area #1 due to undermining upgrade of failure.
