FULL-DEPTH REPAIR OF JOINTED PCC PAVEMENTS  
CAST-IN-PLACE AND PRECAST PROCEDURES

Samuel S. Tyson  
Research Engineer

Virginia Highway & Transportation Research Council  
(A Cooperative Organization Sponsored Jointly by the Virginia  
Department of Highways & Transportation and  
the University of Virginia)

March 1976  
VHTRC 76-R44

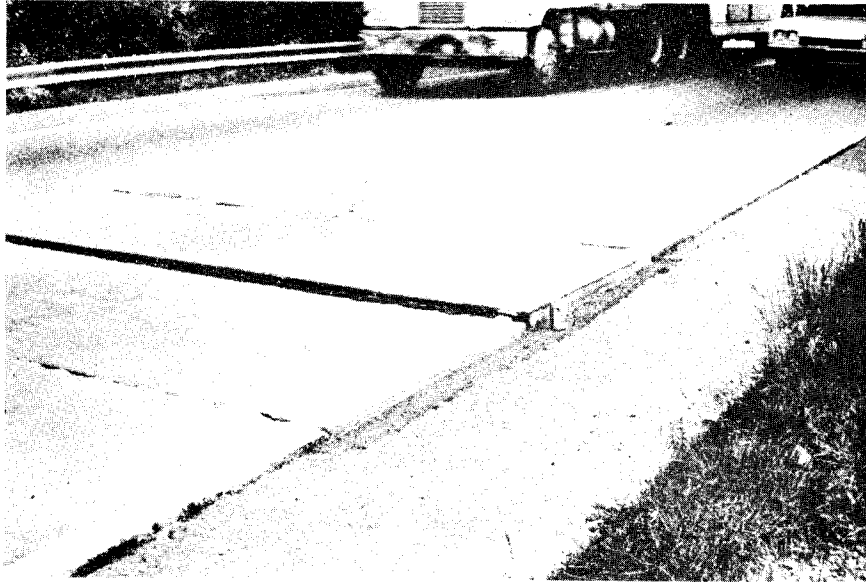
Figure 1. Faulting of repaired transverse joint due to pumping of subbase fines.

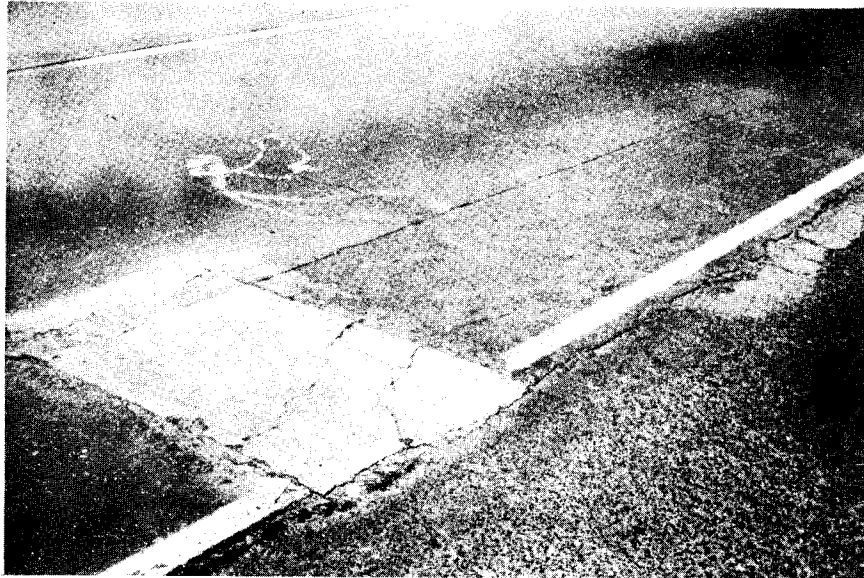
The enduring quality of some repairs installed by state crews is demonstrated in Figure 2. Repairs such as this, away from the transverse joints, are not typical. However, it is of interest to note that the light colored patch in the foreground, placed by a contract crew alongside the repair placed 2 years earlier by a state crew, failed at an age of 1 month. Aside from the fact that the second patch was not adequately consolidated, the problem with the initial repair was that it did not extend far enough to remove all of the unsound concrete.

Figure 2. Initial full-depth repair in background did not remove all unsound concrete. Subsequent repair in foreground did not receive adequate consolidation.

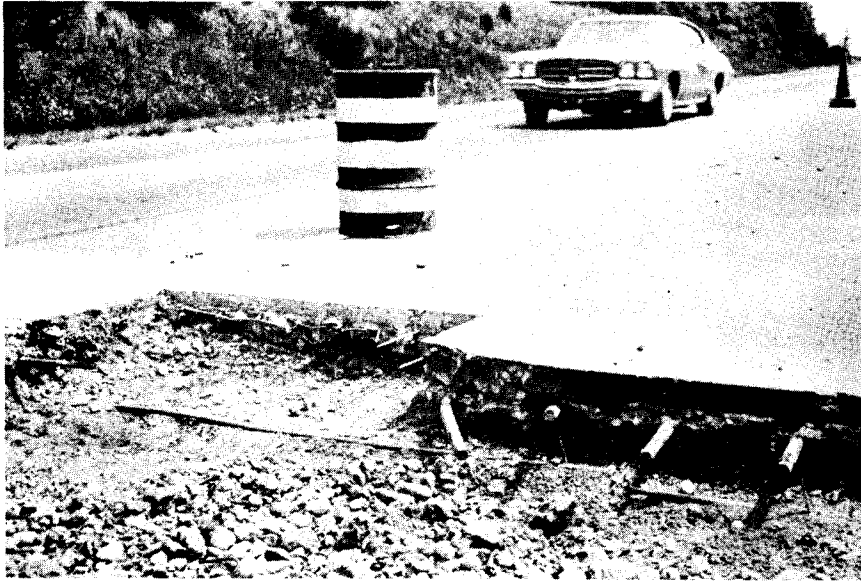
Various other situations can lead to difficulty with full-depth repairs. In Figure 3 several of the dowels at the transverse joint have been removed with the unsound concrete. The risk with this incomplete restoration is that all of the dowels may not be properly aligned when the repair concrete is cast and the transverse joint may be prevented from functioning properly.

Figure 3. Incomplete full-depth restoration presents difficulty with dowel alignment.

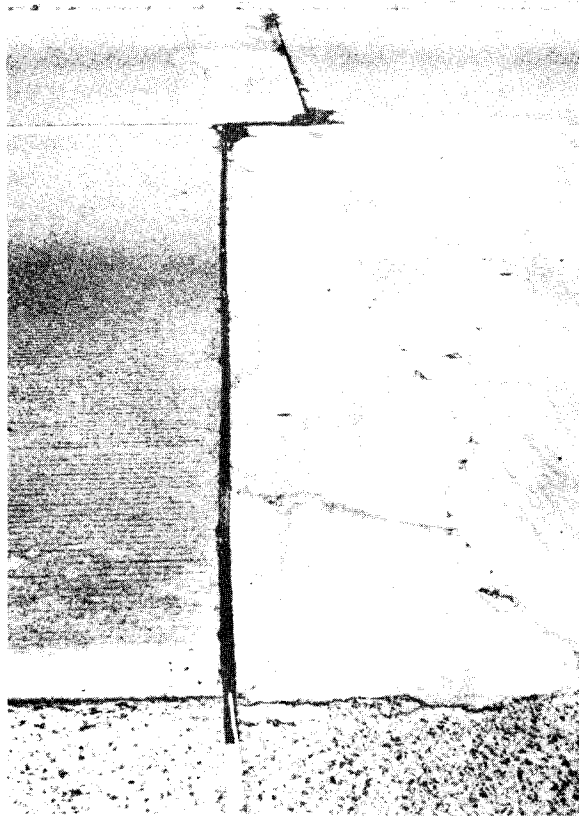
In Figure 4 the undoweled replacement joint in the near lane is not functioning. Since the lanes are in contact at the centerline and some bond strength must have developed along the lower face of the replacement joint, contraction has been accommodated in the repair concrete by a crack that formed in general alignment with the working joint in the far lane. The intended working joint should have been restored at the location of the original transverse joint.

Figure 4. Full-depth replacement joint not functioning due to misalignment.

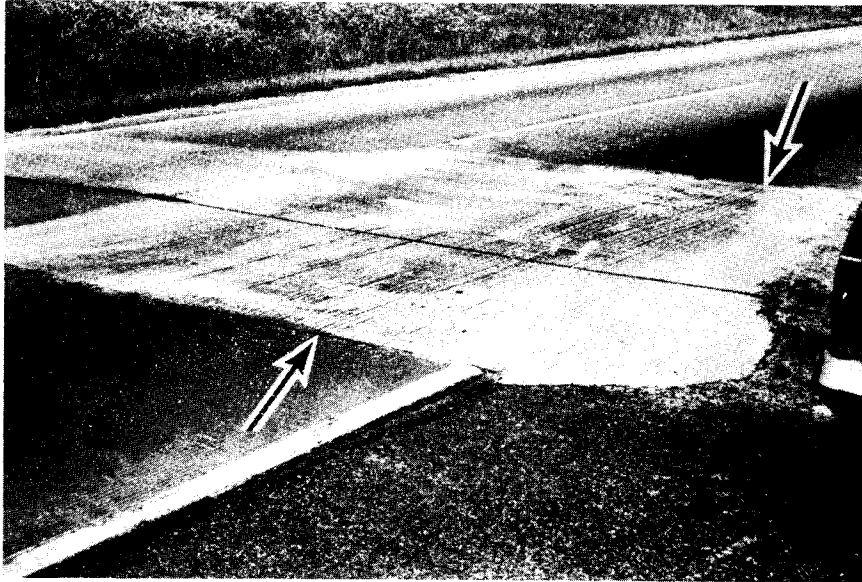
Even though care was exercised to restore the doweled joint in Figure 5, transverse cracks formed at the repair limits. Shoulder material had been removed with the deteriorated concrete pavement so that casting of the repair concrete beyond the edge limit of the existing slab caused the repair to be keyed into the shoulder. The repair tended to remain stationary with the shoulder as the old pavement contracted longitudinally and pulled away.

Figure 5. Full-depth restoration keyed into shoulder resulted in transverse cracks indicated by arrows.

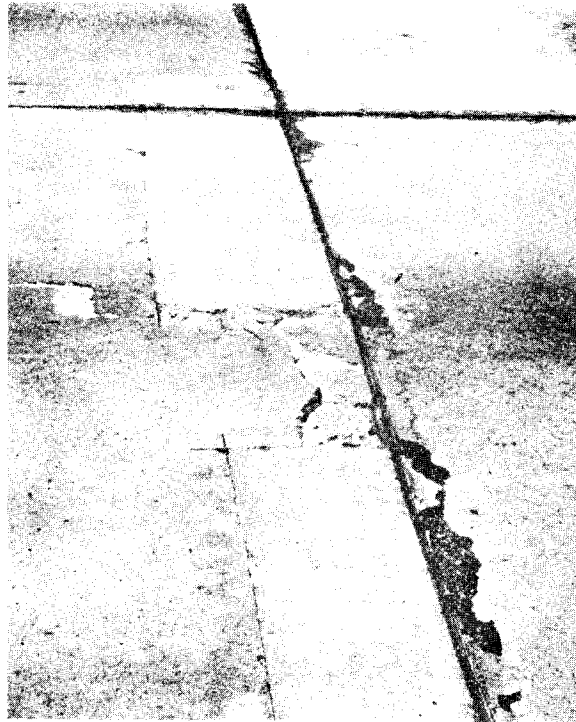
Due to the several combinations of factors that may cause deterioration<sup>(1)</sup> some difficulty has been experienced in determining the severity of distress that has existed in some pavement locations that have been repaired. After the transverse joint in the near lane in Figure 6 received partial-depth repairs the far lane underwent full-depth restoration. Within a week of the full-depth repair, spalling was observed in the near lane. Full-depth removal of the concrete in the far lane relieved the compressive stresses that had not already been relieved in that lane through extensive deterioration of the concrete. Because the two lanes were connected by tie bars at the pavement centerline, the transverse joint of the near lane carried an increased compressive stress. This stress level and resultant strain was apparently sufficient to cause the additional spalling.

Figure 6. Continued deterioration of concrete in foreground occurred after full-depth restoration of lane in background.

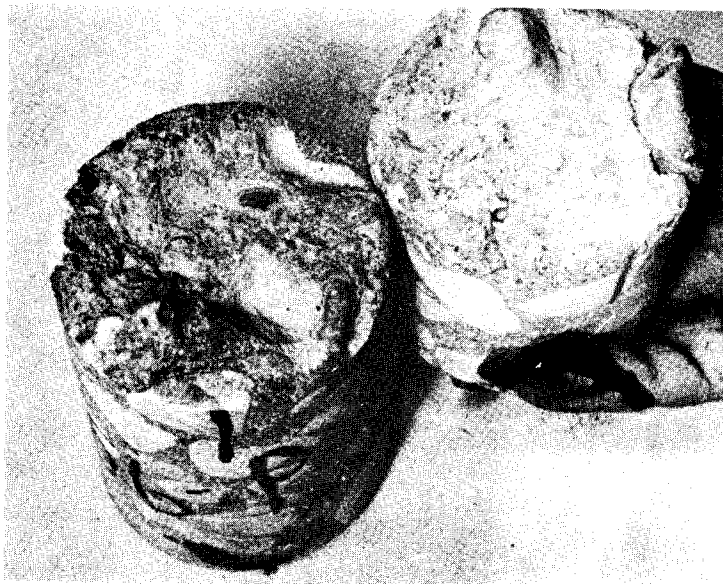
Unsound concrete was found in the area in the near lane to the left of the second partial-depth patch by hammer soundings. The core shown in Figure 7 was removed from the old pavement approximately two feet from the transverse joint. A nearly horizontal fracture plane was found at a depth of 5 inches (127 mm). This was not surprising because of the increased joint stresses. However, examination through X-ray diffraction techniques of material in the fracture plane revealed not only finely ground compacted concrete that was very unlikely to have been deposited during the wet drilling, but also an underlying thin coherent layer of calcite. This finding suggested that the fracture had existed prior to the time that the repairs were made at either joint since the calcite, formed by a reaction between  $\text{Ca(OH)}_2$  in the concrete and  $\text{CO}_2$  from the atmosphere, in the amount observed would have required a longer period of time to form than the 90-day period that elapsed between the initial repair installation and the coring operation. Identification of pavement distress by visual means only is obviously not sufficient.

Figure 7. Fracture plane in old pavement containing compacted layer of finely ground concrete underlain by thin coherent layer of calcite.

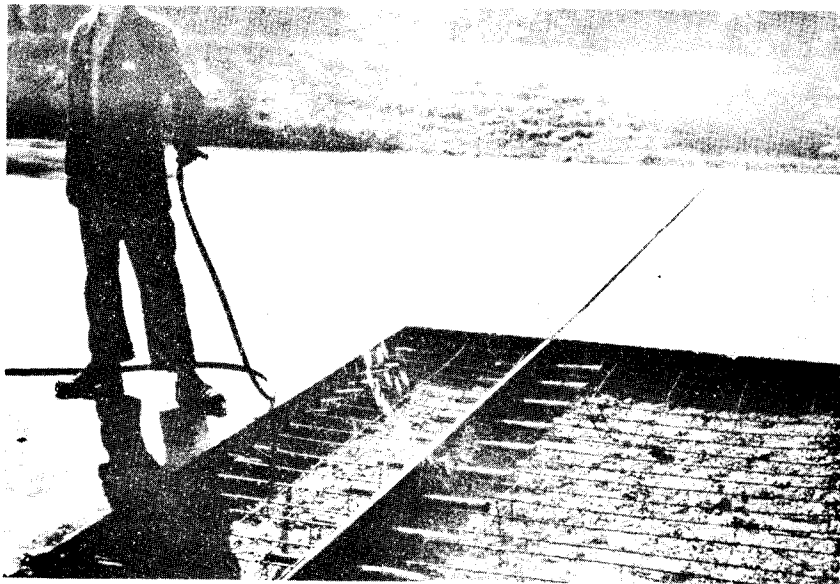
Figure 10. Precut steel fabric reinforcement and prefabricated dowel assembly in place.

The precut steel fabric reinforcement and prefabricated dowel assembly used in the repair are shown in place in Figure 10. This reinforcement was tied to the existing reinforcement protruding from the slab. The dowel assembly was fixed to the subbase and included a bituminous impregnated felt strip to form the contraction joint through the full slab depth.

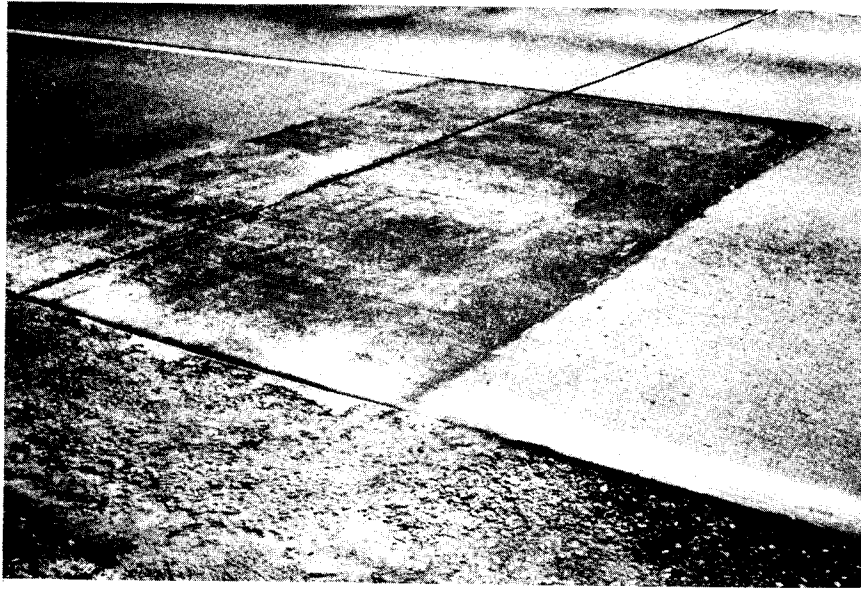
Thirteen initial repairs of the type shown in Figure 11 have performed satisfactorily for more than 2 years. The functioning of the restored transverse joints and the proper tie-in at the construction joints between the repair concrete and existing pavement slabs were studied. Movements in several of the restored

Figure 11. Hardened cast-in-place restoration made with HAC concrete.

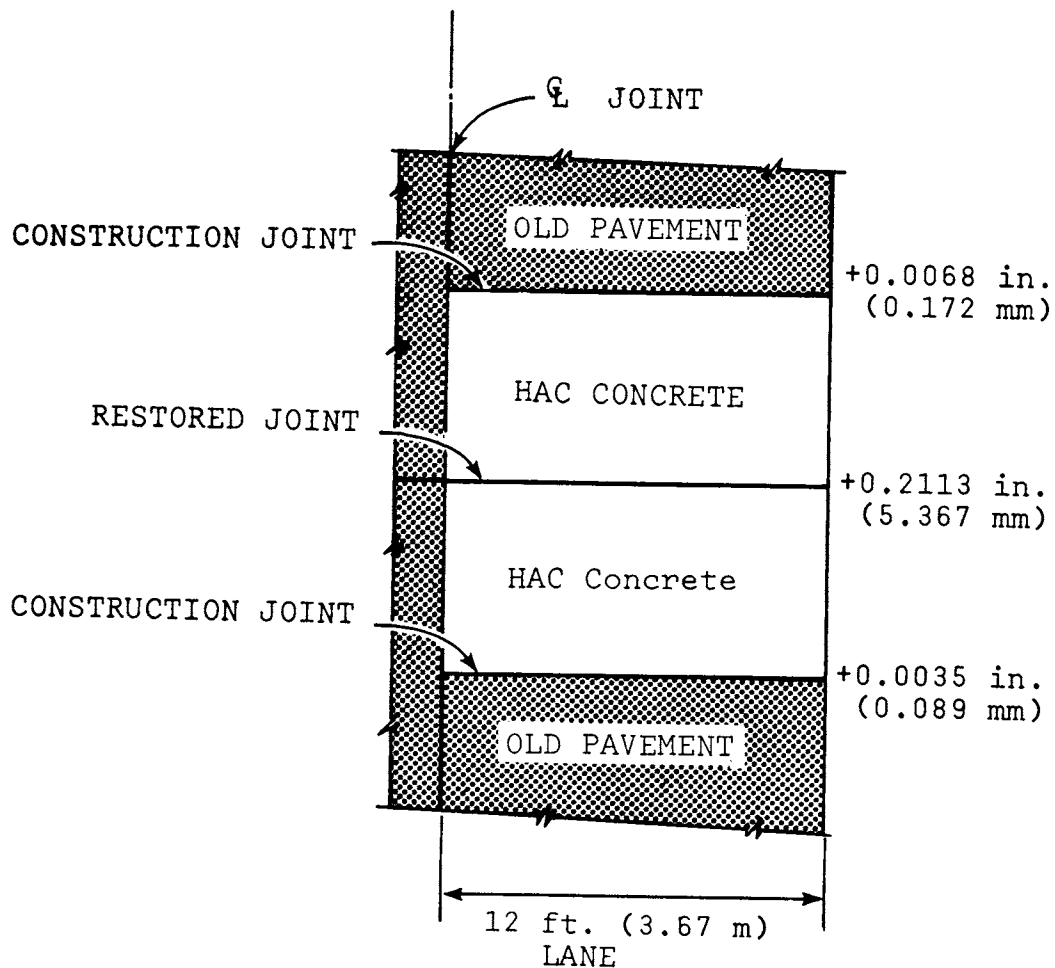
Figure 12 shows typical data recorded during the joint monitoring. The ratio of the restored joint movement to the average of the two construction joint movements was 40 to 1, which shows that practically all of the slab movements were being accommodated by the transverse contraction joint. This was the desired behavior. The observed movement for the working joint was 0.2113 inch (5.367 mm), which compared quite well with the predicted value of 0.1800 inch (4.572 mm). The tightness of the construction joints can be attributed to the careful tie-in of reinforcement mesh between the old pavement and the repair concrete. The vertical section of a core drilled down through the construction joint reveals the overlapped transverse bars of the mesh in Figure 13. Excellent potential for load transfer can be seen in the mechanical interlock between concretes in that figure. The favorable irregular face in the old pavement was created by the concrete removal technique described earlier, and good bonding was achieved at the construction joint interface by adequate consolidation following the application of a bonding slurry made of HAC.

Figure 12. Joint movements (+ openings) occurring over a 17-hour period with an ambient temperature change from 75° F to 28° F (24° C to -2° C).

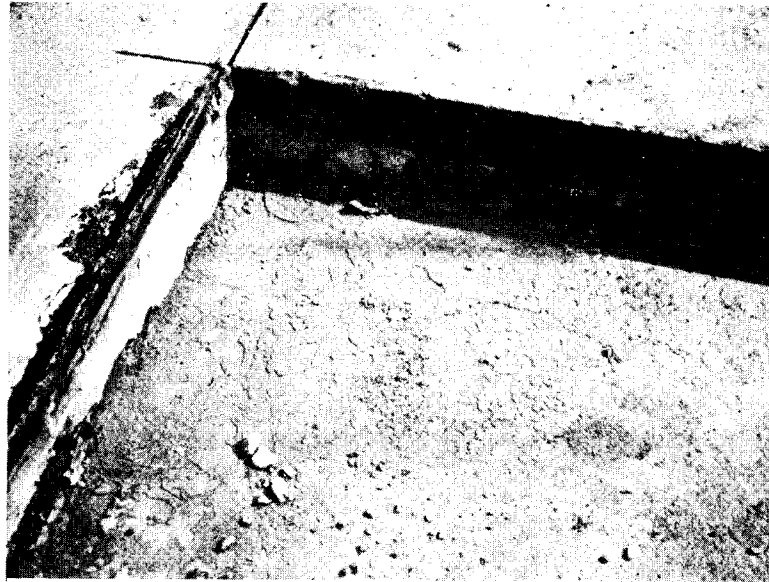
Figure 31. Fine subbase material infiltrated between mortar layer and precast slab from underneath adjacent roadway areas (roadway centerline on left).
