FURTHER REDUCTION IN INCIDENCES OF WRONG-WAY DRIVING

Dr. N. K. Vaswani
Senior Research Scientist

Virginia Highway & Transportation Research Council
(A Cooperative Organization Sponsored Jointly by the Virginia
Department of Highways & Transportation and
the University of Virginia)

May 1977
VHTRC 77-R45

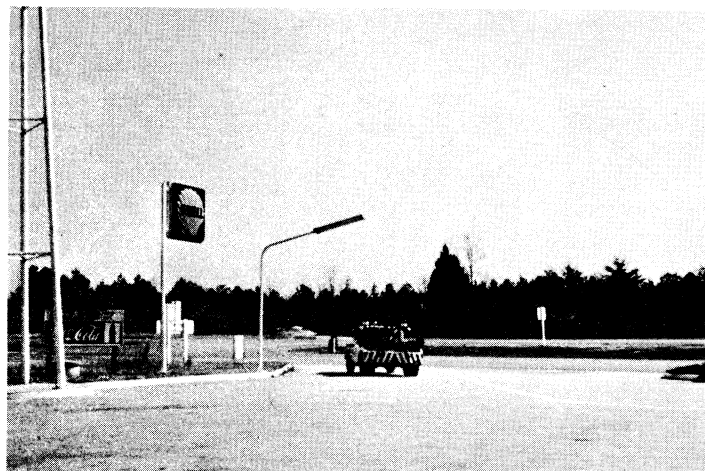
Figure 3. Example of an intentional wrong-way exit from a gas station.

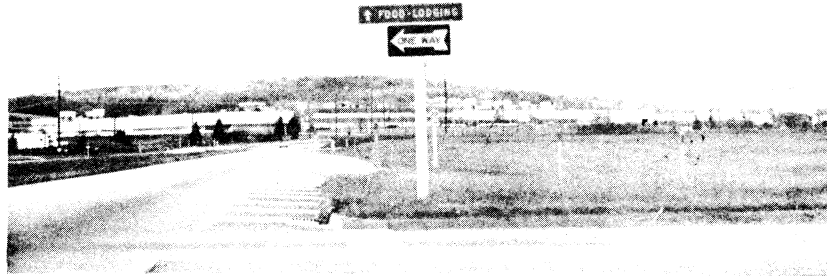
Observations have shown that arrows placed close to the intersection of the crossroad and the exit ramp are visible to the potential wrong-way driver making either a right-hand or left-hand turn into the exit ramp as shown in Figure 6, and that those placed beyond 4 to 5 m (13 to 16.5 ft.) from the intersection are not visible. Therefore, the first arrow on the exit ramp should be very close, say within 1.5 m (5 ft.), to the junction of the exit ramp and the crossroad. This arrow will then be visible to the potential wrong-way driver during the day and at night under low beam headlights. The second arrow on the exit ramp should be placed approximately 30 m (100 ft.) from the stop line as recommended,⁽⁴⁾ so as to provide a second warning to the wrong-way driver.

Figure 6. Visibility of pavement arrow marking when placed near the stop line. No wrong-way incident reported.

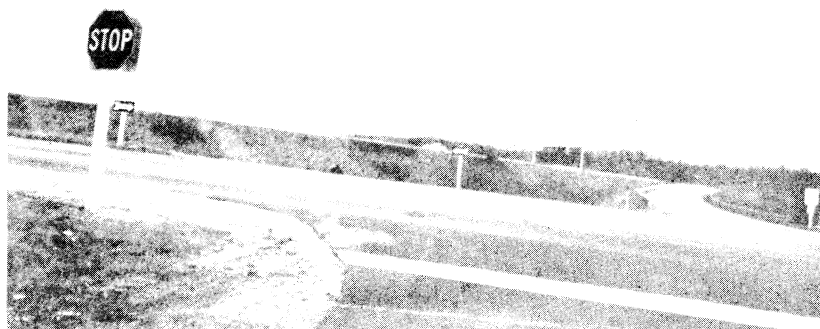
It has been found that on almost all interchanges on which wrong-way entries have been made, either into an exit ramp or from an exit ramp into a crossroad, the left edge of the left lane of the exit ramp has been flared into the right pavement edge of the crossroad. An example of such a flare is shown in Figure 7. Such flares probably mislead the driver into the wrong lane.

Figure 7. Junction of exit ramp and primary highway before marking of the left flare. Site of six wrong-way incidents before improvement.

The results of removing such flares have been very encouraging. The following example shows how the wrong-way entries have been completely eliminated by their removal. Figure 7 shows the flare at the intersection of an interstate exit ramp and a primary highway. This intersection had experienced six wrong-way entries (the highest in Virginia), all by non-drunken drivers during the first 2 years of the survey period. In 1974 the author suggested that the flare be eliminated by installing two right angled lines.⁽⁵⁾ This suggestion was implemented as shown in Figure 8, and as of October 1976, no wrong-way incidents had been reported. The marking apparently discourages drivers from quickly turning left onto the wrong side of the median, and also increases the visibility distance on the primary highway.

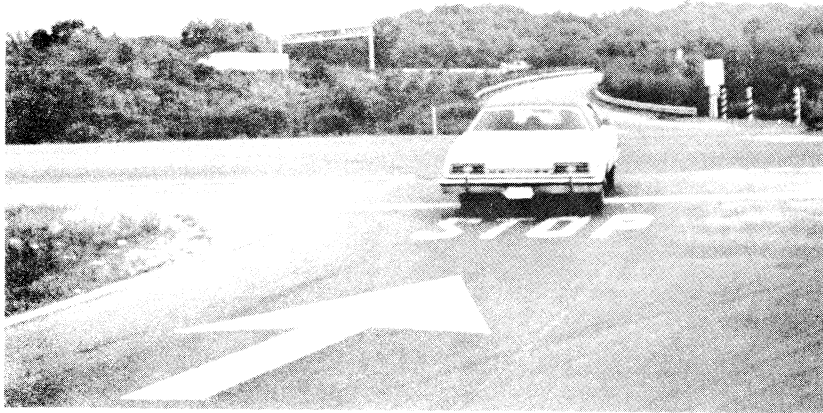
Previously, in approaching the crossroad from the exit ramp all drivers would stop on the stop line. With the introduction of the flare marking, a driver who needs an increased visibility distance crosses the stop line and comes to a stop at the corner of the flare marking as shown in Figure 8. Other examples of the removal of flares are given in a report by the author.⁽¹⁾ Scrifes also has recommended the removal of flares to reduce wrong-way driving.⁽⁶⁾

Figure 8. Junction of the exit ramp and primary highway after marking of the left flare. Note that the driver ignores the stop line to get a better view of the crossroad. No wrong-way incident after marking.

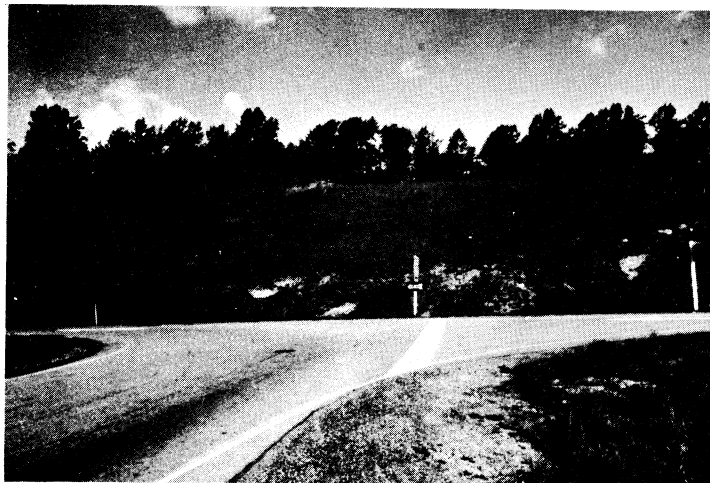
During the investigations it was found that at a few locations the stop line was very close to the intersection of the crossroad and the exit ramp. Such lines were found to be very clearly visible from considerable distances ahead of the intersection while driving along the crossroad during the day and at night under low beam headlights. An example is shown in Figure 9. A stop line placed very close, say within 1.5 m (5 ft.)

Figure 9. Clear visibility of the stop line from a considerable distance on the crossroad. No wrong-way incident after the marking of stop line.

of the junction of the crossroad and the exit ramp, will be visible to the driver on the crossroad at day and night, and hence will be of immense help in preventing wrong-way entries into the exit ramp. Figure 10 shows the placement of the stop line at the intersection.

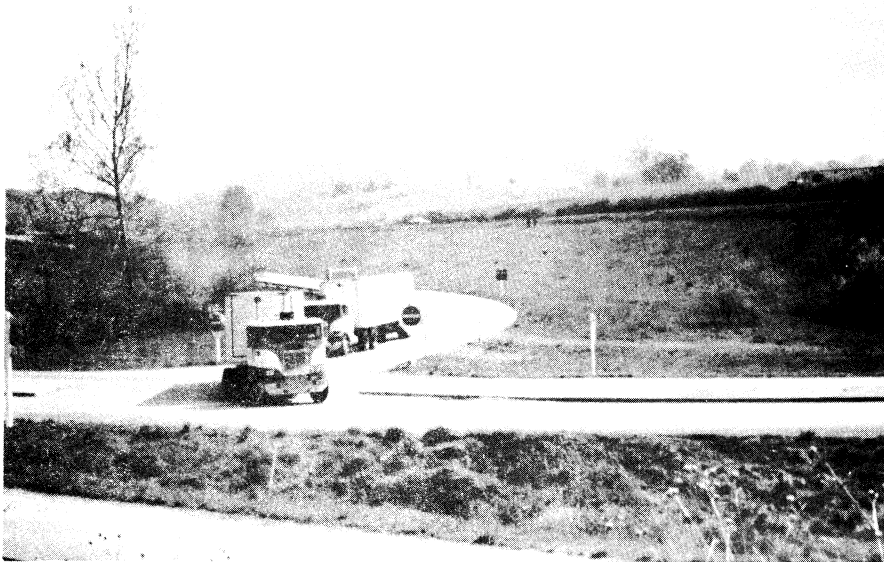
Locations where the widths of the crossovers were reduced were investigated, and many times it was found that even after extension of the nose of the median there was an ample gap between the nose and the biggest trailer truck. A photograph showing this gap at one of the interchanges is given in Figure 12. The left-hand median in this photograph was recently extended to reduce the width of the crossover. To assist a traffic technician locate the nose for a channelized crossover, a simple ordinate method has been developed.⁽²⁾ By this method the shape and location of the two noses on either side of the crossover can be determined and the crossover can be properly channelized.

Figure 12. Even after extension of nose of median, there is ample gap between nose and biggest trailer truck. A site of wrong-way entries.

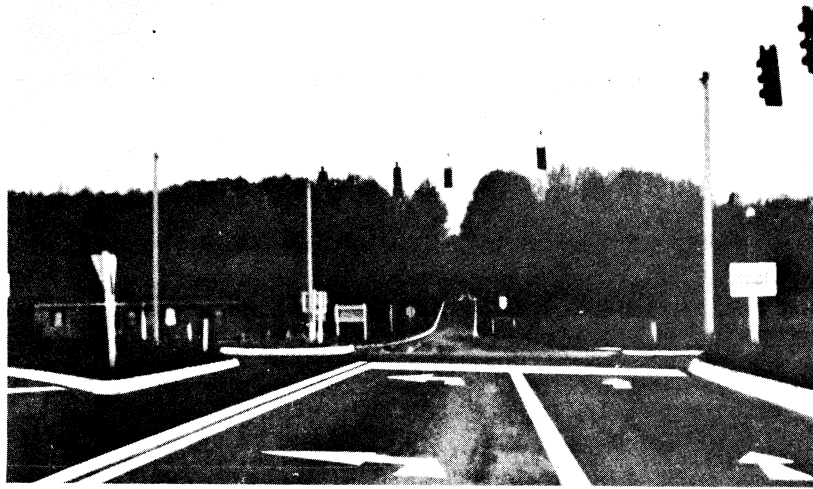
Figure 13 is a photograph of the lighted intersection at which one of the wrong-way entries was observed. On inquiry, the driver (local, non-drunken) said that he did not see the lane on the far side of the median. This is a level intersection, and unless a person is very observant he is unable to see the lanes on the far side of the median. A "divided highway" sign visible on the left of the driver before he negotiates the intersection and makes a left turn will inform him of the geometry of the intersection. An additional turn sign at the left nose of the median would provide further guidance. The locations of both such signs are shown in Figure 14. These signs have been installed on an experimental basis at 72 intersections over a 92-km (57-mile) stretch of a primary highway in Virginia. Figure 14 is a photograph showing both these signs and their locations at one of these intersections.

Figure 13. Intersection showing poor visibility of the lanes across the median. A site of wrong-way entry.
