Virginia Transportation Research Council

Condition Assessment
and Determination of Methods
for Evaluating Corrosion Damage
in Piles Encapsulated in Protective Jackets
on the Hampton Roads Bridge-Tunnel

April 2010
VTRC 10-R13

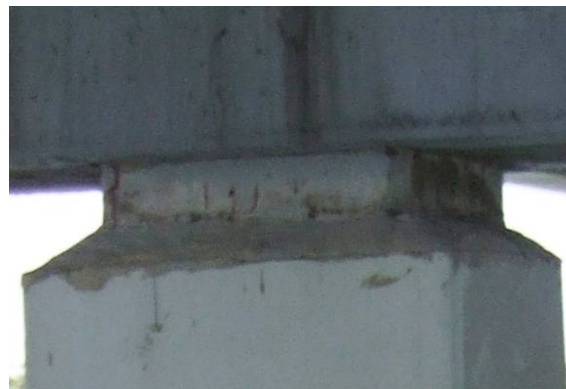
The mortar fill was surveyed for signs of damage in the form of corrosion product, section loss, and exposed reinforcement. If the fiberglass was intact on a pile, it was not possible to assess the condition of the mortar or the substrate. The exception was a small portion of exposed substrate at the top of the pile (Figure 9).

Figure 9. Substrate Exposed Above Jacket

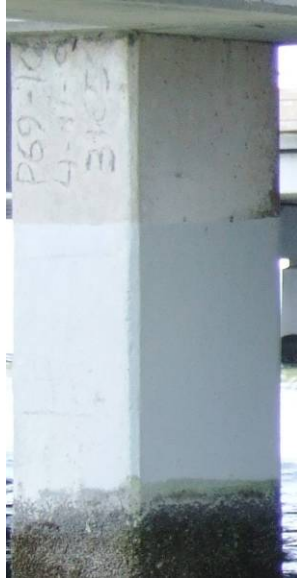
Table 5 shows the results of the visual inspection of the fiberglass on the four HRBT bridge structures. Of all jacketed piles, the fiberglass was damaged on 49% (752 piles), which includes the fiberglass being split, partially missing, or completely missing. Jackets were not installed on the piles installed in 1999 as part of the widening of Structures 2900 and 2902. Although these piles comprised 18% (326 piles) of the total HRBT piles, they were not included in the data for Table 5. The non-jacketed piles had a surface-applied epoxy coating along the tidal region (splash zone) of the pile (Figure 17).

Figure 17. Epoxy-Coated, Not Jacketed, Pile

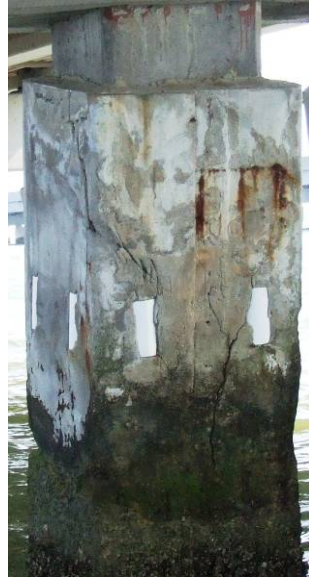
Visual inspection of the mortar revealed numerous foreign items cast into the mortar, including sections of PVC pipe, typically 6 in long (Figure 18); blocks of wood, typically 4-in long 2-in by 4-in sections (Figure 19); and in one instance a bundle of rope.

Figure 18. Mortar with Polyvinylchloride Pipe

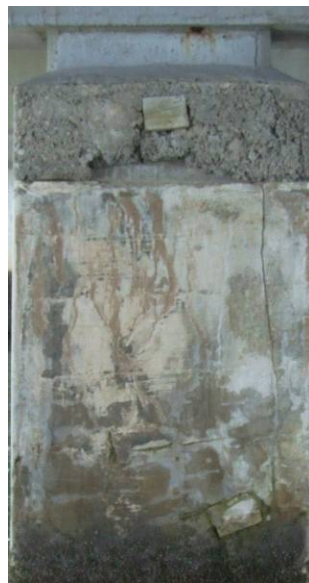
Figure 19. Mortar with Wood Blocks

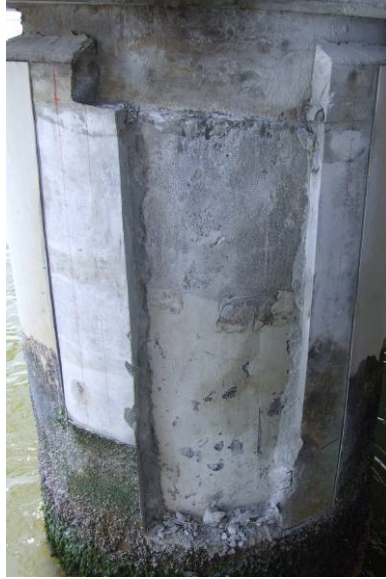
The mortar reinforcement was inconsistent. The square jackets were to contain WWF, and the round jackets were to contain a reinforcement cage constructed of vertical No. 4 bars and lateral No. 3 bars. However, several of the piles did not have reinforcement or the reinforcement that was present was not in accordance with the specifications on the construction documents (Figure 20). When the mortar reinforcement was incorrectly placed on square piles, it was typical to have WWF placed in only a portion of the jacket or even completely missing. On the circular piles, often the reinforcement cage was missing or a WWF was placed instead of reinforcing bars. Mortar without reinforcement was typically in better condition than the mortar

Figure 20. Mortar Without Reinforcement

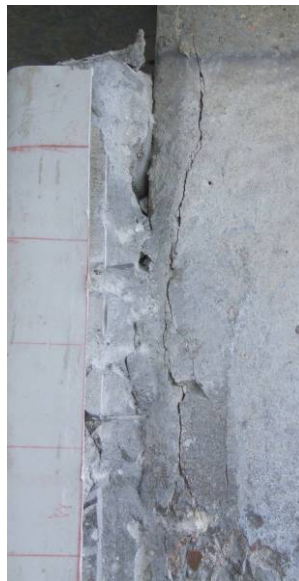
Figure 21. Vertical Crack Beneath Mortar

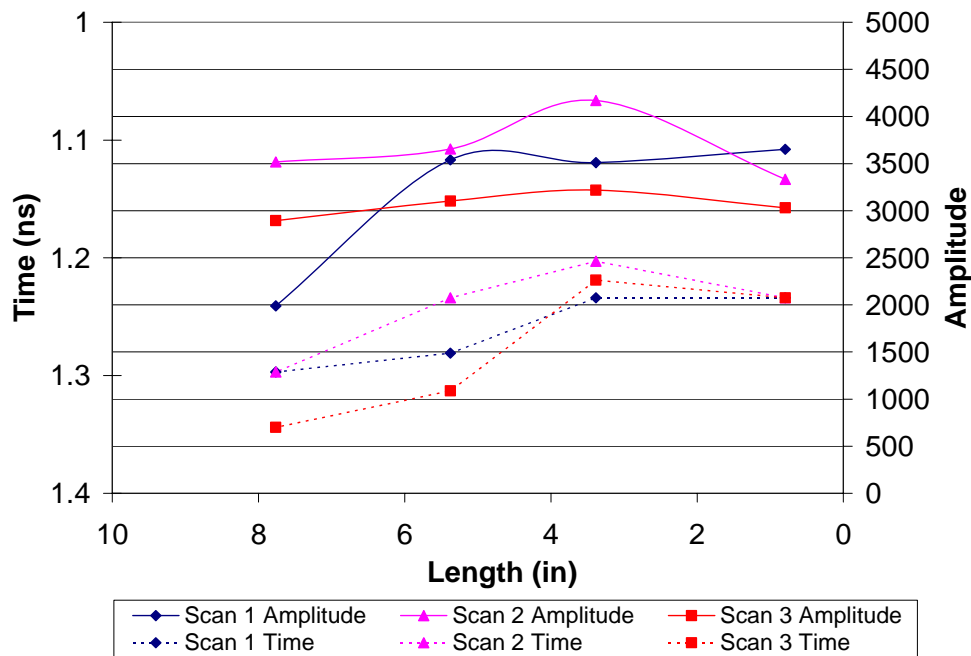
GPR was also completed on the substrate of Structure 2902, Bent 23, Pile C to determine the condition of the reinforcement. Pile C is a square pile, so vertical and horizontal scans were made. However, the limited area of exposed substrate allowed only a few short scans. Figure 24 represents the horizontal scans, in which the vertical steel could be detected. The amplitudes of the steel in all three scans varied, but those variations correlated closely to the signal travel time. As the travel time increased, the amplitudes decreased, and as travel time decreased, the amplitudes increased. The amplitude shift seen in the plot was most likely related to increased travel time. This was not indicative of damage but rather to a deeper cover over the reinforcement causing attenuation of the signal.

Figure 24. Structure 2902, Bent 23, Pile C, Ground-Penetrating Radar Scan of Vertical Steel

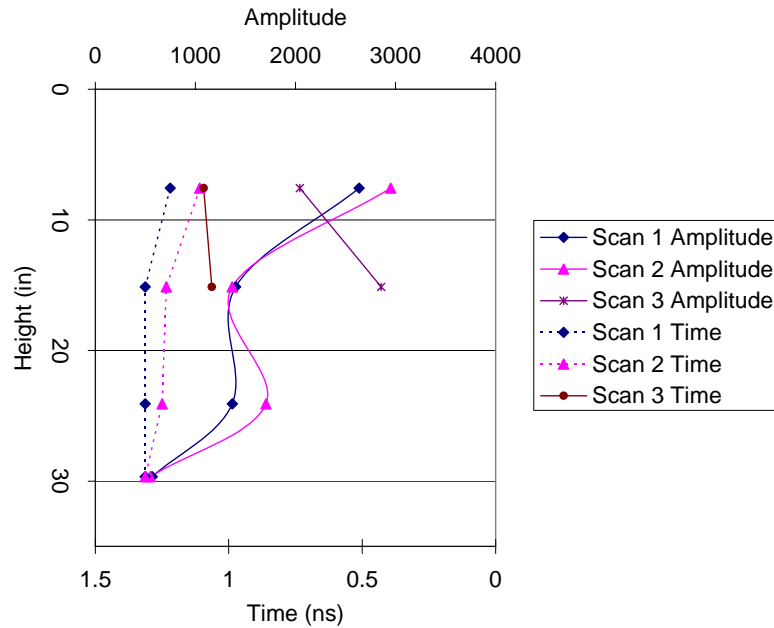
Figure 25 presents amplitudes of reflections from the horizontal reinforcement detected by vertical scans. The amplitude decreased as the scans progressed down the pile, whereas the time of reflection increased slightly. The shift in amplitude was larger than the shift in the horizontal scans, even though the travel time shift was similar. The GPR indicated possible damage to the horizontal reinforcement via this decrease in amplitude of the signal. During autopsy, light corrosion product was discovered on the horizontal wire reinforcement wraps, which confirmed this assessment. The results of all GPR scans are presented in Appendix G of Pailes (2009).

Figure 25. Structure 2902, Bent 23, Pile C, Ground-Penetrating Radar Scan of Horizontal Steel

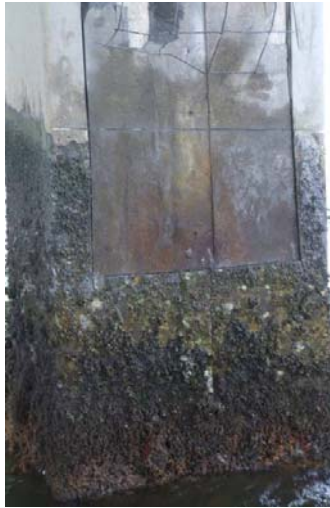
Figure 53. Saturated Mortar Behind Fiberglass

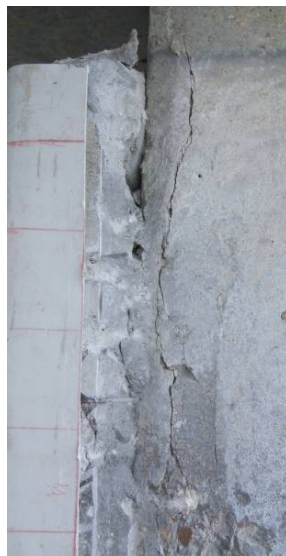
Figure 54. Structure 2866, Bent 67, Pile G, Vertical Crack in Substrate Beneath Mortar

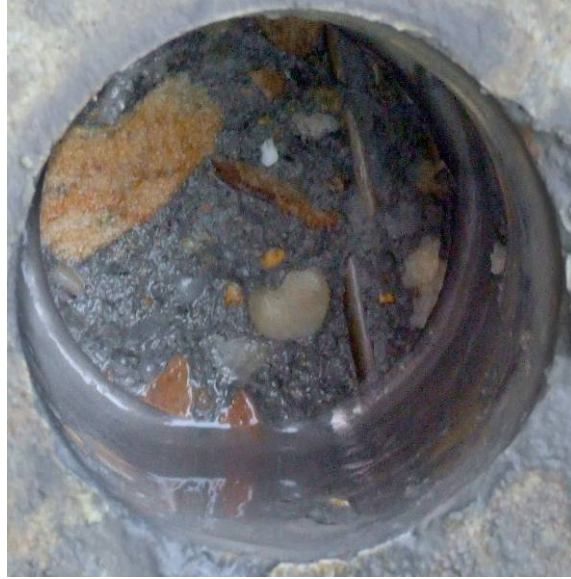
Figure 56. Structure 2866, Bent 67, Pile H, Exposed Reinforcement

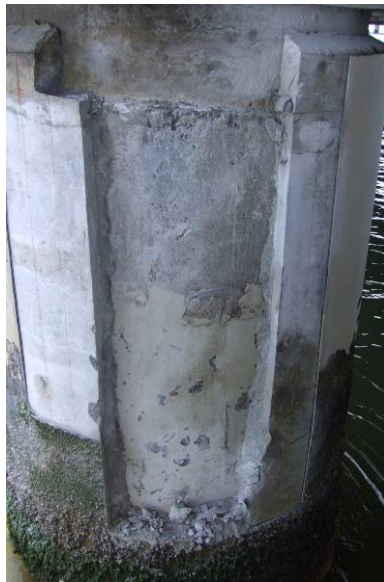
Figure 57. Structure 2900, Bent 45, Pile A, Improper Reinforcement

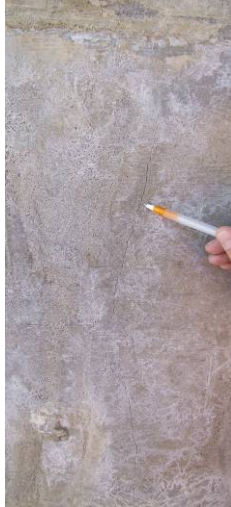
Figure 58. Structure 2900 Bent 45 Pile A, Vertical Crack Beneath Mortar

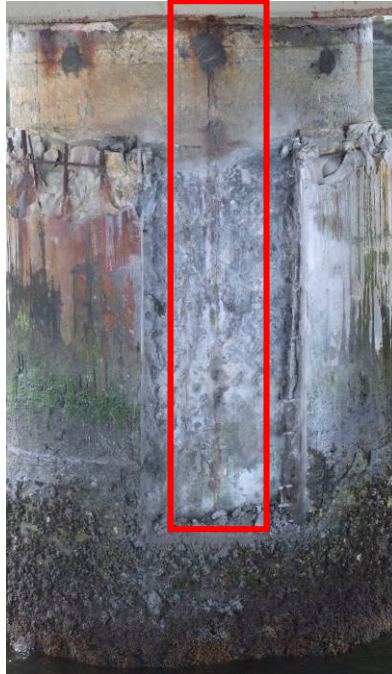
Figure 60. Structure 2900, Bent 45, Pile B, Exposed Substrate

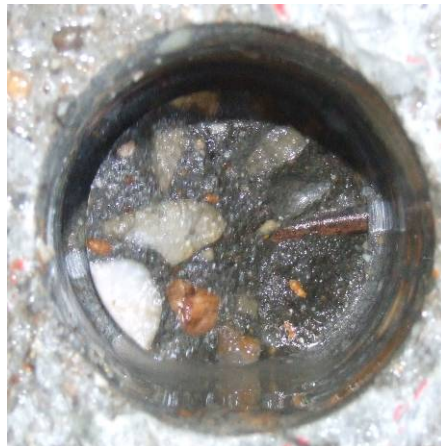
Figure 64. Structure 2902, Bent 23, Pile C, Exposed Reinforcement

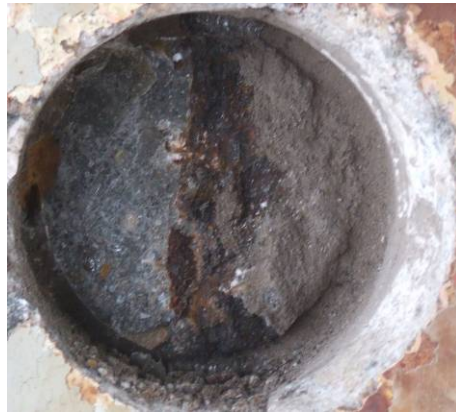
Figure 65. Structure 2900, Bent 5, Pile B, Exposed Vertical Tendon

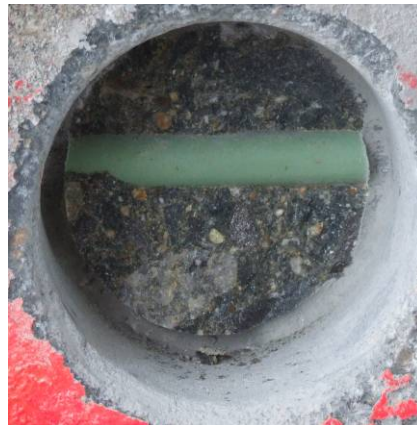
Figure 66. Structure 2900, Bent 32, Pile A, Epoxy-Coated Reinforcing Wrap
