1. Report No. FHWA/LA.10/11-1TA		2. Government Accession No.	3. Recipient's Catalog No.
4. Title and Subtitle Evaluation of the LA 1 Bridge at the Morganza Flood Control Structure		5. Report Date

Evaluation of the LA 1 Bridge at the Morganza Flood Control Structure

LTRC Project No. 11-1TA

November 2010

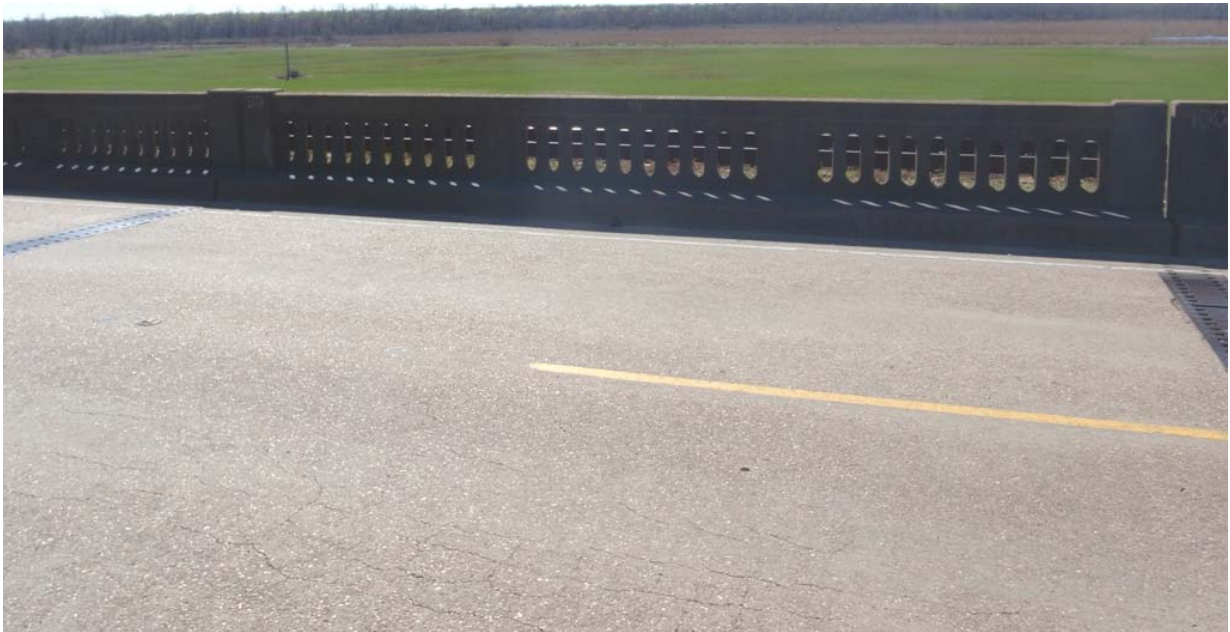
This report will concentrate on the LA 1 bridge deck at the Morganza flood control structure. On March 9, 2010, the Louisiana Department of Transportation and Development (LADOTD) bridge design section contacted the author regarding a specific cracking pattern on the LA 1 Bridge at Morganza, LA. The cracking pattern can be seen at the bottom of Figure 1. Bridge design's concern dealt with the extent of the deck damage, whether the cracking was due to corrosion of reinforcing steel, and any possible concrete delamination.

Figure 1
Span 99 looking west (Northbound lane is closest)

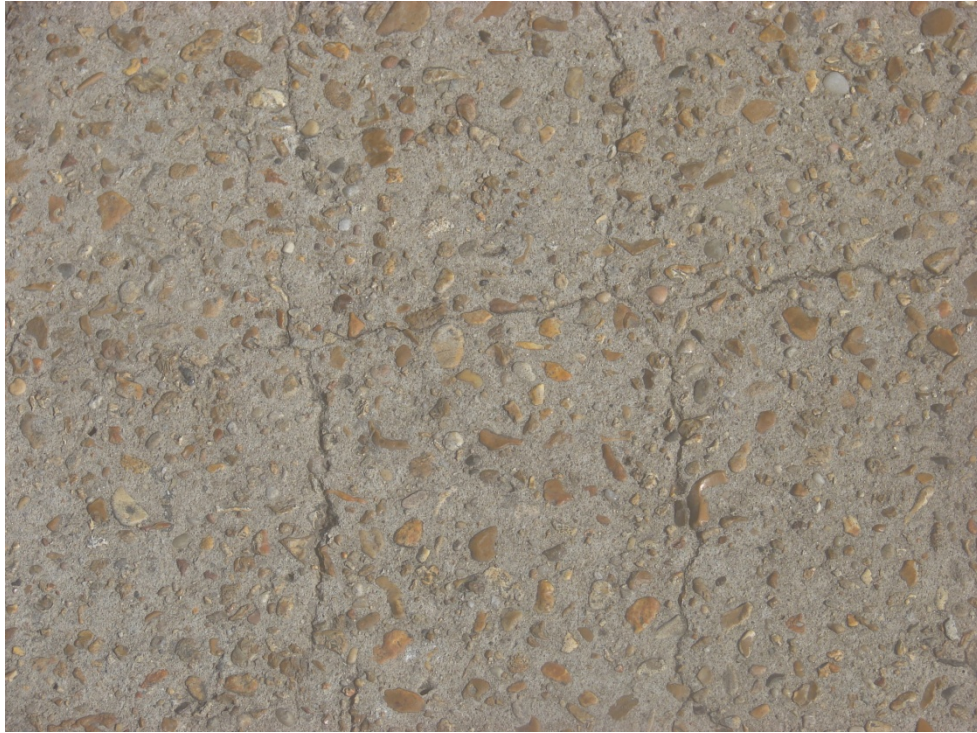
This section will detail the deck condition, delamination assessment, and in-place steel condition. The deck condition as noted on July 20, 2010, was typical of a deck that has undergone many years of wear. The deck surface had exposed gravel aggregate and many spans exhibited the cracking pattern shown in Figure 2. The cracks were observed to generally occur above reinforcing steel but were usually limited to a depth less than 1.5 inches. Figure 3 gives an indication of crack depth in one of the most affected spans where the crack depth was about 2.5 inches. The author was asked to investigate the effect of fire on the deck surface. A fire had occurred sometime in the past five years on spans 104 and 105 southbound. The fire-affected spans (104 and 105 southbound) did exhibit a noticeably different surface texture and color shown in Figure 4. The field investigation team noted that the fire-affected spans had been repaired with a cementitious based surface treatment in the past. Based on laboratory results, the author believes this is surface damage due to the fire and not structural.

Figure 2
Exposed aggregate and crack pattern (Note the crack pattern is approximately 4 – 6 inches square)

The in-place condition of the bridge deck showed signs of wear in terms of exposed aggregate and cracking. The depths of the cracks generally did not extend to the reinforcement steel. The condition of the reinforcing steel showed little to no corrosion in the full depth and partial depth cores. No delamination was found when the site was visited. The tensile and compressive strengths proved adequate and the pull-off test strengths showed that an epoxy type overlay will be very well suited as a rehabilitation technique.

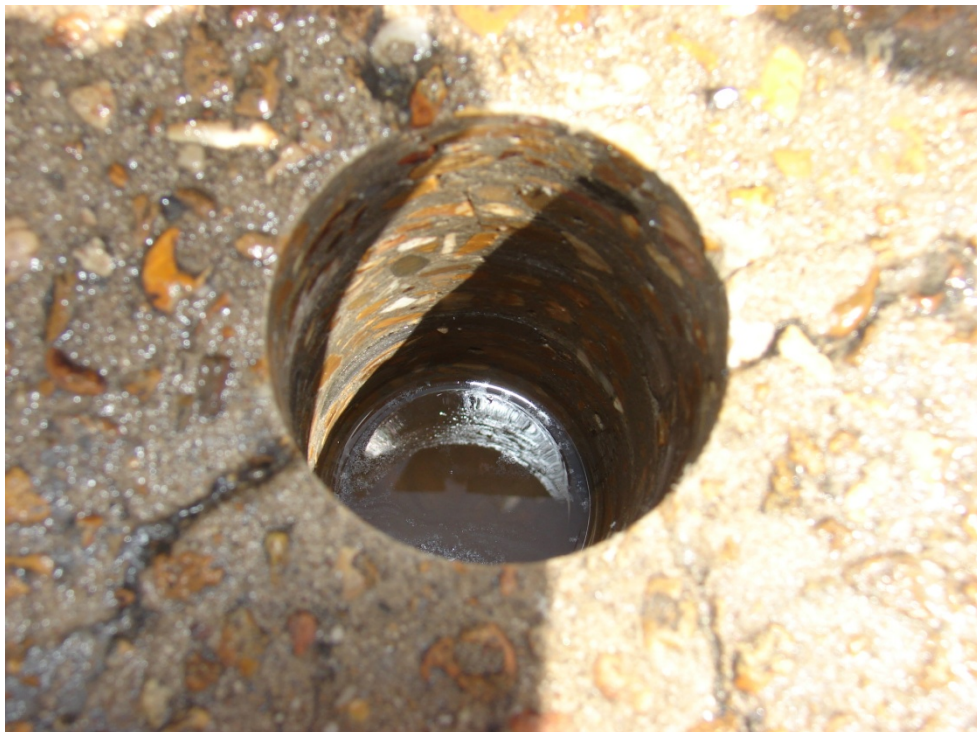
Figure 3
Cracked deck in span 99 northbound (Note the crack depth here was about 2.5 inches)

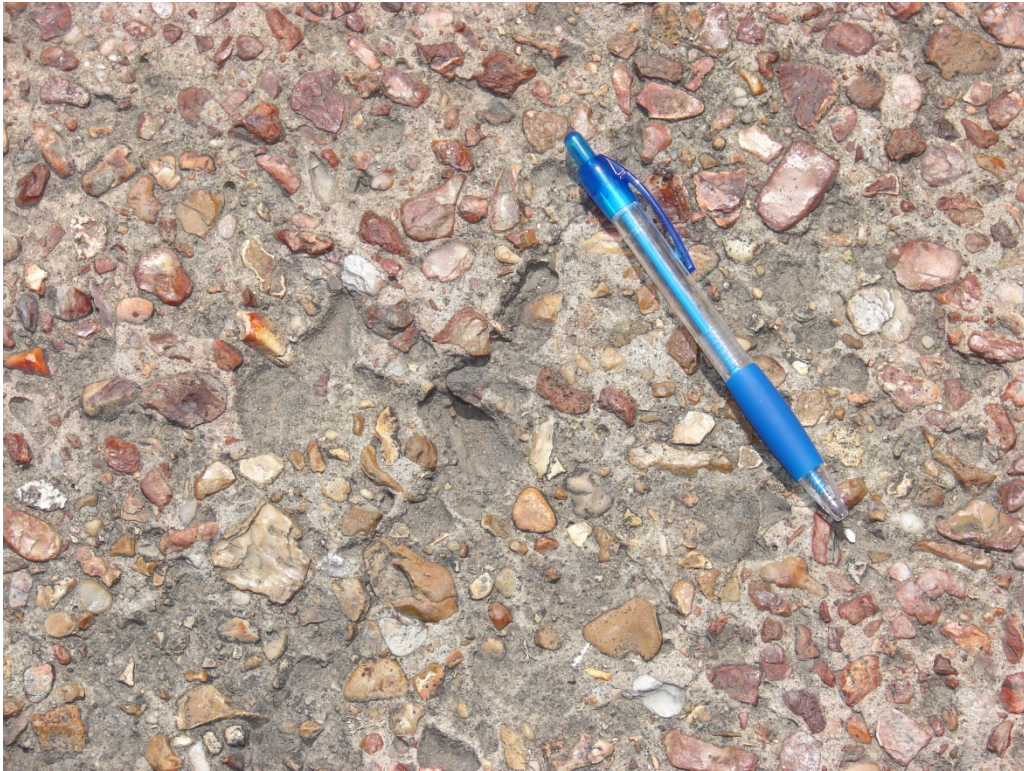
Figure 4
Surface texture and color in span 105 southbound, a fire affected span

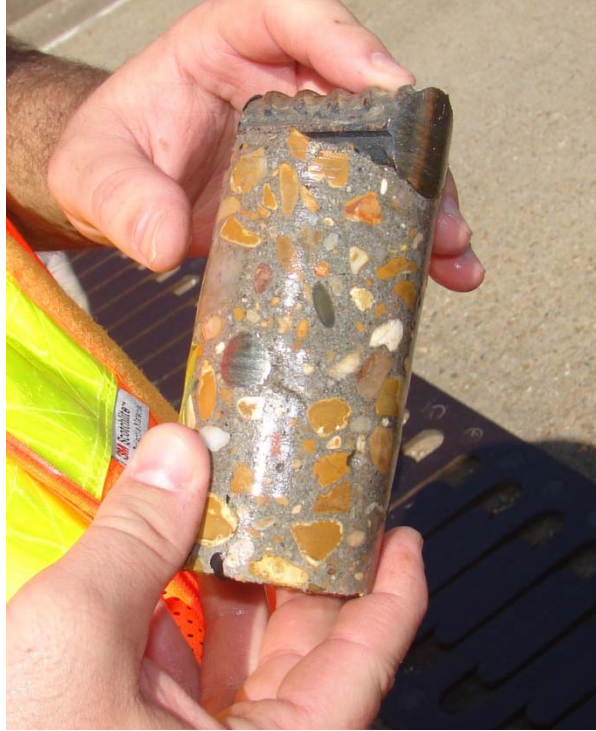
The in-place steel condition was much better than expected for the author. The in-place steel showed little to no signs of corrosion either in the partial depth cores or in the full depth retrievals. Figure 5 and Figure 6 illustrate the state of the reinforcing steel as encountered on July 20, 2010. The condition of the steel and noted crack depths led the team to reduce the number of core samples by about one third.

Figure 5
Full depth core showing no steel corrosion

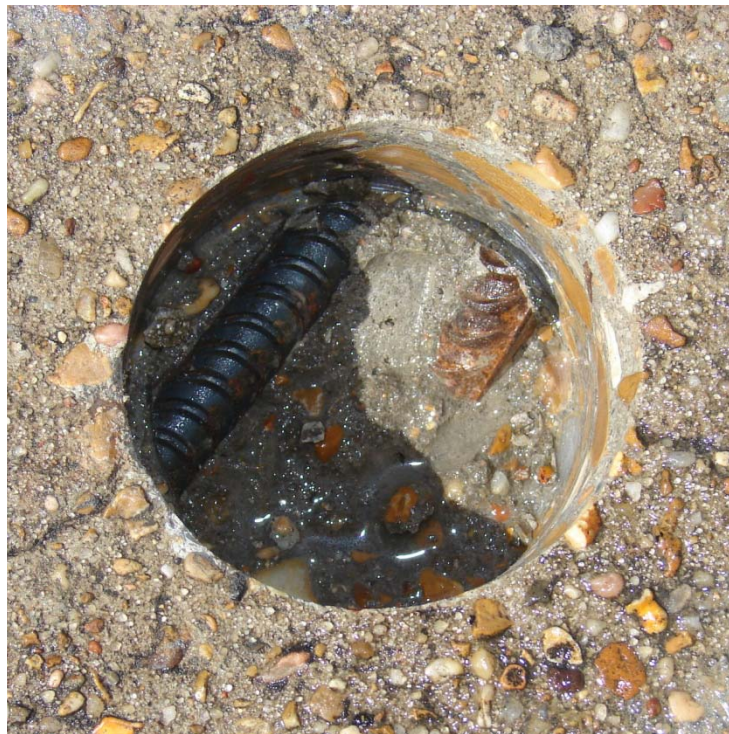
Figure 6
Partial depth core showing little steel corrosion
