# Premature Deterioration of Jointed Plain Concrete Pavements

FINAL REPORT

Date April 2011

By (PI) Dr. J. M. Vandenbossche, P.E.  
University of Pittsburgh

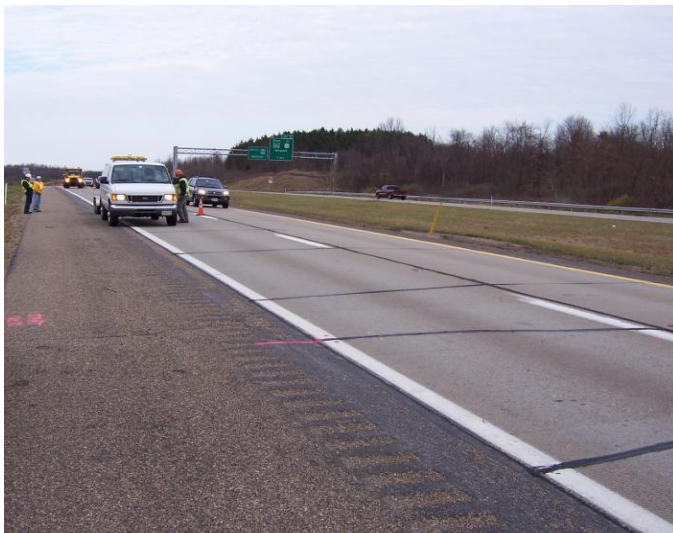
Figure 4: Overall Condition of SR 60 Segment 323 Southbound (Distressed Section)

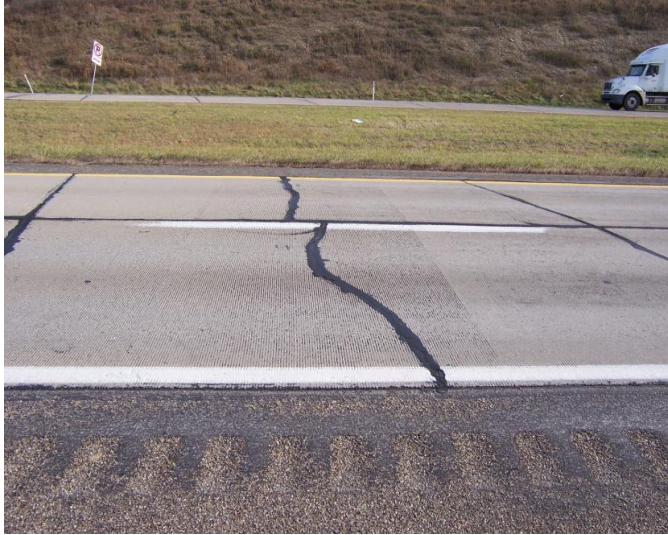
As mentioned previously, the major distress observed for both sections was mid-panel transverse cracking. An example is presented in Figure 6. According to the distress identification manual, the transverse cracks were categorized based on their severity level. The severity level is a function of the size of the crack and the size of the spalling around the crack, if any. A breakdown by severity shows that 74 percent of slabs exhibit high severity cracking and 14 percent of slabs exhibit medium severity cracking for the Distressed section. For the Control section, 4 percent of the slabs exhibited low severity cracking, 12 percent of the slabs exhibited medium severity cracking and only 4 percent of the slabs exhibited high severity cracking. Section 2.13 of this report explores the marked difference in the transverse cracking between the Distressed and Control section for SR 60 while Section 8 discusses how the overall performance of the pavement is related to performance of the OGS base layer used in the Distressed section.

*Figure 6: Mid-slab Transverse Cracking for SR 60 Segment 323 Southbound, Slab 5 (Distressed section).*

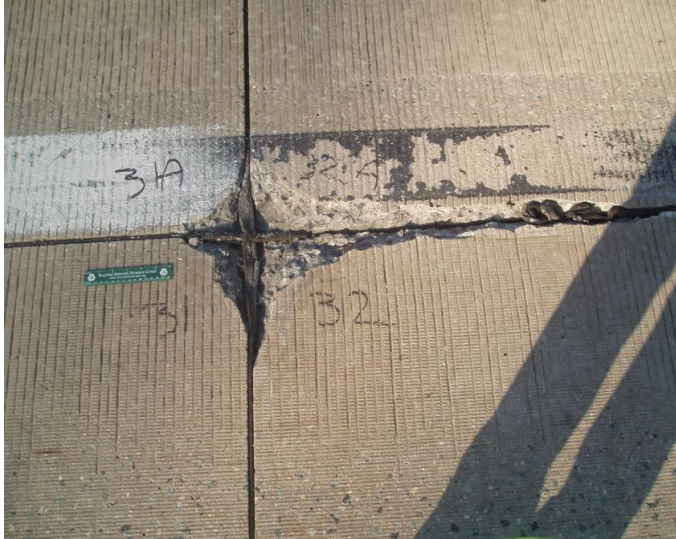
The major distress observed in the section was spalling at the intersection of the longitudinal and transverse joints. A typical manifestation of this distress can be seen in Figure 36 and Figure 37. This type of distress is present in 94 percent of the slabs. A further breakdown of the data reveals that the severity of the spalling is high in 44 percent of the slabs, moderate in 35 percent, and low in 15 percent of the slabs.

Figure 36: Joint Intersection between Adjacent Lanes of SR 202 Segment 440 Northbound Slabs 31 and 32.

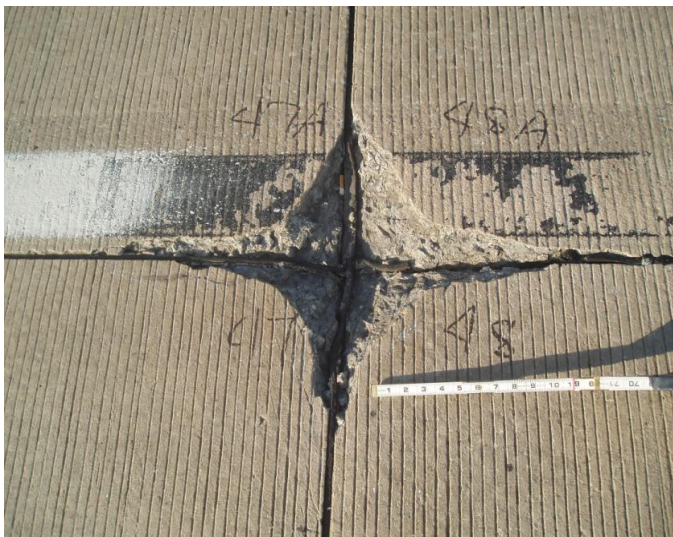
Figure 37: Joint Intersection between Adjacent Lanes of SR 202 Segment 440 Northbound Slabs 47 and 48.

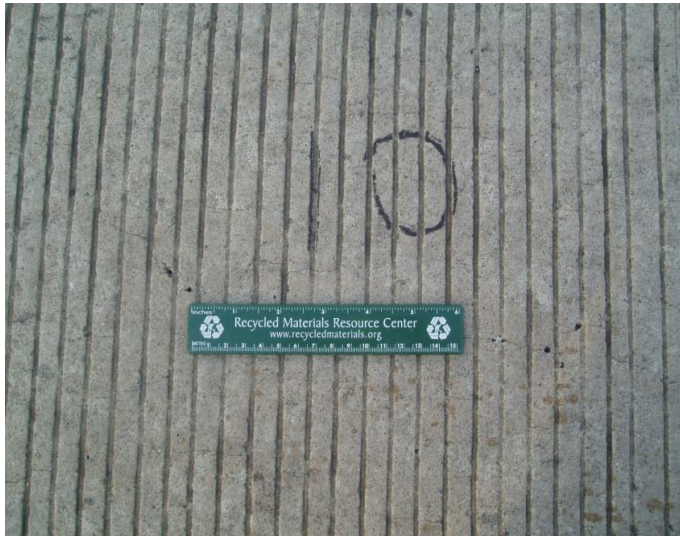
Map cracking was the other major distress observed in Segment 440. Map cracking over the entire surface of the slab was observed in 55 percent of the slabs. The microcracks within the map cracked areas are mainly oriented in the longitudinal direction of the slabs and are interconnected by finer cracks randomly distributed as shown in Figure 38 and Figure 39.

Figure 38: Close-up of Fine Microcracking of SR 202 Segment 440 Northbound, Slab 10.

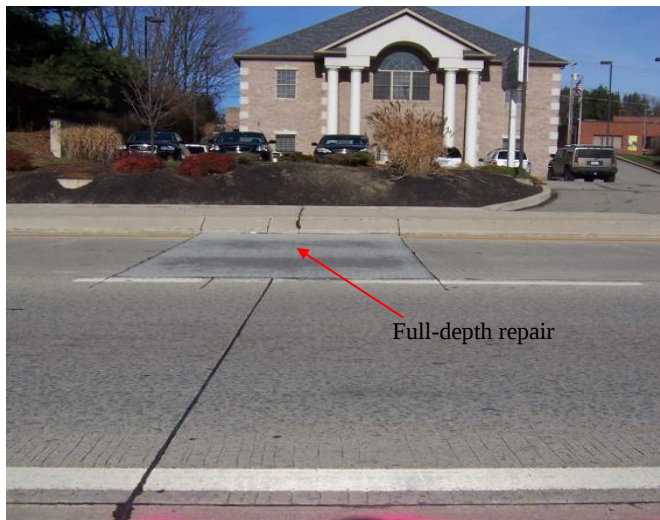
Although the passing lane was not part of the distress survey, it was noted that in addition to the driving lane, the adjacent passing lane also exhibited several full-depth repairs as well as extensive diamond grinding. Unlike the driving lane, the areas in which full depth repairs were performed to repair corner breaks for the passing lane were distinguishable based on visual observation and not based on observed base type. This can be seen in Figure 51

*Figure 51: Full Depth Repair in the Passing Lane of US-22 Murrysville Segment 50 Eastbound.*

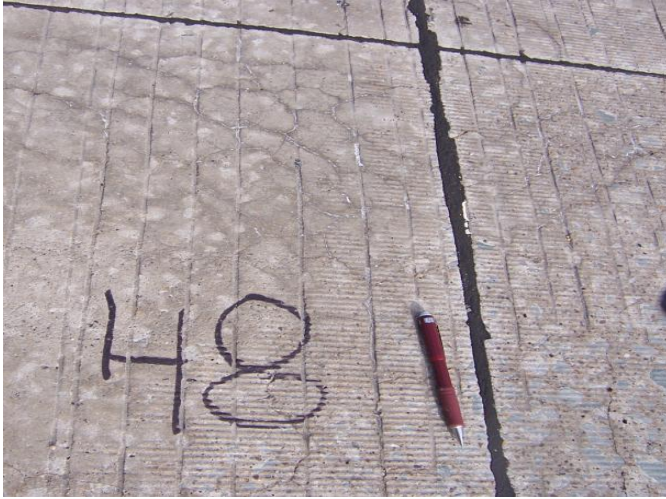
A common distress observed in the section was fine map cracking. At midslab, the cracking is oriented parallel to the longitudinal joints. The fine cracks concentrated near the transverse joints with the concentration of cracking being heavier at the intersection of the transverse and longitudinal joints. Typical examples can be seen in Figure 52 and Figure 53. In addition, white deposits were observed in the vicinity of the fine cracks in the corners. These deposits can be seen in Figure 52. Based on the cracking pattern and the presence of the white precipitate, it appears that alkali-silica reaction (ASR) might be present. A variation in the color of the cement paste between different slabs and in some cases within the same slab was observed during the visual observation of the cores. Some of this variation in the color of the cement paste can be attributed to the use of a ground granulated blast furnace slag while in other cases it is apparent that different concrete mixtures were used in constructing various sections of the roadway.

*Figure 52: Joint Close-up of US-22 Murrysville Segment 50 Eastbound Slabs 48 and 49.*

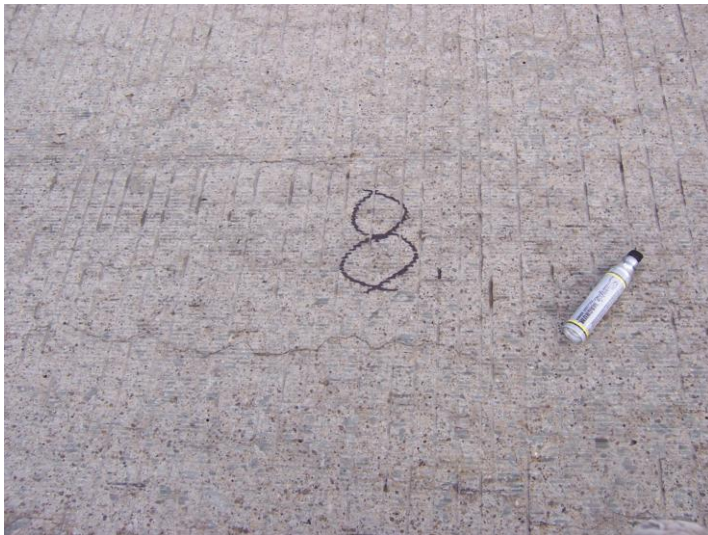
*Figure 53: Slab Close up of Midslab Longitudinal Cracking from US-22 Murrysville Segment 50 Eastbound, Slab 8.*

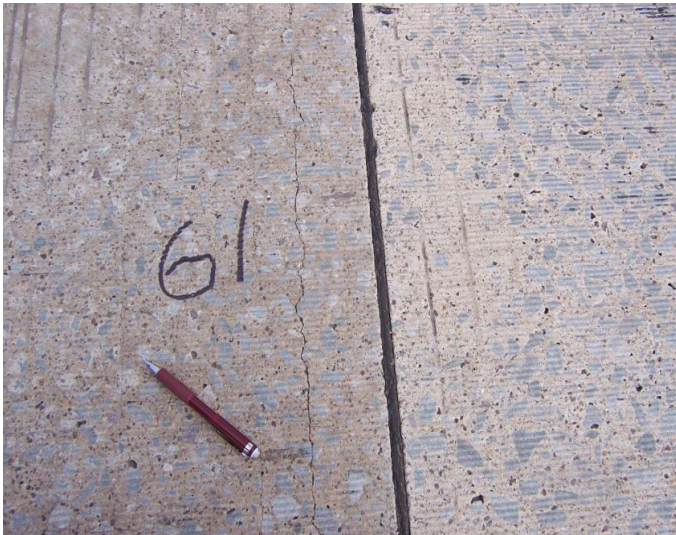
Corner cracks were not present of the time the survey was performed because they had been repair prior to this time. Corner cracks can develop as a result of pumping that result in the development of voids beneath the slab. The FWD results will show that voids are not present. Another cause of the development of corner cracks could be joint lockup.

Figure 54: Joint Close-up of US-22Murrysville Segment 50 Eastbound, Slabs 61 and 62.

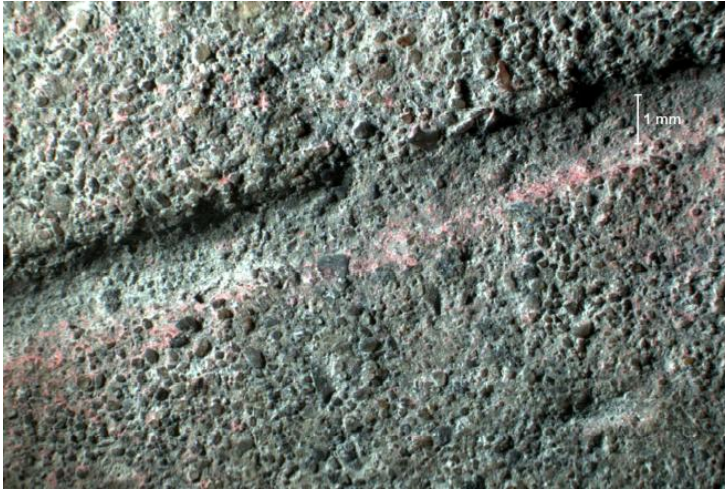
*Figure 65: Wear/Erosion of the Pavement Surface as Seen on the Surface of Core C34-MS22.*

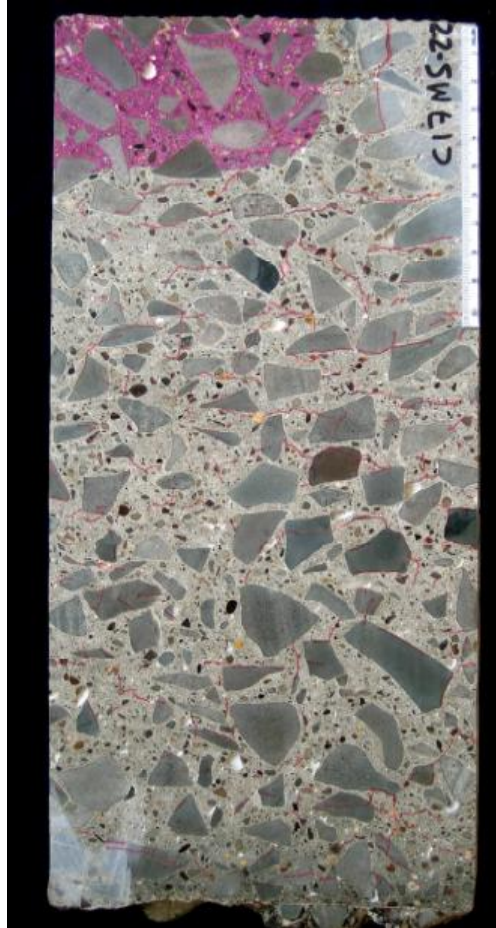
*Figure 66: Development of ASR Gel in Carbonate (Coarse) Aggregate at Depth in Core C17-MS22 of US-22 Murrys ville, Westmoreland County Segment 50 Eastbound.*

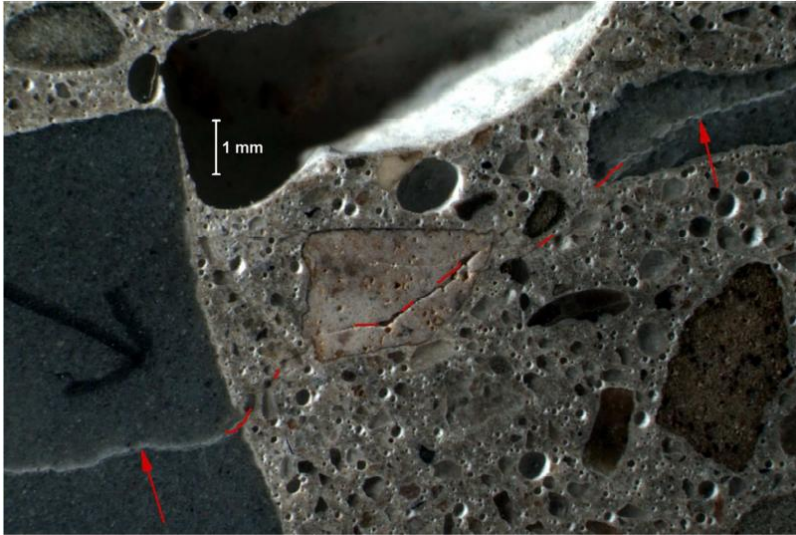
*Figure 68: Influence of ASR on Microstructure of Concrete in Core C17-MS22 of US-22 Murrys ville Segment 50 Eastbound. Magnification 10x*

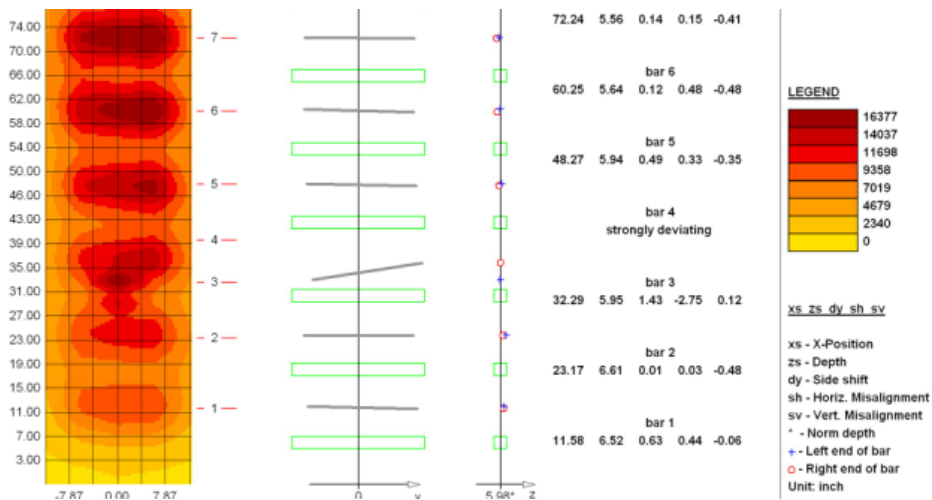
Figure 76: MagnoProof Output Illustrating Misaligned Dowel at Joint 14 of US-22 Murrysville for Segment 50 Eastbound

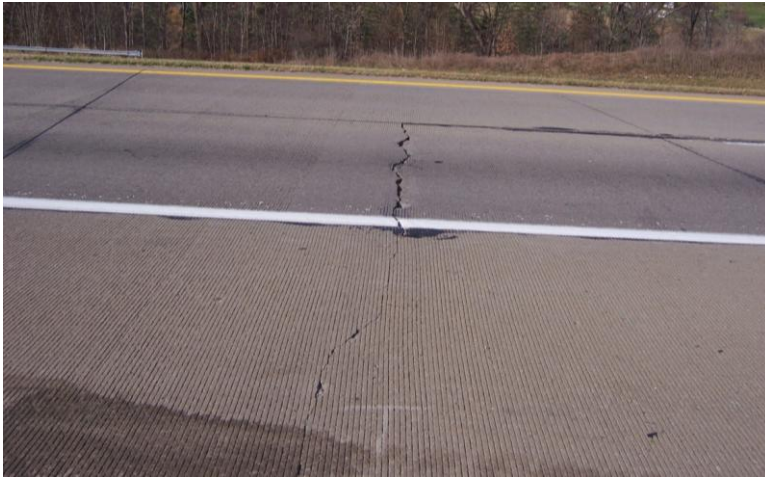
*Figure 87: High Severity Transverse Crack of I 79 Segment 470 Northbound (Distressed Section)*

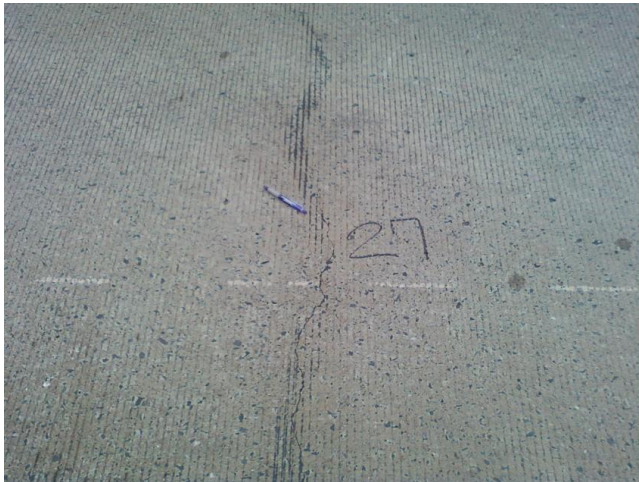
*Figure 122: Low Severity Transverse Crack of I 80 Segment 1914 Eastbound (Distressed Section)*

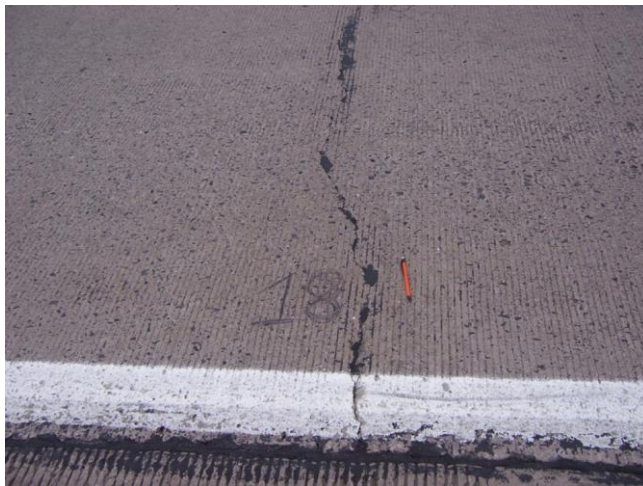
*Figure 123: Medium Severity Transverse Crack of I 80 Segment 1914 Eastbound (Distressed Section)*

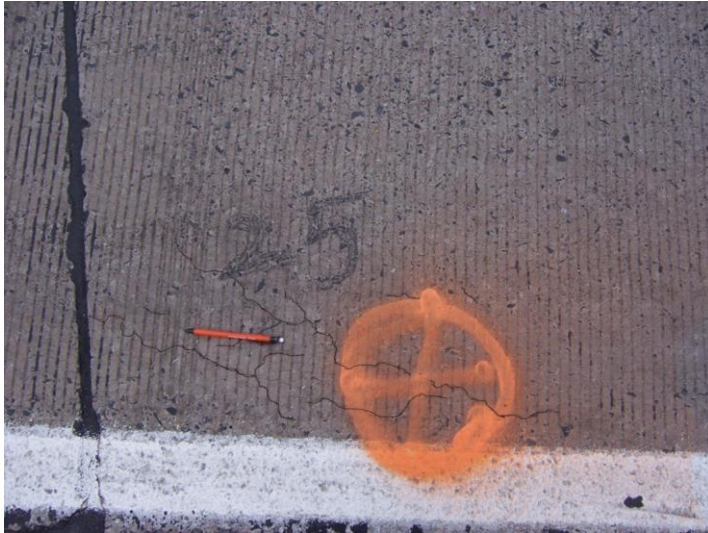
*Figure 125: Digitally Enhanced Map-cracking of I 80 Segment 1914 Eastbound (Distressed Section)*

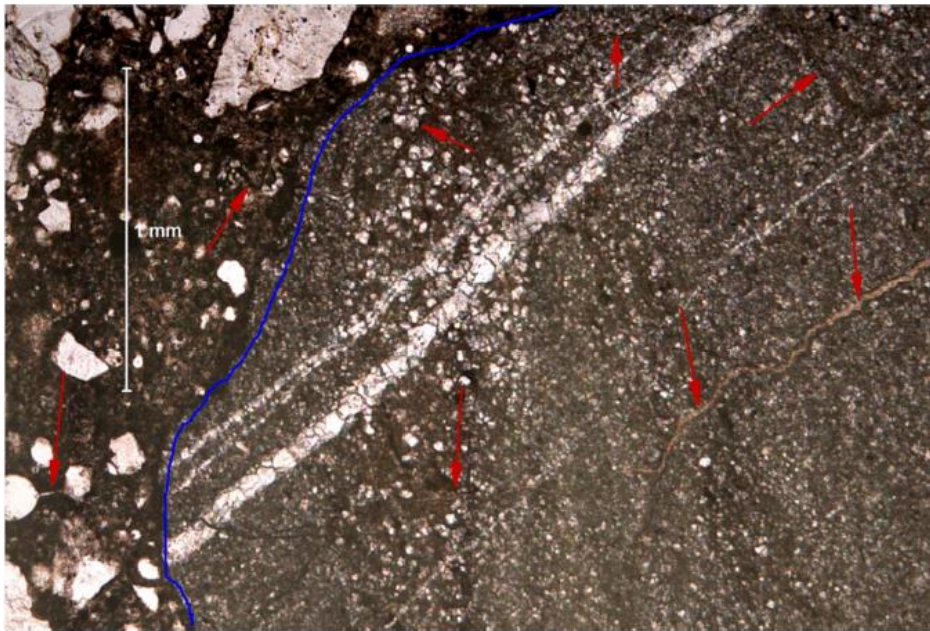
*Figure 145: Development of ASR gel in Carbonate (Coarse) Aggregate of I 80. Magnification*

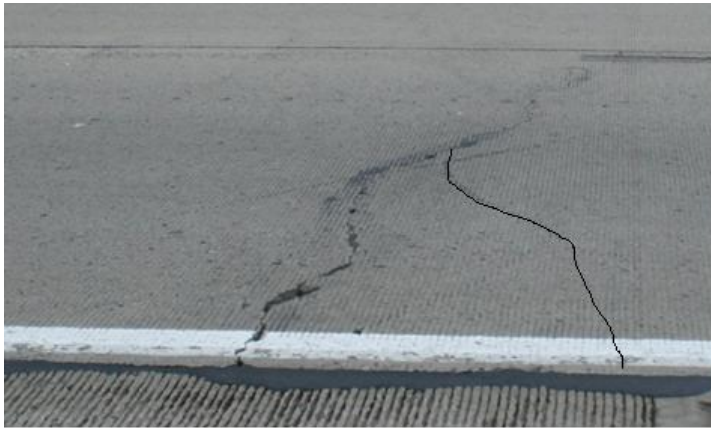
*Figure 151: Medium Severity Transverse Crack with Digitally Enhanced Branching Drying Shrinkage Crack on I 80 Segment 1914 (Distressed Section)*
