**FAILURE OF
REARWARD FACING SEAT-BACKS
AND RESULTING INJURIES
IN A
SURVIVABLE TRANSPORT
ACCIDENT**

FAA-AM 62-7
c. 2

**FEDERAL AVIATION AGENCY,
Civil Aeronautical Research Institute
AERONAUTICAL CENTER
OKLAHOMA CITY, OKLAHOMA**

APRIL 1962

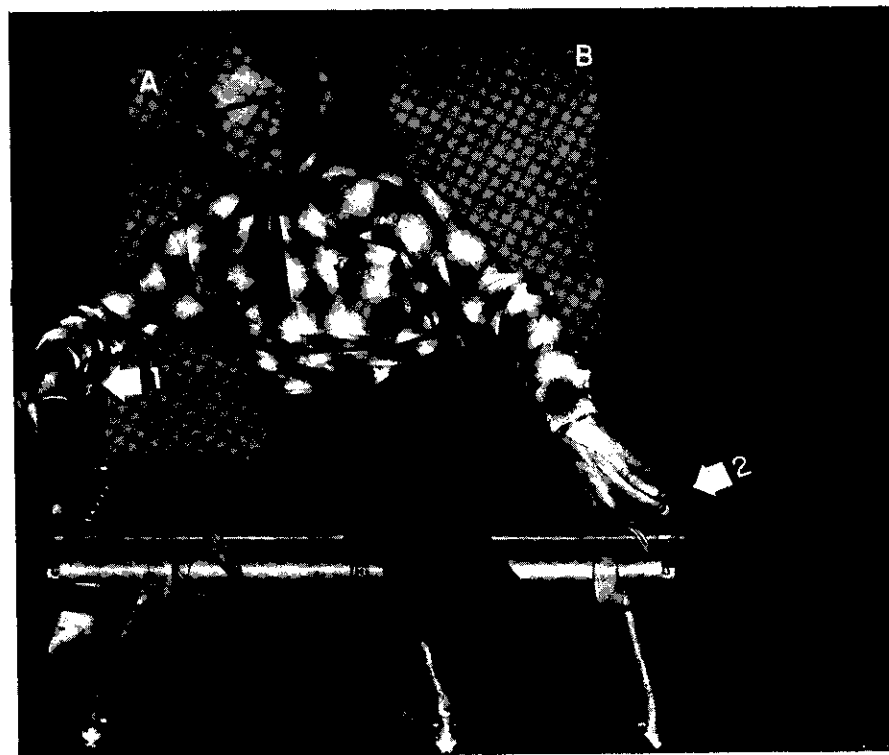
PHOTO 1

One rearward facing survivor who sustained serious spinal injury reportedly was sitting in the position shown, looking out the window toward the No. 1 engine at the time of impact.

Seat-back "A" failed completely at its point of attachment to the load bearing armrest (arrow No. 1). Seat-back "B" although not failing, went through its complete recline range, probably due to inadvertent operation of the recline release lever (arrow No. 2).

There are several possible means of inadvertently unlocking the recline mechanism; (a) the occupant may have had the fingers of his left hand on the release lever at the time of impact (arrow No. 2, photo No. 1) acceleration of his hand could have caused the recline lock to disengage; or (b) if the occupant's leg was in the position shown in photo No. 2 (instead of up over the armrest) acceleration of the knee up against the recline release lever (arrow, photo No. 3) may have caused inadvertent release.

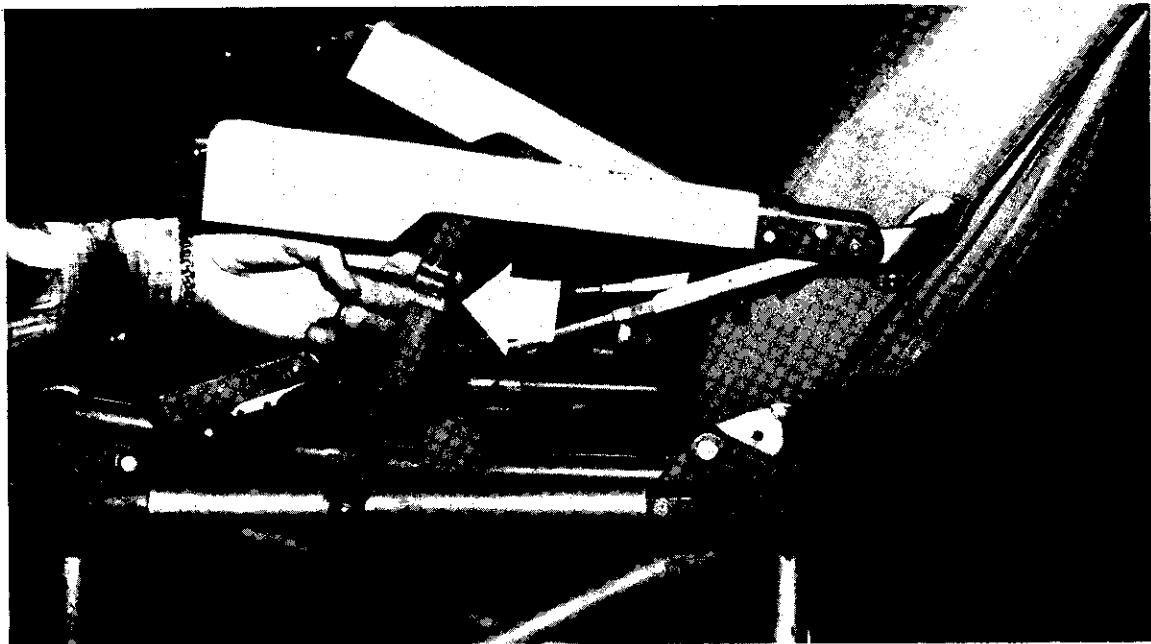
PHOTO 4

The armrest adjacent to, or below, the occupant's left was distorted and its cast support arms were fractured (arrow, photo No. 4) in an outward (toward the aisle) direction.

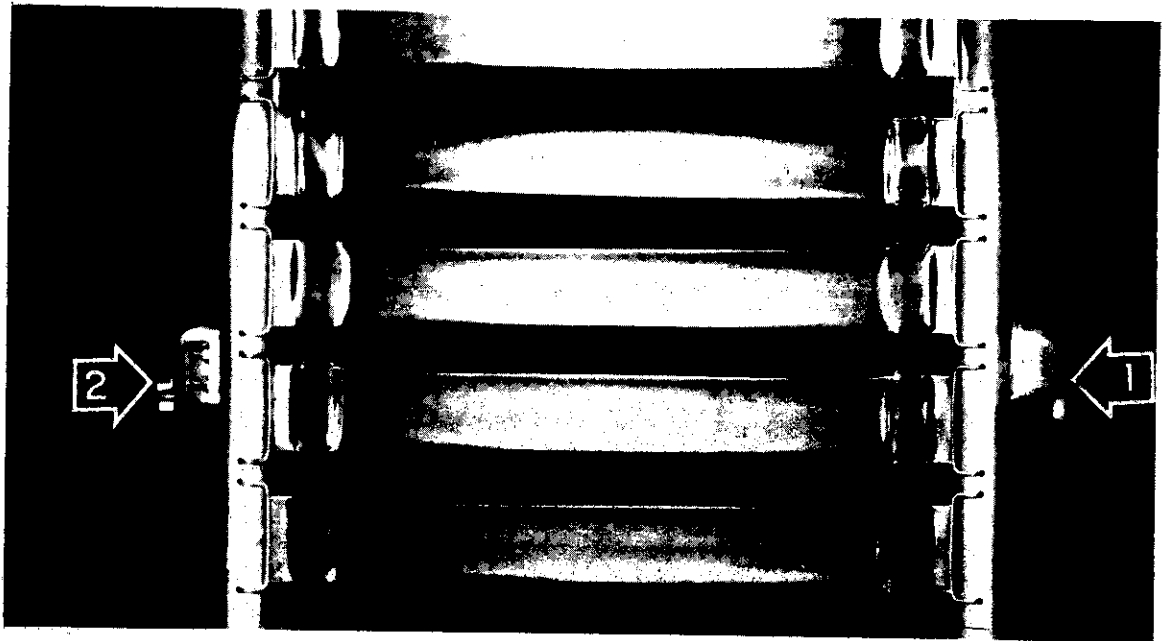
PHOTO 8

The two armrest attachment fittings shown in Photo 8 are dissimilar in strength and somewhat different in appearance. The one on the right (arrow No. 1) is steel and is welded to the lefthand steel seat-back tube. The one on the left (arrow No. 2) is an aluminum alloy casting and is bolted to the righthand seat-back tube.

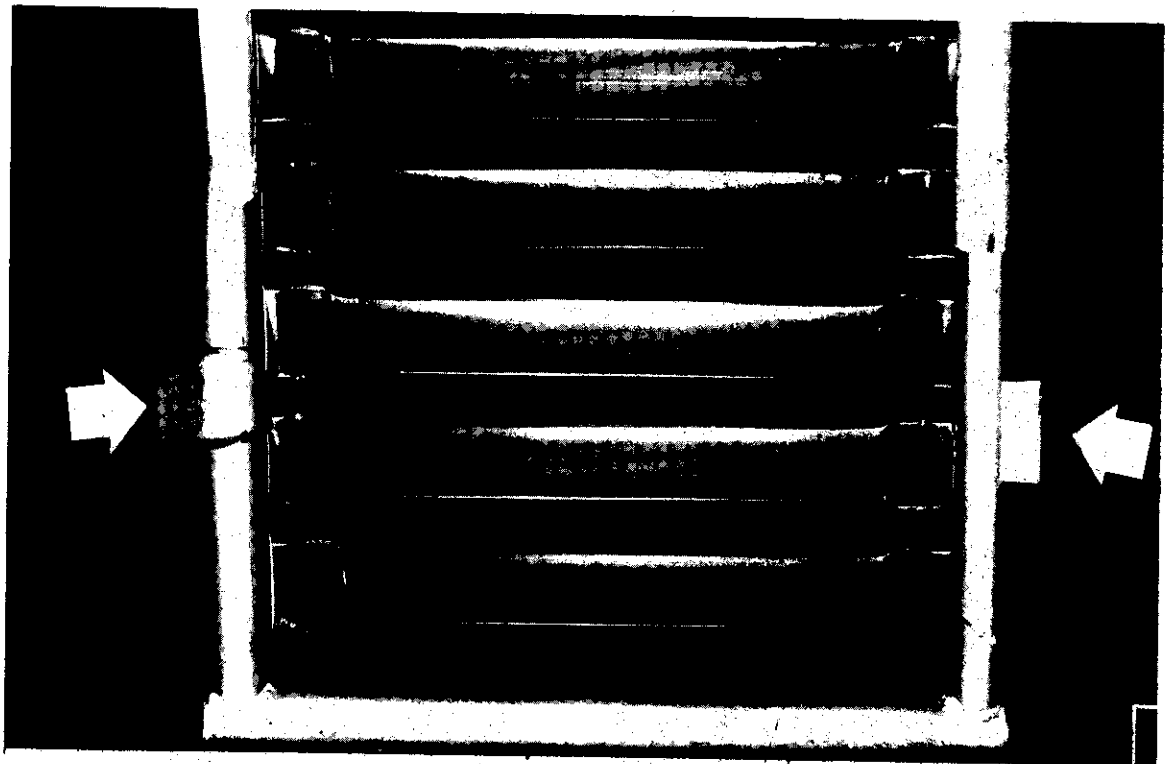
PHOTO 9

The difference of appearance of the fittings is obvious in this rear view of "bare" seat-back structure; however, upholstery tends to hide this difference.

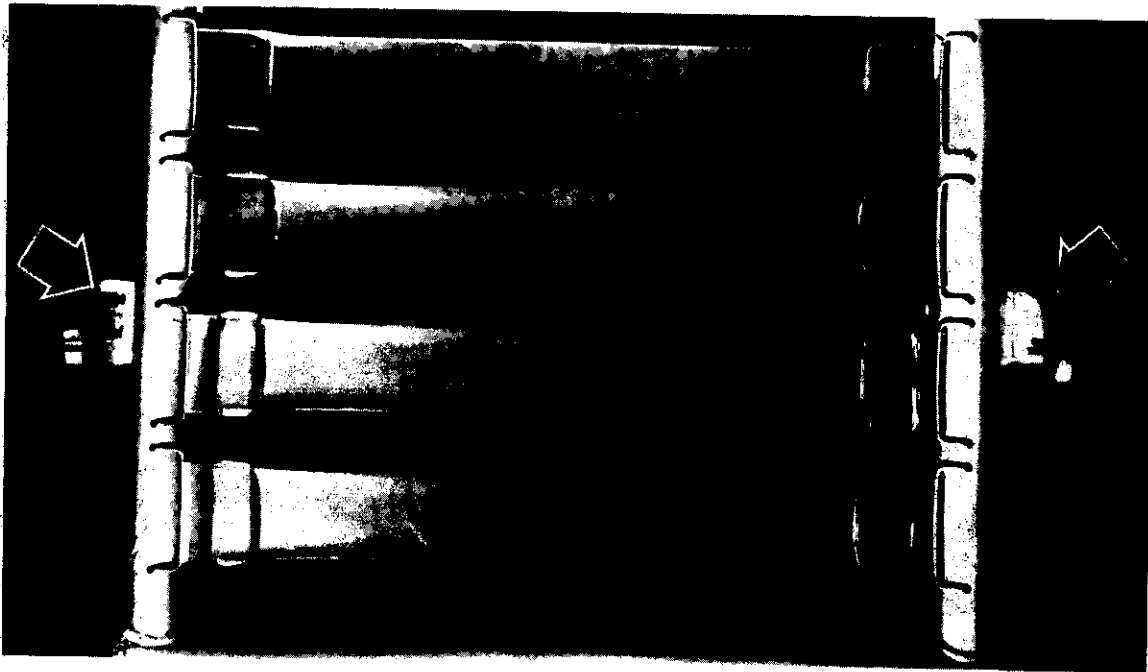
PHOTO 10

Difference of appearance of fittings (looking toward forward side of seat-back) can be seen easily on "bare" seat-back frame; however, upholstery makes close inspection necessary to note difference.

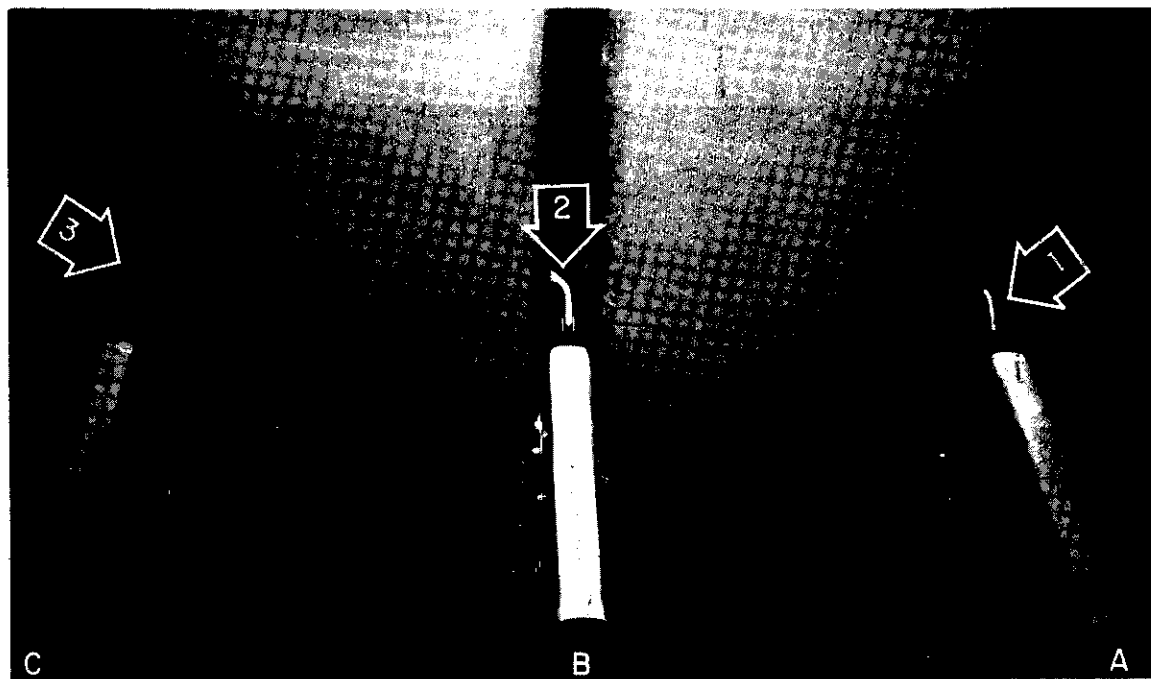
PHOTO 13

Proper installation of armrests is shown here; load bearing armrests "A" and "B" are attached to steel-welded fittings (arrows No. 1 and No. 2). Non-load bearing armrest "C" is attached to aluminum alloy fitting (arrow No. 3).

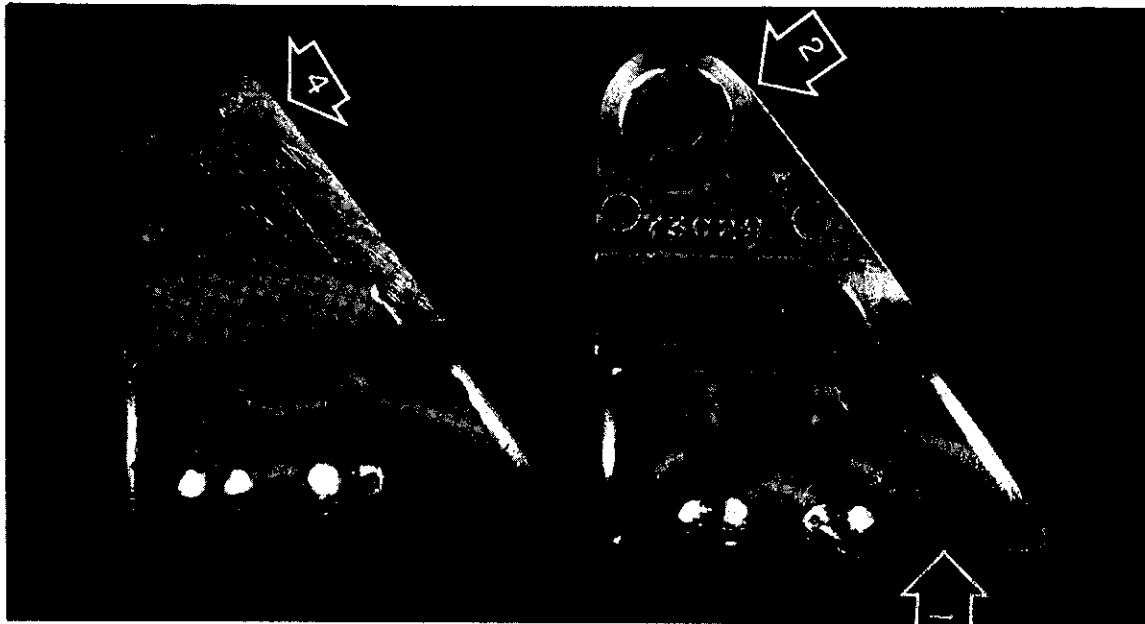
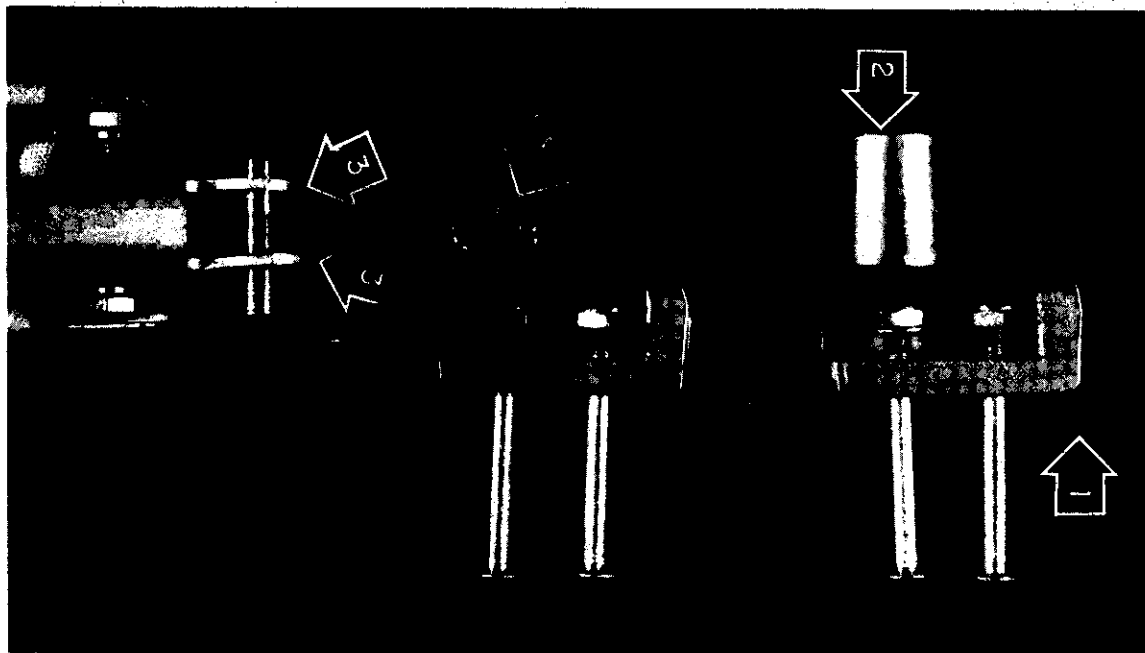
The aluminum alloy fittings, as originally delivered with the seats, are shown by arrows No. 1 in photos 14 and 15. The protruding boss on the original fittings is indicated by arrows No. 2. This boss is of sufficient width to prevent insertion into a load bearing armrest (arrows No. 3).

Field modification — filing — of these fittings (arrows No. 4) was apparently undertaken to permit attachment to the load bearing armrests.

It is recommended that no field alterations be made to any aircraft equipment, including seats, without first obtaining approval of the manufacturer or authorized engineering personnel.
