1. Report No. FHWA/TX-11/0-6120-1		2. Government Accession No.		3. Recipient's Catalog No.	
4. Title and Subtitle TREATMENTS TO REDUCE THE FREQUENCY OF FREEWAY EXIT SIGN HITS				5. Report Date January 2011 Published: June 2011

# **TREATMENTS TO REDUCE THE FREQUENCY OF FREEWAY EXIT SIGN HITS**

Report 0-6120-1

January 2011

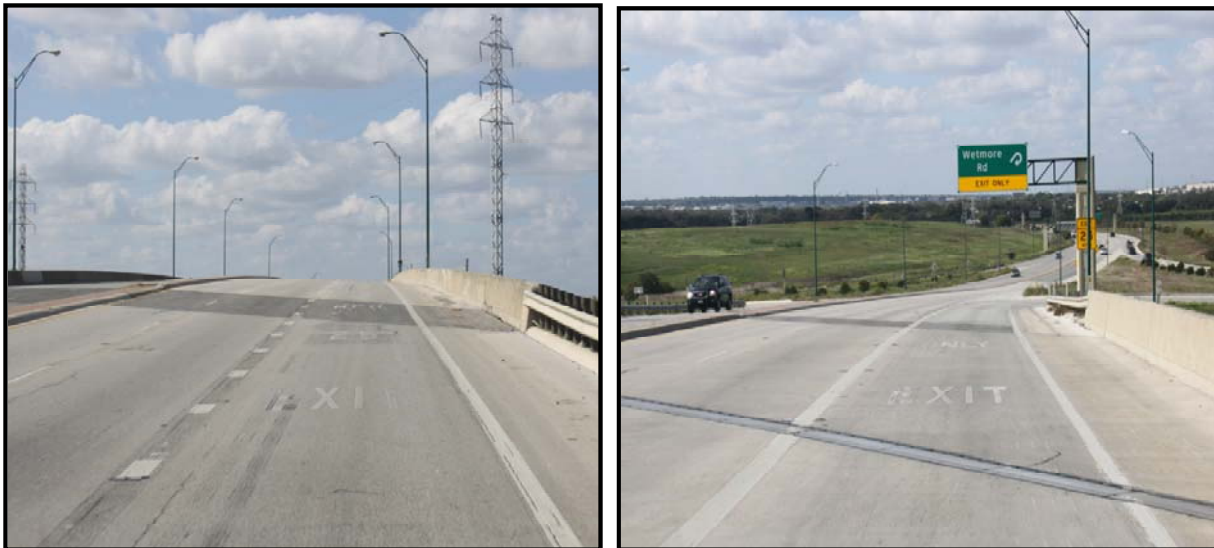
**Figure 18. Example of a Potential Hazard—Steep Grade before an Exit.**

Roadway conditions requiring significant deceleration were also taken into account. These include inadequate superelevation, sharp horizontal curve, steep grade, inadequate shoulder, lane drop, and lane width reductions. Figure 18 illustrates an example of a steep grade approaching an exit. Posted and advisory speeds were recorded and operating speeds were measured for each location. This allowed researchers to determine the adequacy of existing sight distances. Field staff also assessed the visibility of potential hazards at each site.
