DEVELOPMENT OF A MASH TL-3 MEDIAN BARRIER GATE

Research/Test Report 9-1002-2

TEXAS TRANSPORTATION INSTITUTE THE TEXAS A&M UNIVERSITY SYSTEM COLLEGE STATION, TEXAS

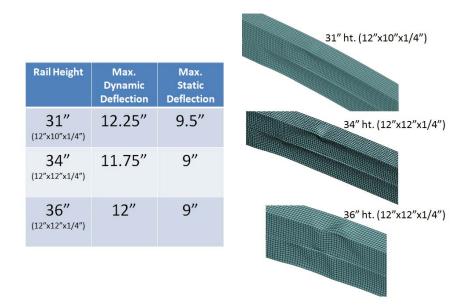
Figure 2.3. Rail Deformation and Deflection Results.

As shown in Figure 2.3, the maximum dynamic deflection and permanent deflection was similar for all three rail configurations. Some localized buckling was observed in the 12-inch \times 12-inch \times 1/4-inch tube.

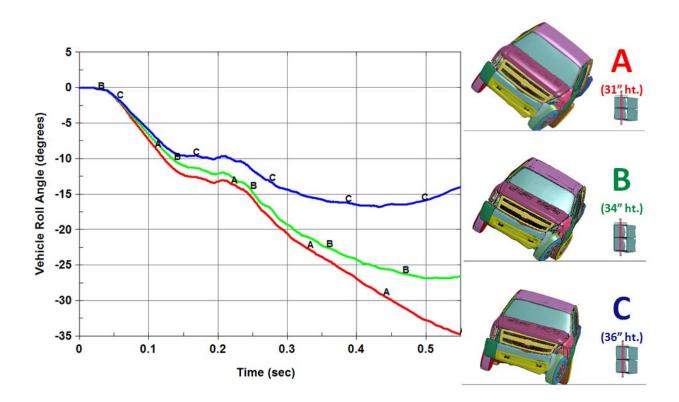
Figure 2.4. Vehicle Roll Angle Results.

Figure 2.4 shows vehicle roll angle versus time. At time of termination of the simulation runs (0.55 seconds), the vehicle roll angle for the 31 inch rail height was 35 degrees and still increasing. Vehicle rollover for this configuration is likely. The vehicle was very stable in the impact with the 36 inch rail height, with a maximum roll angle of only 17 degrees. The vehicle was also successfully redirected in the simulation with the 34 inch rail height, but the vehicle had a higher roll angle of 27 degrees.

Results showed that a 12-inch \times 10-inch tube section was not feasible as a rail member for the new median barrier gate. It was not capable of redirecting the pickup truck in a stable manner at its maximum height of 31 inches. Thus, further evaluation efforts focused on the 12-inch \times 12-inch steel tube sections.

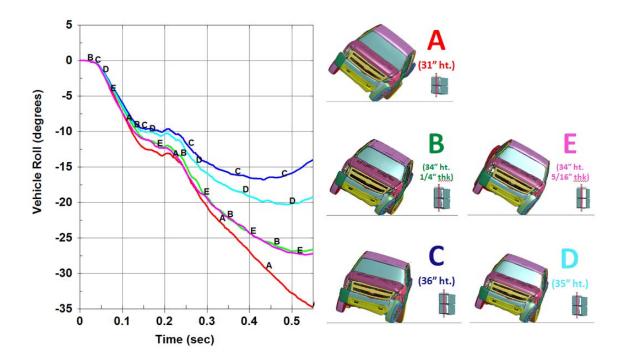
Figure 2.5. Predicted Vehicle Roll Outcomes for Different Rail Configurations.

Figure 2.5 shows vehicle roll angle versus time for these additional simulations superimposed on the results from the previous simulations. Results from the two cases with different rail thickness (cases B and E) are similar in terms of vehicle roll angle, indicating that the increase in rail thickness did not affect vehicle stability. Consequently, there was no compelling reason to adopt a thicker, heavier, more costly rail section. It was concluded that the 12-inch \times 12-inch \times 1/4-inch tube section was the optimal choice as a rail member for the new median barrier gate. Not only does it provide adequate strength to contain and redirect the pickup truck, it is a lighter and less expensive section than the 8-inch \times 8-inch \times 1/2-inch tube section used in the EOS (refer to Table 2.1).

The rail height selected for the new median barrier gate was 35 inches. The pickup truck was stably redirected at this rail height as shown in Figure 2.5. Further, this is the maximum height that can be achieved with the stacked 12-inch \times 12-inch \times 1/4-tubes when constrained by a maximum clear opening of 11 inches between the ground and bottom of the rail to reduce potential for vehicle snagging.

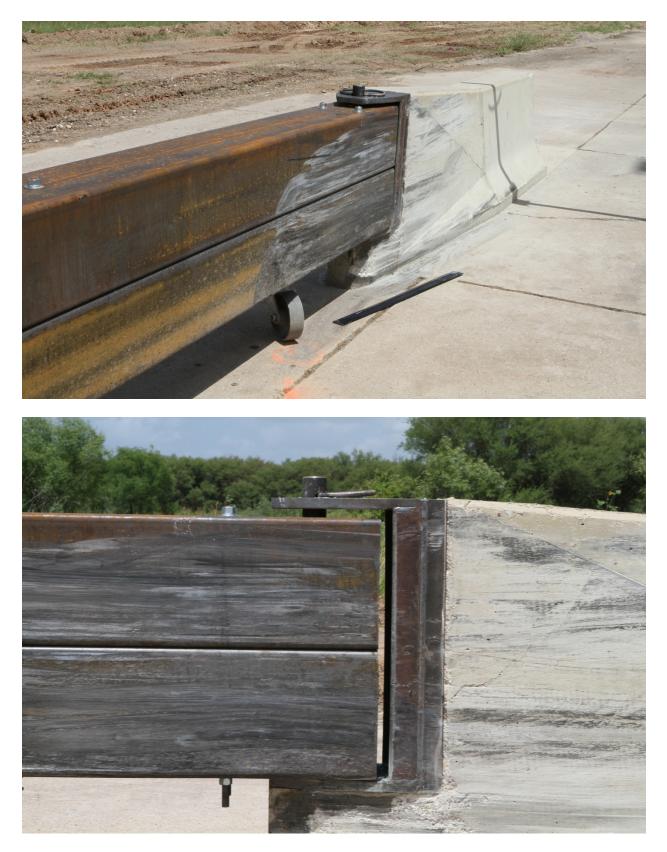
Figure 6.4. TxDOT Median Barrier Gate after Test No. 420020-6.

Damage to the gate itself was only cosmetic and consisted of scuff marks as shown in Figures 6.3 and 6.4. The end of the upstream concrete parapet sustained two thin stress cracks on the field side. Minor concrete spalling was observed on the field side of the end of the downstream concrete parapet. No rebar was exposed and the spall was considered to be cosmetic in nature. The vehicle was in contact with the installation 10.2 ft. No measurable dynamic or permanent deflection was noted.

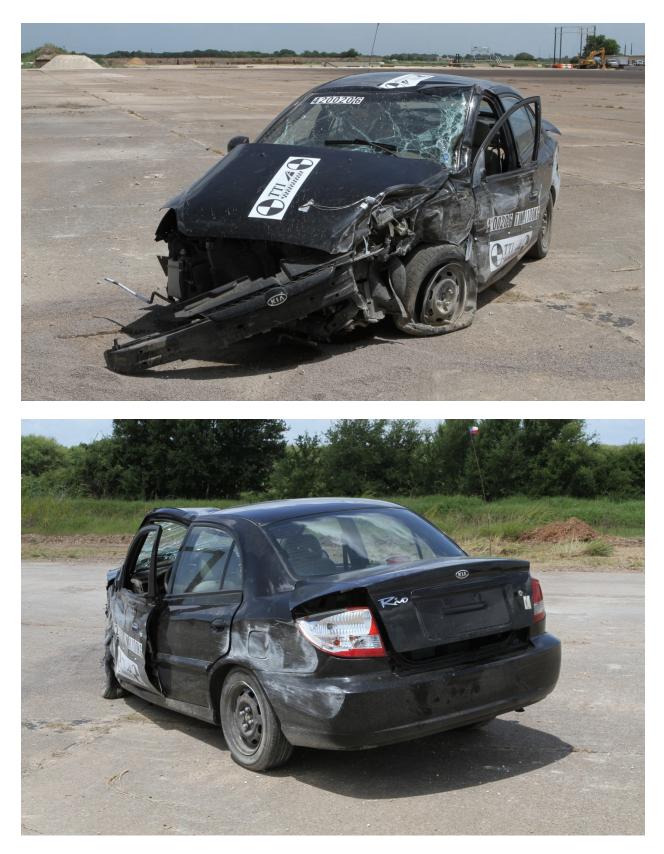
Figure 6.5. Vehicle after Test No. 420020-6.

As shown in Figure 6.5, the vehicle sustained damage to the front and left side. The left front strut, strut tower, and A-post were deformed. Also damaged were the front bumper, hood, grill, radiator and support, left front fender, left front tire and wheel rim, left front door and glass, the left rear door, and left rear quarter panel. The roof was deformed and the windshield sustained stress cracking. Maximum exterior crush to the vehicle was 12.0 inches in the side plane at the left front corner at bumper height. Maximum occupant compartment deformation was 3.0 inches in the firewall area near the toe pan on the driver side. Figure 6.6 shows photographs of the interior of the vehicle. Exterior crush and occupant compartment deformation measurements are provided in Appendix C, Tables C1 and C2.

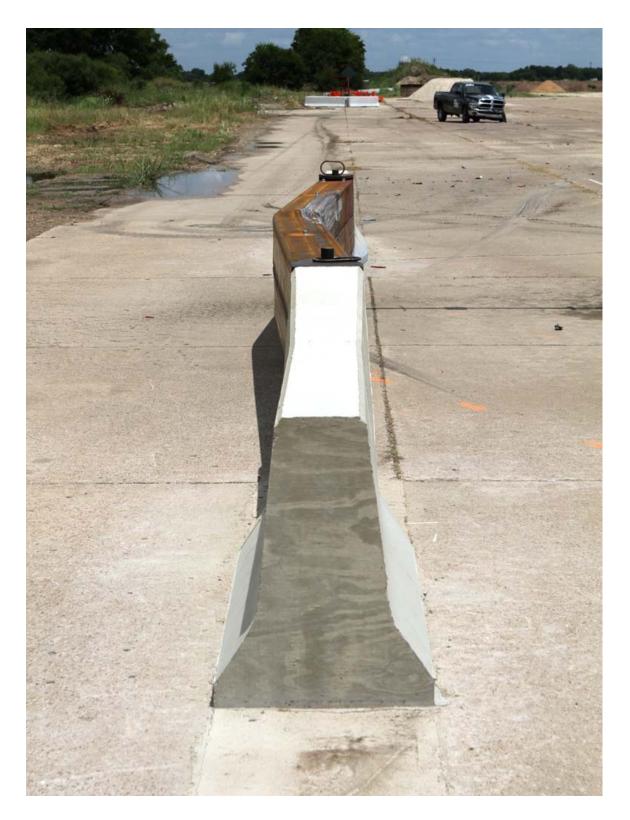
Figure 7.3. Vehicle/Gate Positions after Test No. 420020-7.

The steel barrier gate sustained moderate damage as shown in Figures 7.3 and 7.4. The traffic faces of the steel tubes were deformed inward and the tubular rails were buckled near midspan. There was no damage noted to the concrete parapets. The vehicle was in contact with the installation a distance of 14.9 ft. Working width was 1.1 ft. Maximum dynamic deflection of the median barrier gate during the test was 1.1 ft, and maximum permanent deformation was 0.8 ft.

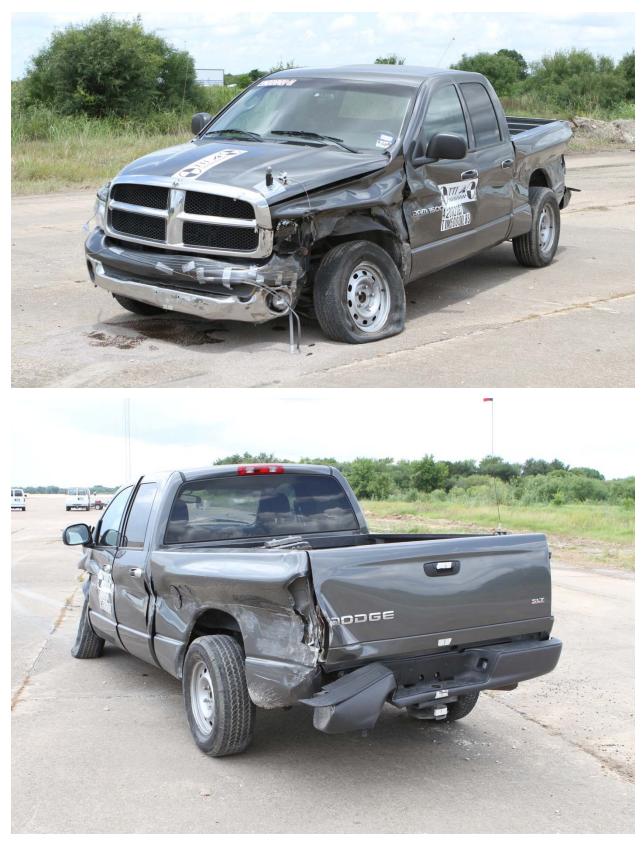
Figure 7.5. Vehicle after Test No. 420020-7.

As shown in Figure 7.5, the majority of the damage sustained by the 2270P vehicle was to the left front corner and above the top wheel line along the left side. The left upper A-arm was deformed. Also damaged were the front bumper, grill, left front fender, left front tire and wheel rim, left front and rear doors, rear of the cab, left exterior bed, left rear wheel rim (no loss of air in the tire), rear bumper, and tailgate. Maximum exterior crush to the vehicle was 12.0 inches in the side plane in the left front corner at bumper height. Maximum occupant compartment deformation was 0.5 inches across the cab at hip level on the driver side. Figure 7.6 shows photographs of the interior of the vehicle. Exterior crush measurements and occupant compartment deformation are provided in Appendix C, Tables C4 and C5.

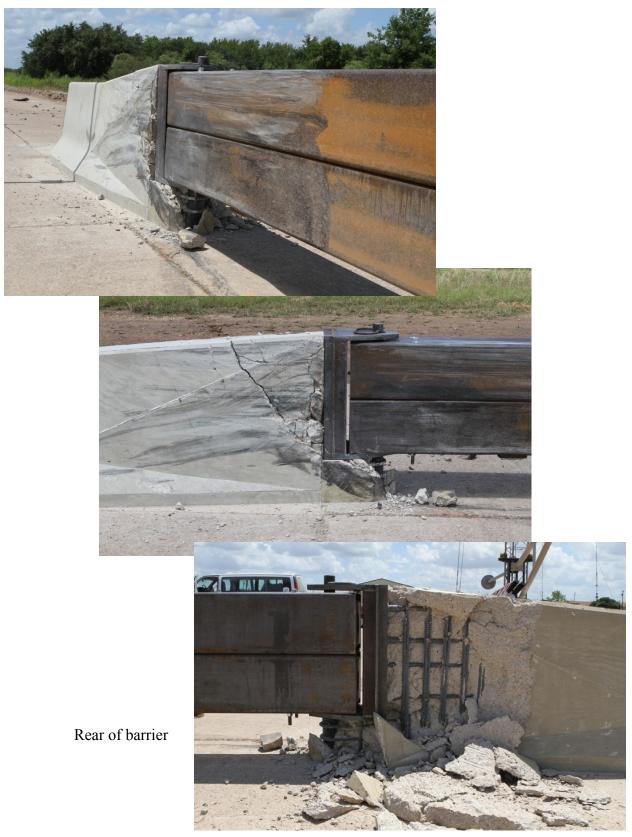
Figure 8.4. Installation after Test No. 420020-8.

The lower toe and end of the concrete barrier sustained significant damage, as shown in Figures 8.3 and 8.4. The concrete was cracked and fell away from the reinforcement in the toe of the concrete barrier and also from the field side of the barrier. The concrete on the end of the traffic face of the barrier was cracked, but remained in place. The end bracket was pushed toward the field side 1.0 inch. Tire marks were present along the traffic face of the steel gate and traffic face of the concrete barrier for a distance of 11.75 ft. Working width, maximum dynamic deflection, and maximum permanent deformation were 1.25 inches.

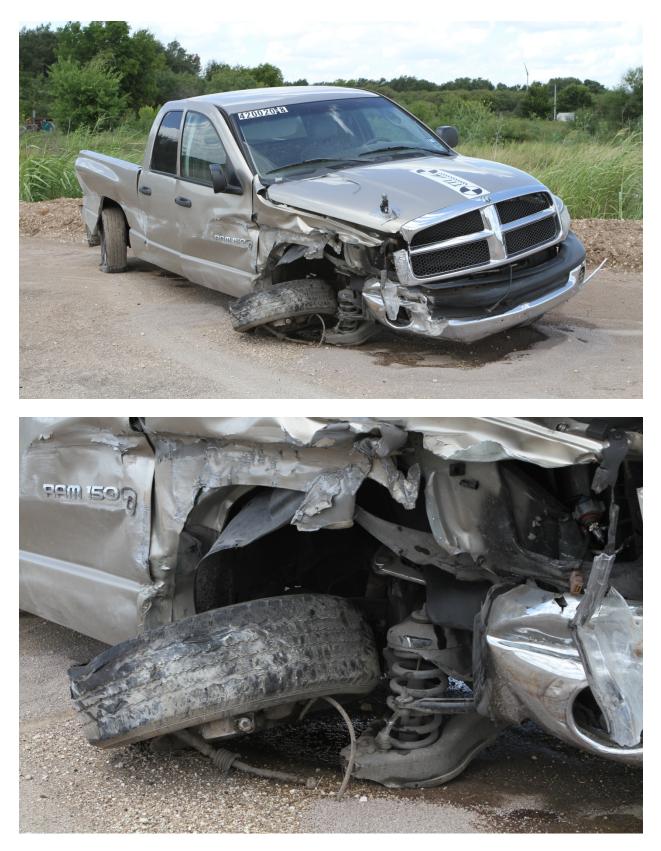
Figure 8.5. Vehicle after Test No. 420020-8.

Figure 8.5 shows the damage to the vehicle, which was mostly in the right front quarter in the side plane. The right upper and lower ball joint, right tie rod end, right frame rail, right front upper and lower A-arms, drive shaft, rear axle, and rear U-bolts and springs were damaged. Also damaged were the front bumper, hood, grill, right front fender, right front tire and wheel rim, right front and rear doors, right rear cab, right rear exterior bed, right rear tire and wheel rim, rear bumper, and tailgate. The windshield sustained stress cracks. Maximum exterior crush to the vehicle was 19 inches in the side plane at the right front corner at bumper height. Maximum occupant compartment deformation was 5.25 inches in the right firewall area near the toe pan on the front passenger side. Figure 8.6 shows photographs of the interior of the vehicle. Exterior crush and occupant compartment deformation are provided in Appendix C, Tables C7 and C8.
