1. Report No. FAA AM- 72-7		2. Government Accession No.		3. Recipient's Catalog No.	
4. Title and Subtitle EVALUATION OF A FIBERGLASS INSTRUMENT GLARE SHIELD FOR PROTECTION AGAINST HEAD INJURY				5. Report Date February 1972

6. Performing Organization Code	
7. Author(s) E. D. Langston John J. Swearingen, D. Av. T.				8. Performing Organization Report No.	
9. Performing Organization Name and Address FAA Civil Aeromedical Institute P. O. Box 25082 Oklahoma City, Oklahoma 73125				10. Work Unit No.

# EVALUATION OF A FIBERGLASS INSTRUMENT GLARE SHIELD FOR PROTECTION AGAINST HEAD INJURY

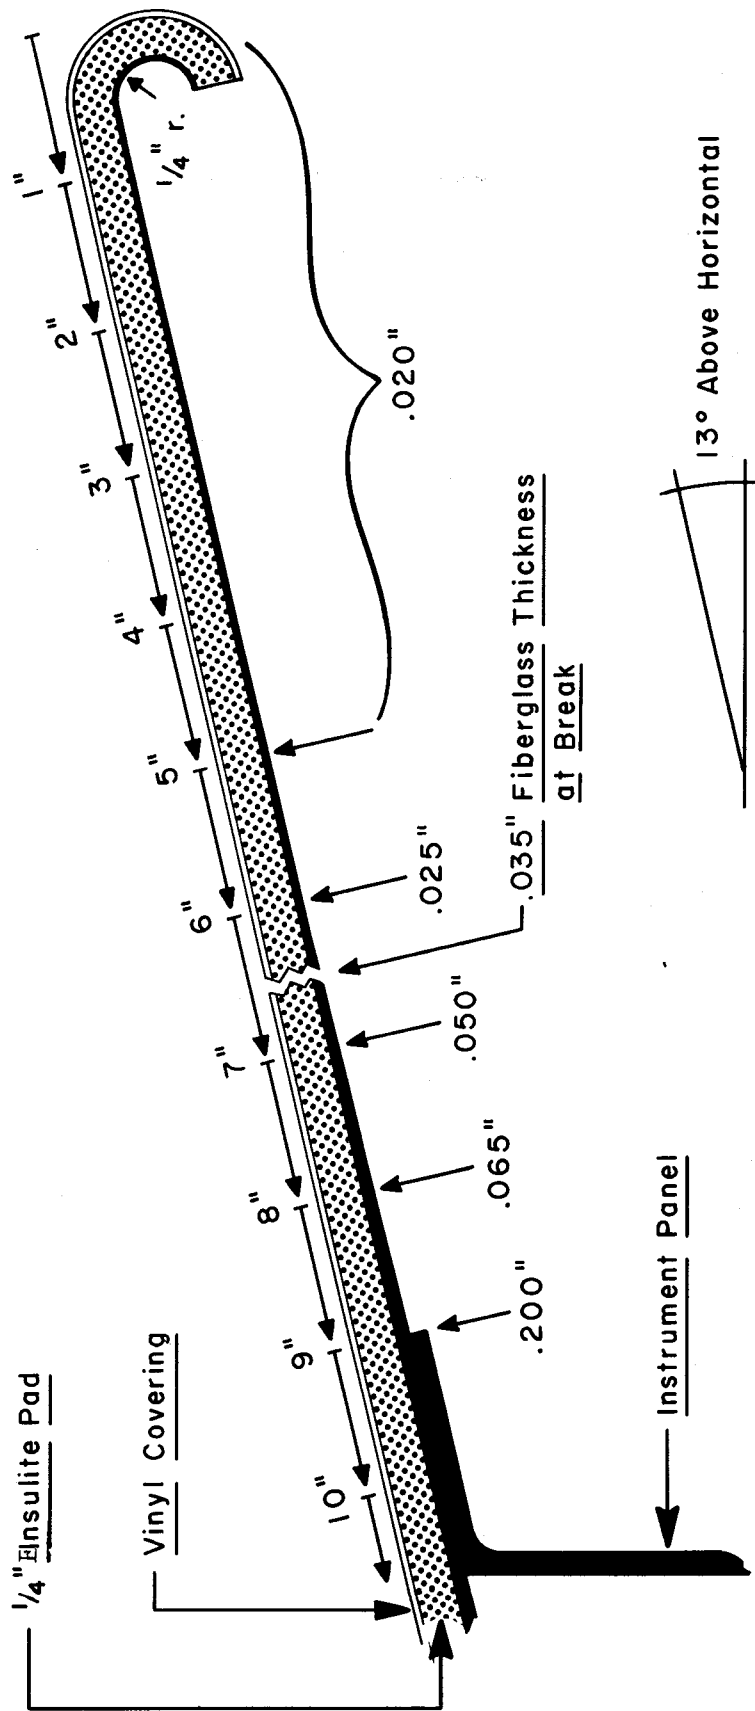
The glare shield shown in Figure 3 consisted of a basic structure of a thin fiberglass layer covered with a 1/4-inch thick layer of Ensolite and a thin layer of plastic vinyl. It extended 9 1/2 inches from the instrument panel toward the pilot and was elevated about 13 degrees above the horizontal. On the protruding edge nearest the pilot the shield was rolled down and under with an inside radius of curvature of approximately 1/4-inch. After impact testing had been completed, the covering was removed from a portion of the shield so that the thickness of the fiberglass could be measured. The first five inches (nearest the pilot) were of a uniform thickness of .020 inches, increasing to 0.025 inches at six inches, to .050 inches at seven inches, and .065 at eight. At nine inches the thickness abruptly increased to 0.200 inches due to the lap with the instrument panel.

FIGURE 3. Cross section of the glare shield showing thicknesses at various points.

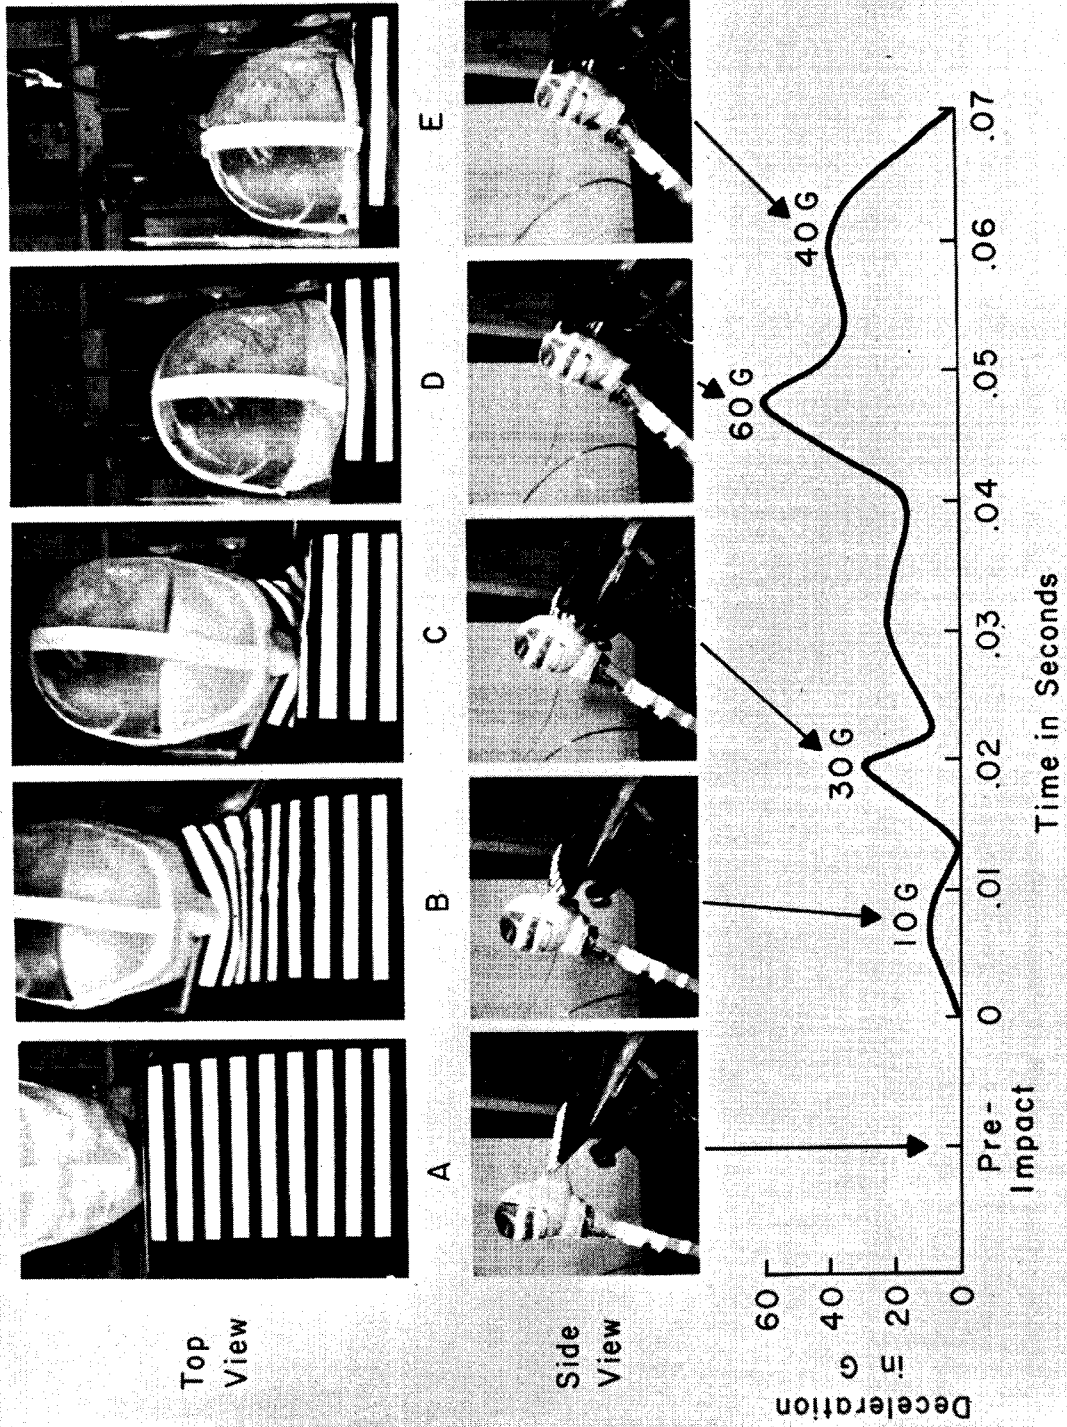
Figure 4 presents a pictorial sequence of events correlated with deceleration measured during Test One (30 ft./sec. head impact velocity). The initial head contact with the edge of the glare shield was with the maxilla just below the

nose producing an initial deceleration peak of 10 G's followed by a second peak of 30 G's as the shield began to collapse. Chalk deposited on the head form from the edge of the glare shield during this phase of the impact was lifted by means of masking tape and the area of facial contact determined to be 3.75 square inches. Based on previous research,<sup>7</sup> it appears unlikely that major facial fractures would occur during this initial head impact. From 0.025 seconds to 0.04 seconds, the glare shield folded down over the instruments and prevented head contact with them. However, beginning at about 0.04 seconds, the fiberglass broke about 6½ inches from the edge of the glare shield. The thin edge of the shield, supported by the instrument panel flange penetrated the ¼-inch padding and cut the rubber head form covering, as shown in Figures 5 through 8. A peak head form deceleration of 60 G's was produced as the rigid head form contacted this thin edge. In Reference 7 it is stated that the forehead can tolerate 80 G's on one square inch without bone fracture. If we assume that the forehead contacted a four-inch length of this 0.035-inch-thick fiberglass edge, we can calculate a contact area of 0.14 square inch and any impact deceleration in excess of 12 G's would be expected to produce

FIGURE 4 Results of a 30-ft./sec. head impact against the fiberglass glare shield.

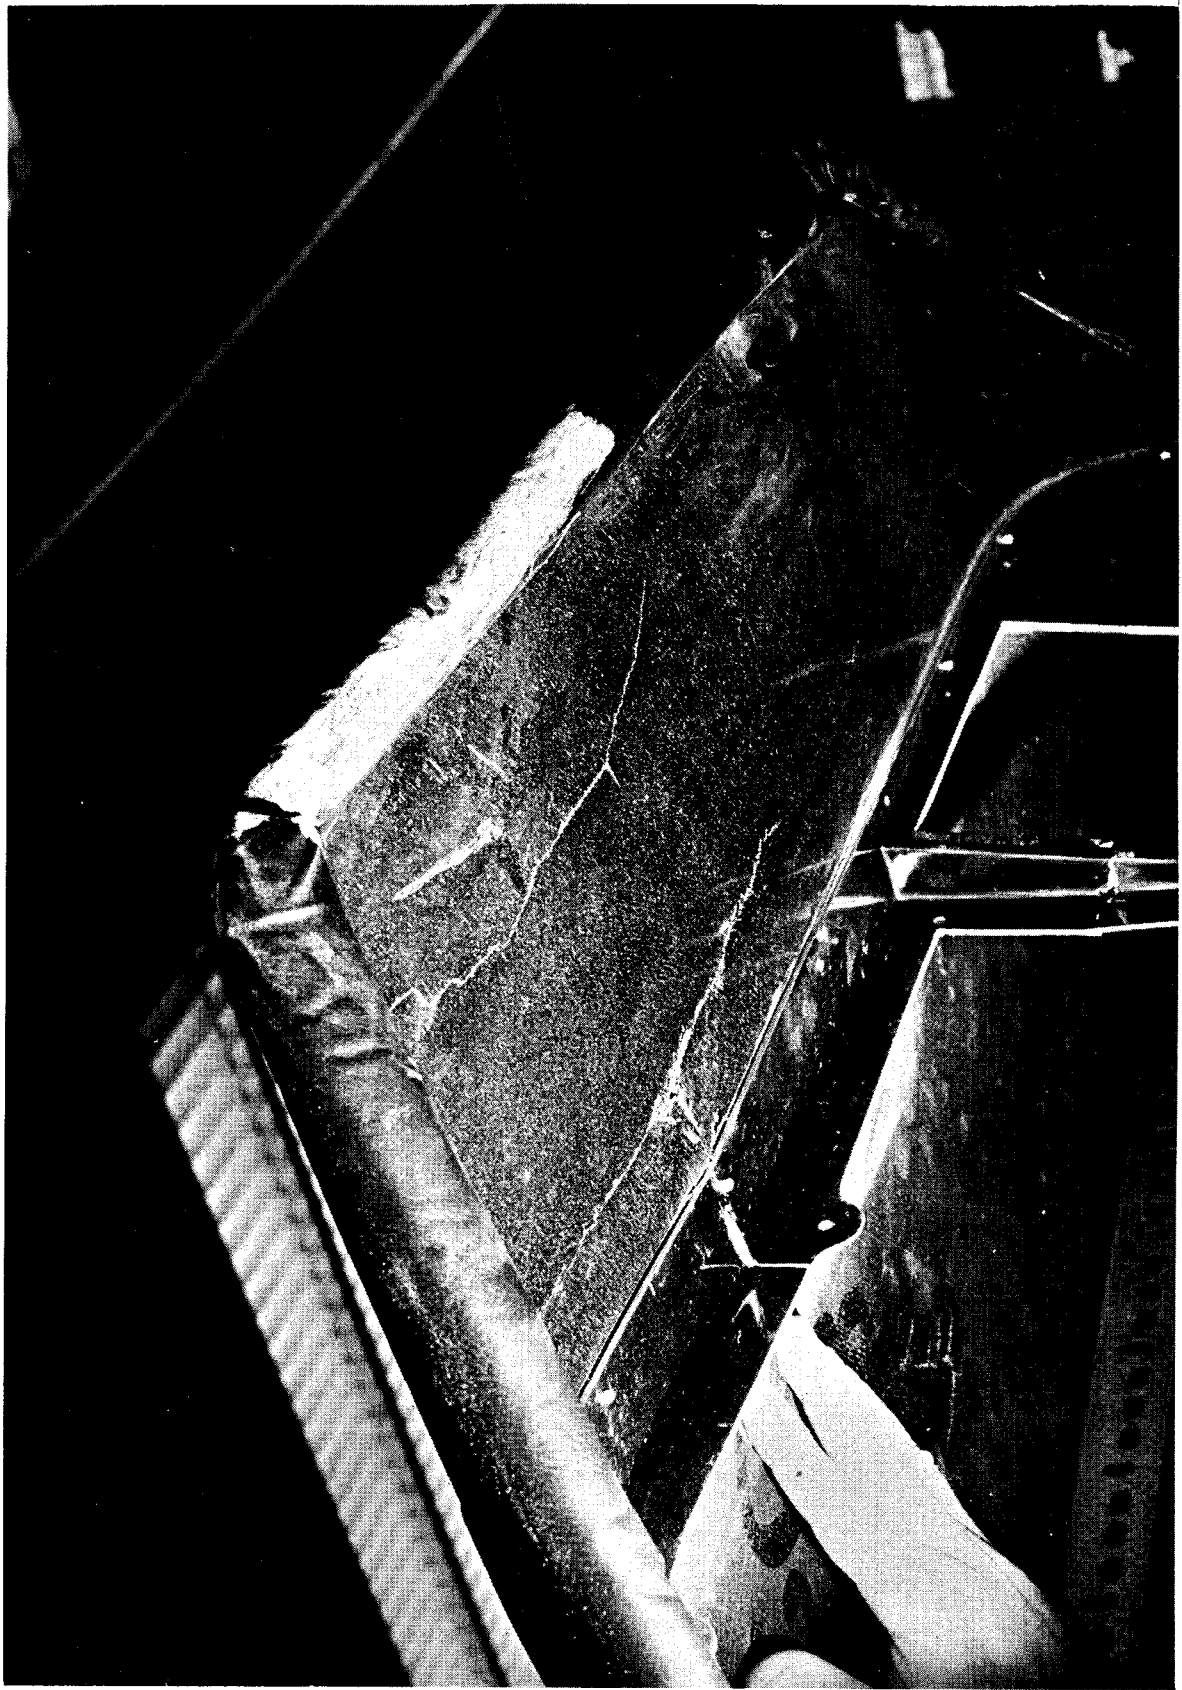
FIGURE 6. Lower view showing fractures in fiberglass.

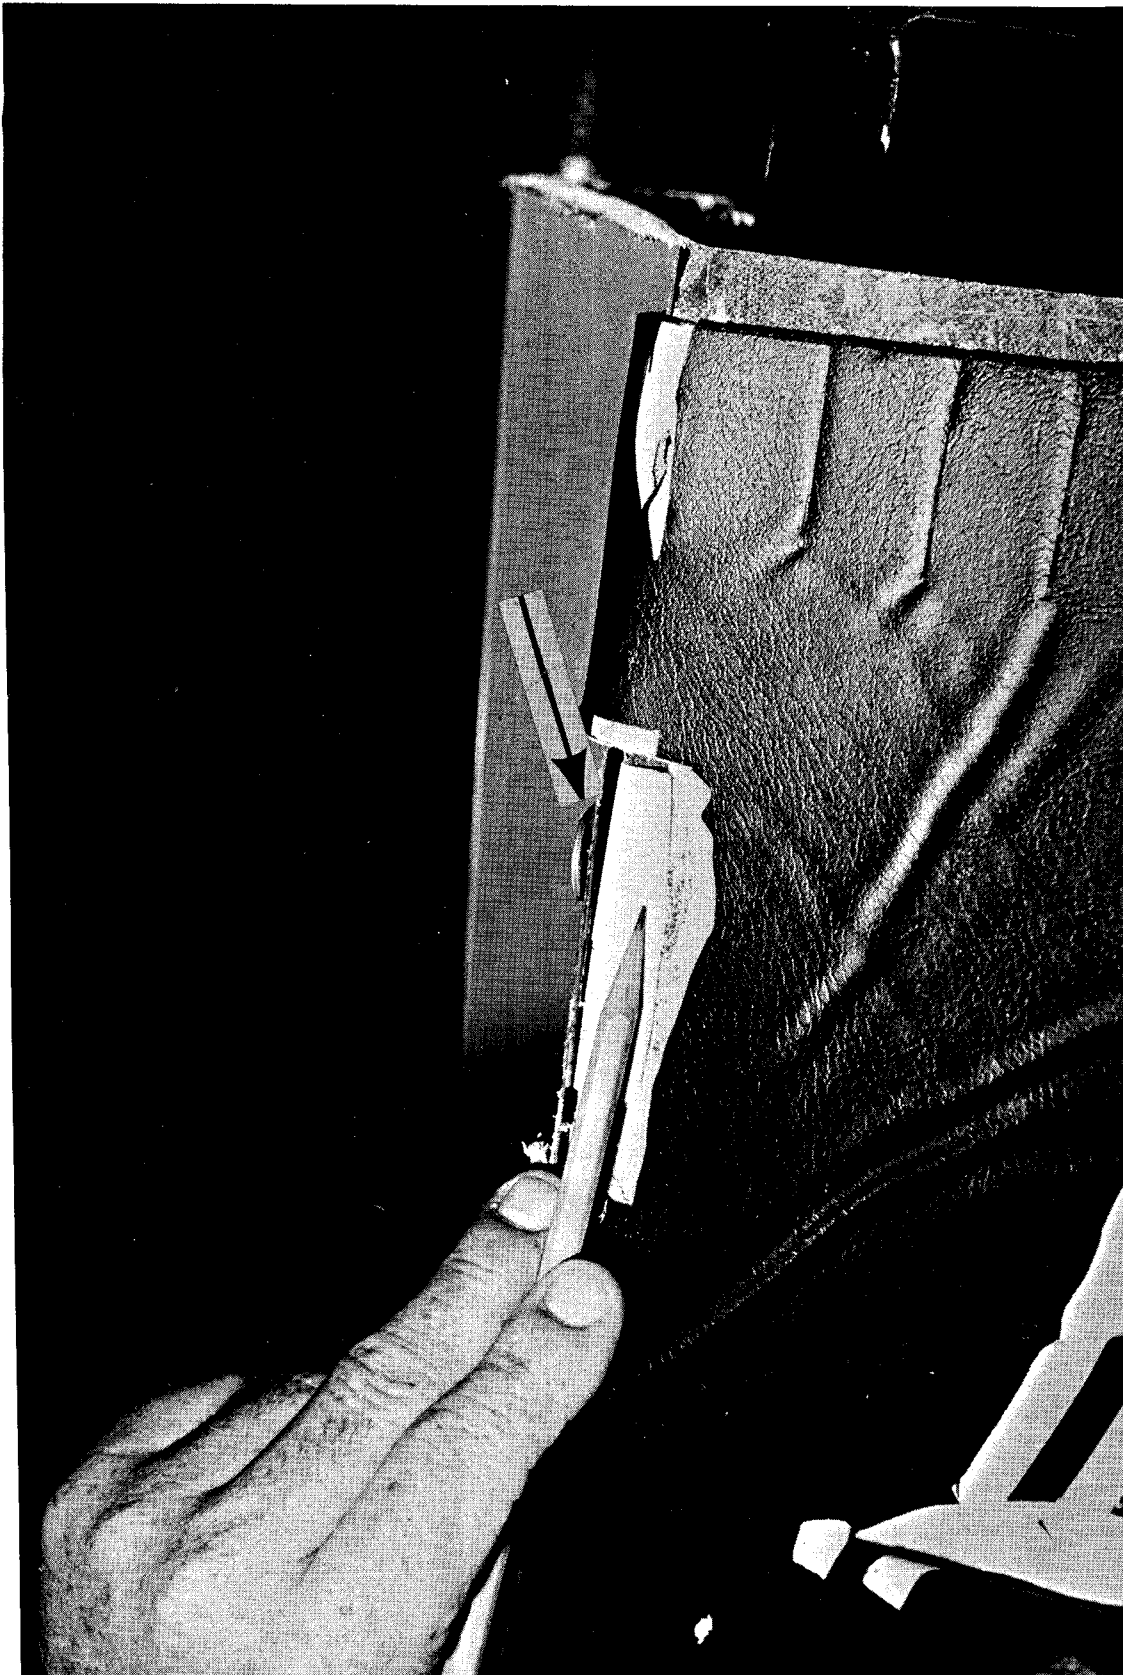
FIGURE 7. Fiberglass edge at break (see arrow). Dime is shown for thickness reference.

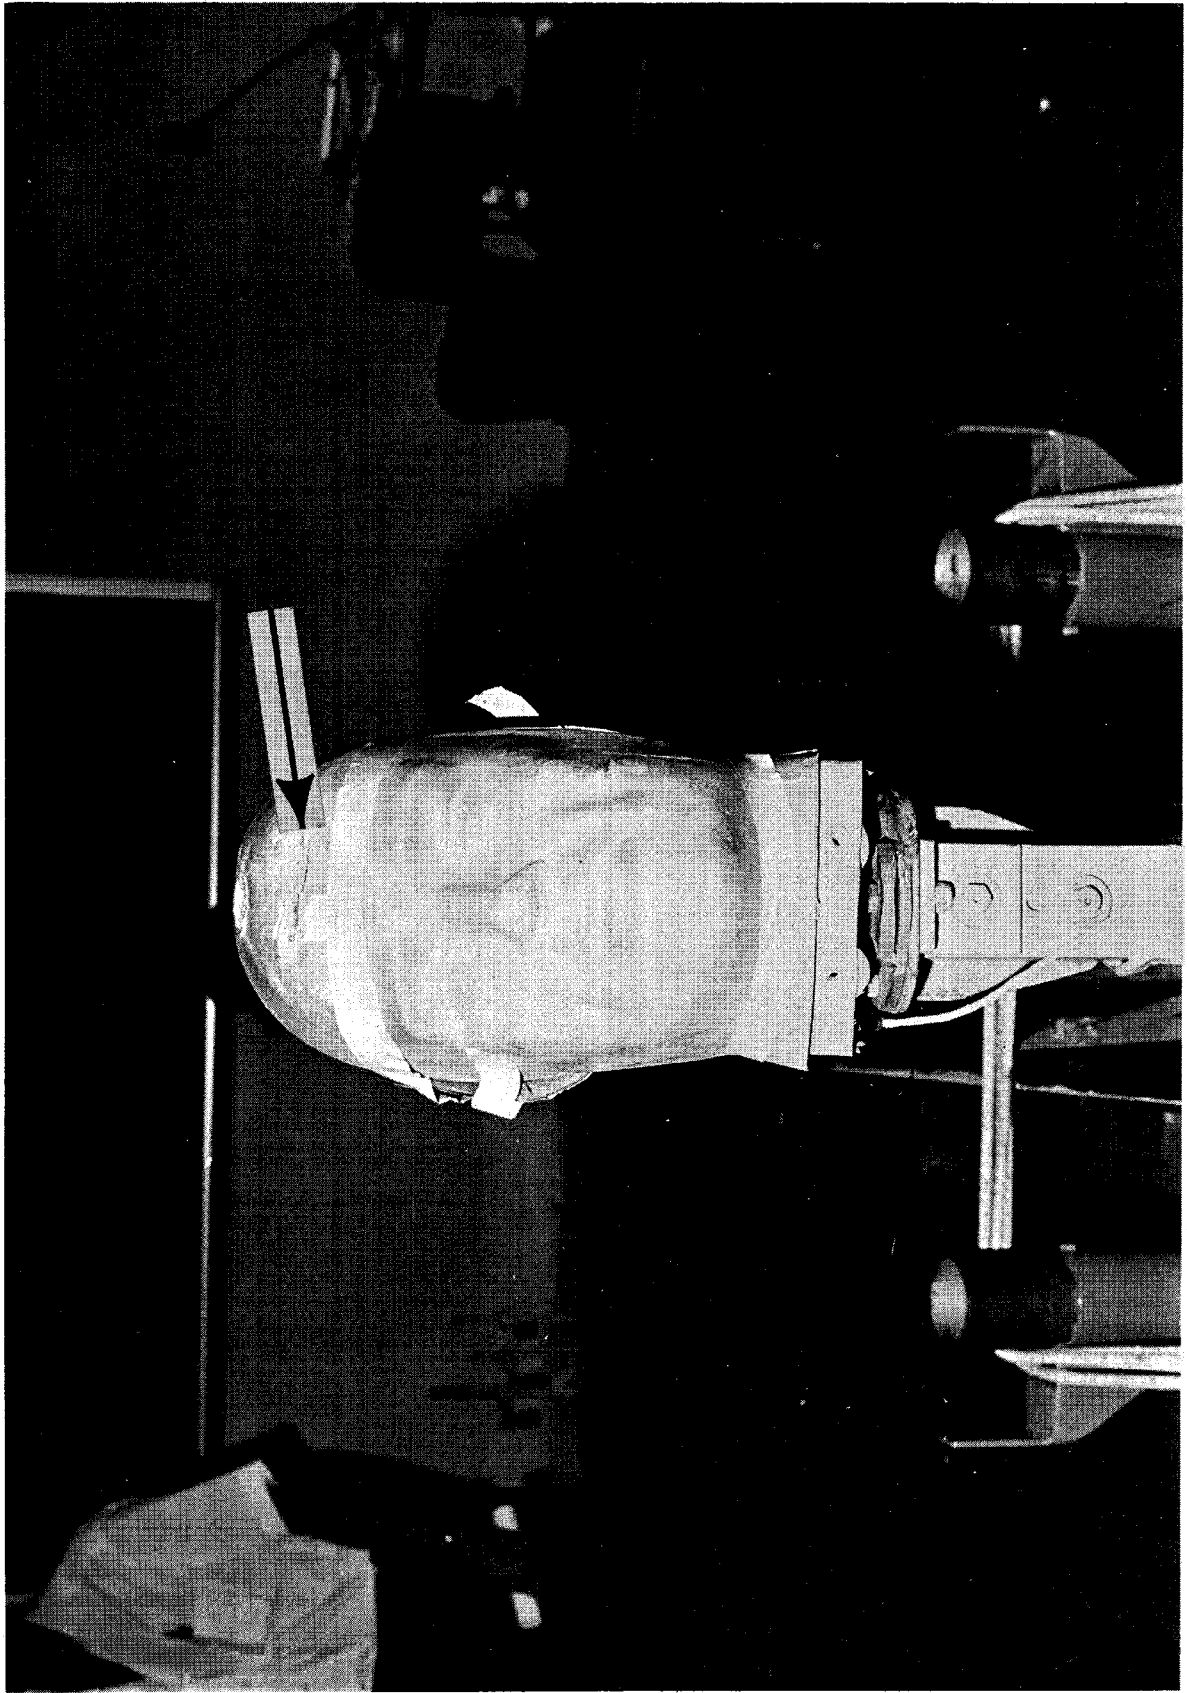
injuries. The impact of 60 G's in this test would produce severe lacerations (Figure 8) and extensive fracture of the anterior cranium.

Fracture in rubber covering on dummy head forehead from impacting broken fiberglass.
