1. Report No. FAA-AM-73-1		2. Government Accession No.		3. Recipient's Catalog No.	
4. Title and Subtitle APPLICATION OF COMMERCIAL AIRCRAFT ACCIDENT INVESTIGATION TECHNIQUES TO A RAILROAD DERAILMENT.			5. Report Date January 1973		6. Performing Organization Code

APPLICATION OF COMMERCIAL AIRCRAFT ACCIDENT INVESTIGATION TECHNIQUES TO A RAILROAD DERAILMENT

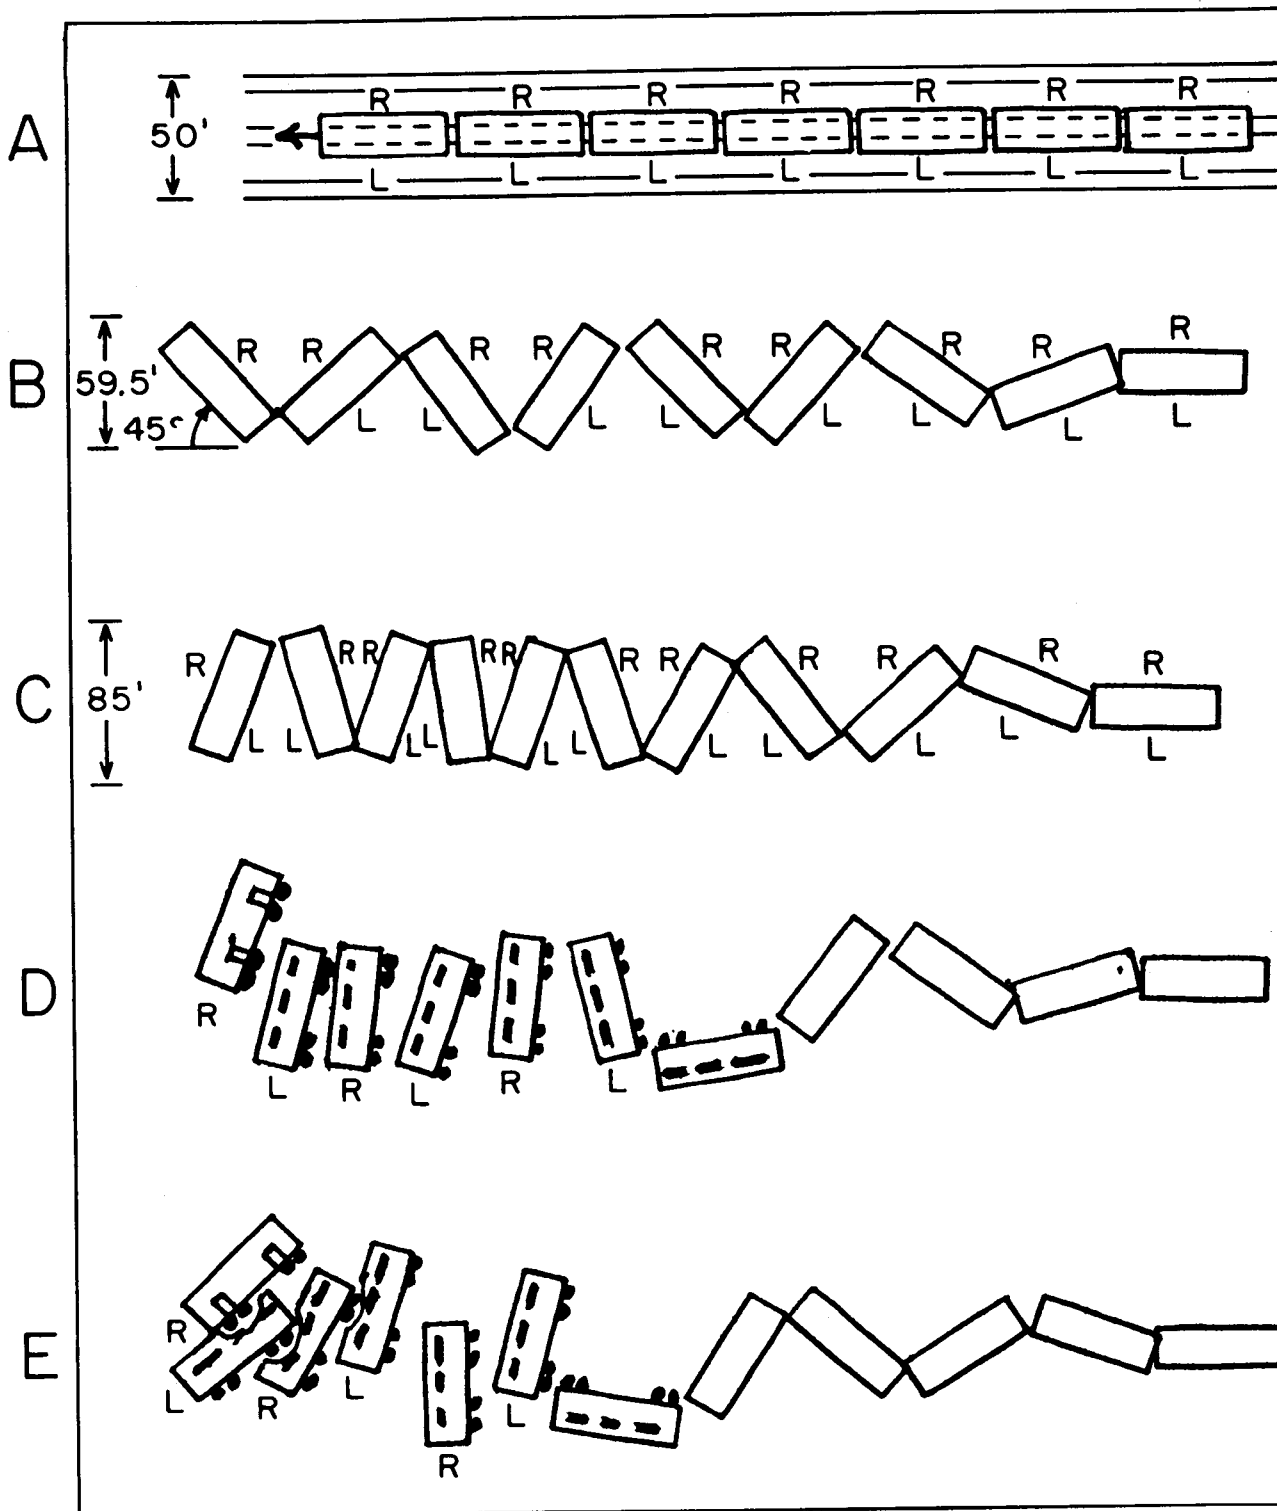
FIGURE 1. Sequence of events following derailment presented diagrammatically.

In (c) of Figure 1 the lead cars are approaching an angle of 90° to the original line of travel and are sweeping a path about 85 feet wide. At about this point the friction caused by the cars, trucks, and wheels sliding sideways and their gouging into earth, rails, and cross ties increased, causing the cars to overturn onto their sides (see step d).

It will be noted in (d) a pattern of overturn has been established. The baggage car (first car shown on the left of Figure 1d) is on its right side with front end up; the first passenger car is on its left side with front end down, and so on right-left-right-left. The cause for this arrangement becomes obvious from parts (b) and (c) of Figure 1, which show right sides approaching right sides and left sides left.

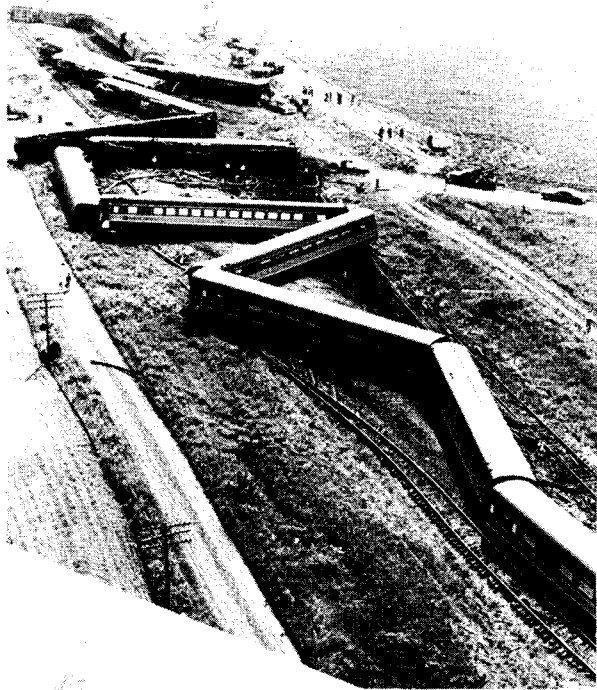
a. Aerial view of train derailment site. Of the four locomotives and 14 cars involved, it may be observed that the two lead locomotives, the baggage car, and the first six passenger cars are overturned and lying on their sides. The accident occurred at a location where three sets of tracks ran parallel to one another. Note that all rails, cross ties and road beds have been swept clean by the forward two-thirds of the train.

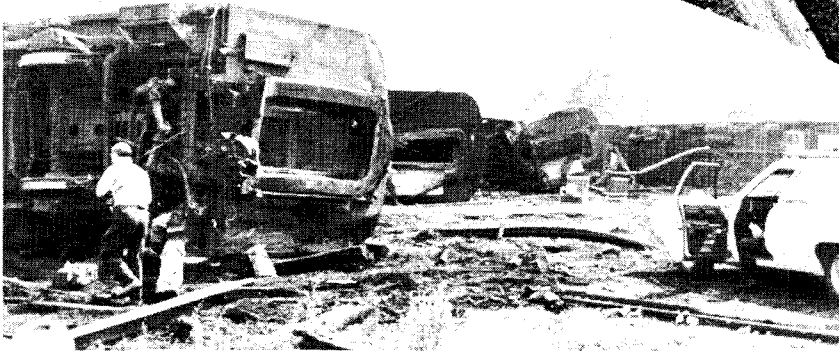
b. Close-up view of the ends of four of the overturned cars.

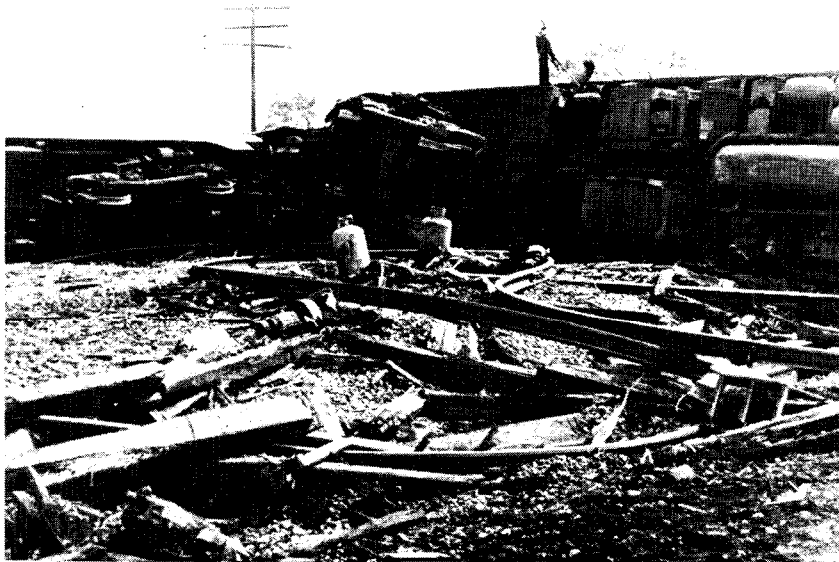
c. Twisted rails and splintered cross-ties attest to the severity of the forces involved. Note large loose gas bottles (used for air conditioning).

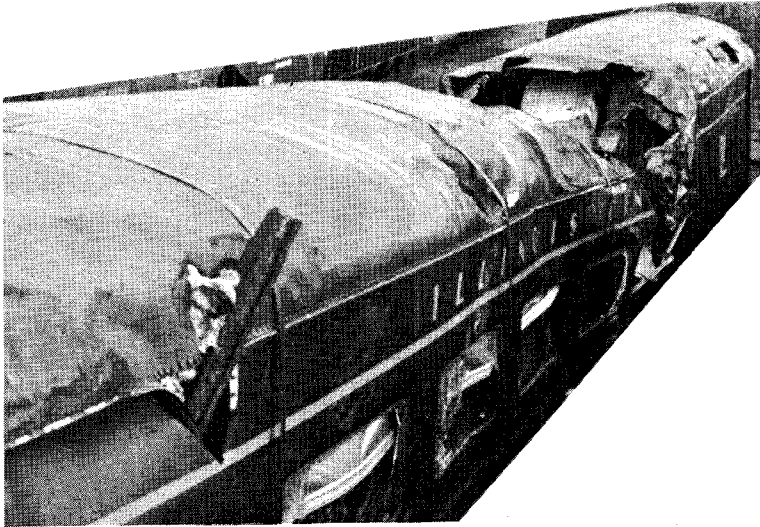
b. Damage to the left side of car number one as viewed from front to back. Note the area of the roof crushed in by contact with the wheels of the baggage car, two rail penetrations, and broken windows with window shades bent outward.

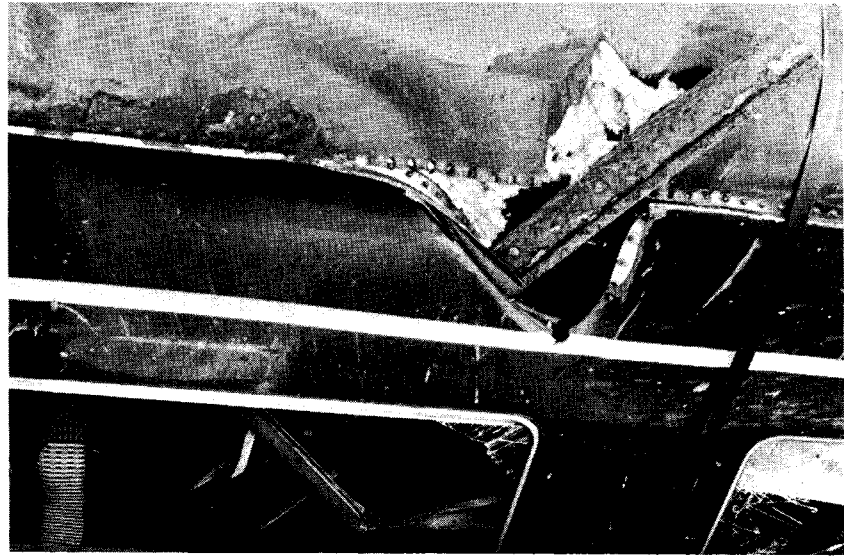
a. Rail penetration of left forward roof of car number one. The angle of penetration indicates that the car was sliding rear-end forward when it picked up the rail.

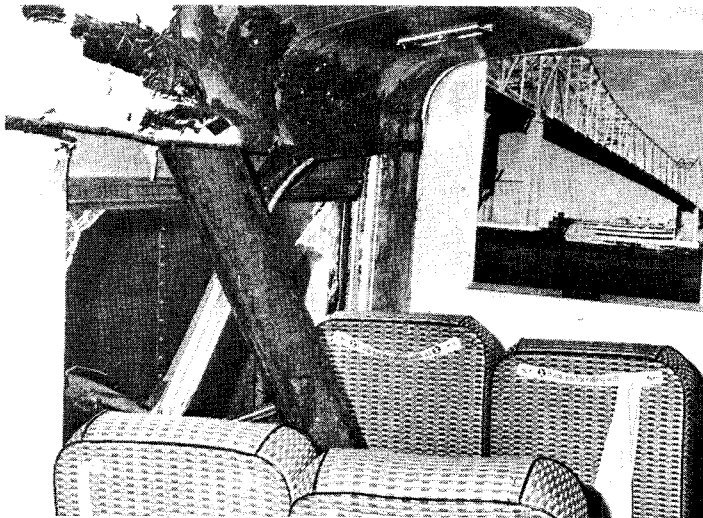
b. Rail went between first and second seats. Fortunately this area was not occupied at the time of rail penetration.

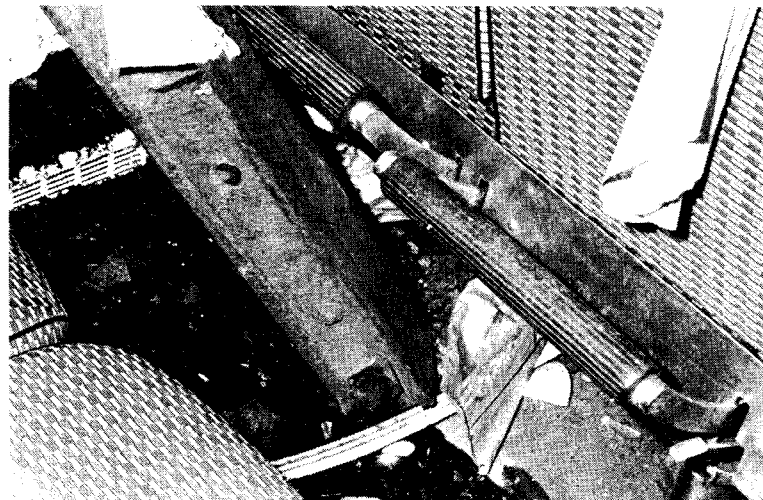
c. Rail stopped when the end of it rammed against the floor.

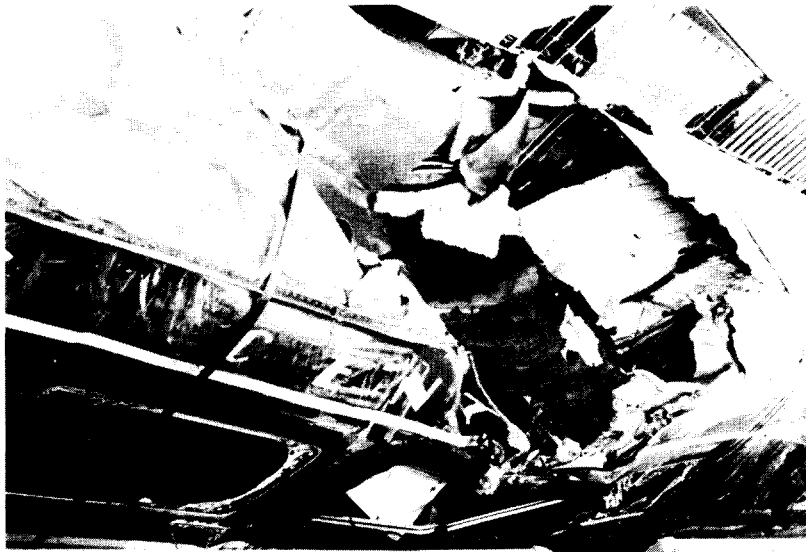
a. Close-up view of depression in the roof of car number one made during the impact with the wheels of the baggage car.

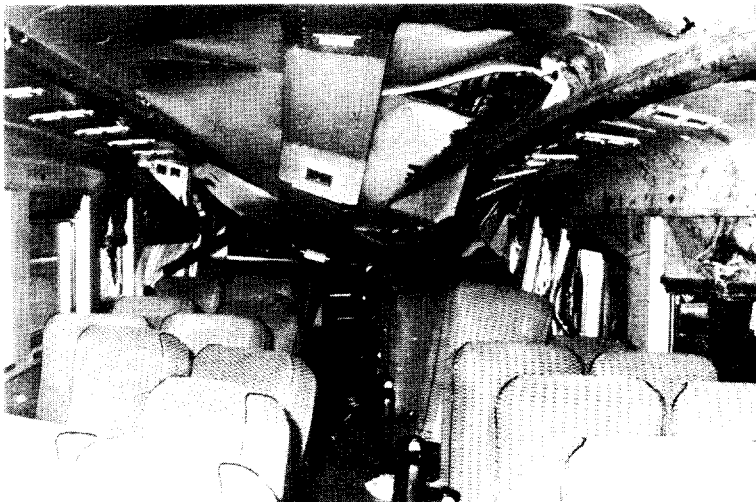
b. Inside view of car no. one looking toward the rear. Railroad seats are designed to be rotated after pulling them toward the aisle 3/4-inch to unhook a catch. Note that all the seats in the left of the picture (right side of car) are unhooked and rotated aisle-end forward.

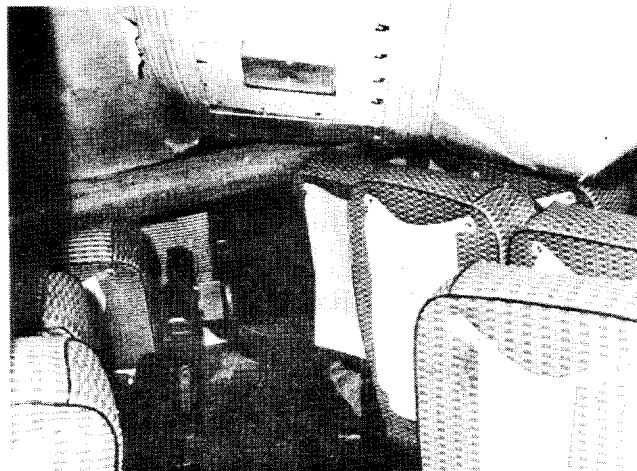
c. Roof is depressed below the level of seat back tops. Passengers were trapped in their seats.

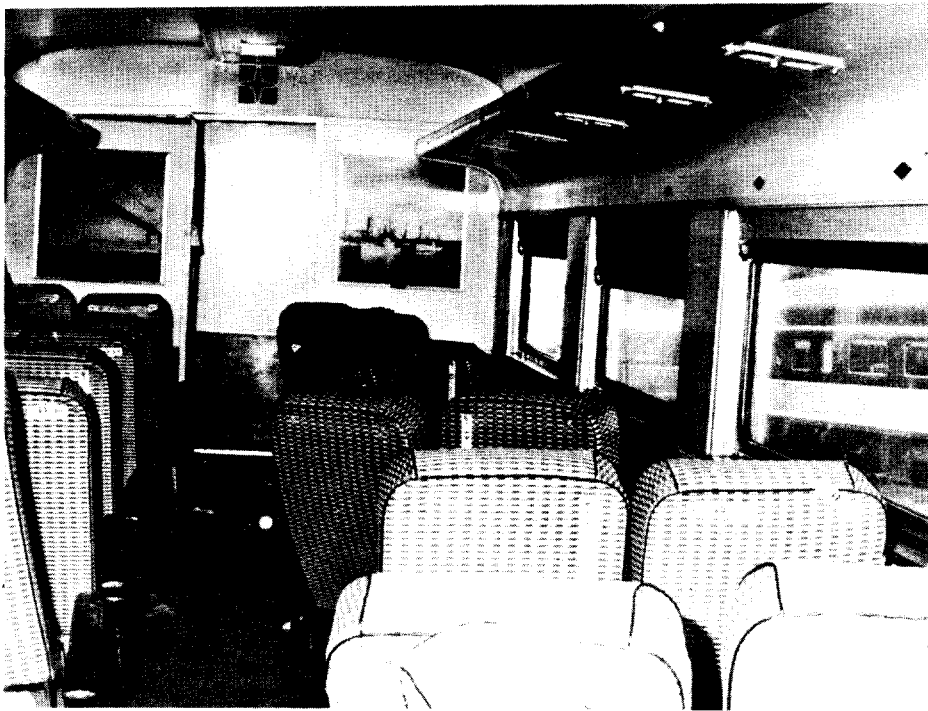
a. Right forward section--very minor damage--seats rotated.

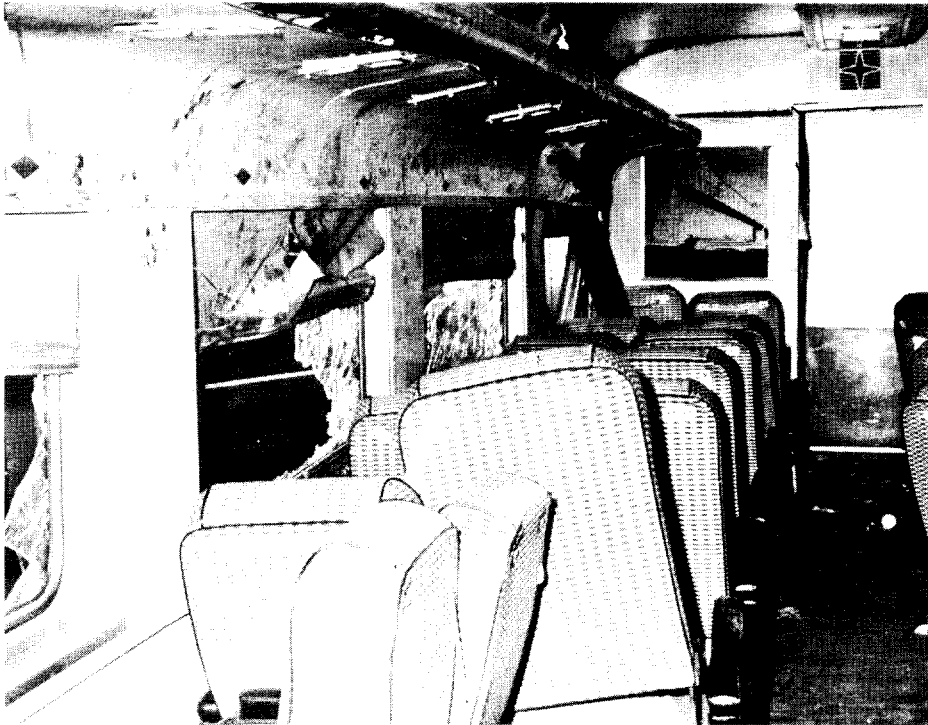
b. Large windows (5 ft. long, 2 ft. high) broken out by body impacts as car rolled over. Note seat in foreground rotated 90° to face window. Passengers ejected (at least two).

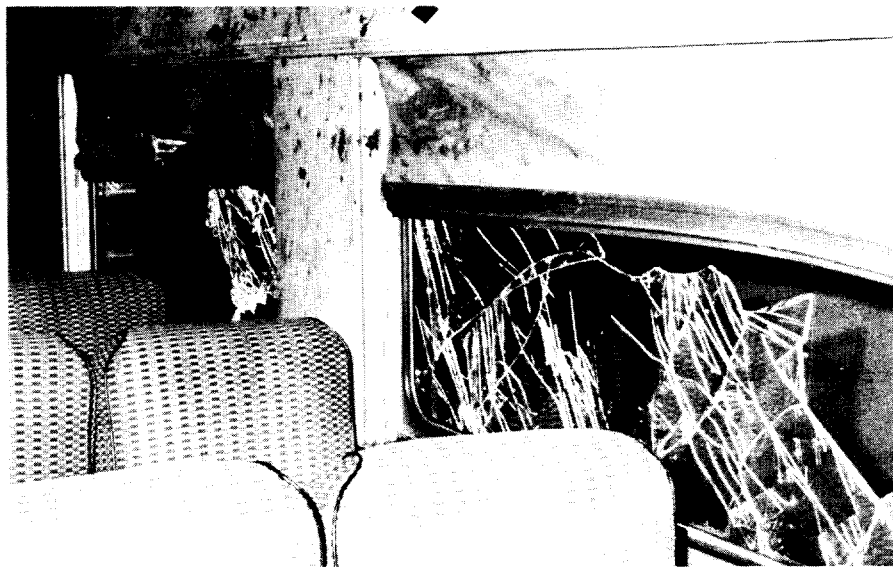
a. Window shades bent out and windows broken by body impact.

Sharp edges and protruding objects are two factors which could cause injury. Most serious are sharp edges of the structures associated with the window and window shade framework in the passenger compartments. The passenger overhead light switch, a long-handle metal toggle-type switch pointing almost straight down toward the passenger's head, should also be redesigned or relocated.

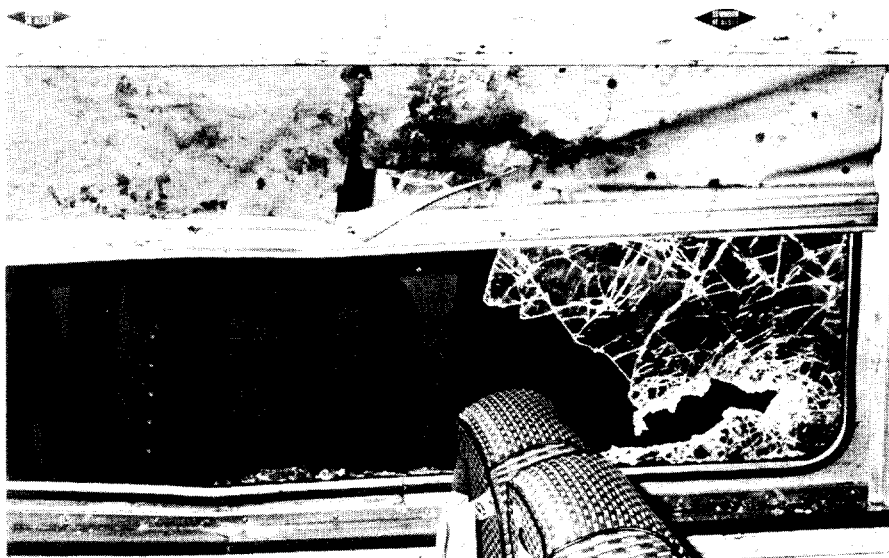
b. Close-up of dents in window shade rod and lower window sill. Since the sun was shining in the left side of the car, some shades were partly drawn and probably prevented ejection of some passengers.

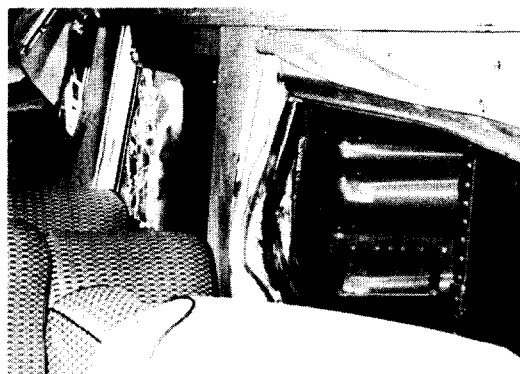
c. Window shade rod bent upward as passenger from right side of car was thrown across the car and ejected through this window.

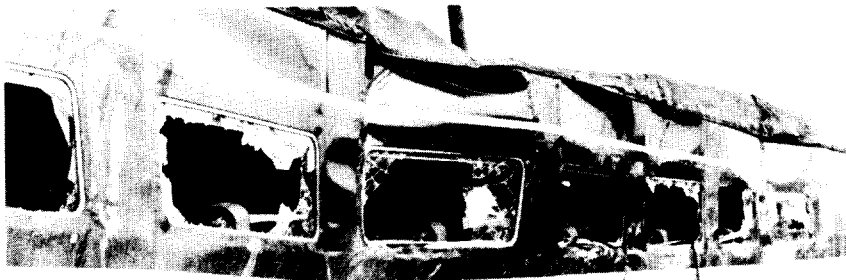
a. Right side (down side) of passenger car no. 2. Six of 7 large windows knocked out. Note window shades are up. Depression in roof is from contact with wheels of car no. one.

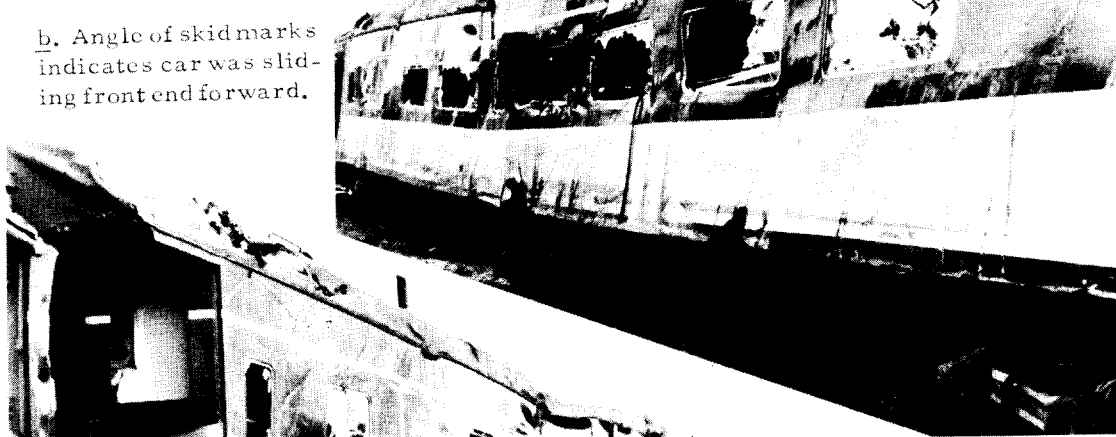
c. View of right side of car from rear end. Note rail penetration into boarding area.

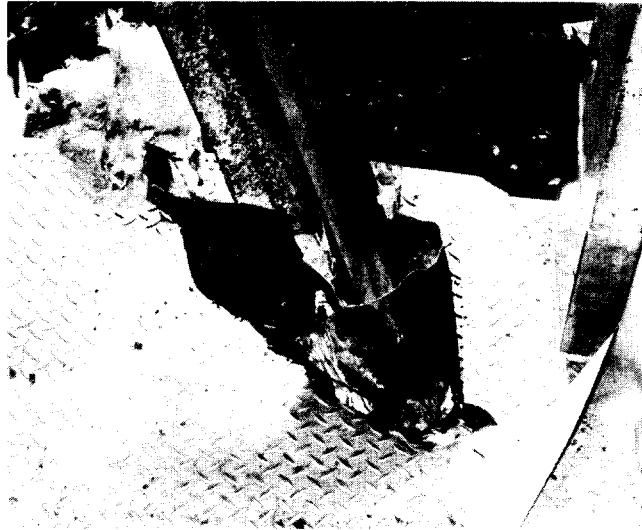
c. End of the rail shown in above picture terminated its travel against the steel floor of the right rear boarding station. Note roof metal and insulation still wrapped around the end.

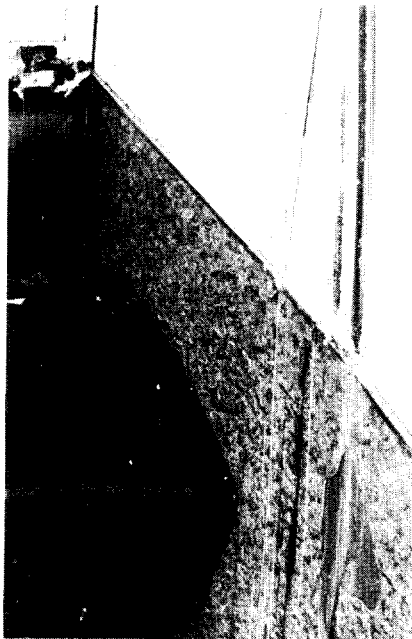
d. Mark on rest room wall at the rear end of the passenger area made as the end of the second rail slid down the wall

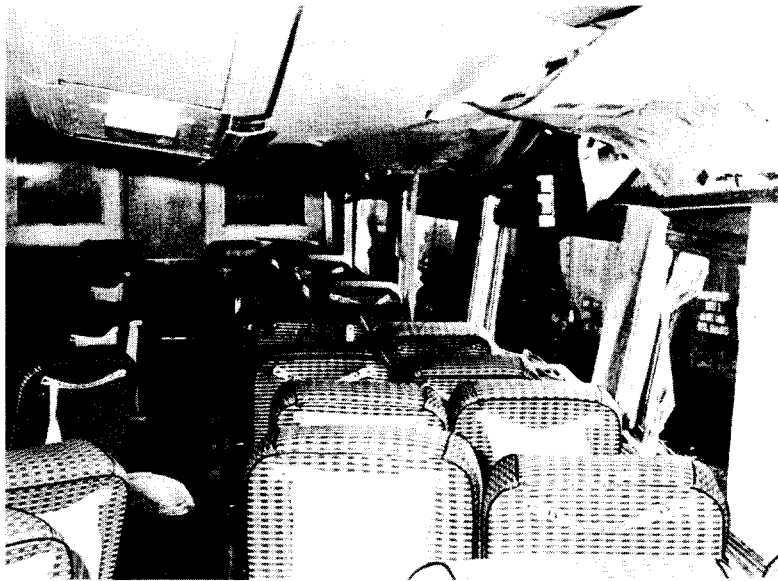
a. Interior view of the right side of car no. 2, looking from the rear. Note that the roof depression with sharp edges is not as severe as in car one, leaving about 5 feet of clearance above the floor. Seats are relatively straight, but damage to windows is severe.

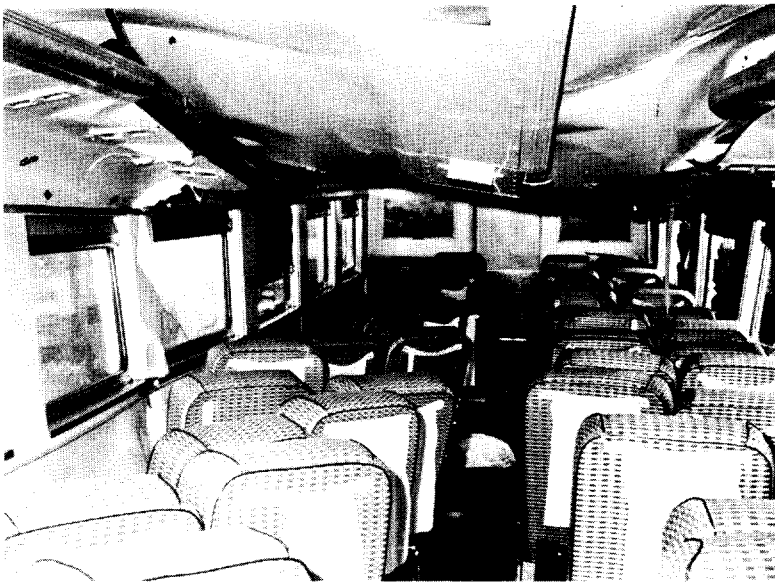
b. All seats on the left side of the car are unhooked and rotated aisle side forward approximately 45° . This rotation may have protected some passengers to a degree as some were trapped in their seats and not thrown to the opposite side of the car.

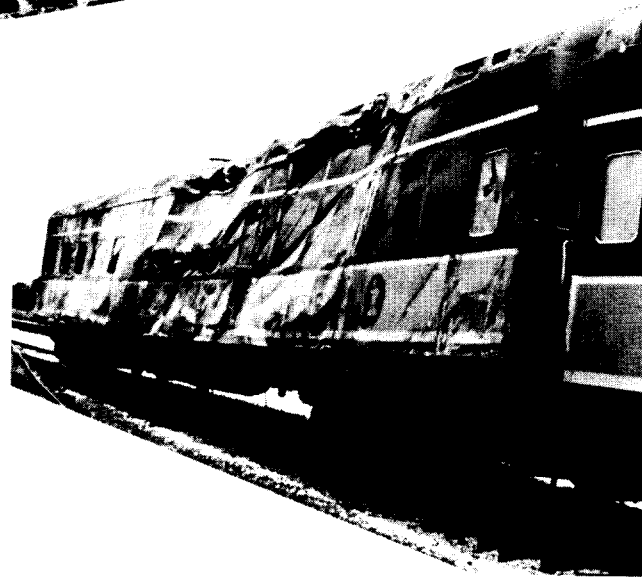
b. Skid marks on the rear end of the left side of the diner indicate that the car slid at about a 45° angle rear-end forward after it rolled over onto its side. The area of most severe damage (without windows) is the kitchen and counter serving area.

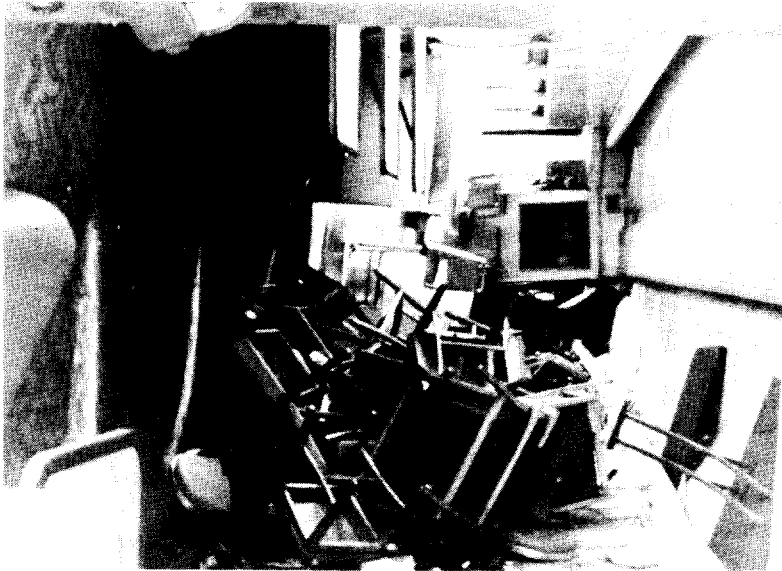
a. Inside view of diner looking toward the rear of the car while it was still on its left side. Passengers, loose chairs and broken tables were all thrown into a pile.

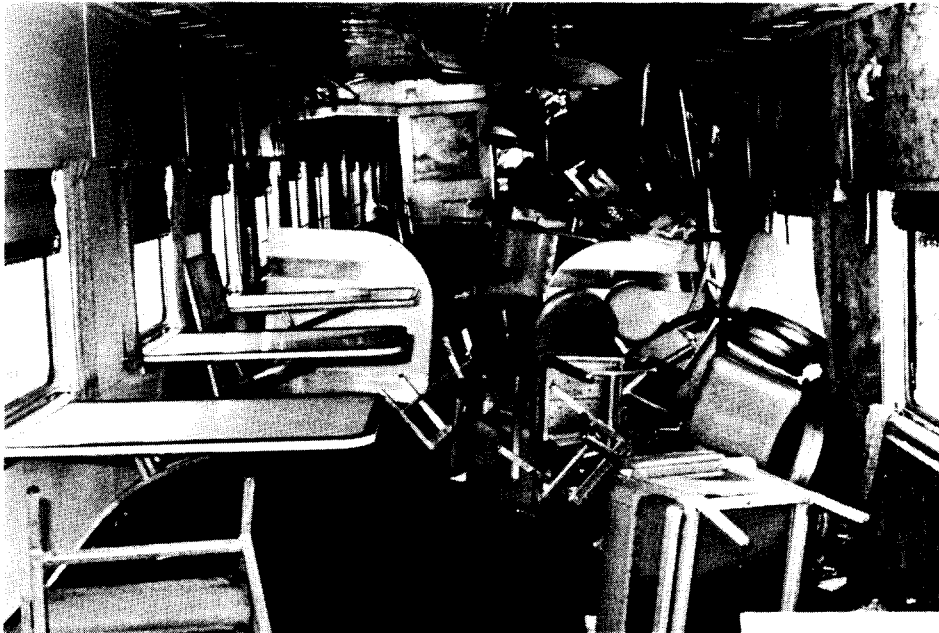
b. Same view as a above except that the car has been righted. At least two passengers were ejected through one of the windows in the right of the picture.

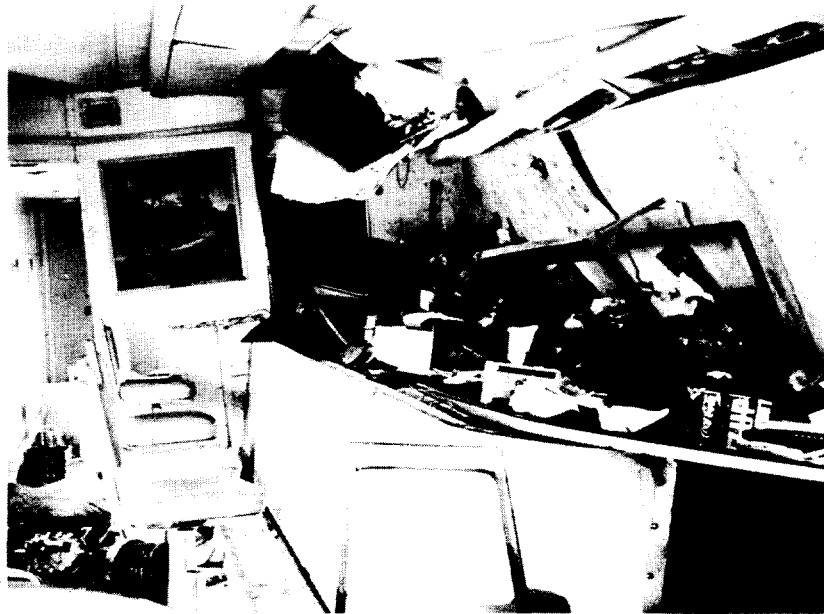
a. The diner was not penetrated by any railroad rails, but a heavy compressor entered through the upper left corner of the car above the counter serving area and hit one of the stools, breaking it off. Hole and compressor are visible in the picture.

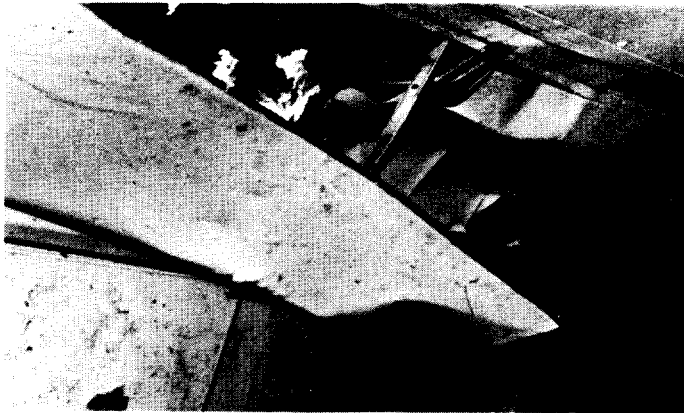
b. Close-up of hole made by entrance of the compressor. Fortunately, no one was struck by this heavy missile since most of the passengers had been thrown to the front of the car before the car turned over and picked up the compressor.

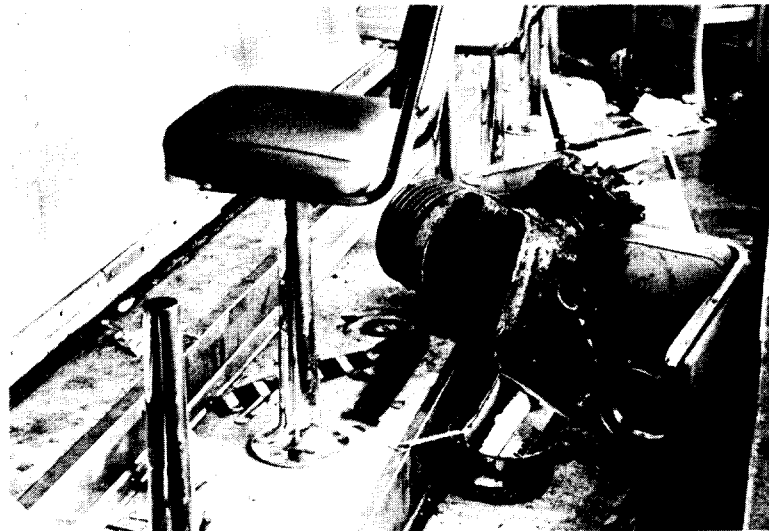
B. Crashworthiness Design. The electrical equipment and table storage cabinet doors were the type that could be lifted up and off the hinge pins. When the cars overturned, the doors moved free of the hinge pins and the doors and cabinet contents fell into the aisle, blocking escape routes and possibly causing injury. Another example of similar design was found on the bar stool seats in the Diner. Attached to the under side of the seat pan was a shaft $1\frac{1}{2}$ inches in diameter and 6 inches long. This shaft rested inside the pedestal column and was free to rotate. It was also free to slide out of the pedestal column when the Diner car overturned as shown in Figure 14c.

c. Close-up view of compressor and broken stool.

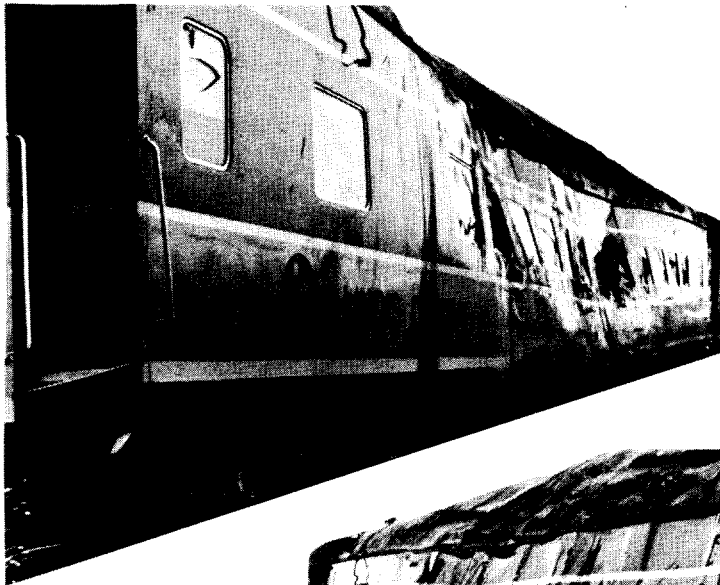
a. Right side of passenger car no. 3, showing the most severe damage was to the central portion. This area near the roof was pushed in over 2 feet. Note windows in this car are smaller (34" long, 24" high) and less glass is broken out.

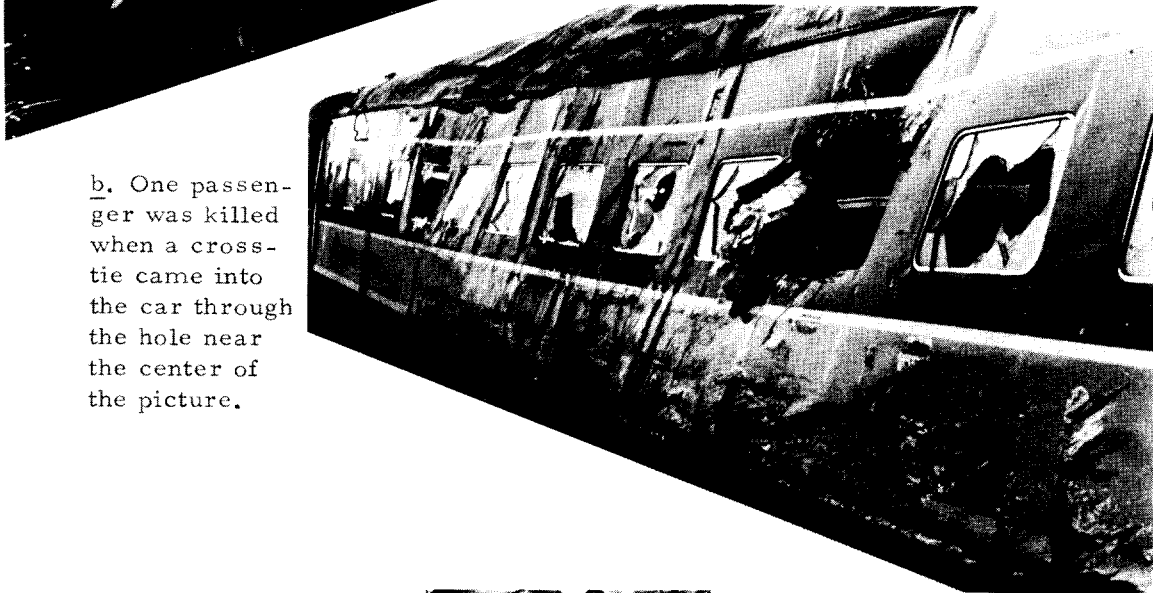
The seventh body was also found in Car Number 3. Injuries included skull fracture and lacerations of the back of the head. The color of hair matched that found on the end of a cross tie found in the car and it can be assumed this

b. One passenger was killed when a cross-tie came into the car through the hole near the center of the picture.

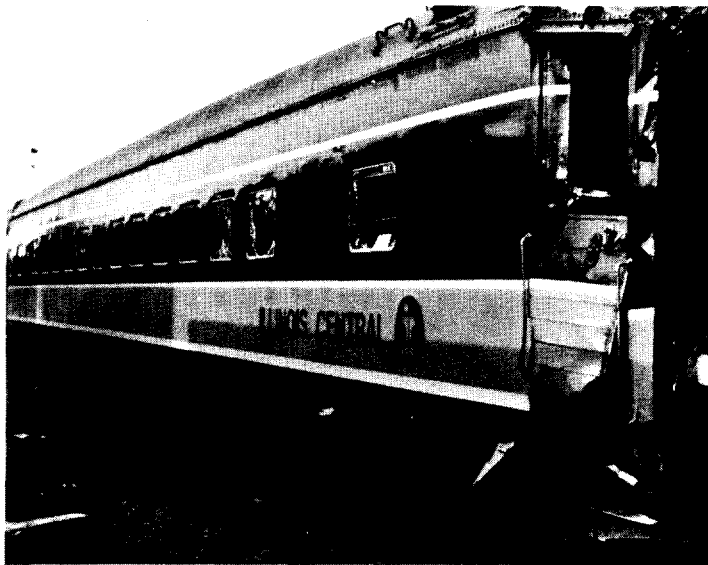
c. Left side (up side) of passenger car no. 3 shows little damage. Missing windows were knocked out by rescue workers.

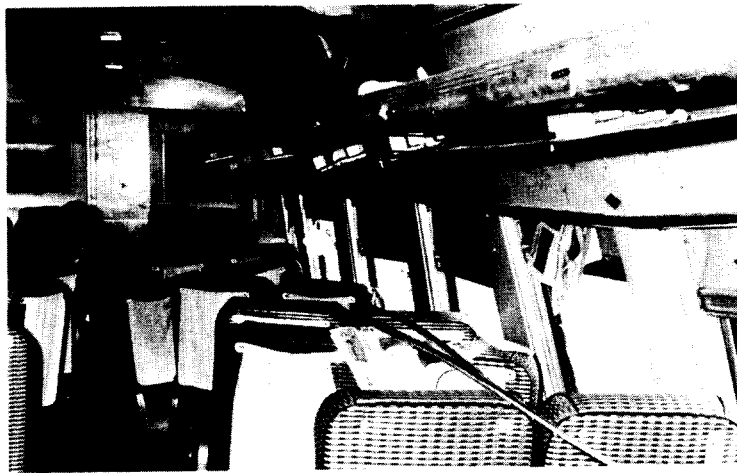
a. Interior view of the right side of car no. 3 showing heavy damage to seats where the wall was crushed in.

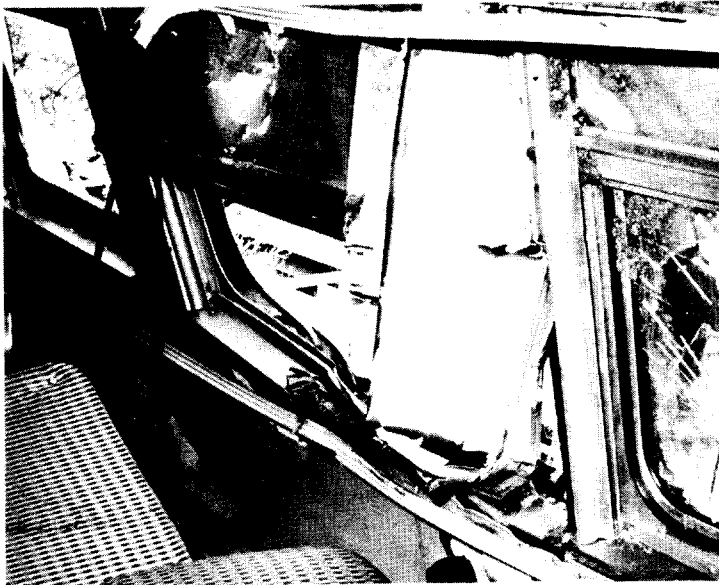
b. Close-up view of damage caused by intrusion of a cross-tie.

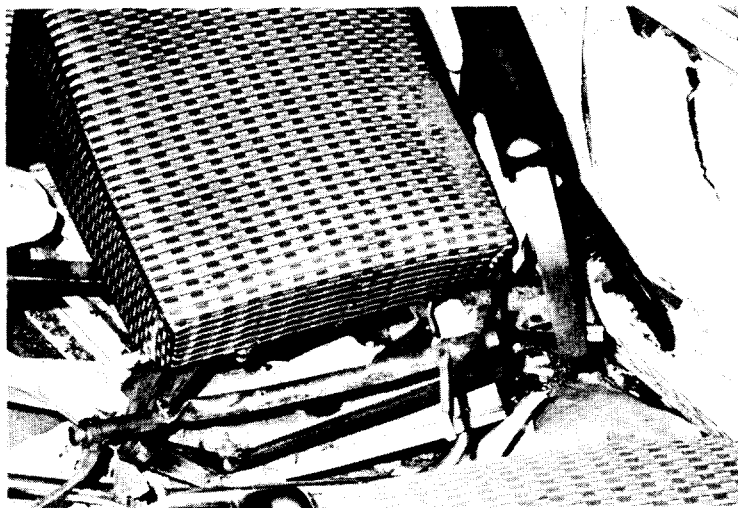
c. One seat was almost completely demolished.

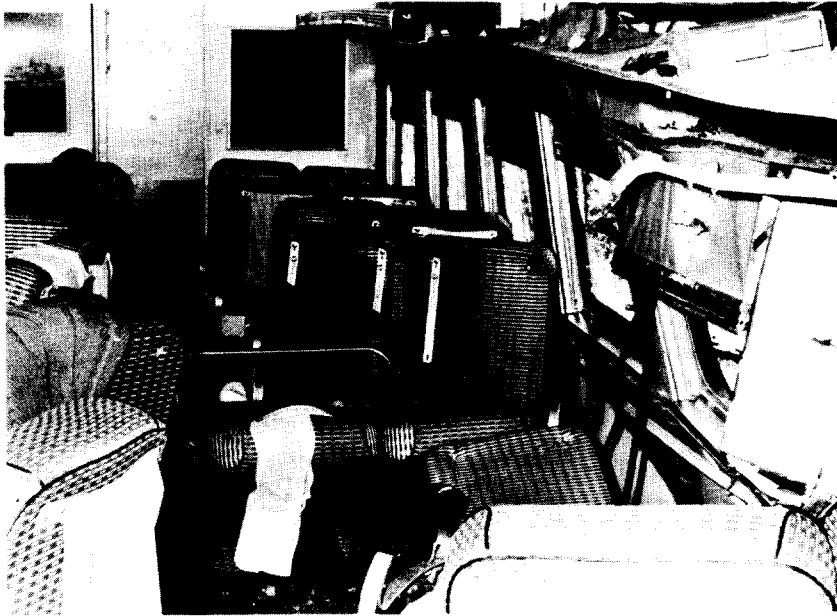
a. Seats are unhooked and rotated aisle end forward as in previous cars. As upper right wall was pushed in, the baggage rack broke down and left numerous sharp edges. Passengers received severe injuries when thrown against these edges as car rolled over.

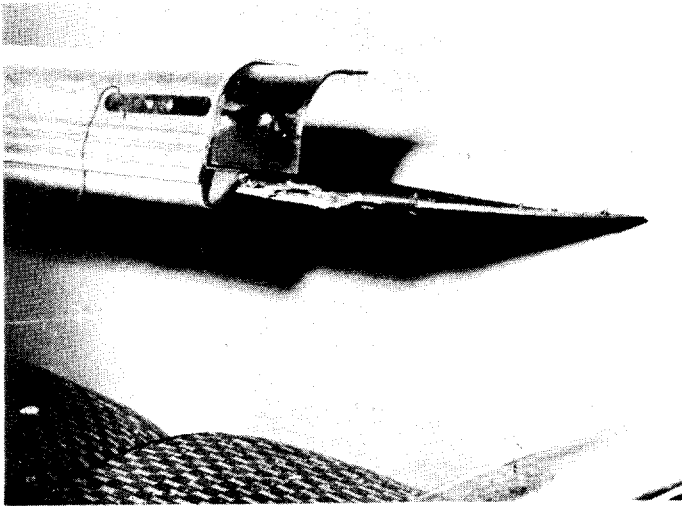
b. Close-up view of sharp end of baggage rack.

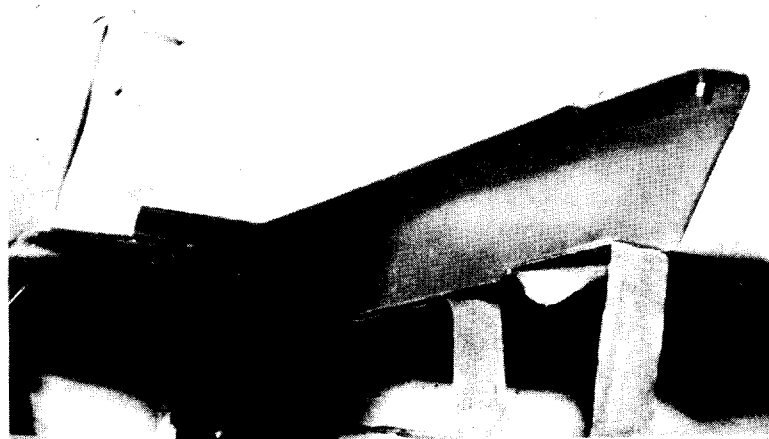
c. Sharp baggage rack support structures exposed when rack collapsed.

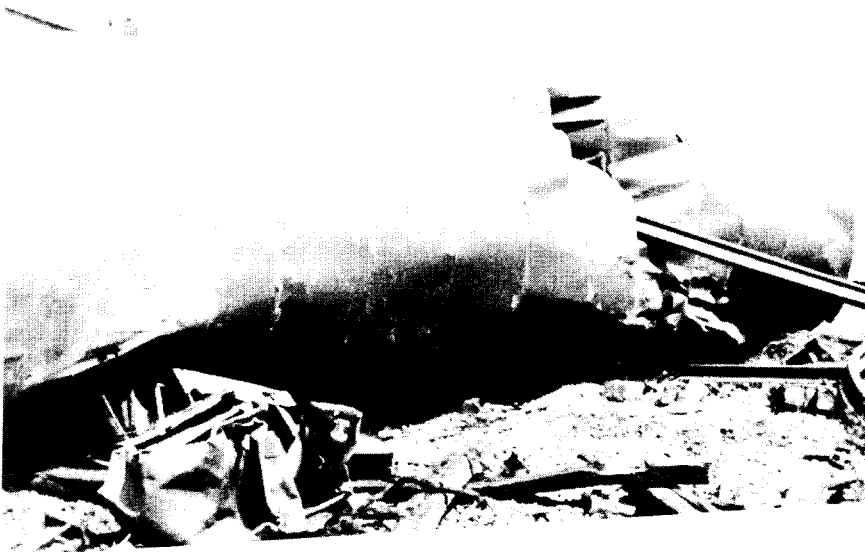
a. Passenger car no. 4 down on its left side with two rail penetrations. One passenger crawled through the hole made by the rail and walked down the rail to the ground.

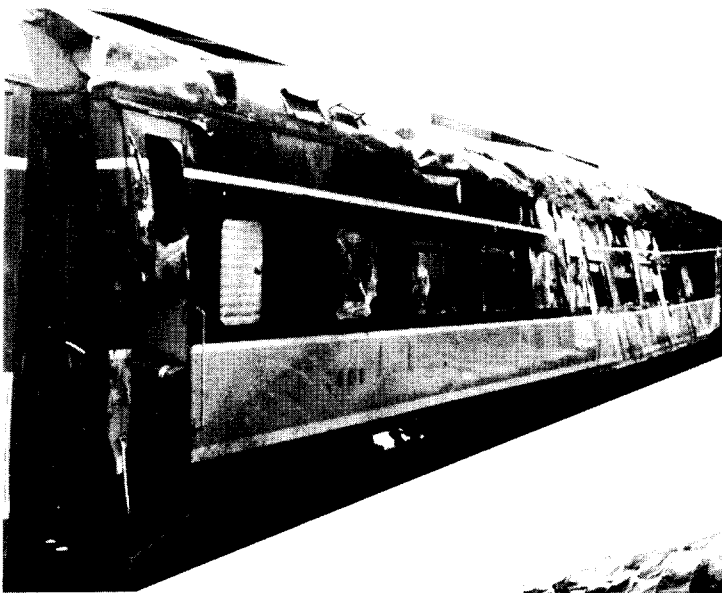
Bodies 9 and 10 were found just inside the forward end (the boarding area) of Passenger Car Number 4. Both bodies received crushing injuries, but those of Number 9 were more severe than Number 10's. Number 9 had been decapitated and mangled. Injuries of Number 10 included head injuries and fractures of the left leg, right arm, and right knee. Since Bodies 8, 9, and 10 were all found in or just outside the boarding area of Passenger Car Number 4 and were the remains of a woman and two children, all with the same last names, it is possible that these three were caught in the boarding area on their way to or from the Diner and died from crushing injuries as the front end of the car was crushed in (see left side of Figure 18*b*).

b. View of left side after it had been righted shows side caved in similar to car no. 3. The number of deaths and seriously injured in this car was greater than in any other single car.

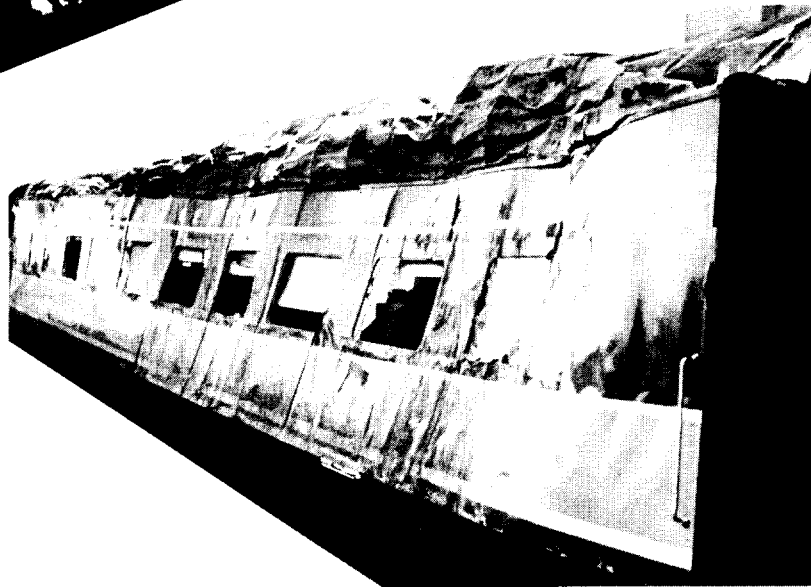
c. Close-up of severely damaged end shows scratch marks to indicate that the car was sliding perpendicular to the tracks after it turned over.

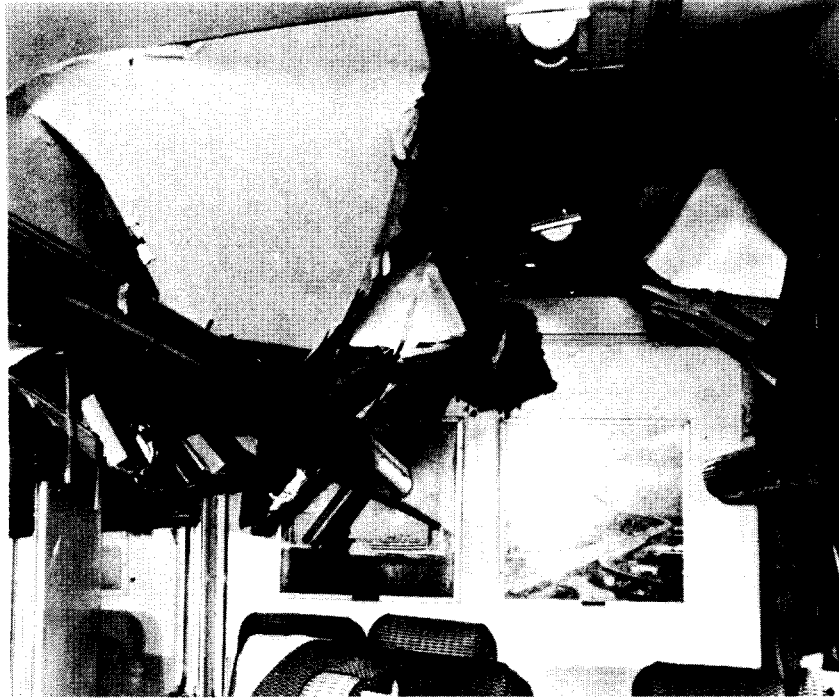
a. Hole made by the second rail penetration in passenger car no. 4. Note also outside wall collapse has almost completely obstructed aisleway under ladies rest room.

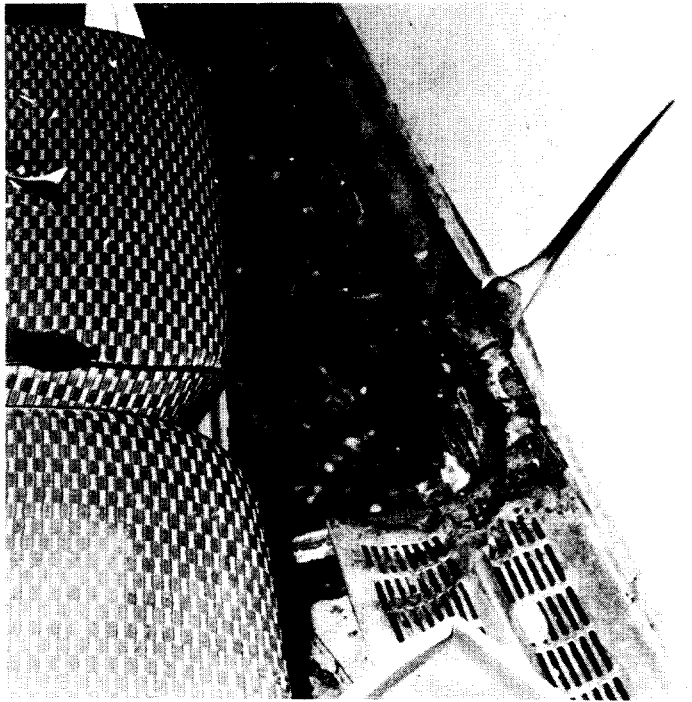
b. End of rail slid down the wall and pinned a woman's dress to the floor, but did not injure the woman.

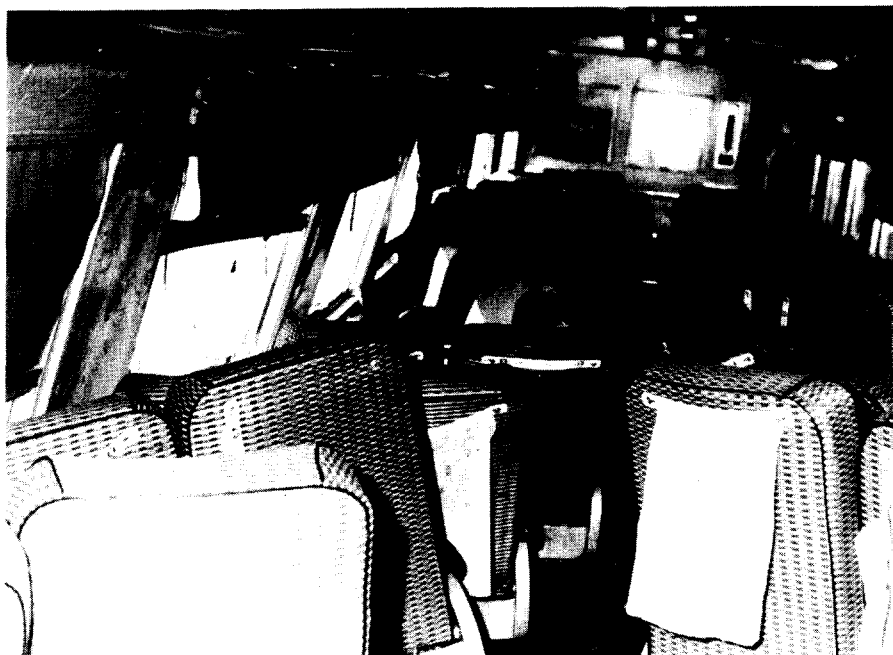
a. Interior view of passenger car no. 4, looking forward. Most of the seats are unhooked and rotated aisle end forward.
