1. Report No. FAA-AM-73-1		2. Government Accession No.		3. Recipient's Catalog No.	
4. Title and Subtitle APPLICATION OF COMMERCIAL AIRCRAFT ACCIDENT INVESTIGATION TECHNIQUES TO A RAILROAD DERAILMENT.			5. Report Date January 1973		6. Performing Organization Code

APPLICATION OF COMMERCIAL AIRCRAFT ACCIDENT INVESTIGATION TECHNIQUES TO A RAILROAD DERAILMENT

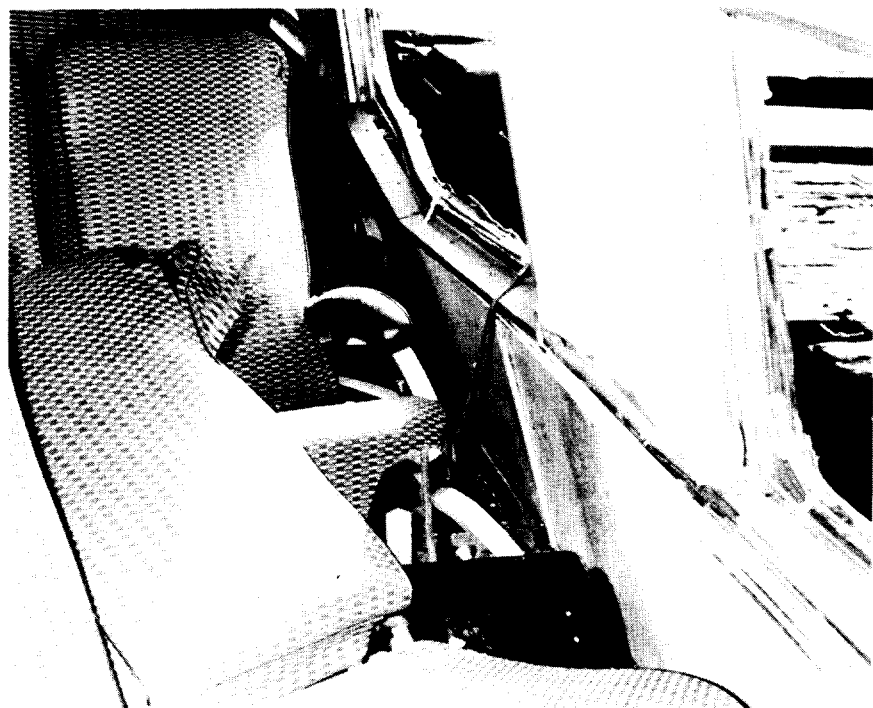
b. Seat damage in the area where the side wall was pushed in.

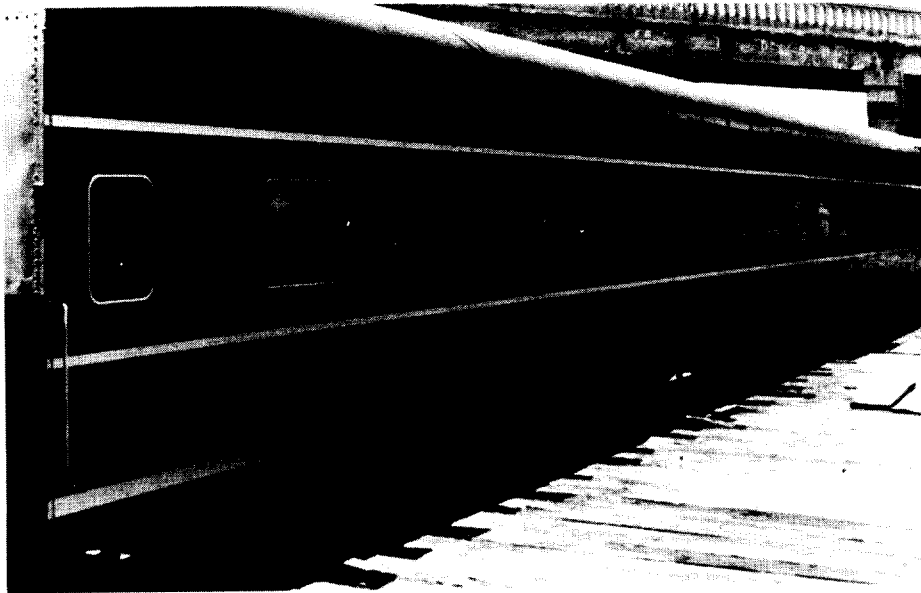
a. Passenger car no. 5 overturned but was unoccupied and is not shown. This is passenger car no. 6. It remained upright as did cars 7, 8 and 9 with passengers and cars 10, 11, 12 (empty). Damage is slight and injuries to the passengers were minor or none.

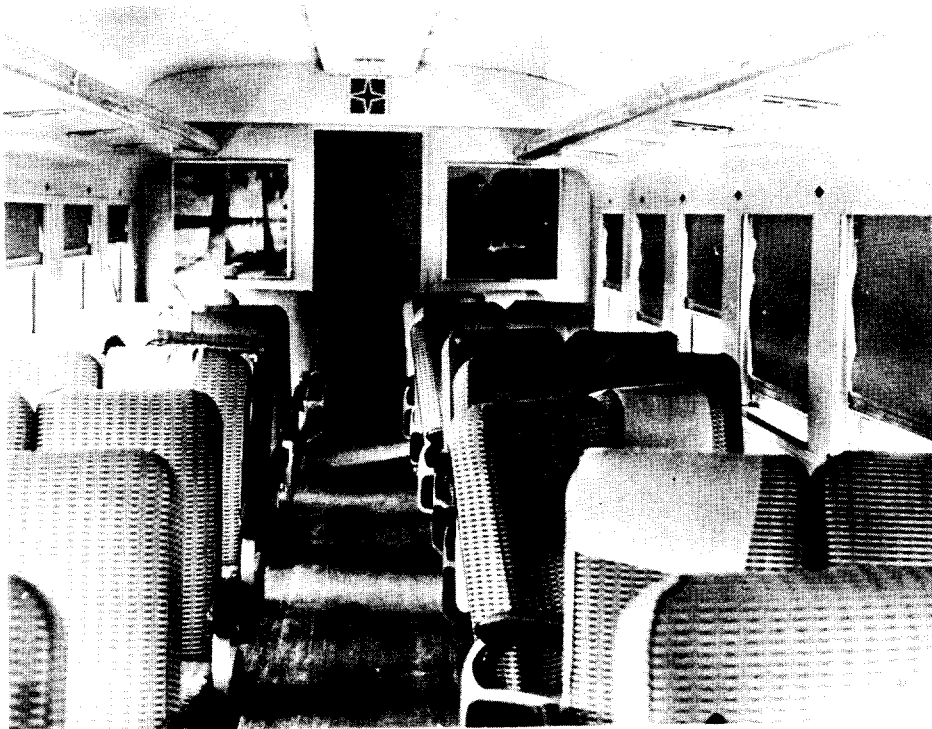
b. Even though the car remained upright, some seats became unhooked and rotated. The passengers in these cars stated they were able to remain in their seats by holding on.

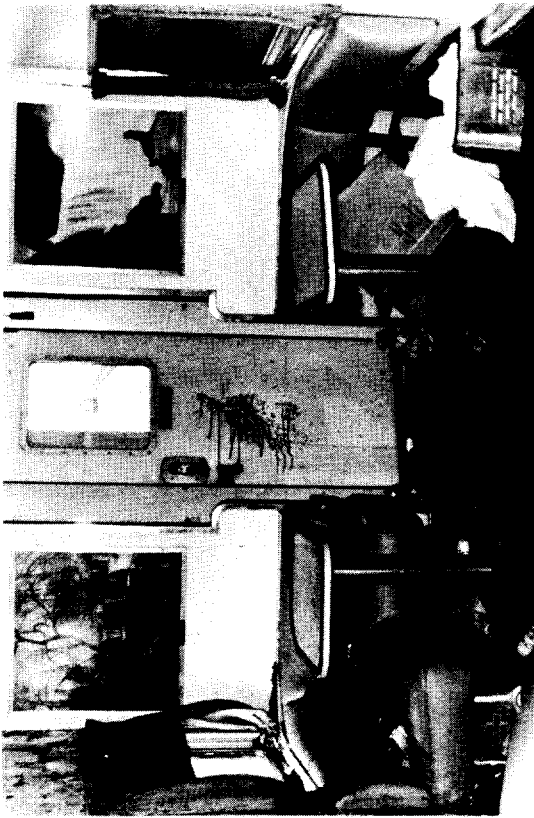
a. Front end of diner as it appeared with car on its side. Passengers escaped by climbing up on the booth and out the end door.

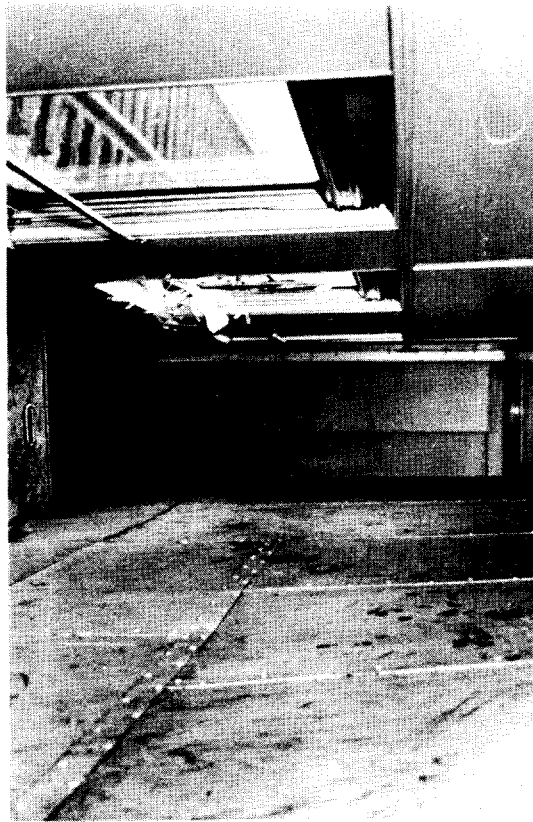
b. Rear end of diner on its side offered a more difficult escape route. One passenger climbed up into the 2-ft. high tunnel shown here and was rescued through the small broken window.

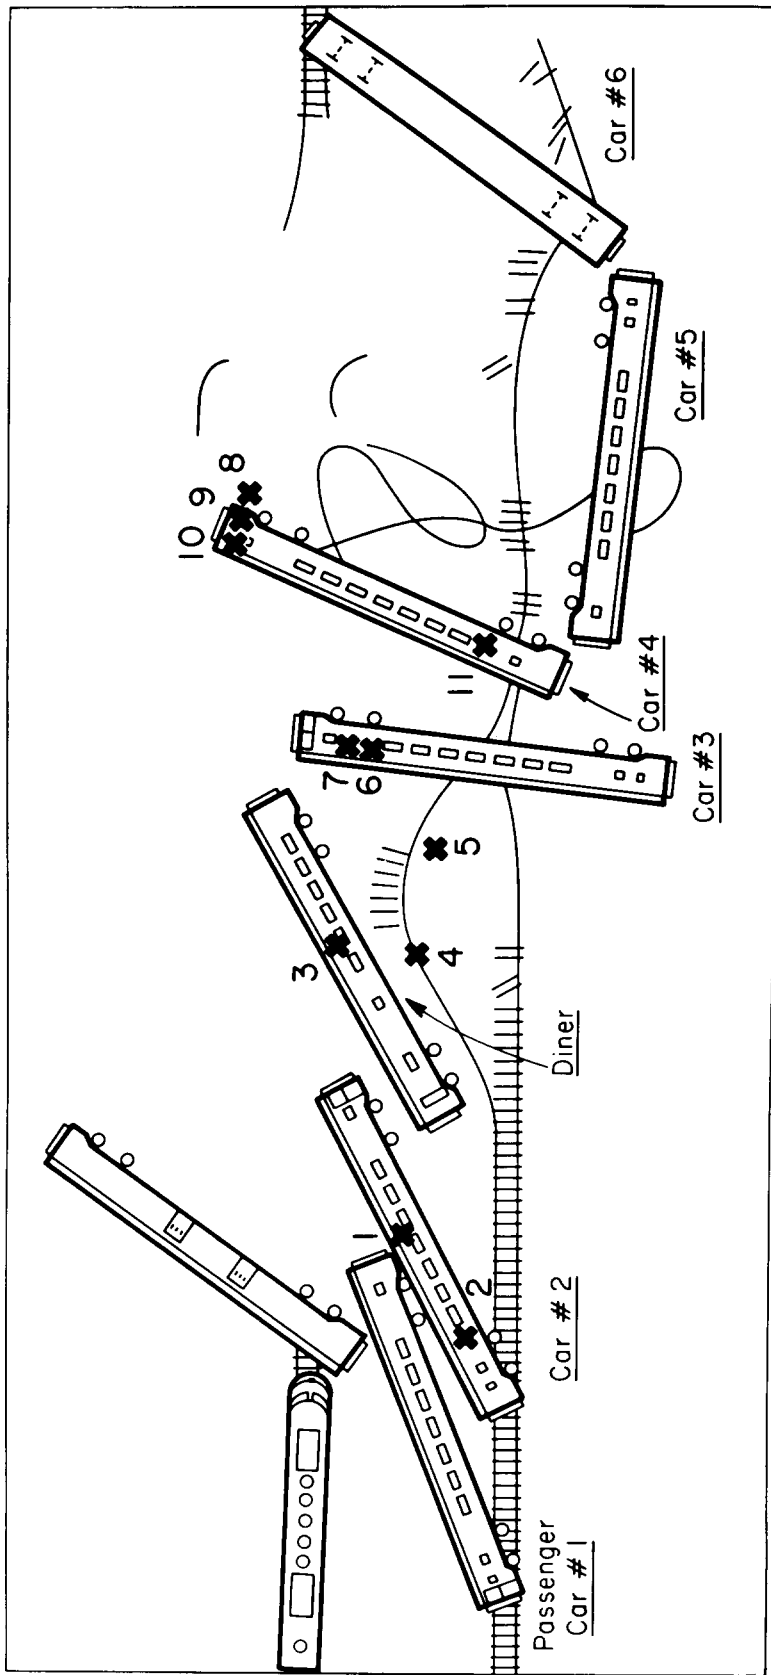
FIGURE 24. Diagram of crash site showing location of the bodies of the ones who were fatally injured.

Body Number 1 was ejected through a window of Car Number 2 and pinned beneath the car. Injuries included scalp laceration with possible skull fractures and fractures of the right shoulder, right upper arm, left forearm, and both knees.

Body Number 2 was found inside the second passenger car with fractured skull, severe lacerations of scalp and forehead, lacerations under both arms and across the chest, and severe lacerations of the right hip around to the groin. This passenger was probably ejected partly through a window and then fell back, or was pulled back, into the car.

Body Number 3 was found under the Diner. Injuries include massive skull fracture with drag marks on the side of the face and head and lacerations of the left knee and chest. This passenger was ejected through one of the windows of the Diner and dragged under the car as it slid on its side.

Body Number 4 was ejected from Car Number 1 as the car rolled onto its side; the body then became pinned under a rail between the Diner and Car Number 3. This person suffered head injuries, fractured pelvis, and lacerations of the shoulder, hip, and both lower legs. In addition, there was evidence of peritoneal bleeding.

Body Number 5, found between the Diner and Car Number 3, was crushed and torn beyond recognition. The body was ejected from one of the cars and was crushed as one or more cars slid over it.

Body Number 6 was found inside Passenger Car Number 3. Injuries included severe scalp lacerations and possible skull fracture, and lacerations of both arms and the left side of the neck. Lacerations indicate that the head and upper trunk were partially ejected through a window.

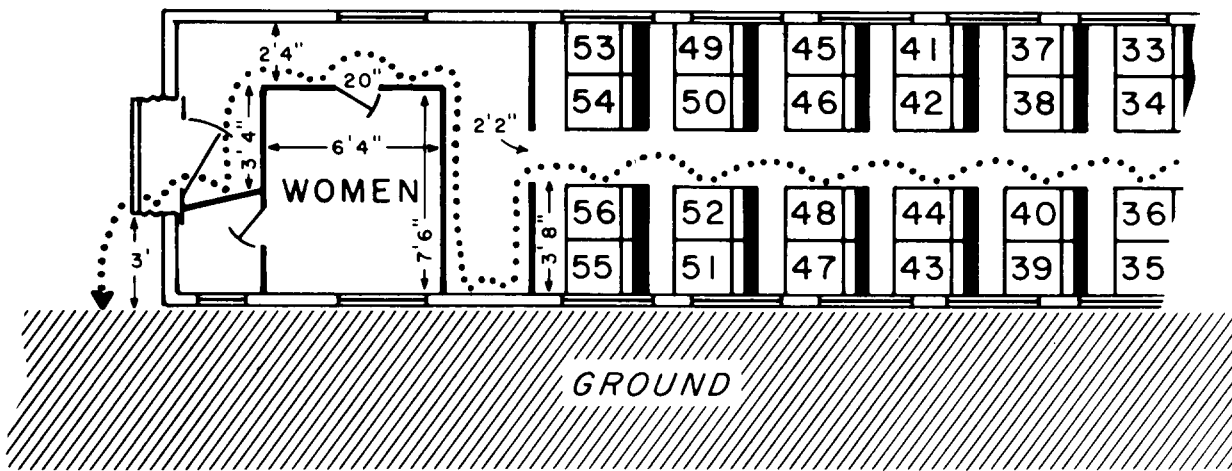
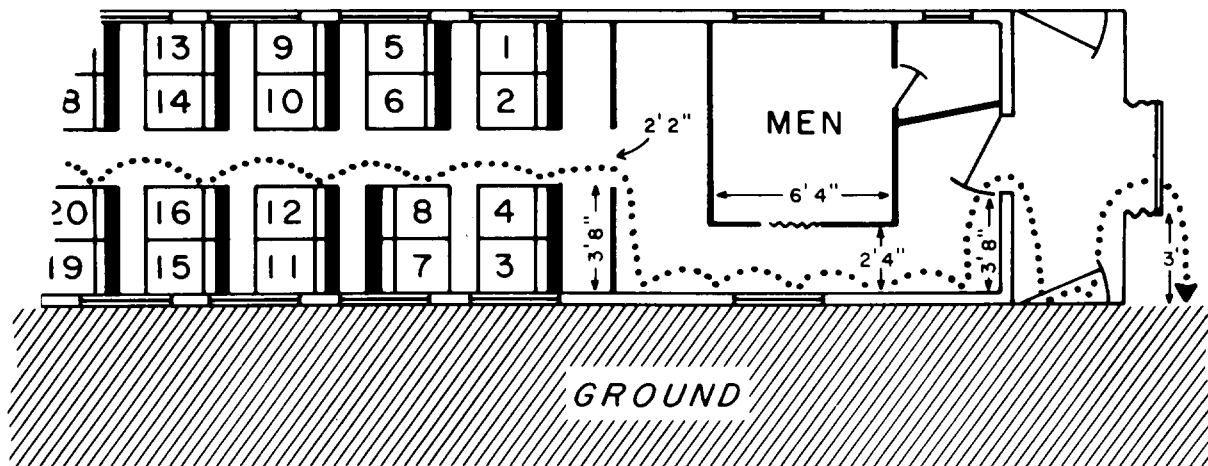
FIGURE 25. Diagrams showing two possible escape routes from a railroad passenger car that has rolled over onto its side.

95th percentile adult male, and some of the large adults will be forced to scoot through the tunnel under or over the restrooms on their bellies. (3) The third and last means of escaping an overturned railroad car is to climb up on the seats using the seat arms as steps and break out one of the double-pane windows on top of the car (Note none of the top windows of the overturned cars in this crash were broken out during the crash). Only those passengers with minor or no injuries were able to utilize one of these three difficult routes of escape on their own initiative.
