1. Report No. FAA-AM-81-10		2. Government Accession No. AD-A103 316		3. Recipient's Catalog No.	
4. Title and Subtitle IMPROVING THE CRASHWORTHINESS OF GENERAL AVIATION AIRCRAFT BY CRASH INJURY INVESTIGATIONS,		5. Report Date MAY 1981		6. Performing Organization Code

8. Performing Organization Report No.		10. Work Unit No. (TRAIS)	
7. Author(s) William R. Kirkham		11. Contract or Grant No.		13. Type of Report and Period Covered

IMPROVING THE CRASHWORTHINESS OF GENERAL AVIATION AIRCRAFT BY CRASH INJURY INVESTIGATIONS

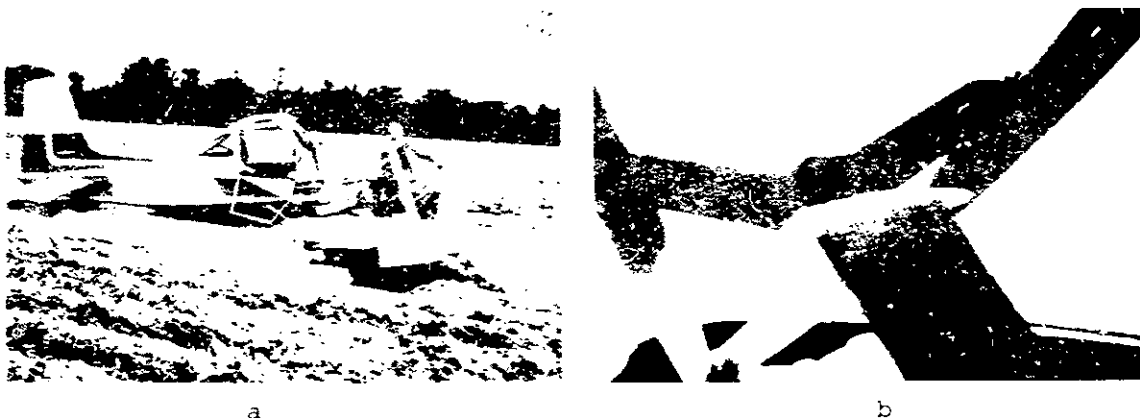
Many aerial application aircraft have been built with a strong crashworthy cockpit frame. Pilots are provided a seat, lapbelt, a shoulder harness, and in many aircraft a large metallic roll on the panel to distribute impact forces over the pilot's body should he strike it in an accident. Further, the pilot usually wears a helmet. The crashworthiness of an aerial application aircraft was illustrated when, on fuel exhaustion, the aircraft stalled and struck the ground in a 45° nosedown attitude. As illustrated in Figure 1a there was moderately severe damage to the engine and hopper. The pilot, who was wearing a lapbelt and shoulder harness, received lacerations above the right eye and a fractured left arm and left knee. He had conspicuous shoulder harness and lapbelt abrasions and contusions. A notable finding was the forward bending of the shoulder harness attachment bracket and cracking of the bond where the bracket had been welded to the cockpit structural bars (Figure 1b). During deceleration the force of the pilot's body against the shoulder harness apparently caused this deformation. Fracturing of the seat pedestal and detachment of the seat from the seat track probably increased the freedom of the pilot's body, allowing it to come forward and strike the instrument panel. The intact upper torso restraint probably prevented the pilot from receiving lethal injuries.

Figure I. In this accident damage was limited and cockpit was intact (a). However, shoulder harness attachment brace showed v-shaped deformation (b) due to force of pilot's body against restraint during crash.

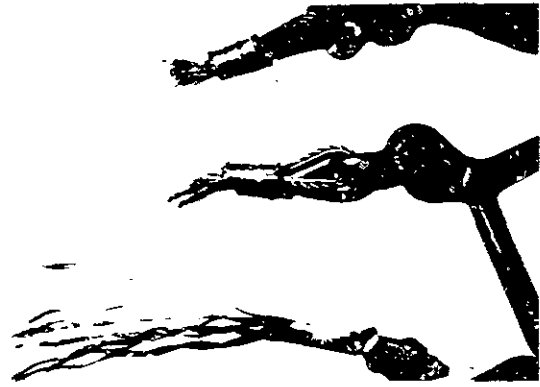
The pilot of an aerial application aircraft inadvertently dipped his right wing in some wheat and, on recovering, struck a parked cotton trailer with the left wing tip. The aircraft hit the ground and came to rest inverted. The cockpit remained intact (Figure VIa) but the seatbelt attachment cables and the shoulder harness cable failed (Figure VIb), allowing the pilot to come forward. His head struck the metallic wirecutter in front of the windscreen and his chest made a broad impact on the panel. The pilot's helmet sustained a large vertical cleavage corresponding to the impact with the wirecutter and the pilot suffered a corresponding laceration of the forehead.

The crash injury investigator could not understand why all three cables would fail in such an accident. He began to look at other aircraft in service and study the cables. In this aircraft the cable to the shoulder harness coursed over a pulley and down behind the pilot to an inertia reel. The lap-belt attached to cables that passed through an opening in a bulkhead (around

Figure VI. Pilot of aircraft (a) received head and chest injuries as, on impact, he came forward into windscreen, wirecutter, and instrument panel. Cables used on shoulder harness and lapbelts all failed (b). Stronger cables and modified routing apparently rectified the condition.

the pilot) and the cables were fixed to the frame of the aircraft. In both places, over the pulley and where cables pass through the bulkhead, they were subjected to wear and considerable recurrent acute bending. In some operational aircraft, filaments of the multistrand cable were found to be broken. This configuration of the cable attachments for the shoulder harness and lapbelts appeared to subject them to wear and bending that weakened and broke strands of the cable. Thus, in the aircraft accident investigated, the cables probably had been preweakened by wearing, bending and breaking of filaments; and during the impact the pilot's body probably exerted force on the restraint system sufficient to break the cables.

These observations were reported to others in the Federal Aviation Administration and published in General Aviation Inspection AIDS (3), a bulletin that calls technical matters to the attention of inspectors in the field. The manufacturer was also informed of the finding in this accident. Subsequent to the publication of this notice for inspectors, the manufacturer issued a service bulletin by which stronger and different cables were put in the aircraft and the configuration of the lead-in through the bulkhead was modified so as to eliminate most of the bending. Since the modification, there have been no accidents in which we have observed the cables to have broken and an examination of operational aircraft in the field has revealed no flaws in the cables.

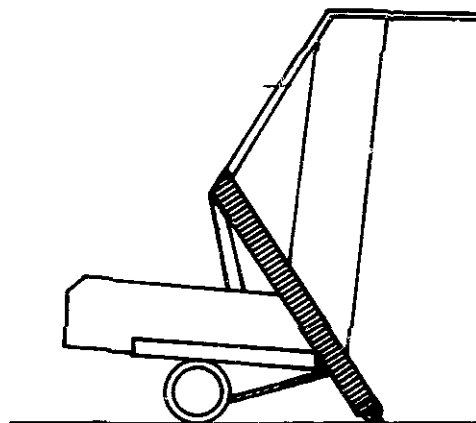
An additional crashworthiness feature involves an aircraft in which the main spar is a large aluminum tube that passes through the cockpit. This hollow tube serves also as a fuel cell. The two-seat aircraft has both seats mounted side by side on a small metallic track directly on top of the main spar. The bottom of the seat is plywood and the seat cushion consists of 2 inches of foam rubber. This arrangement appears to offer little attenuation of impact forces by the seat. During impact, forces, particularly vertical forces, would tend to be transmitted through the main spar to the pelvis and the axial spine of the occupant.

Figure XI. Schematic of aircraft seat showing mounting directly over large tubular main spar with little space or structure to attenuate vertical impact forces.

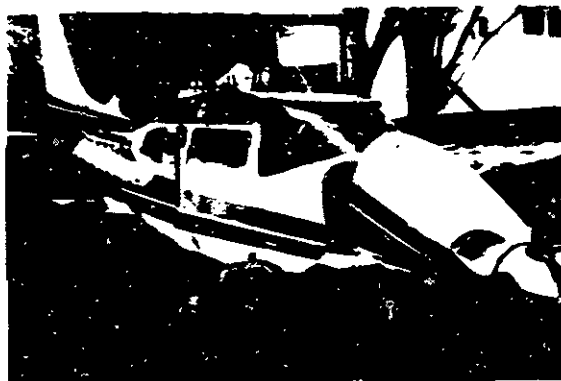
application aircraft as illustrated in Figure XII. The six people in this aircraft all received moderate to severe injuries. The pilot and person in the copilot position had facial injuries and spine fractures. The forward four seats were partially or completely separated from the seat tracks and the pilot's and copilot's seats had fractured seat pedestals as shown in the figure. Cast seat legs and parts are strong and meet all FAA requirements but in accidents when the failure point is reached they appear to break exposing the occupant to possible high peak decelerative forces in secondary impacts rather than deforming under the occupant and attenuating the energy of impact. At present we do not know how pervasive failures of seats are in general aviation aircraft or how such failures add to the severity of injuries. This is a matter of continuing crashworthiness investigations.

Figure XII. On impact, the occupants of this aircraft received serious injuries. Cast alloy seat pedestals were found to be fractured as can be seen in photograph.
