FAA-AM-80-3

AIRCRAFT CRASHWORTHINESS STUDIES: FINDINGS IN ACCIDENTS INVOLVING AN AERIAL APPLICATION AIRCRAFT

William R. Kirkham, M.D., Ph.D.  
James M. Simpson  
Terry F. Wallace  
Paula M. Grape  
Civil Aeromedical Institute  
Federal Aviation Administration  
Oklahoma City, Oklahoma

April 1980

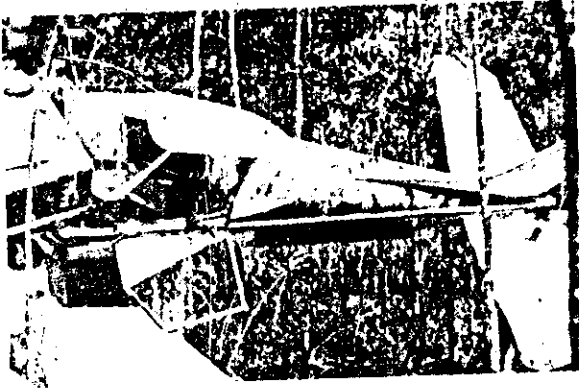
Figure 1-1. 1967 model aircraft partially suspended above ground. Cockpit structure and empennage were relatively undamaged.

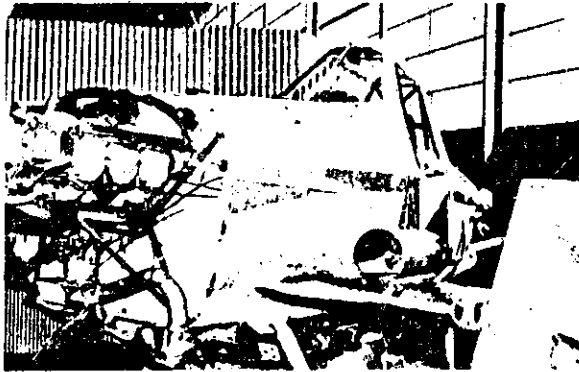
Case 2. This 1968 model aircraft crashed into trees. Both wings and the empennage were torn off (Figure 2-1). The pilot was wearing a helmet, shoulder harness, and lap belt.

Figure 2-1. Empennage and wings were torn off this 1968 model aircraft in a crash into trees.

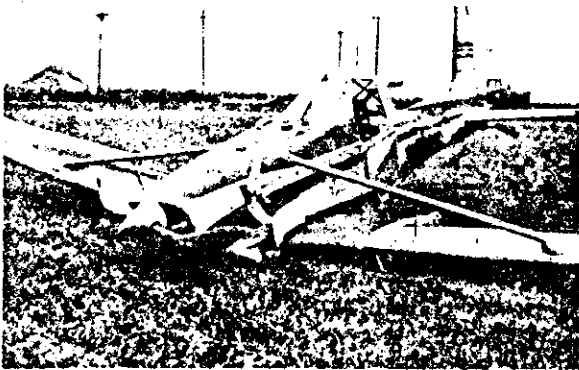
Case 3. This 1968 model aircraft stalled at 100 to 150 feet and struck with relatively minor forces in a soft wheat field. There was slight damage to the wings and fuselage (Figure 3-1). Both landing gears were torn off. The pilot was wearing a crash helmet, shoulder harness, and lap belt. The shoulder harness, lap belt, and seat showed no evidence of impact damage. The seat remained on the track (Figure 3-2). The pilot hit the right window with his head but received no injuries in this accident.

Figure 3-1. 1968 model aircraft with minor damage of wings and fuselage.

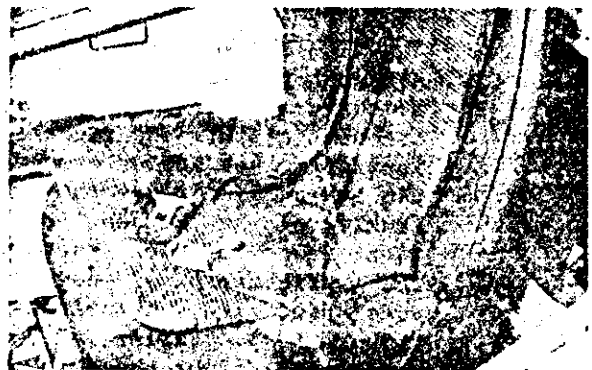
Figure 3-2. Seat and restraint systems undamaged.

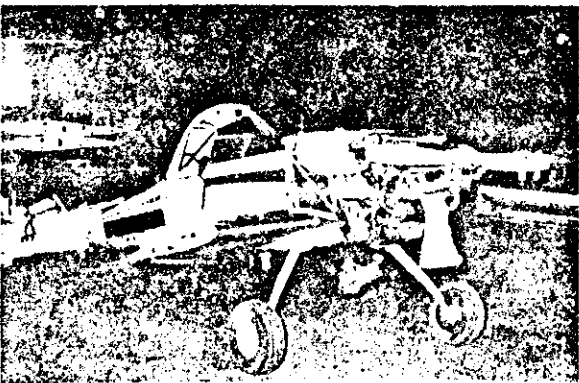
Figure 4-1. 1969 model aircraft in minor impact nosed over damaging propeller, overhead canopy and vertical stabilizer.

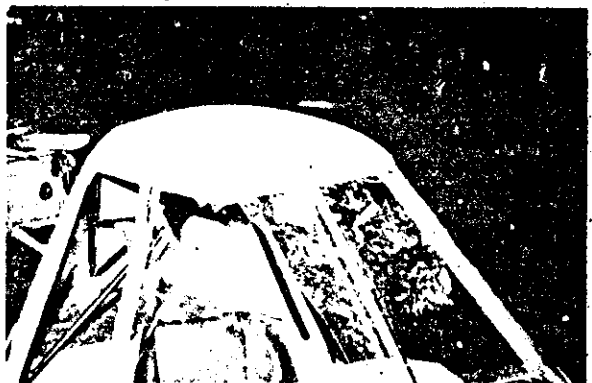
Figure 4-2. Damage to overhead canopy.

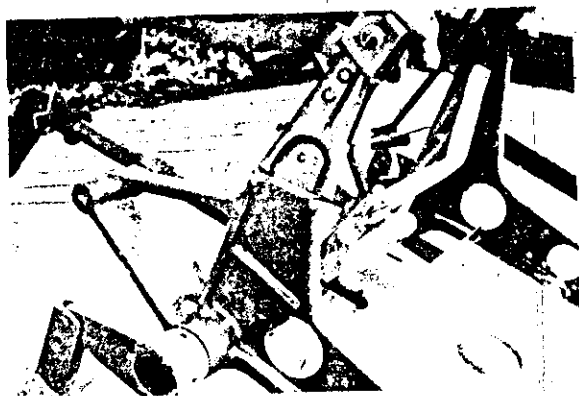
Figure 5-3. Mid-shaft break in right front seat leg. The seat was detached from the seat track.

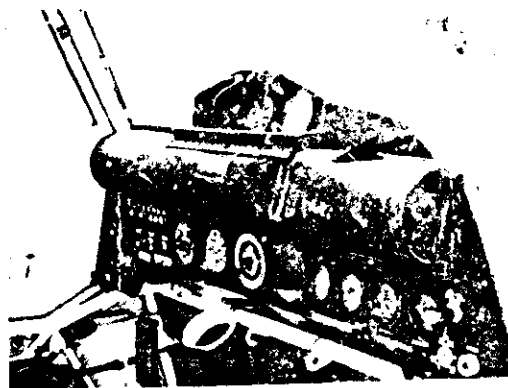
Figure 5-4. Indentation on the panel consistent with a mild head strike.

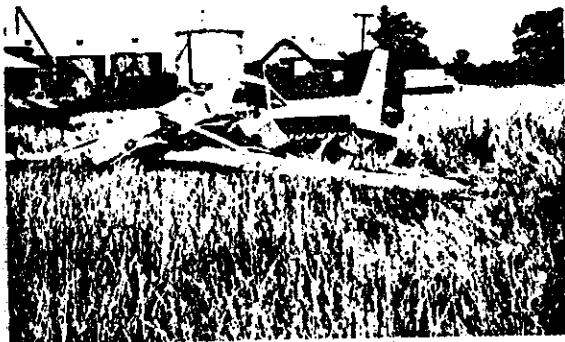
Figure 6-1. 1971 model aircraft with damage to engine and hopper area. Cockpit showed little structural damage.

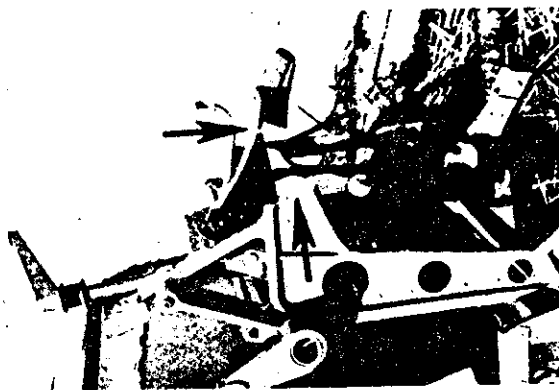
Figure 6-4. Both forward seat legs were fractured. The rivets of the leg-to-seat-track attachment were sheared.

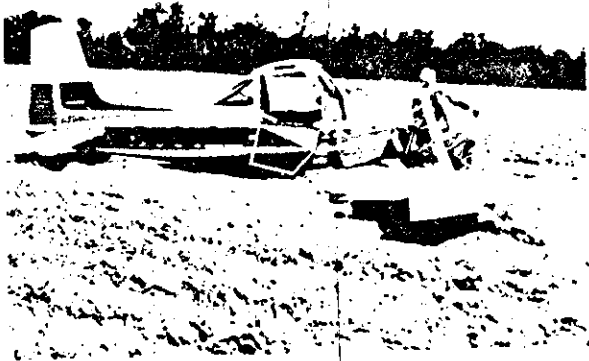
Figure 9-1. 1972 model with substantial engine, hopper and wing damage but intact cockpit.

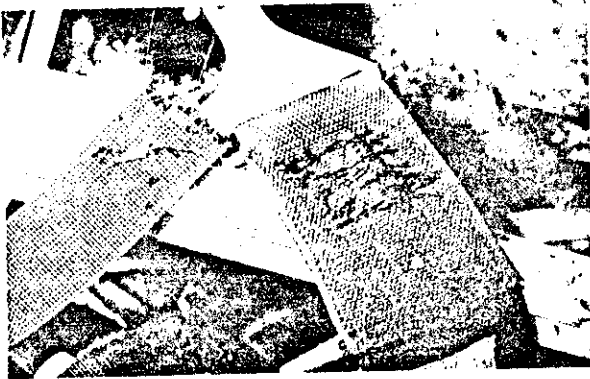
In this severe nosedown, right-wing-down impact, the pilot during deceleration was thrown forward and to the right. The failure of the right shoulder strap where attached to the right limb of the lap belt probably permitted the pilot to travel forward and to the right striking his head on the right side of the instrument panel and cockpit frame. Separation of the seat from the track probably added to the freedom of the pilot to travel forward. The slack in the lap belt customarily used by this pilot probably increased the peak loading on the right shoulder strap. Use of a crash helmet undoubtedly would have lessened the extent of head injuries.

Figure 10-3. The right shoulder harness was detached from the right side of the lap belt. The torn threads were evident.

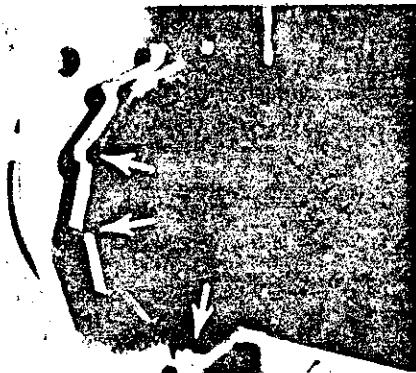
The forces in this accident caused the pilot to travel forward against the shoulder harness. Failure of the inertia reel to completely engage and hold, thereby letting the shoulder harness fully extend, probably accounts for the pilot's head striking the instrument panel. Fracture of the forward legs of the seat and the seat separation probably added to freedom of the pilot to come forward.

Figure 11-3. The reel ratchet gears were flattened and the engaging pall was grooved.

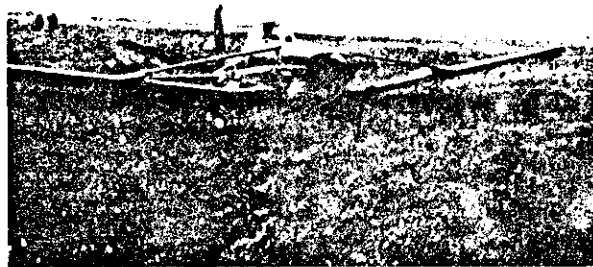
This was a relatively minor impact with peak loading when the aircraft struck the terrace, collapsing the gears and apparently causing significant vertical loading at that time to cause a compression fracture of a vertebra.

Figure 12-1. 1973 model with smoke from engine obscuring pilot's vision struck the ground in near horizontal attitude. Gears collapsed as aircraft hit a terrace. Restraint systems functioned normally but pilot received a compression fracture of a thoracic vertebra.

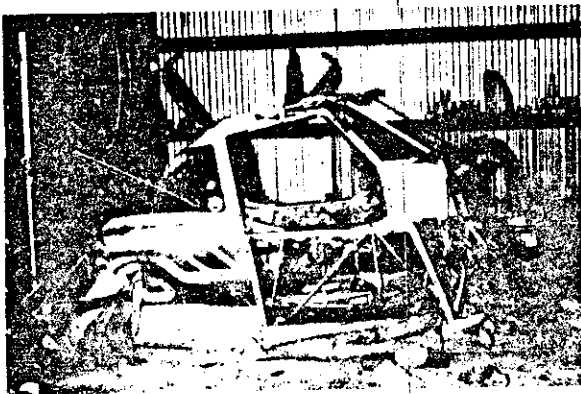
Figure 13-1. Only the structural integrity of the cockpit is maintained in this aircraft.

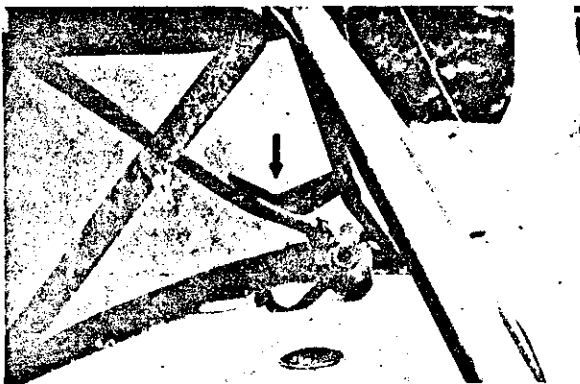
In this severe accident the forward force of the pilot's body during deceleration probably caused forward deformation of the shoulder harness attachment bracket and overloading to an extent that caused failure of the attachment of the shoulder harness to the attachment bracket. The pilot was thereby allowed to come forward and strike the instrument panel. Breakage of the legs of the seat probably gave additional freedom for the pilot's body to move forward.

Figure 14-3. The shoulder harness attachment bracket was bent forward and the shoulder harness attachment to the bracket had failed.

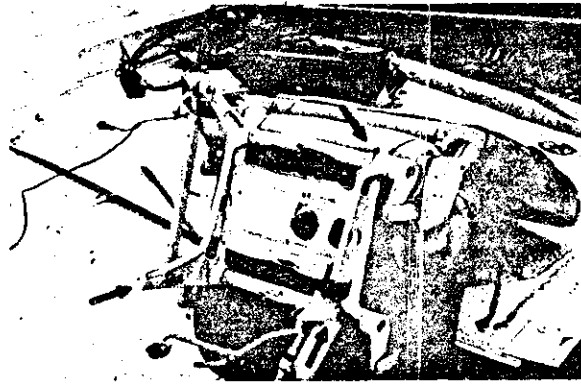
Figure 14-4. Three seat legs and seat pedestal were broken.

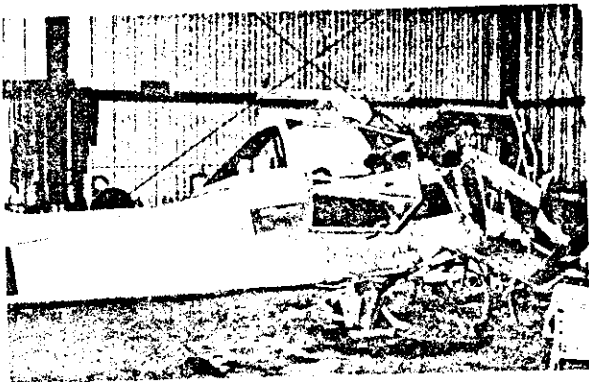
Figure 15-1. The engine and hopper were broken downward and to the left. The overhead cockpit structure was deformed downward on the right.

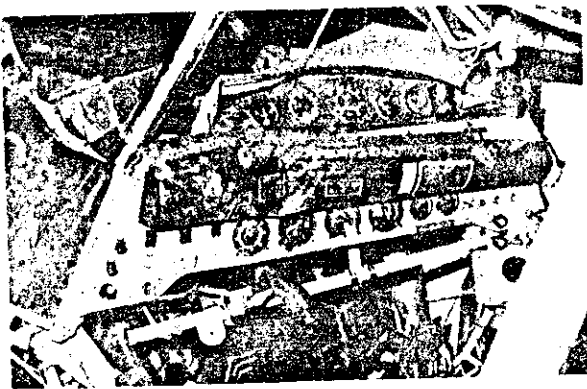
The pilot's major injuries probably resulted from head impact with the instrument panel, partly because the pilot wore his lap belt loose and because of fractured instrument panel support structures that allowed the instrument panel to displace aft to the pilot's head during the impact. Fracture of the left seat pedestal and displacement of the seat forward off the seat tracks probably allowed greater freedom for the pilot to move forward during the impact.

Figure 15-3. The roll of aluminum on the instrument panel was deformed forward.

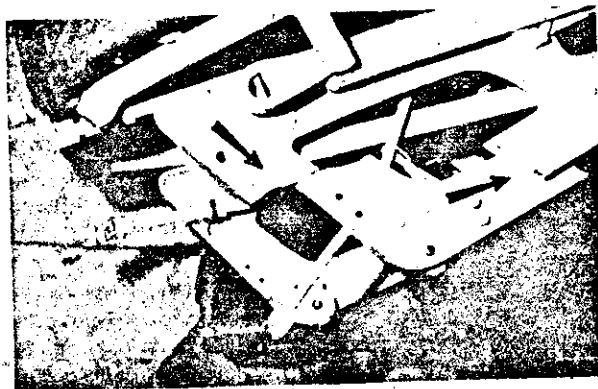
Figure 15-4. The left seat pedestal was fractured in two places and the seat locking pin was displaced aft. The seat was loose in the cockpit.

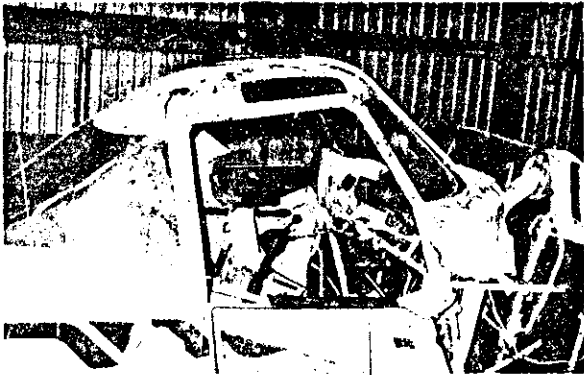
Figure 16-1. Severe impact on this 1974 model broke engine and hopper downward. The structural integrity of cockpit was preserved.

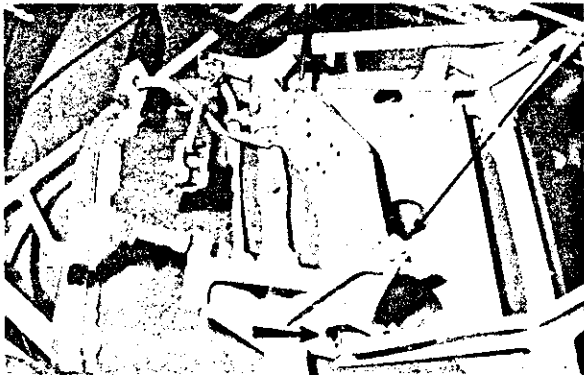
Figure 16-3. The seat-to-track attachments were broken on three of the seat legs and both horizontal portions of the seat frame were broken.

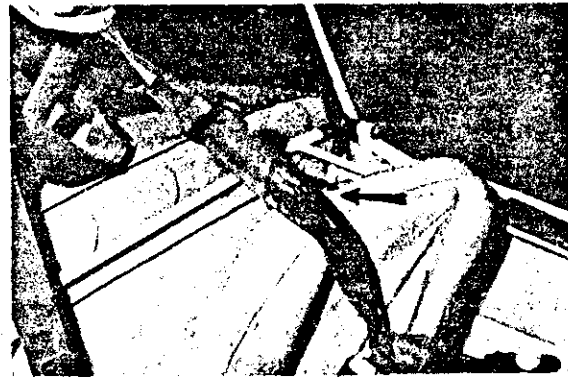
Figure 16-4. Blue color of seat material was apparently transferred to shoulder harness during impact (see text).

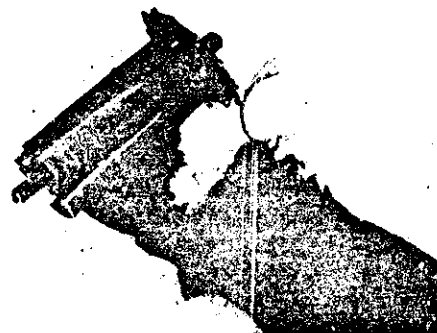
Figure 17-4. Shoulder harness retainer was displaced from reel axle and belt was torn.

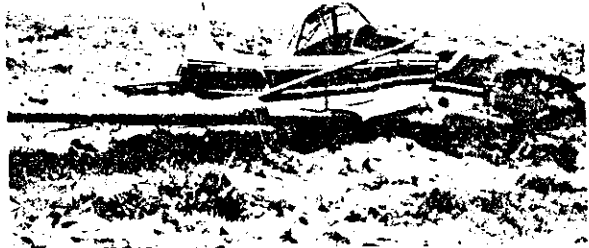
This was a predominantly vertical loading accident. During deceleration the pilot traveled forward against the shoulder harness. The inertia reel apparently engaged but the force caused failure of the locking mechanisms. This failure probably allowed the shoulder harness to fully extend and the pilot to strike the instrument panel. The breaking of the seat legs allowed more freedom for the pilot to come forward into the instrument panel and rebound. The crash helmet probably prevented serious or even fatal head injuries.

Figure 18-1. This 1977 model aircraft struck the ground in a flat spin. Downward deflection of structures indicated considerable vertical loading.

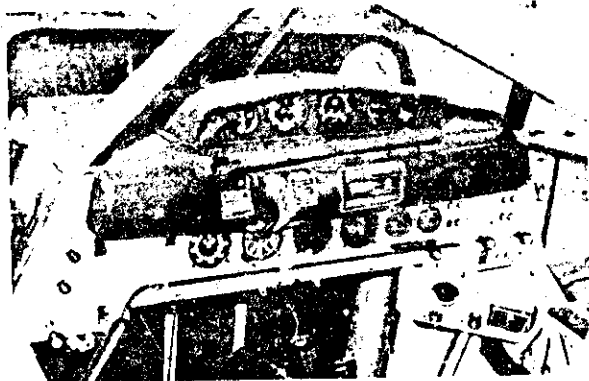
Figure 18-2. Instrument panel showed forward deformation probably caused by pilot's head.
