**CONSTRUCTION MONITORING AND PROCEDURES FOR I-275  
“WARRANTY PROJECT”  
KENTON/BOONE COUNTIES**

**KTC-01-29/FR107-01-1I**

December 2001

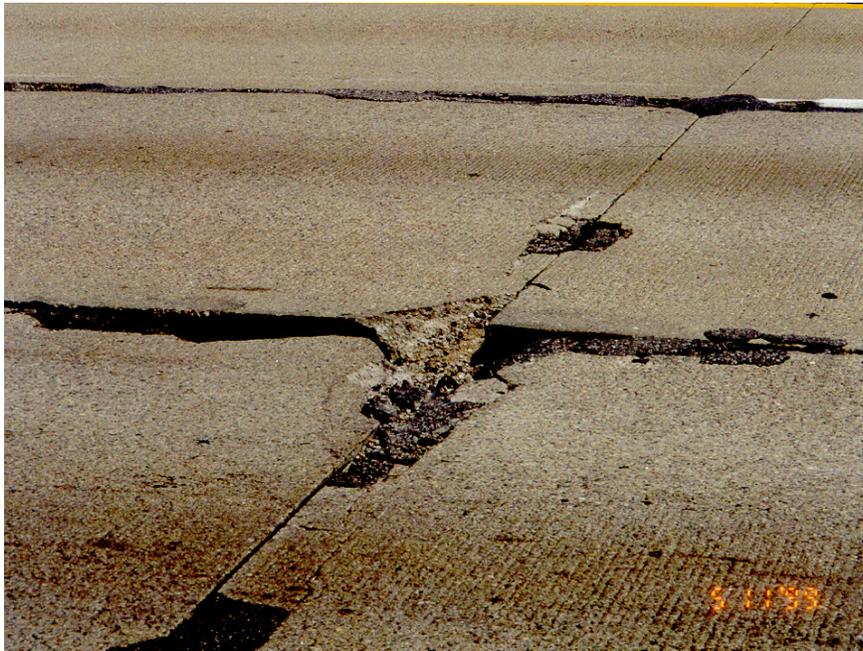
The remainder of the project has seen increasing deterioration of the pavement structure in recent years. The historical rideability of the project is given in Figure 1. Figures 2 and 3 illustrate typical distresses that were found throughout the project. Extensive patching of the deteriorated joints had become overwhelming. During a project recently completed that retrofitted the shoulder joints with dowels to facilitate the maintenance of traffic for the major rehabilitation, a separate item was included to do extensive full width patching of distressed areas. This activity virtually eliminated the need to continue to do pothole patching. The net effect was to provide for a consistent foundation for the anticipated rehabilitation.

Figure2: Pavement Distress.

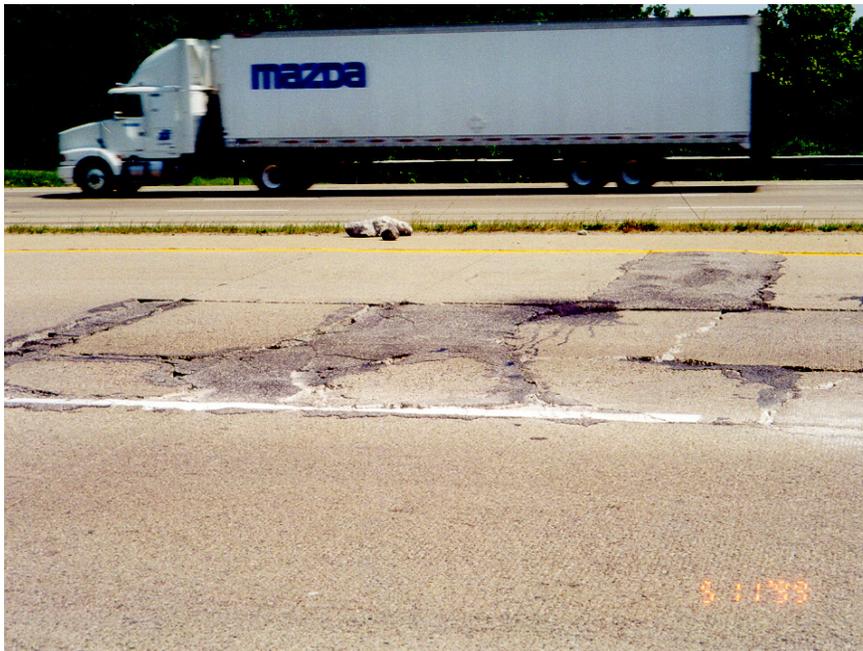
Figure 3: Pavement Distress.

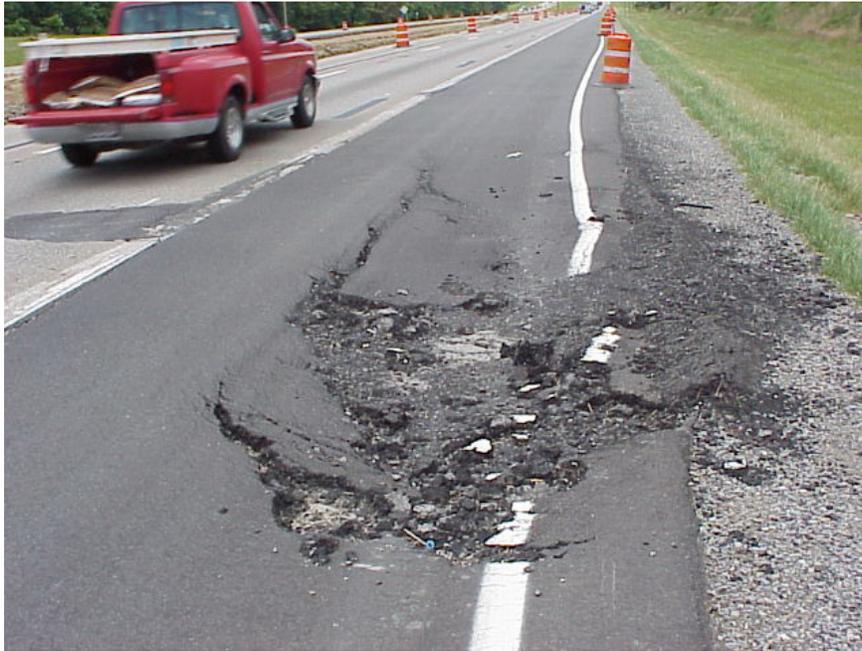
In preparation for the construction of the median cross-over, traffic was shifted to the outside asphalt shoulder of the westbound direction. Within 36 hours of diverting traffic, substantial rutting and other distresses were observed in the shoulder pavement. Figures 4 through 7 illustrate the condition of the shoulder pavement.

Figure 4. Shoulder Failure.

Several areas of weakened pavement structure were observed along the length of the project. It was determined that the shoulder should be replaced from station 366+54 to 578+92 westbound.

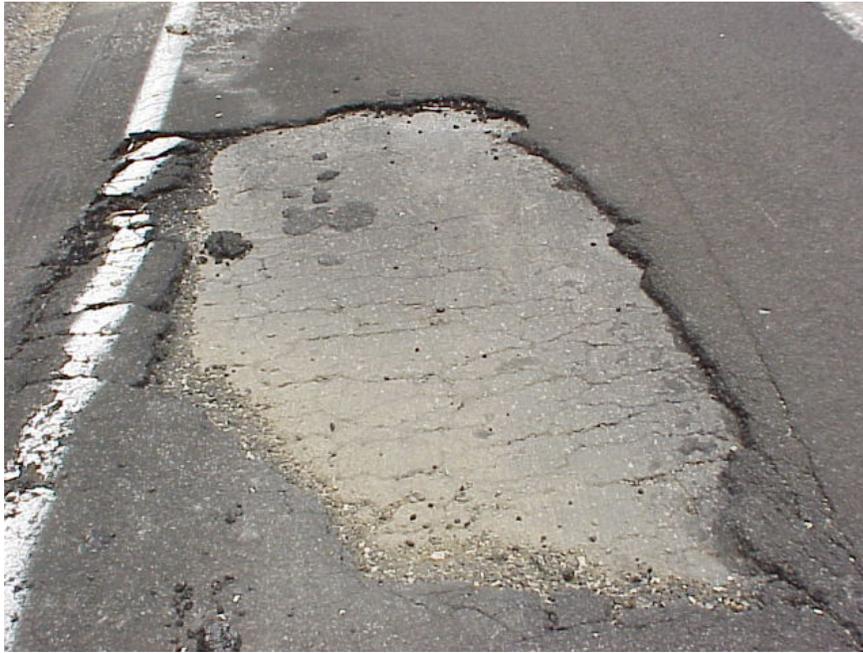
In Figures 5 through 7 there is considerable distress due to traffic being shifted to the shoulders. The surface of the shoulders separated from the base, and severe rutting and shoving occurred at this location. This distress prompted (Kentucky Transportation Cabinet) to request the contractor to make necessary repairs (change order No. 2). The Kentucky Transportation Center tested the shoulder using the falling weight deflectometer. The test showed that sub-grade/base rehabilitation would be necessary.

Figure 5. Shoulder Failure.

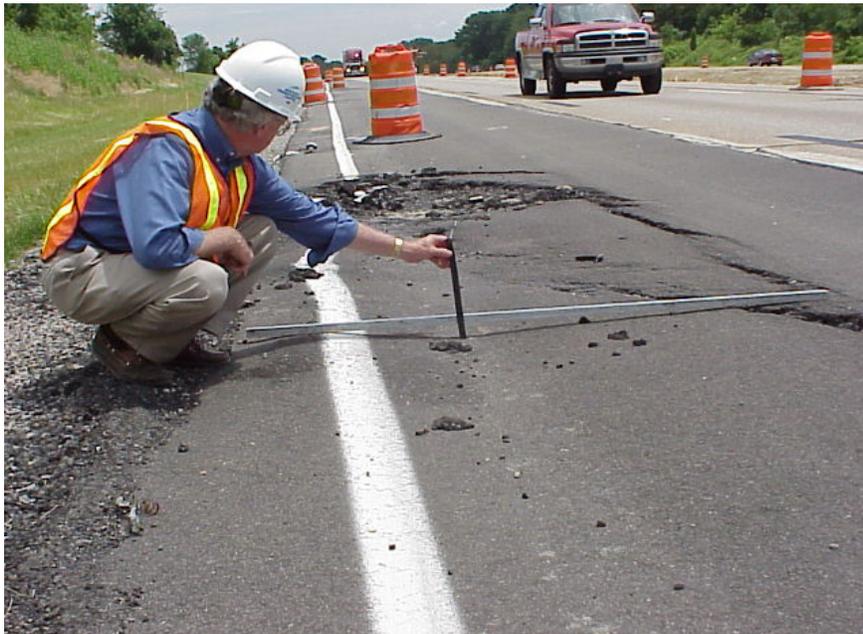
Figure 6: Shoulder Failure.

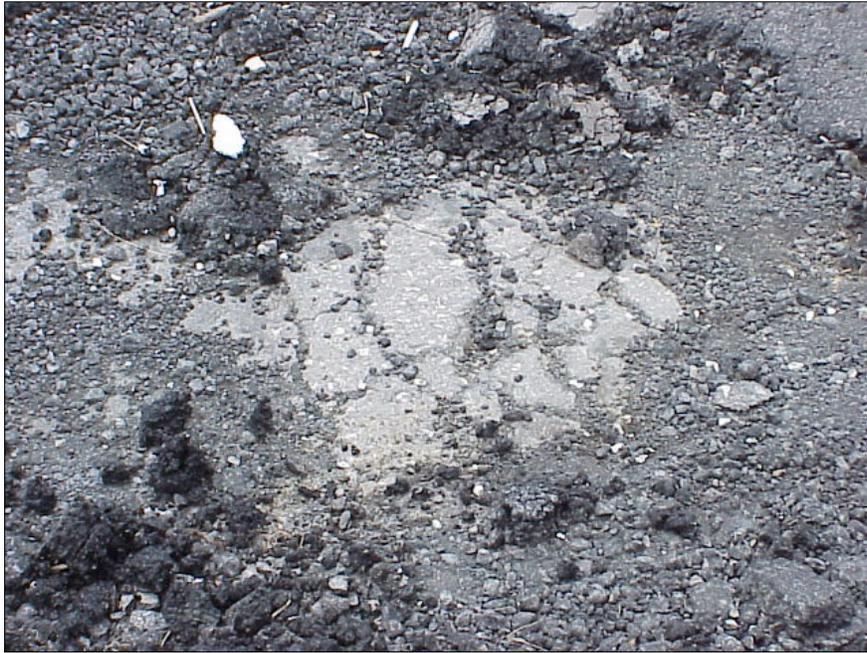
Figure 7. Shoulder Failure.

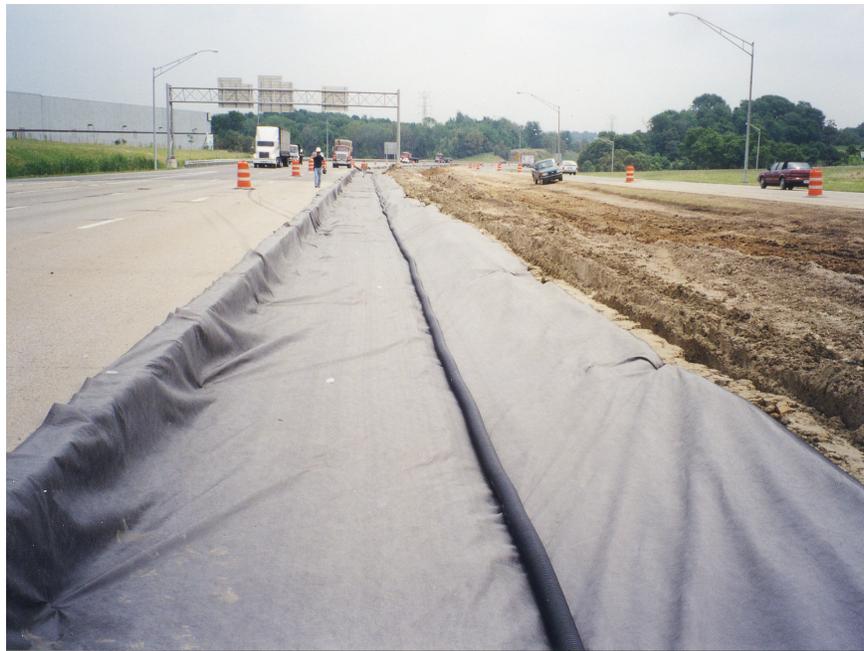
Figure 8. Geo-textile Type IV Fabric and 4-inch Longitudinal Drain Pipe.

- In Figure 8, a Geo-textile Type IV fabric was used to keep aggregate from migrating into an already weak sub-grade. This added structure and provided a good foundation for rebuilding the shoulders.

- In Figures 8 and 9, a 4-inch drain pipe was used to aid in the removal of water from the aggregate and sub-grade. This prevented water from being trapped under pavement thereby causing future problems. A cement-treated aggregate is then placed around the 4-inch pipe to protect the pipe from being punctured by the No. 2 stone.

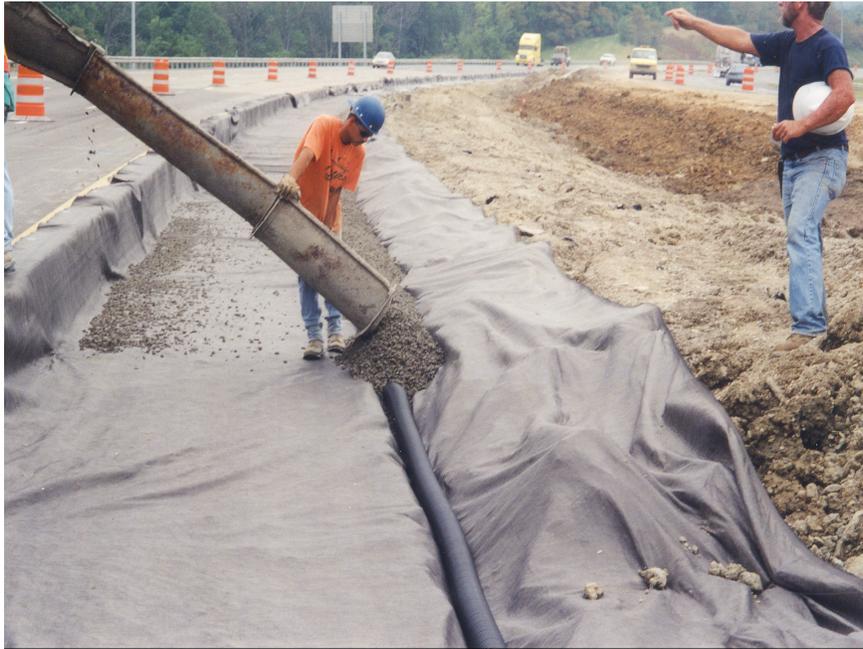
Figure 9. 4-inch Drainage Pipe and Fabric Being Covered by Cement Treated Aggregate.

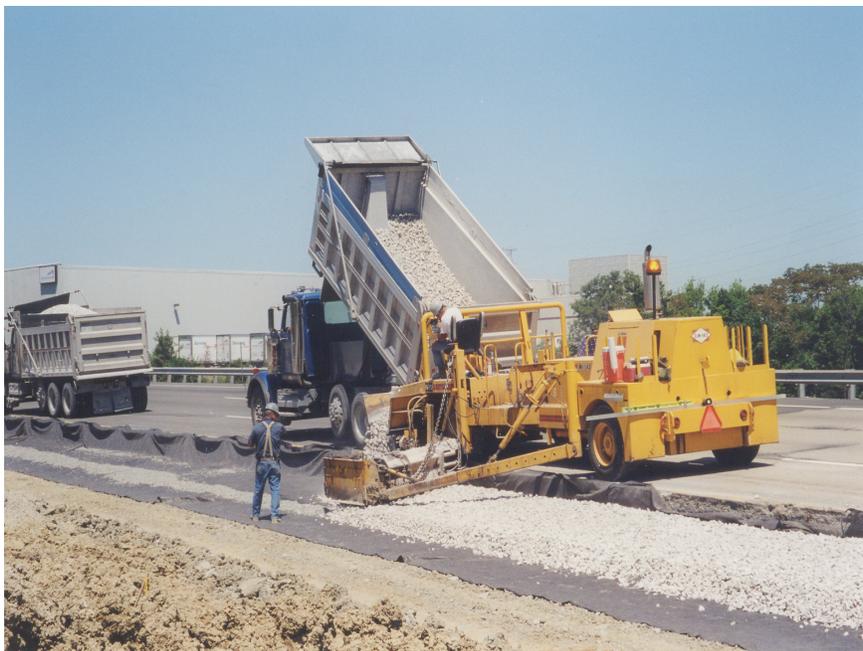
Figure 10. Placing No. 2 Stone.

- In Figure 10, additional structure was added by placing No. 2 stone (8 inches) in thickness over the Geo-textile fabric.
- In Figure 11, a cement treated drainage blanket (4 inches) in thickness was placed over the No. 2 stone to allow water to flow through to the 4-inch drainage pipe. After the cement-treated drainage blanket was placed, it was then treated with a curing agent. After curing is complete, three lifts of an asphaltic concrete mixture, totaling 8 inches, was added.

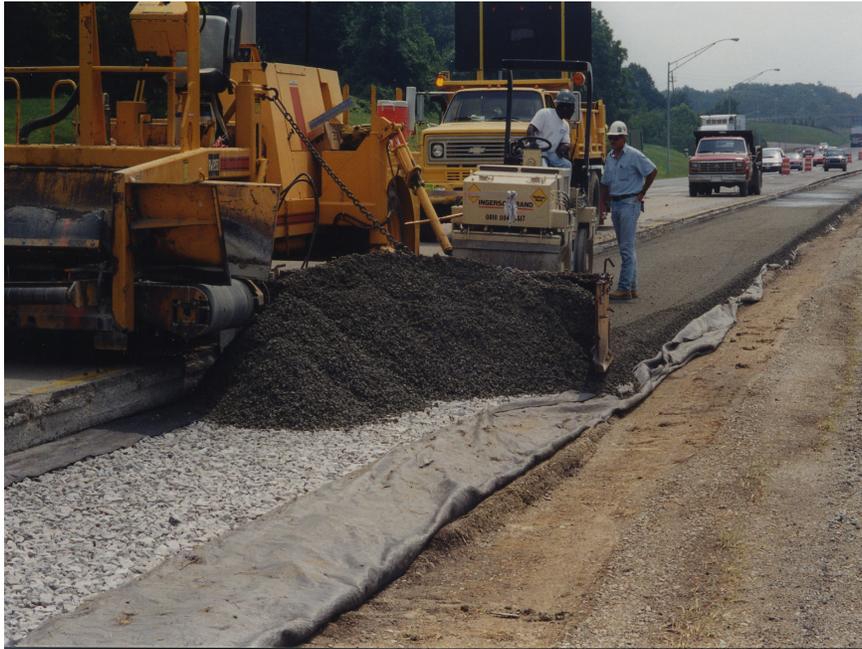
Figure11. Placement of Cement-Treated Drainage Blanket.

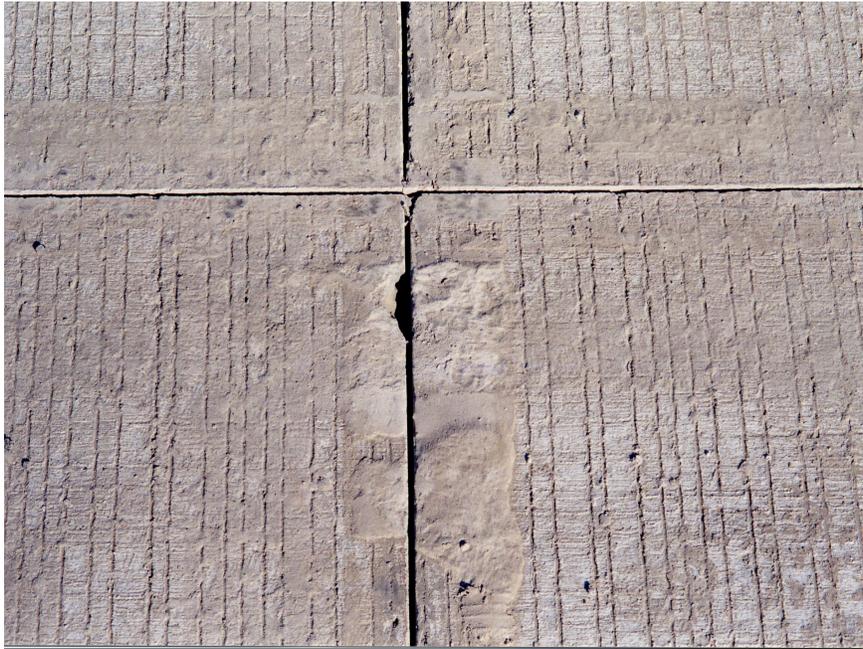
Figure 15. Westbound Corner and D Cracks.

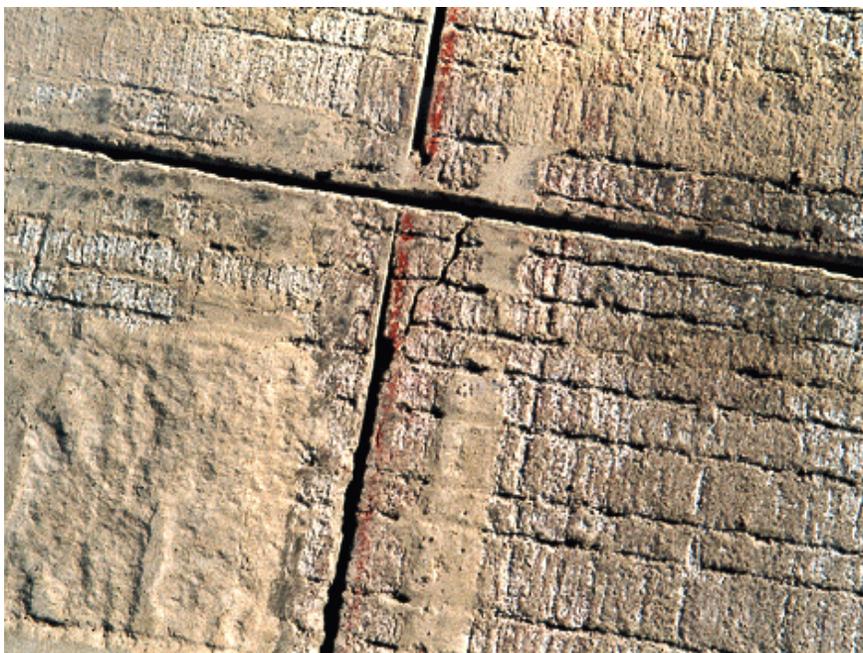
Figure 16: Westbound Corner Crack.

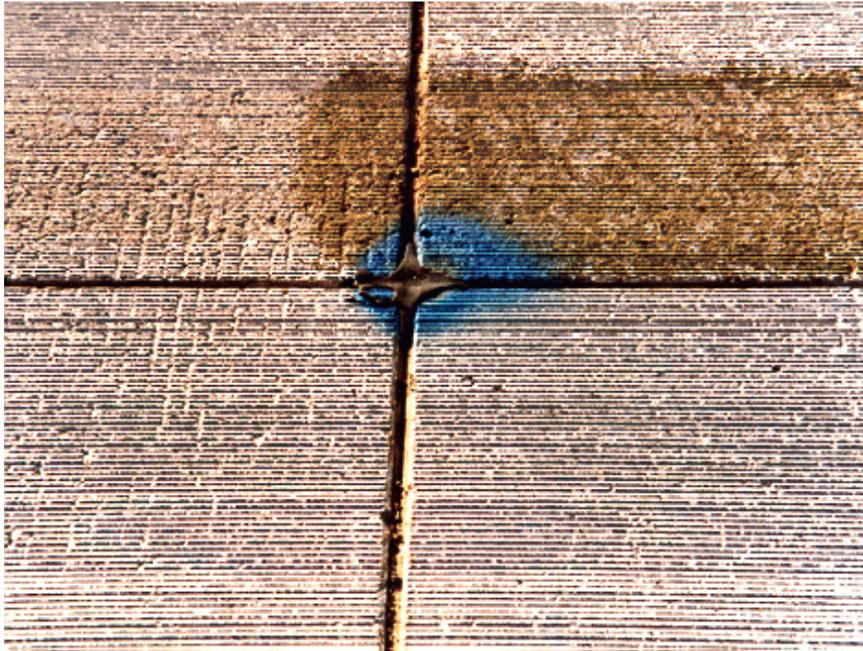
Figure 17: Westbound Patched Corner Crack.

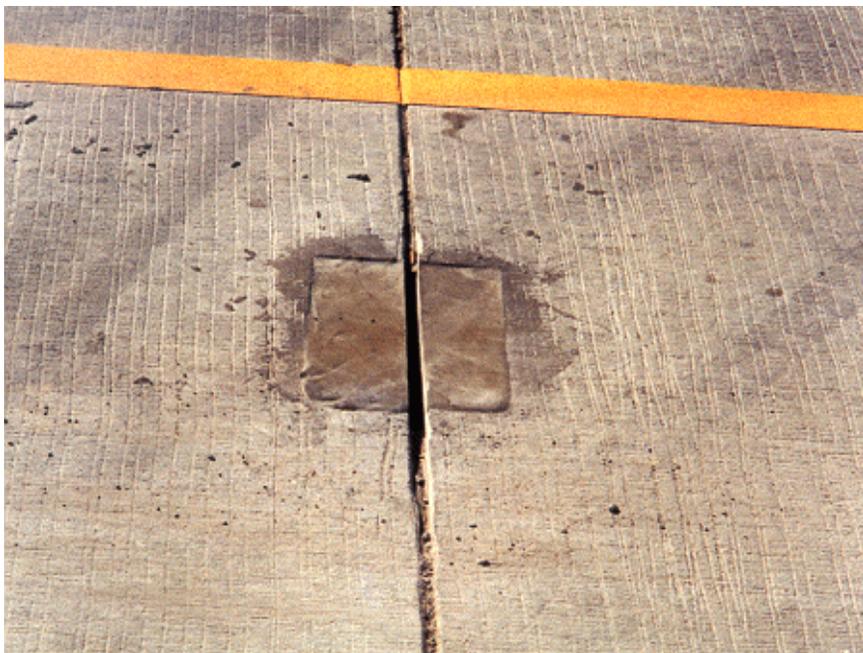
Figure 18: Eastbound Epoxy Patch.

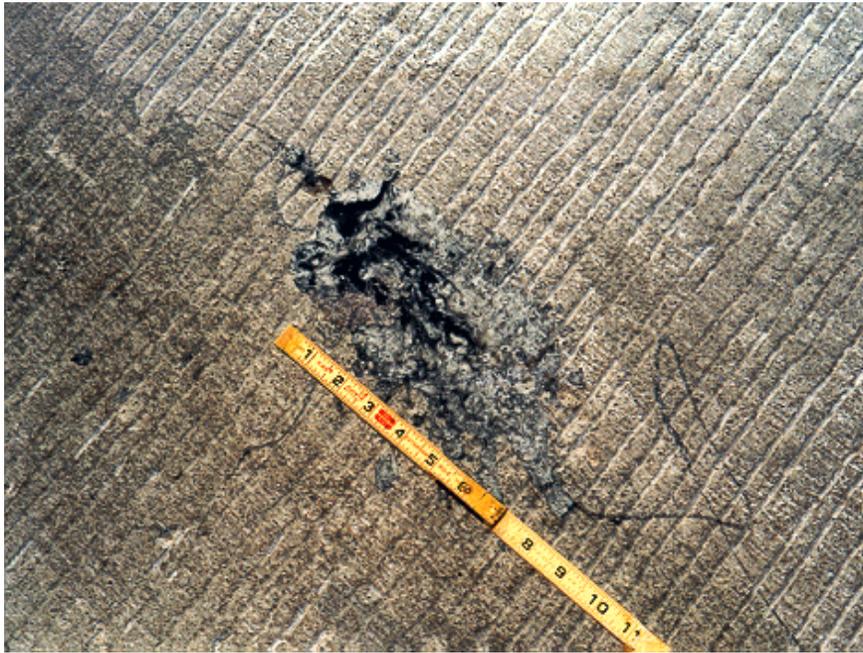
Figure 19: Eastbound Patched Pop Out at Station 452+13.

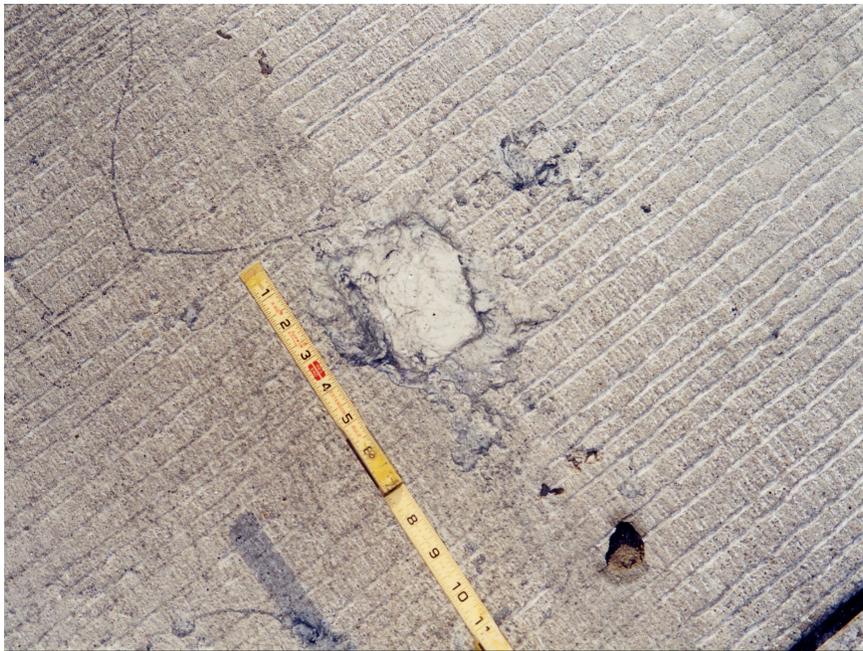
Figure 20: Eastbound Patched Pop Out at Station 452+13.
