**PAVEMENT/SUB-GRADE CONDITION ASSESSMENT I-65
APPROXIMATE MILEPOST 97.5 TO 102.5
(TRANSITION FROM ASPHALT TO CONCRETE) TO (KY 313 OVERPASS)**

Research Report
KTC-05-13/FRT141-04-1F

June 2005

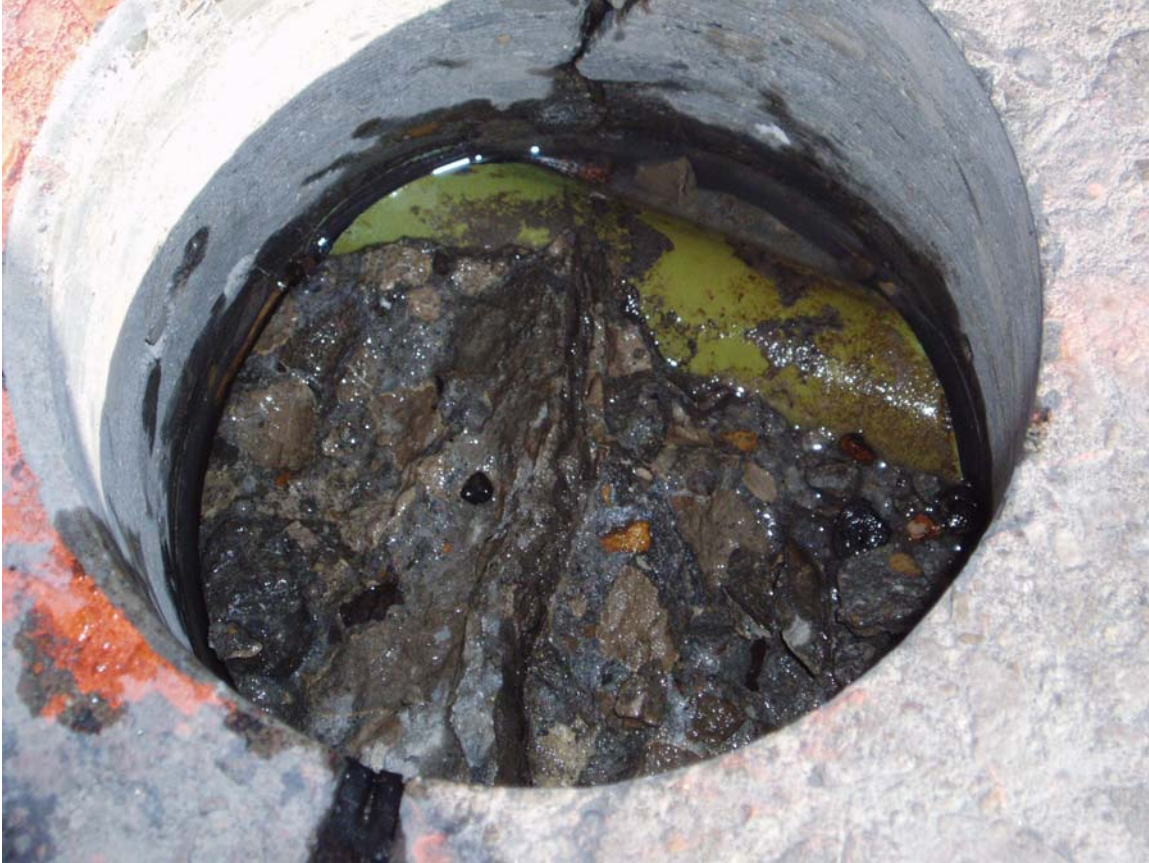
One transverse joint dowel bar was extracted in the northbound middle lane at station number 567+00, to determine the integrity of the protective coating on the dowel bar (Figure 1). As seen in Figure 1, the protective coating appears to be in

place and in good condition. Therefore, it appears that the transverse joint dowel bars have not corroded.

Figure 1: Transverse Joint Dowel Bar

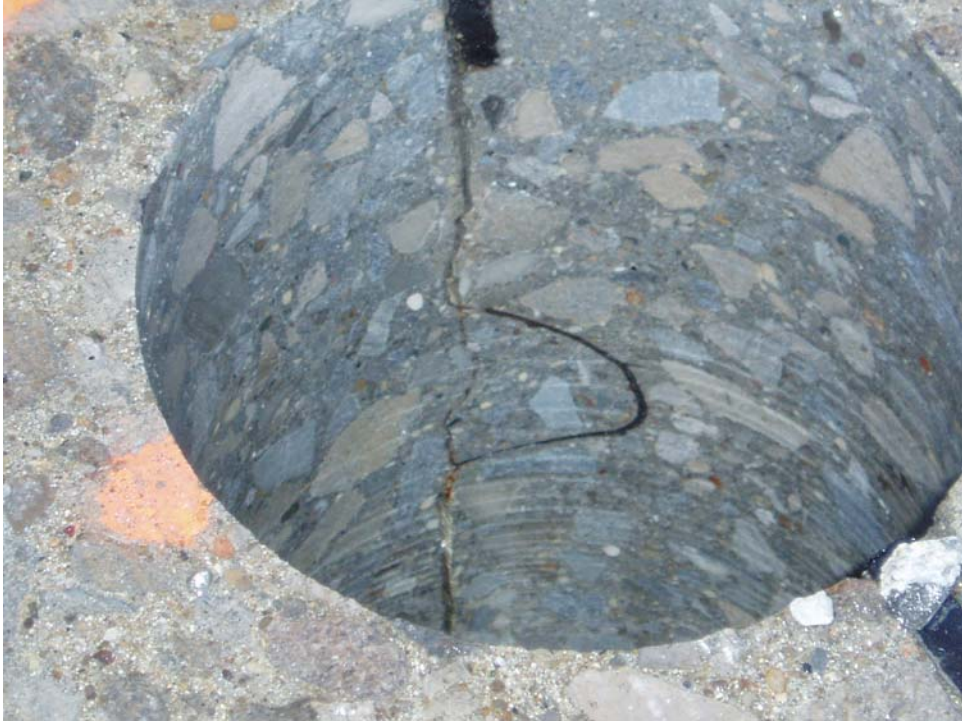
The tie assembly placed in the longitudinal joint between adjacent lanes was inspected to determine its long-term functionality at Station Number 567+00 NBFL (Figure 2). As seen in figure 2, the tie assembly appears to have sheared away from one of its connected sides. Therefore, it is speculated that this longitudinal tie will not support the pavement in the event of differential settlement between lanes. However, no differential settlement was observed in this area or throughout the majority of the project (Figure 3).

Figure 2. Longitudinal Joint Tie Assembly.

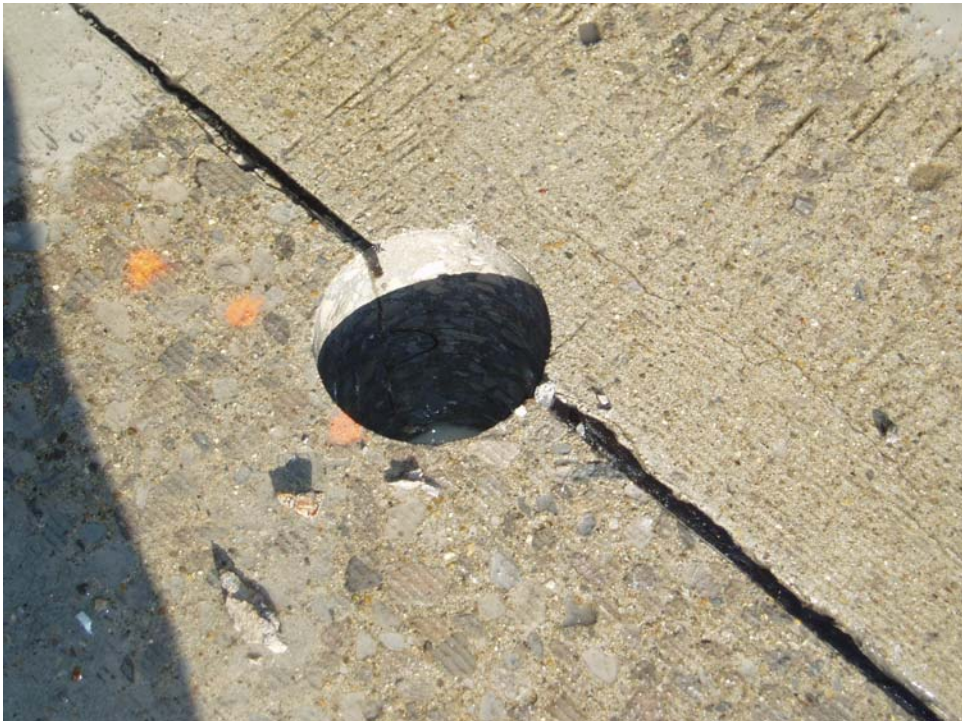
Figure 3. No Presence of Differential Settlement between Middle and inside Lane

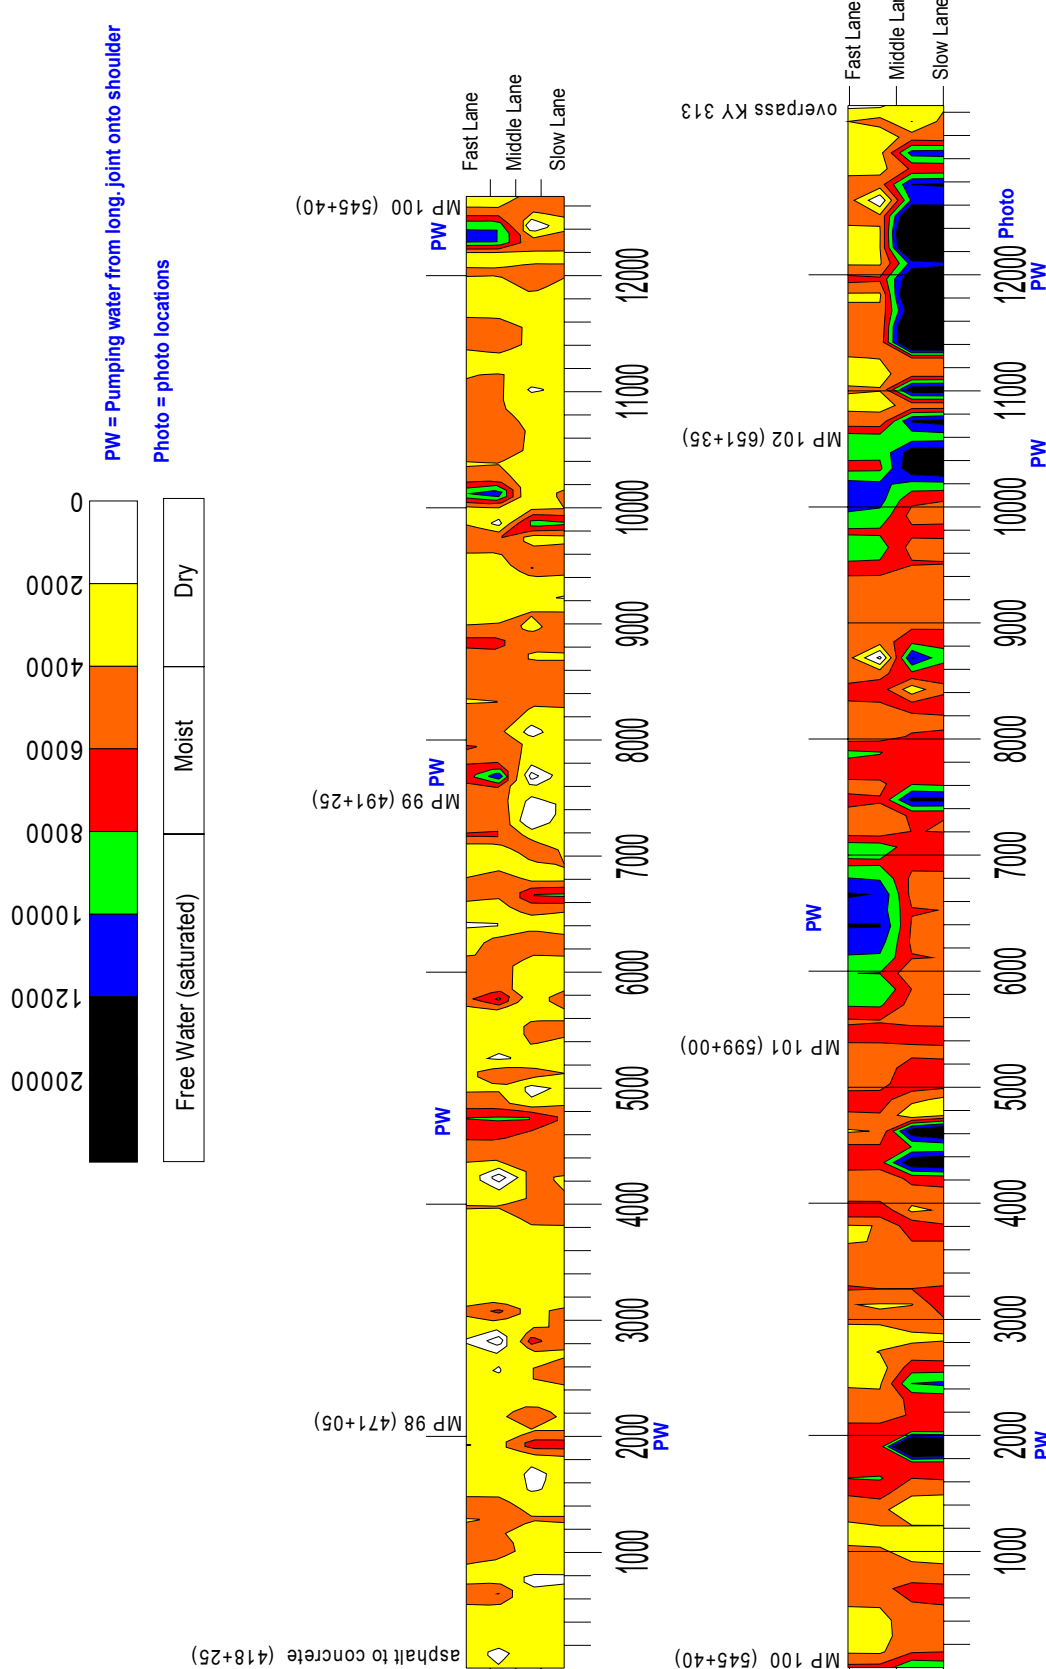
In an attempt to quantify the degree of saturation of the subgrade material, the amplitudes of the reflected radar signal were analyzed at the concrete/D.G.A. interface. Areas that displayed amplitudes greater than 8000 dB were considered to be fully saturated areas. Areas with amplitudes less than 4000 dB were considered to be areas with both dry and normal moisture contents for subgrade material. Finally, areas that had amplitudes ranging between 6000-8000 dB's were considered transition areas--from fully saturated to normal/dry moisture contents.

Figure 4 displays the degree of saturation for the three northbound lanes. Note areas marked with PW, on Figure 4, were areas observed in the field to be pumping water between the shoulder and driving lane as truck traffic passed by (Figures 5, 6). Figure 7 displays the degree of saturation for the three southbound lanes.

Figure 4: Degree of Moisture Beneath the Concrete Surface (Northbound)

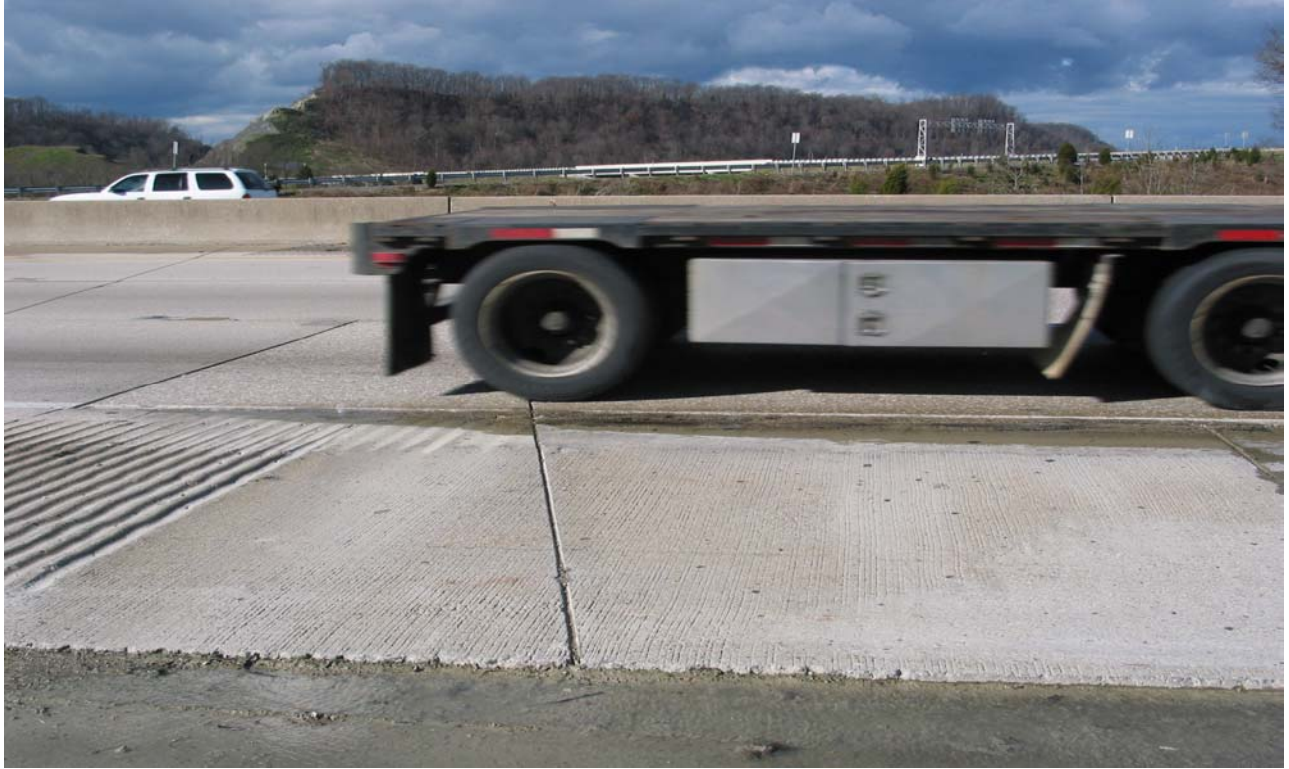
Figure 5: Water pumping Up from Shoulder Joint (Northbound)

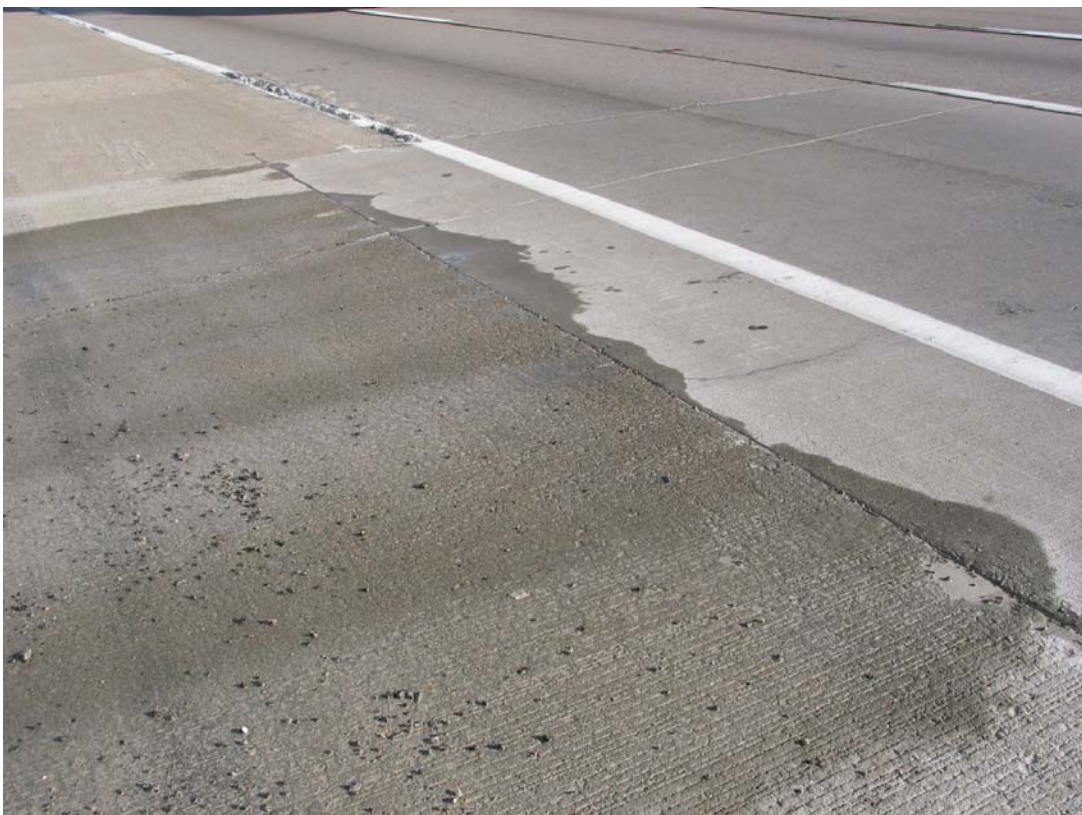
Figure 6: Water Bleeding Out of Shoulder Joint in Patched Area

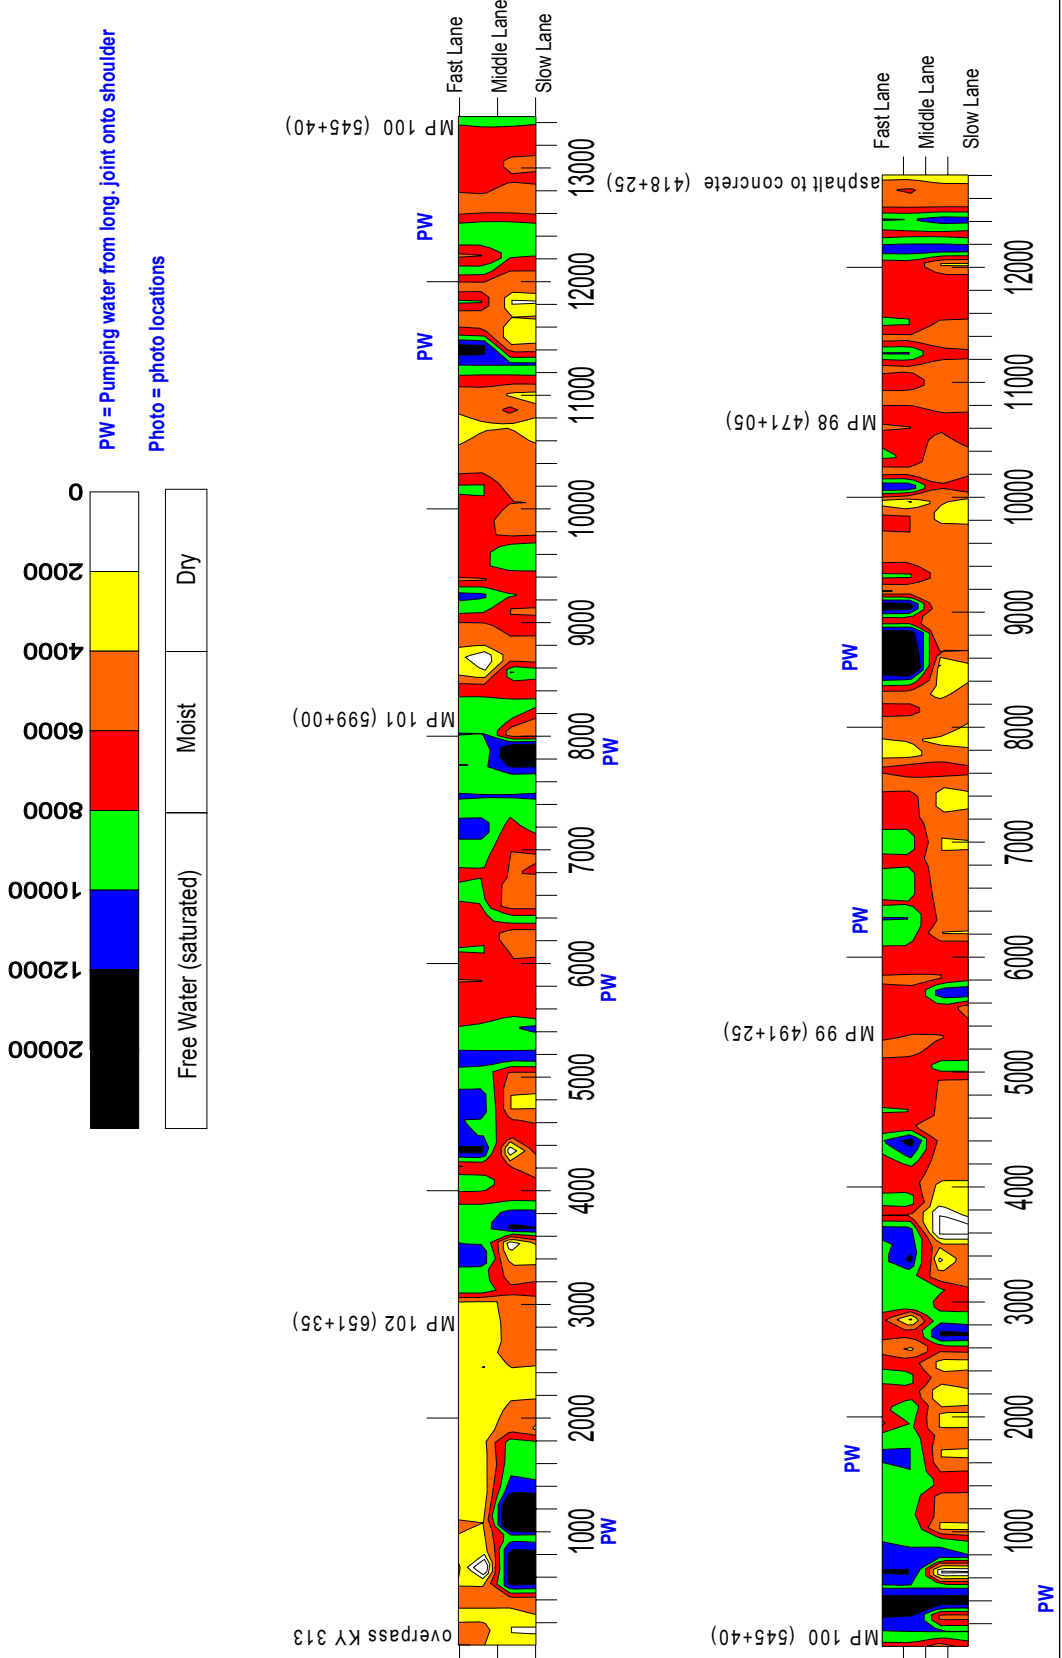
Figure 7: Degree of Moisture Beneath the Concrete Surface (Southbound)

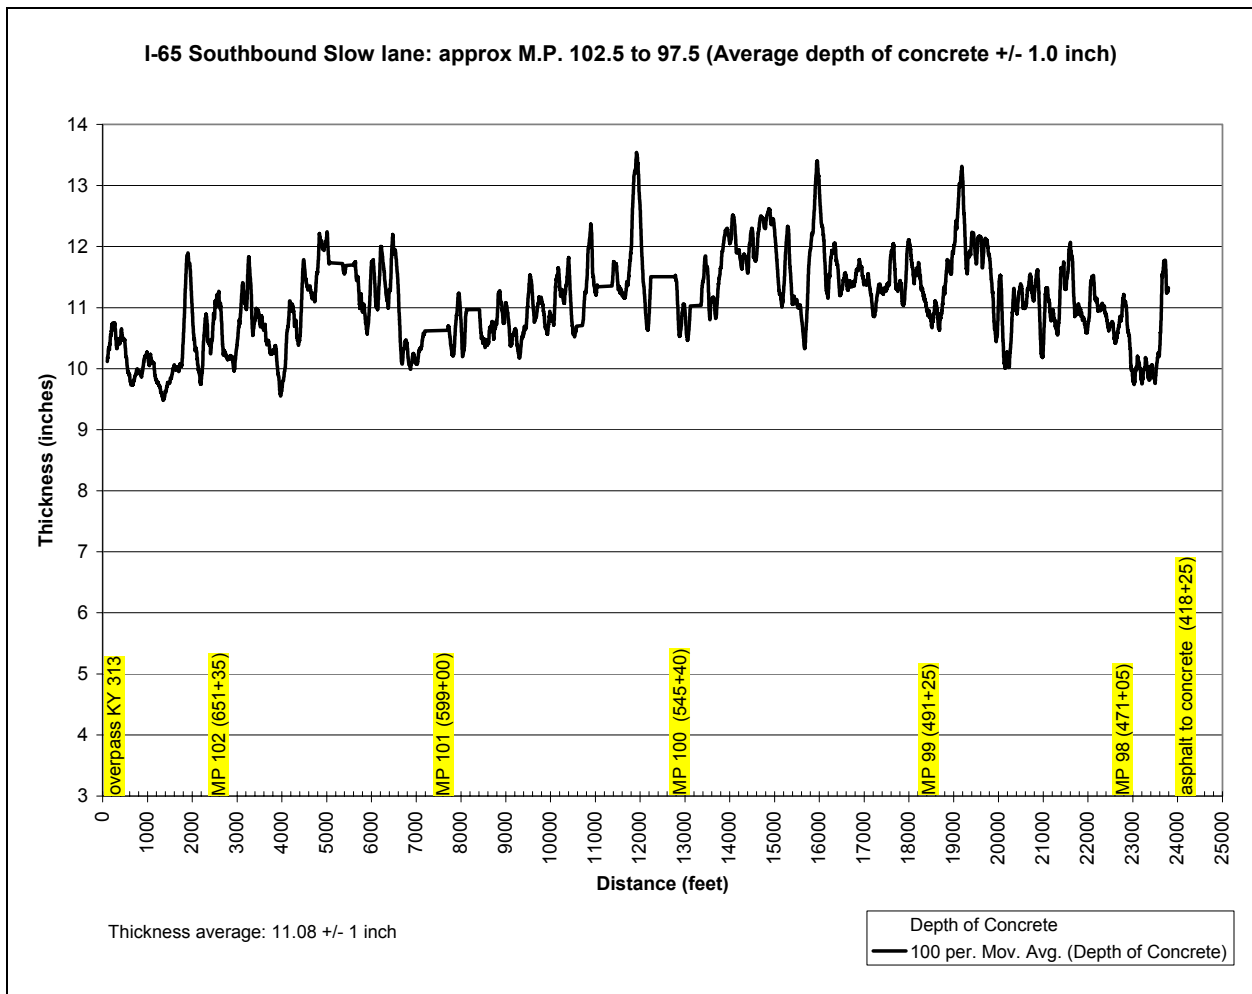
Figure 8: Concrete Thickness Southbound outside lane

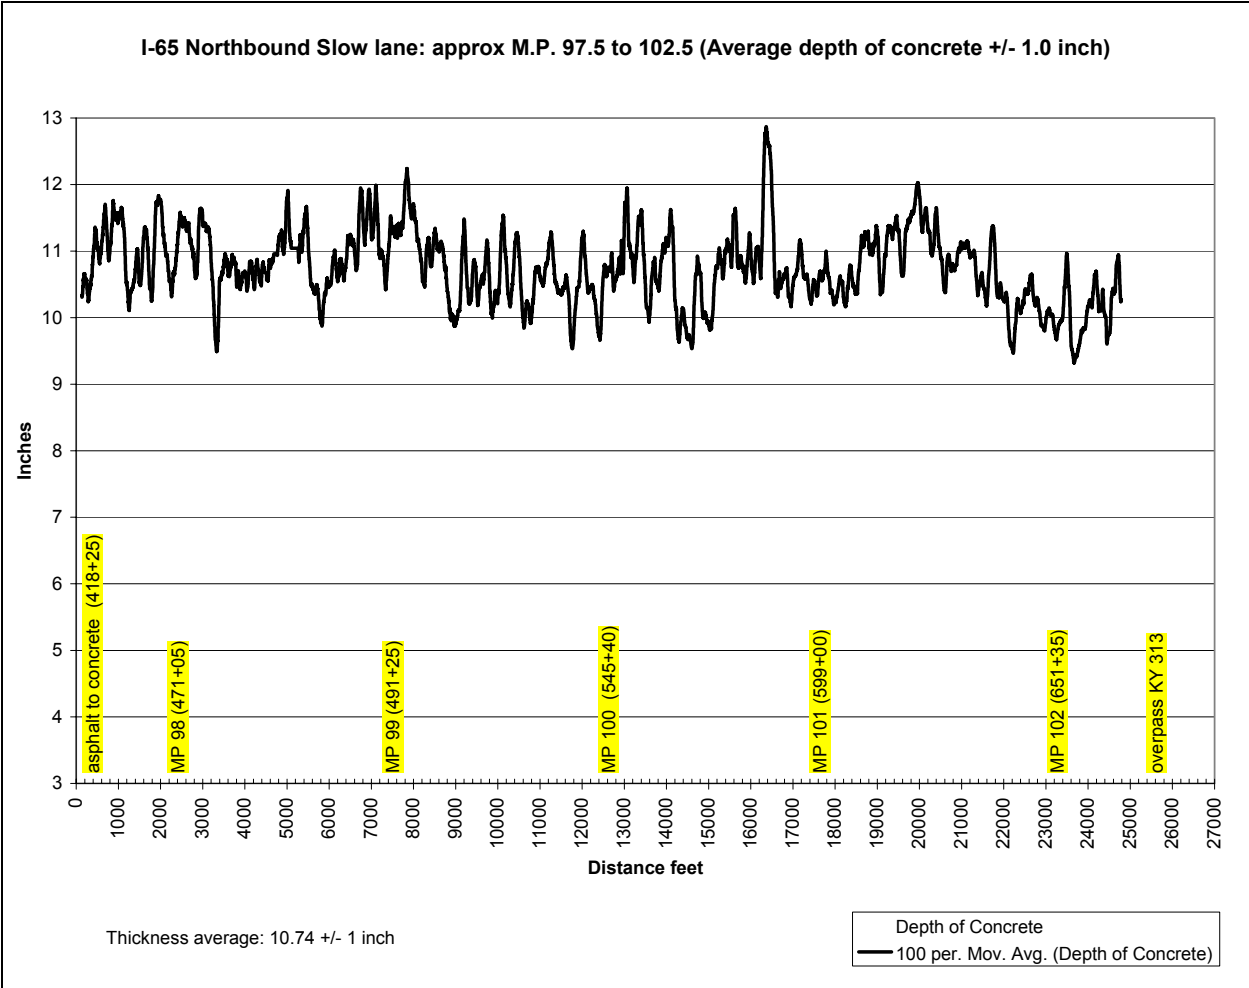
Figure 9: Concrete thickness Northbound outside lane

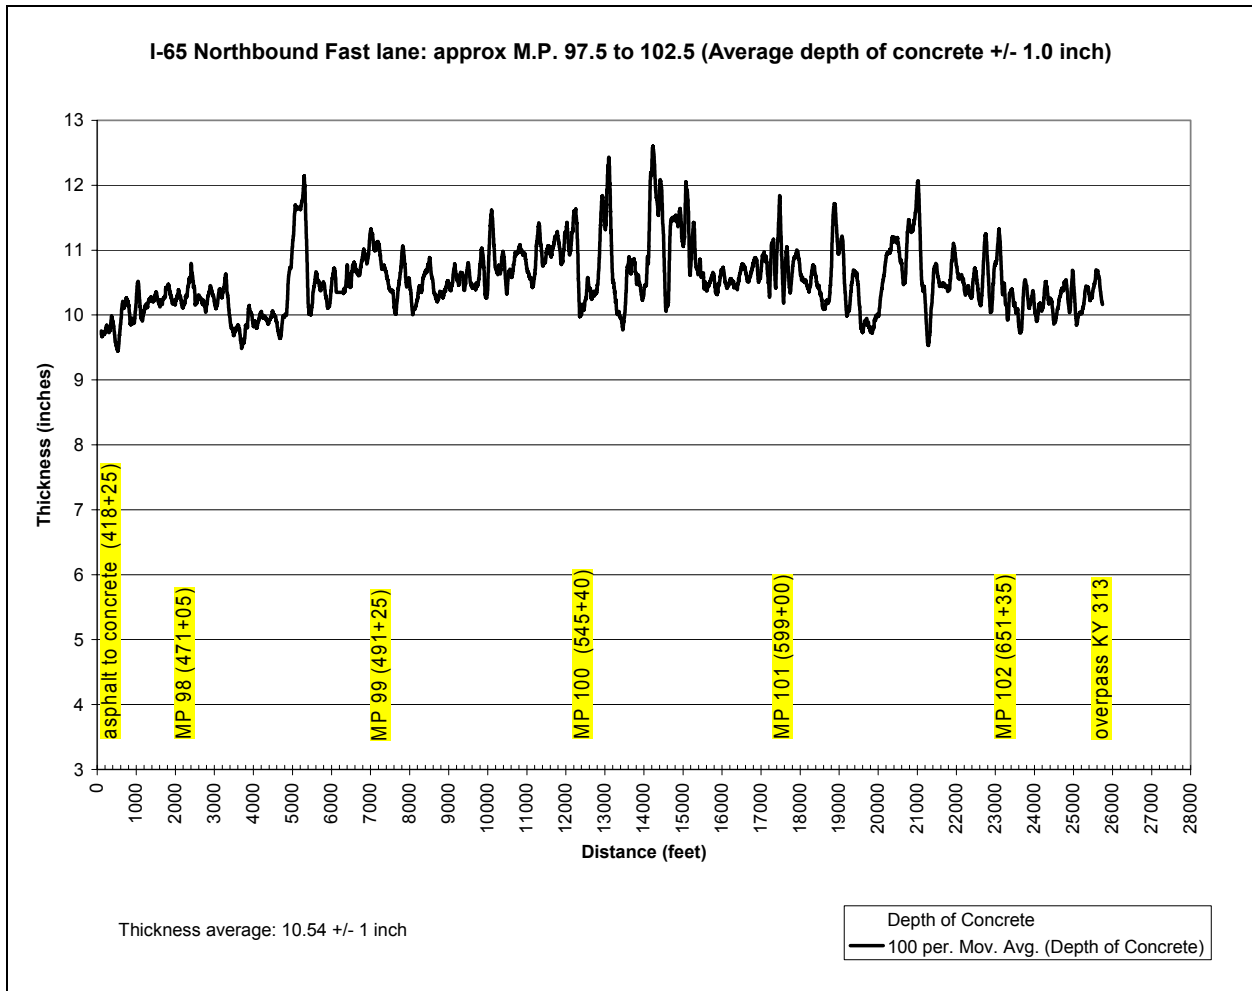
Figure 10: Concrete Thickness Northbound inside Lane

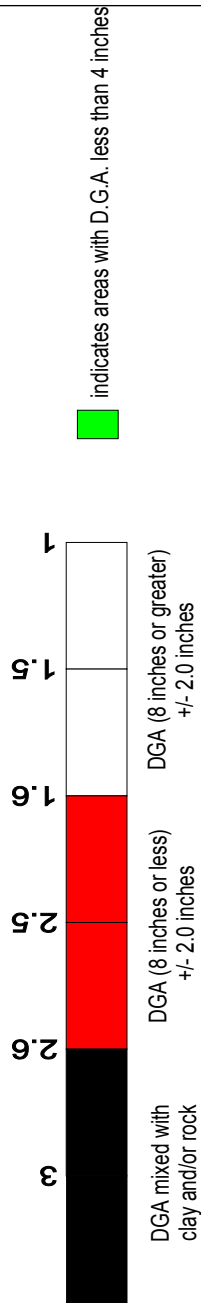
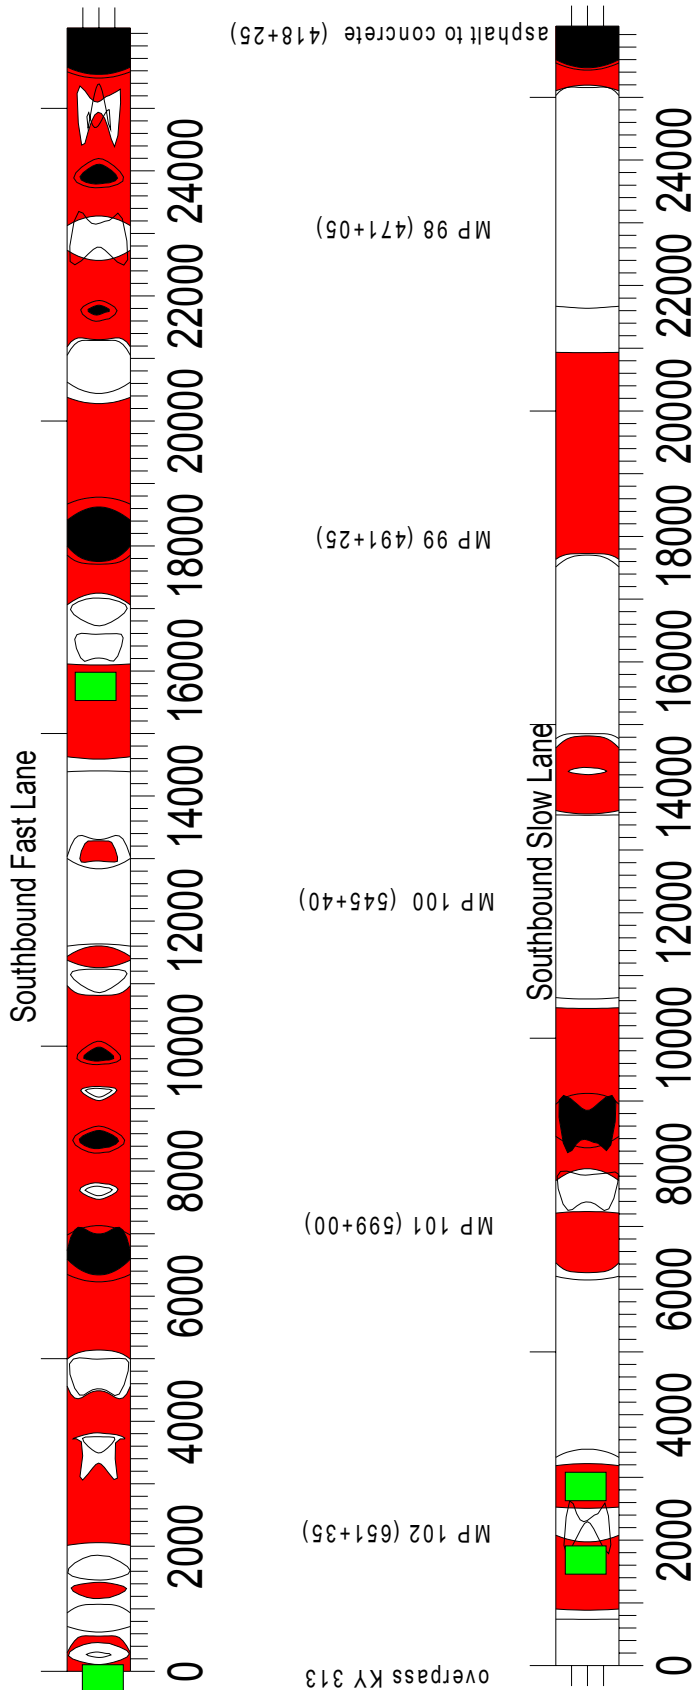
An attempt was made to approximate both the depth of the subgrade material and its material composition using GPR. Figure 11 identifies the subgrade thickness and its composition beneath the concrete layer for the southbound lanes. Figure 12 identifies the subgrade thickness and its composition beneath the concrete layer for the northbound lanes. Note, areas marked in green in Figures 11 and 12 indicate locations that had less than four inches of D.G.A. material beneath the concrete layer.

Figure 11. Subgrade Thickness and Material Composition Beneath Concrete Layer Southbound

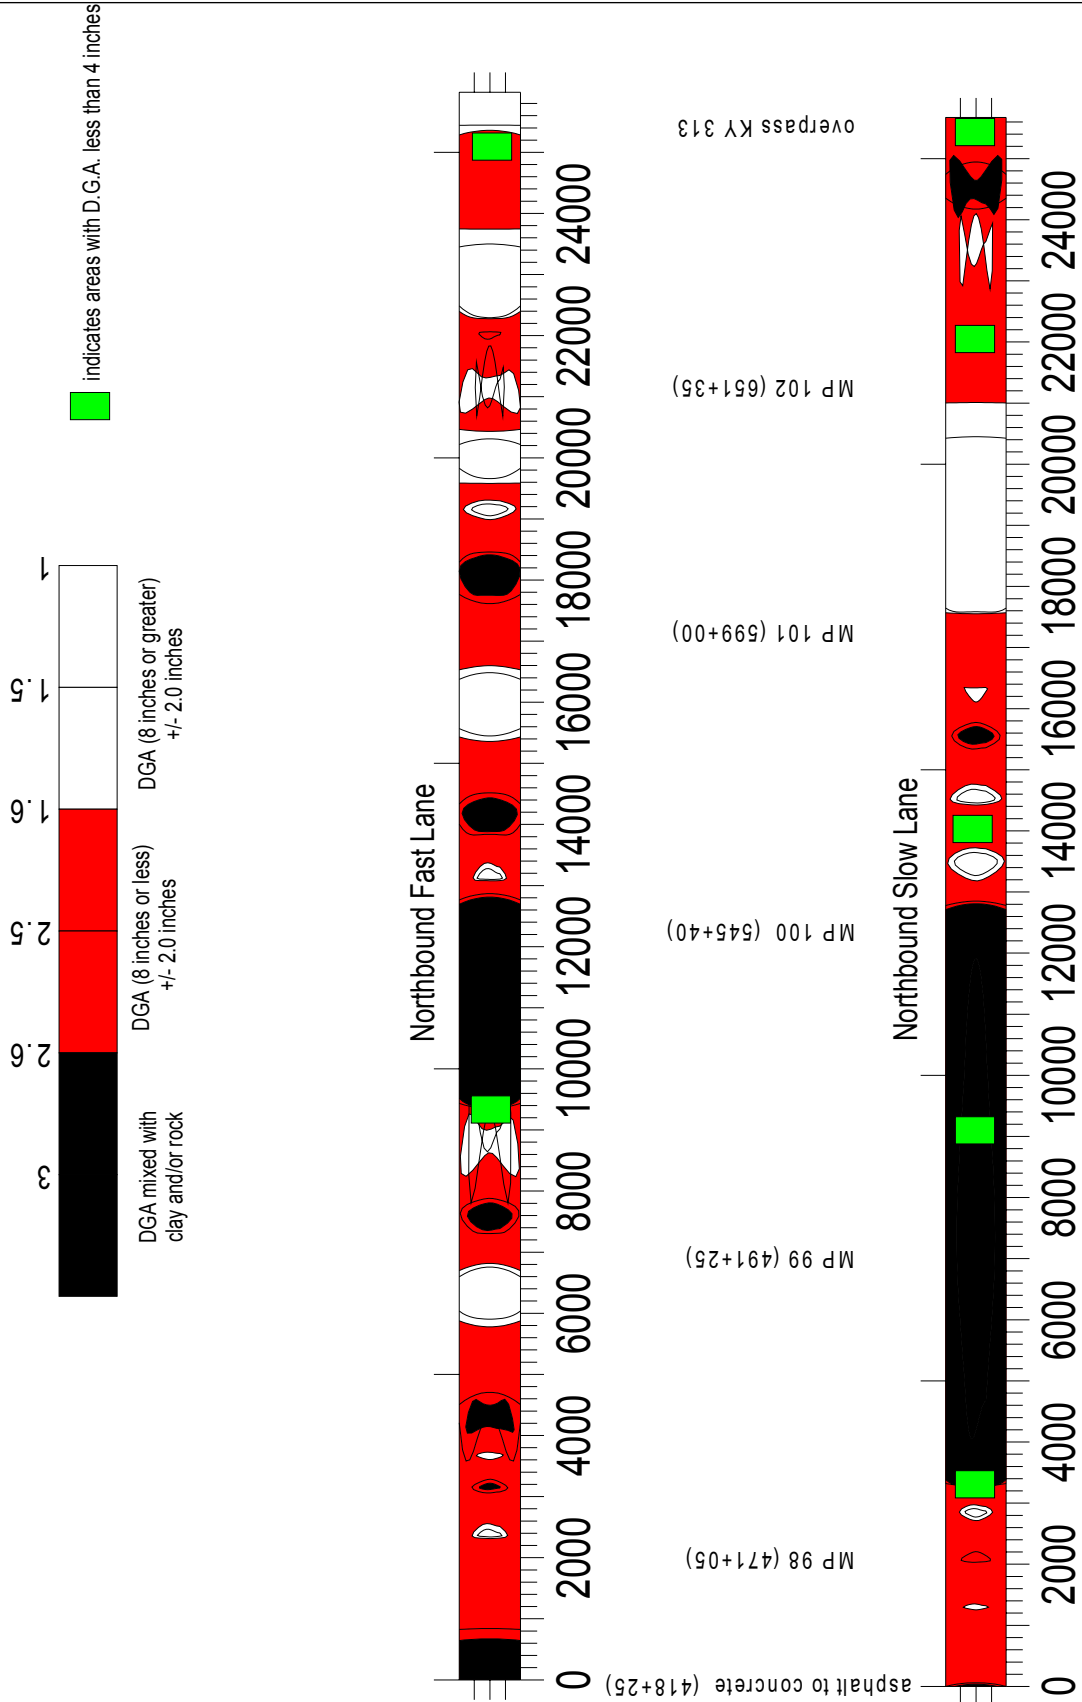
Figure 12. Subgrade Thickness and Material Composition Beneath Concrete Layer Northbound

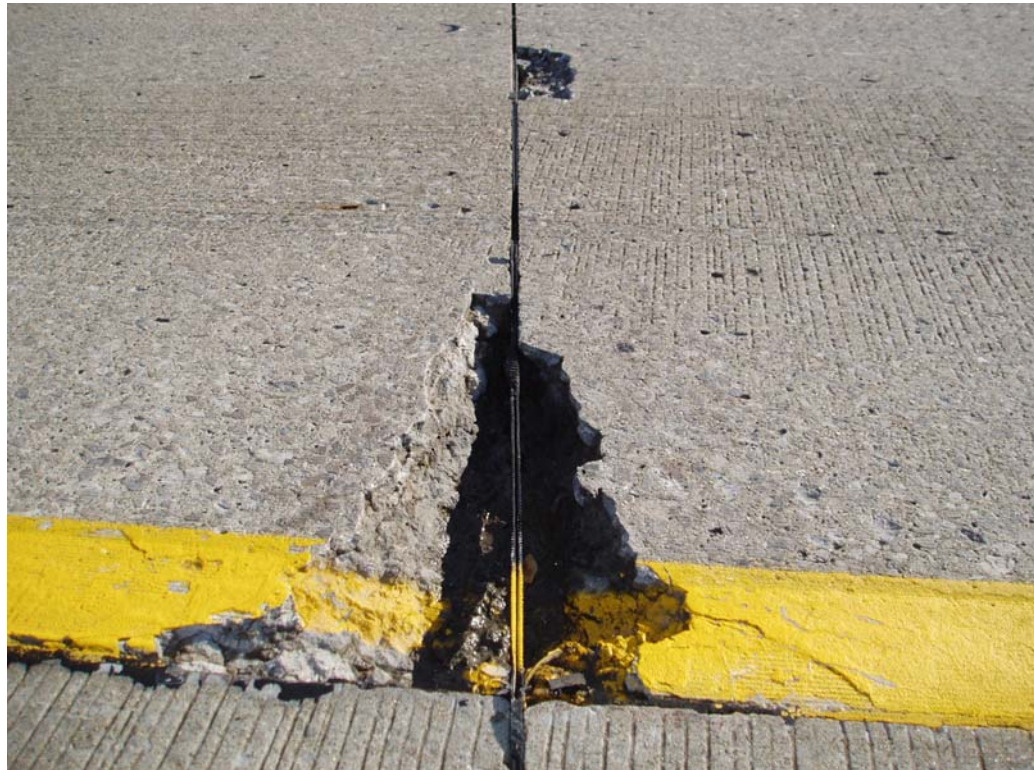
Many of the transverse joints on the project have moderate to severe deterioration, which is manifested in the form of spalling (Figure 13). In addition, a large number of the joints that currently do not display distress have hairline cracks on both sides of the joint, which is the precursor for spalling (Figure 14). Most of the spalls appear to be one to two inches in depth (Figure 15).

It is not clear what the primary causative factor is in the formation of the spalls. The research team did not test any for the cores obtained from the project. Although water has certainly exacerbated the problem of spalling, it is the opinion of the researchers that there may be an inherent problem with the concrete itself which has produced the excessive amount of spalling; however, there was no means of confirming that hypothesis.

Figure 13: Spalled Joint

In the opinion of the researchers, the joint spalling problem appears to be the main concern along with inadequate drainage. The spalling problem may limit the options for rehabilitation of this project. To simply overlay the concrete slab with thick asphalt mat does not appear to be a viable option. The joints will continue to work with temperature and will continue to deteriorate further, causing serious reflective cracking in a few years. Also, overlaying a concrete slab with an asphalt mat without rubblelizing causes the temperature in the old concrete slab to be higher than before (the black asphalt mat transfers more heat to the old slab). This will cause more blow-ups. Therefore, it appears that the best alternative would be an unbonded concrete overlay. The second alternative would be to rubblelize the existing concrete pavement with a sonic-head breaker and overlay with asphalt. Again, drainage would need to be addressed with either alternative.

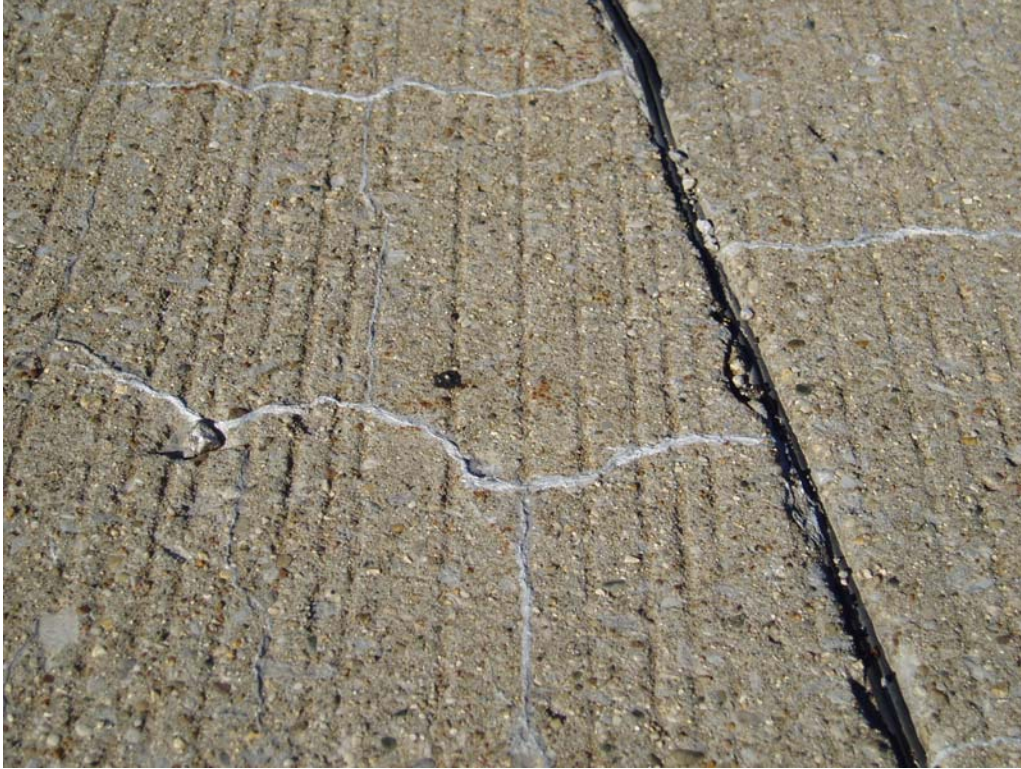
Figure 14: Hairline Cracking Around Concrete Joint

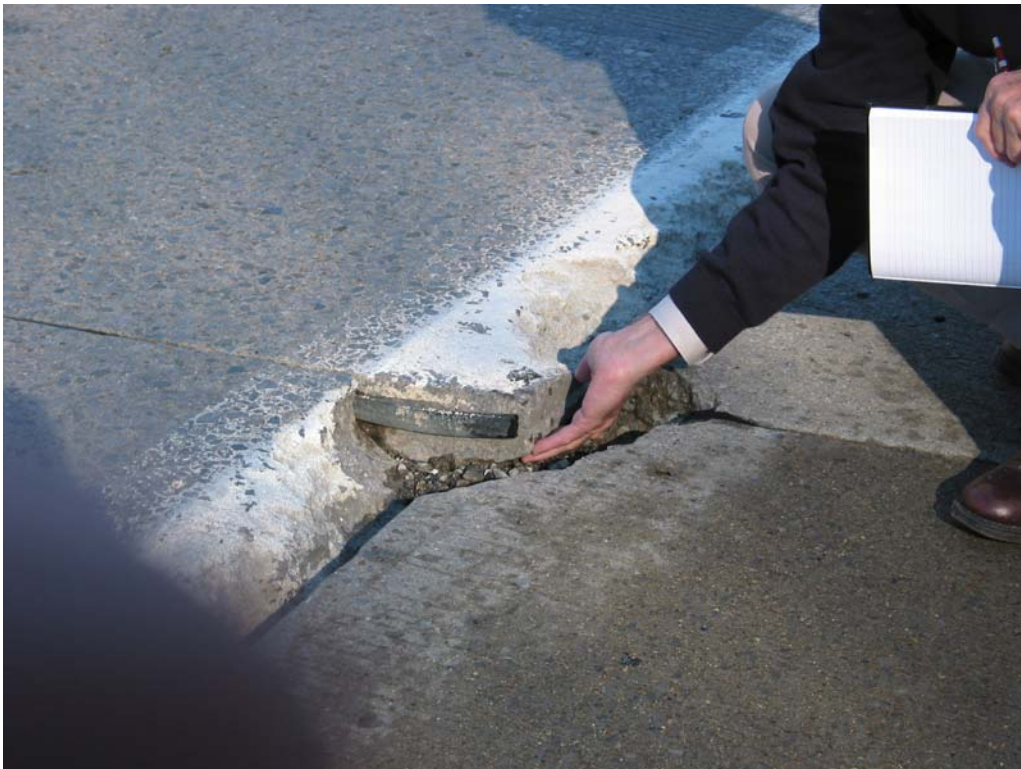
Figure 15: Depth of Spalled Joint
