**CORROSION EVALUATION OF MECHANICALLY  
STABILIZED EARTH WALLS**

**Research Report KTC-05-28/SPR – 239-02-1F**

**Kentucky Transportation Center  
College of Engineering  
University of Kentucky**

September 2005

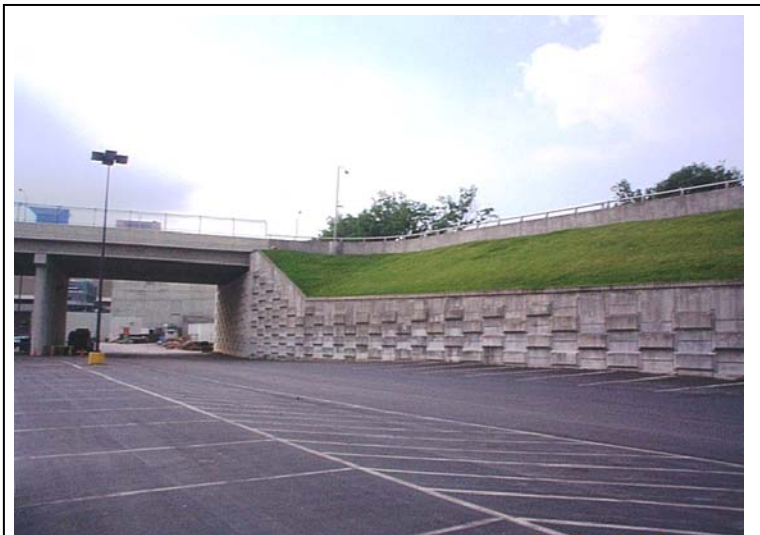
**Figure 1. MSE Wall Tested in Fayette County; Parking Lot of Lexington Civic Center, below KY 1681.**

Five retaining and two abutment MSE walls were constructed in 1979 due to new bridge and interchange construction at this site. These walls are believed to be the second oldest in the state. One wall, as shown in Figure 1, was selected from this group for corrosion monitoring. The backfill was crushed limestone. Gradation of the backfill varied with each sample obtained from three access holes. Samples from two access holes had top sizes between 2 and 1.5 inches. A third sample had a top size of 1 inch. Gradation specifications of the backfill are not known. Access to the wall for testing was through the Lexington Civic Center parking lot. Some rust or corrosion was visible where the reinforcing strap was attached to the panel.

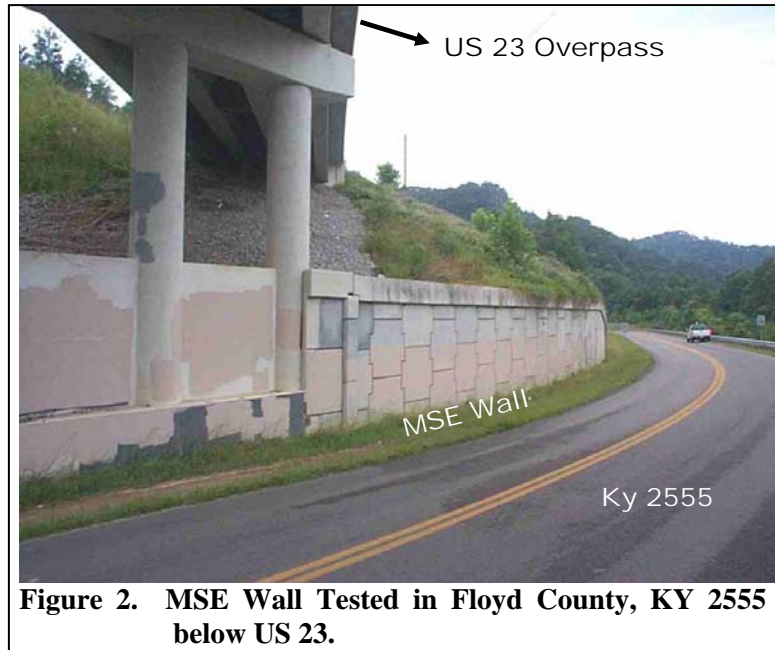
**Figure 2. MSE Wall Tested in Floyd County, KY 2555 below US 23.**

The second MSE retaining wall selected for corrosion monitoring is located in Floyd County and situated adjacent to KY 2555. It is located below the US 23 overpass. Construction of this wall began in 1992 and was completed in 1993. The walls were constructed due to route widening, new bridge and interchange construction. A wall in this site was selected because of geographic location. A few MSE walls have been constructed in Eastern Kentucky. It was felt that at least one MSE wall in Eastern Kentucky should be tested. The back fill immediately behind the wall was crushed limestone with a top size between 2.5 and 2-inches.

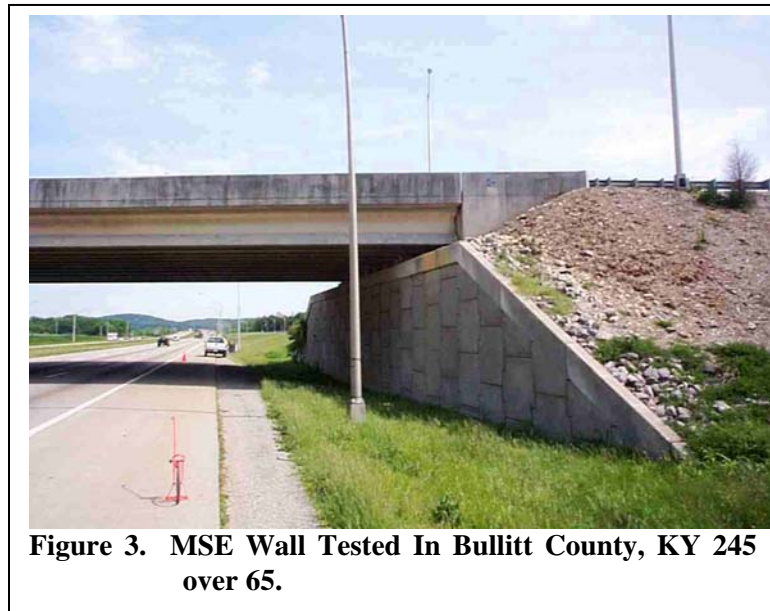
**Figure 3. MSE Wall Tested In Bullitt County, KY 245 over 65.**

Two abutment MSE walls, for KY route 245 overpass were constructed in the late 1980's as part of the I-65 widening project. A wall at this site was selected because it is located in an area where New Albany Shale formation is the predominant bedrock type. The shale was used to

construct the approach embankment. Leachate from the New Albany shale is very acidic. Mitigation measures have been implemented to neutralize run-off from older highway cut slopes constructed in the New Albany shale. The Kentucky Transportation Cabinet now has a policy of covering exposed slopes with compacted clay. The acidic shale is part of the embankment supported by the abutment. The backfill immediately behind the face of the wall was crushed limestone, or manufactured sand.

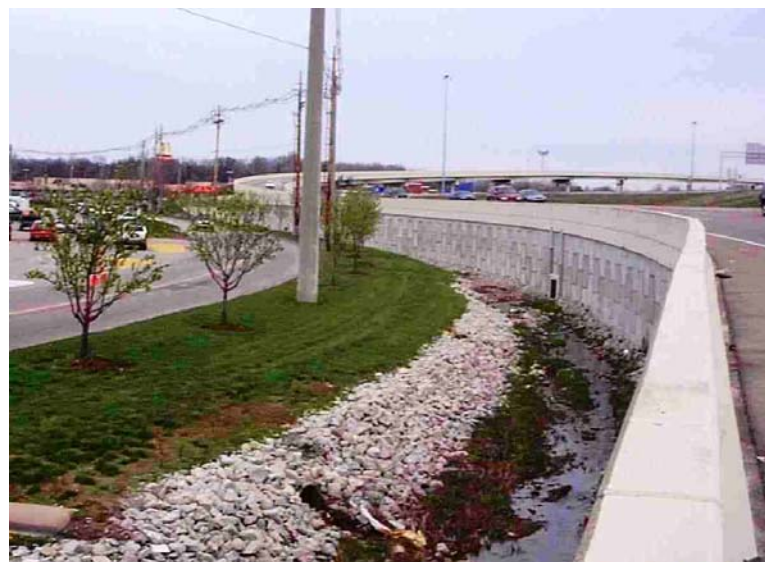
**Figure 4. MSE Wall Tested in Jefferson County, ramp from US 60 to I 264 at St. Mathews Mall.**

Jefferson County-Louisville is Kentucky's largest urban area. MSE walls are frequently constructed in urban areas because of spacing restraints. There were 123 MSE walls inventoried in Kentucky; 78 of those walls are located in Jefferson County. Sixty-four of the walls in Jefferson County are located on the Waterson Expressway, I-264, or on interchanges with I-264 and other routes. At least five additional MSE walls on I-264 have been designed. Three abutment and eight retaining walls were constructed in the mid 1980's as part of the I-264 widening and US 60 interchange project. The wall selected for corrosion monitoring is shown in Figure 4. A construction engineer from the Kentucky Transportation Cabinet indicated some of the fill material in this location consisted of New Albany Shale (see Bullitt County site information). The back fill immediately behind the wall was crushed limestone with a top size between 3 and 2.5 inches. Access to the wall was obtained through the adjacent St. Mathews Mall.

The back fill immediately behind the wall was crushed limestone with a top size between 3 and 2.5 inches. Access to the wall was obtained through the adjacent St. Mathews Mall.

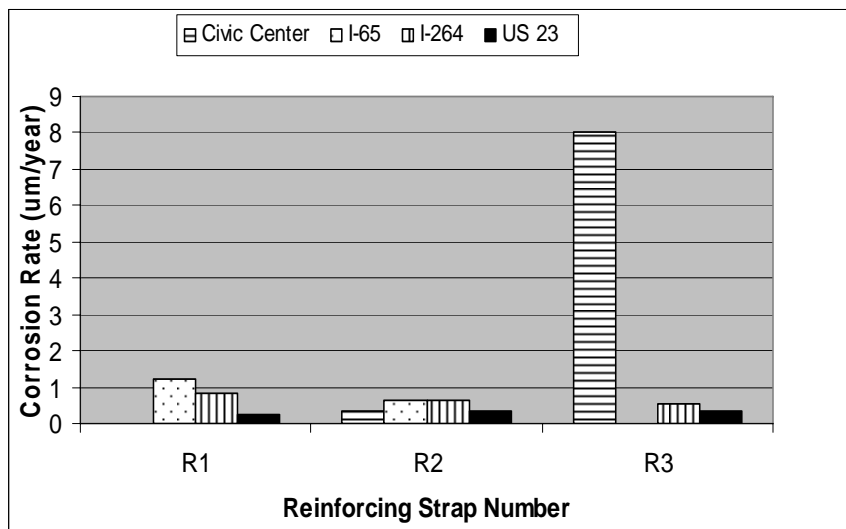
**Figure 7. Corrosion Rates of Reinforcing Elements.**

the rate at that time. Measurements were obtained for three reinforcing straps at US 23 in Floyd County and I -264 in Jefferson County. Data for two straps were obtained at the Lexington Civic Center site and the I-65 abutment wall in Bullitt County. Corrosion rates were below 1  $\mu\text{m}/\text{year}$  except for strap #R1 in Bullitt County and #R3 at the Lexington Civic Center which measured 1.2 and 8.0  $\mu\text{m}/\text{year}$ , respectively.

The 86- $\mu\text{m}$  thick galvanized zinc coating would not be consumed during a 75-year design life at corrosion rates of 1  $\mu\text{m}/\text{year}$ .

The largest corrosion rate measured was about 8  $\mu\text{m}$  at the Lexington Civic Center site. This wall is 26 years old. If the 86- $\mu\text{m}$  thick galvanized zinc coating was consumed in 16 years and the remaining carbon steel corroded at the recommended 12  $\mu\text{m}$  per year, for ten years, then 120  $\mu\text{m}$  of the reinforcing strap would be consumed. The 1.5 mm sacrificial thickness would not be

used for an additional 162 years at the measured rate of 8  $\mu\text{m}$  per year or 108 years if the recommended 12  $\mu\text{m}$  per year is used.

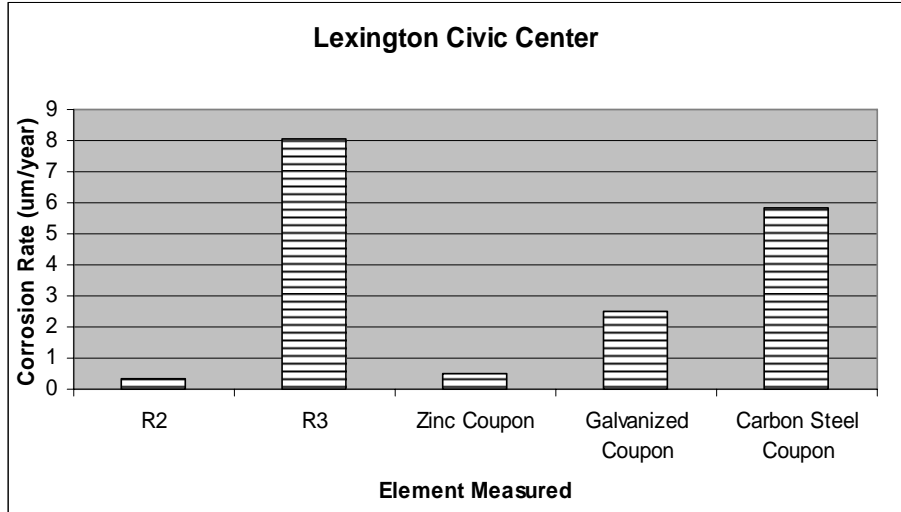
**Figure 8. Corrosion Rates of Reinforcing Straps and Coupons, Lexington Civic Center - KY 1681.**

The carbon steel coupon at Lexington Civic Center had a rate similar to reinforcing strap R3 (almost 6  $\mu\text{m}$  per year for the steel coupon and about 8  $\mu\text{m}$  per for strap R3) indicating the galvanized coating may be consumed in the reinforcing strap as shown in Figure 8. Strap R3 had a corrosion rate about eight times greater than the corrosion rate of the other strap identified as R2.

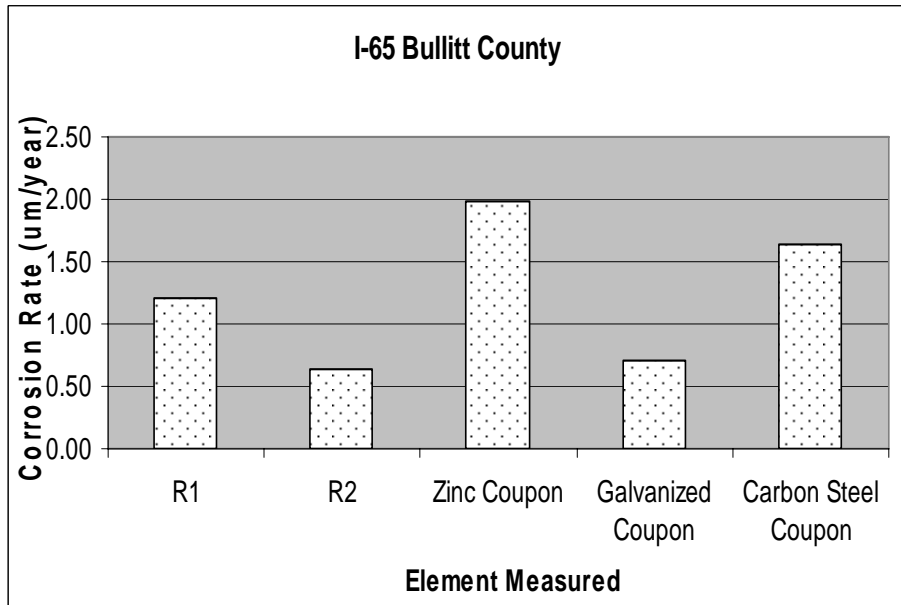
**Figure 9. Corrosion Rates of Reinforcing Straps and Coupons, I-65 Bullitt County**

Carbon steel coupons had larger corrosion rates than zinc and galvanized coupons at all of the sites except I-65 in Bullitt County (Figure 9) where the zinc coupon had a slightly higher rate: 2  $\mu\text{m}$  per year versus 0.7 and 1.6  $\mu\text{m}$  per year for their galvanized and carbon steel coupons, respectively. The galvanized steel coupon had corrosion rates similar to the reinforcing elements at Bullitt County wall. Corrosion rates for the two reinforcing elements measured were within 0.5  $\mu\text{m}$  per year.

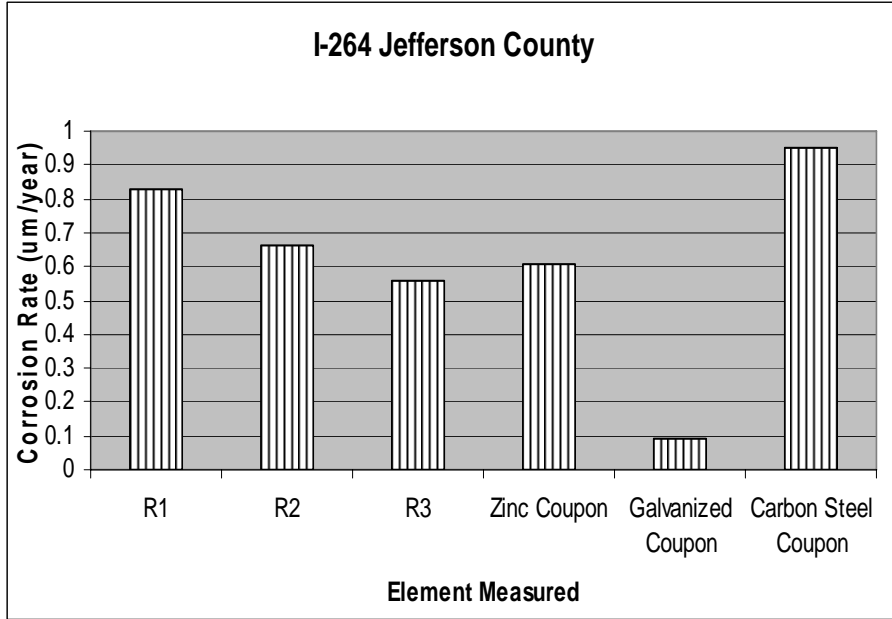
**Figure 10. Corrosion Rates of Reinforcing Straps and Coupons, I-264 Jefferson County**

Corrosion rates for the coupons and reinforcing straps were all below 1  $\mu\text{m}$  per year at the I-264 wall in Jefferson County (Figure 10). Corrosion rates for the reinforcing straps were very consistent for the wall at I-264 (0.6 to 0.8  $\mu\text{m}$  per year). The zinc coupon had a similar rate of 0.6  $\mu\text{m}$  per year, while the galvanized coupon was lower at 0.1  $\mu\text{m}$  per year.

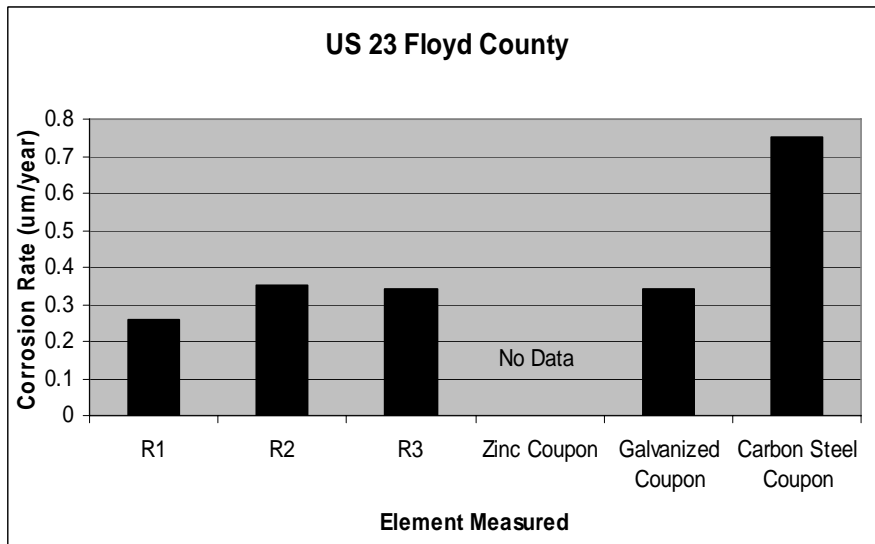
**Figure 11. Corrosion Rates of Reinforcing Straps and Coupons, US 23 Floyd County**

Corrosion rates for three reinforcing straps and the galvanized coupon at the US 23 wall were also very low, about 0.3  $\mu\text{m}$  per year as shown in Figure 11. Measurements could not be obtained on the zinc coupon. The coupon was removed to check wiring connections. A thin film had developed on the coupon possibly preventing the flow of electricity between the coupon and backfill.

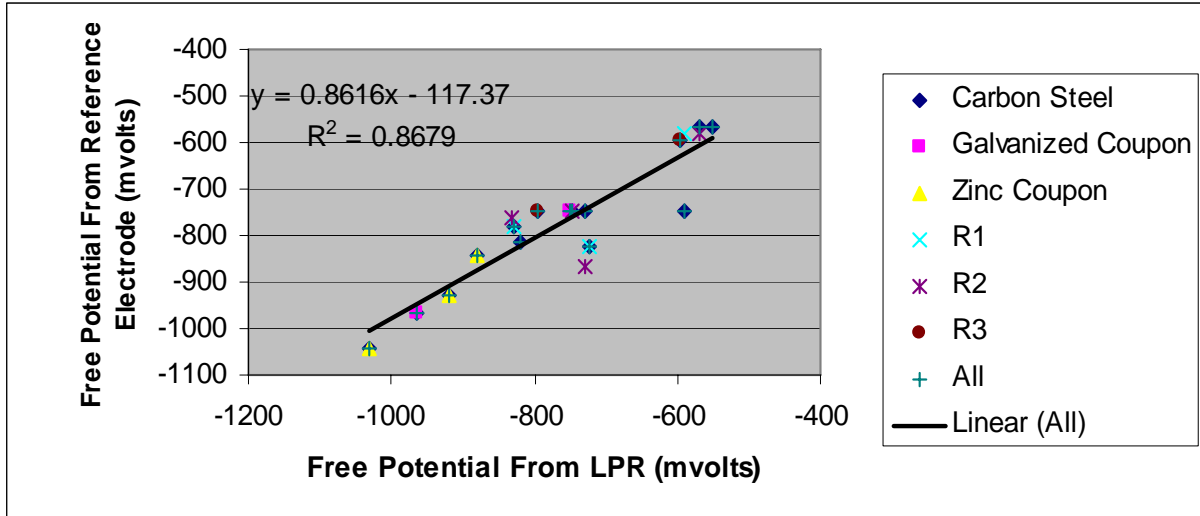
**Figure 12. Relationship between Free Corrosion Potential Obtained from Reference electrode and LPR Equipment.**

Obtaining free corrosion potential using a reference electrode is relatively easy and quick method to evaluate corrosion. Free corrosion potential is also obtained from LPR measurements. Free corrosion is measured between elements or coupons instead of a reference electrode and elements using LPR techniques, so the values will vary some. Comparison of free corrosion potential obtained with a copper copper-sulfate reference electrode and LPR equipment is shown in Figure 12.

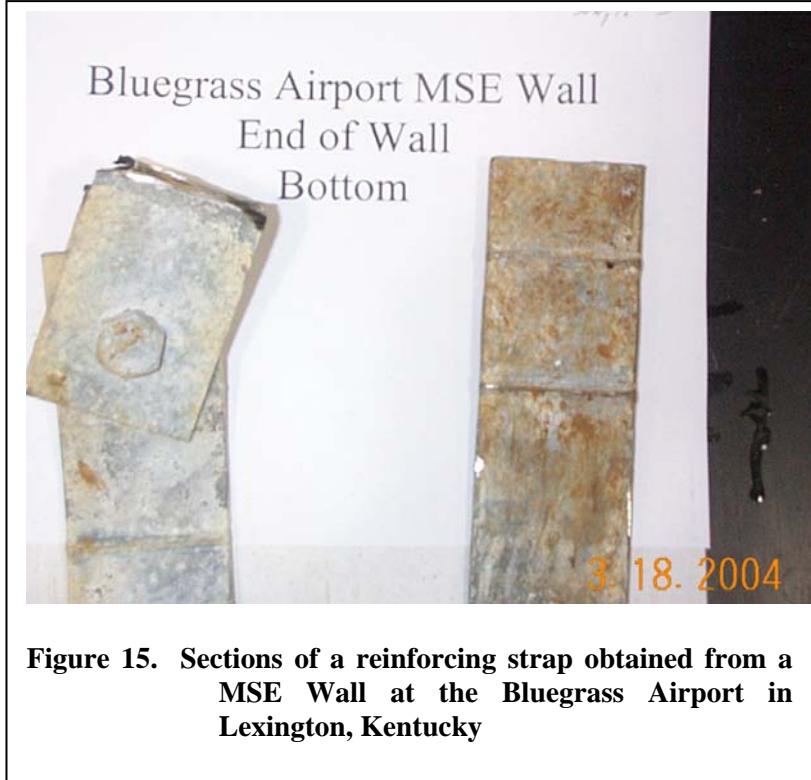
**Figure 15. Sections of a reinforcing strap obtained from a MSE Wall at the Bluegrass Airport in Lexington, Kentucky**

reinforcing straps sections were obtained adjacent to the wall panel and at the free end where the limestone backfill and compacted clay meet. No visible corrosion was observed. The brown color seen in the photographs is soil. Crushed limestone was used for the back fill of the MSE wall is shown in Figure 15. Compacted clay was used to construct the embankment behind the backfilled area.

is on the left and the free end section is shown on the right hand side of the photograph. No visible corrosion was observed in any of the straps. The layer of zinc galvanization was still visible after more than 20 years of service.

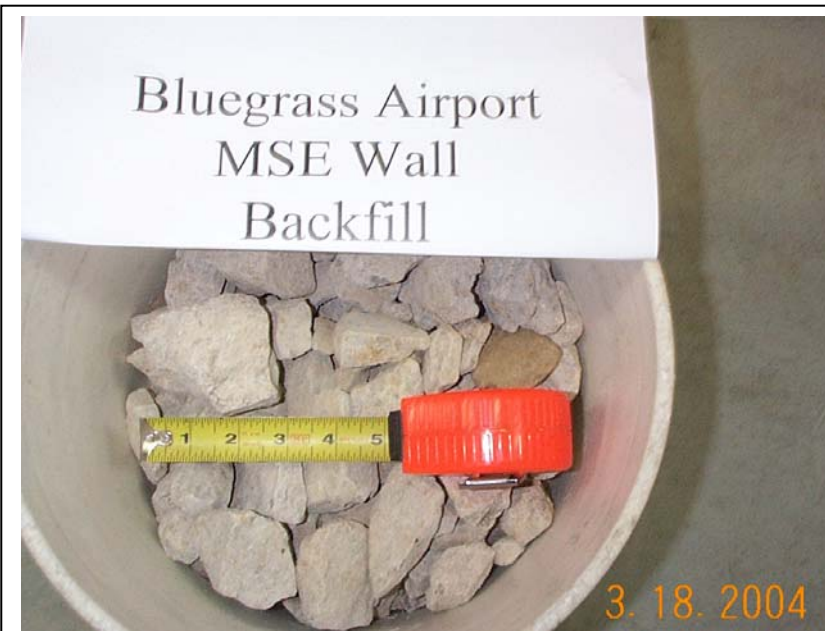
**Figure 16. Backfill Sample from the MSE Wall at the Bluegrass Airport in Lexington, Kentucky.**

The backfill behind the wall was crushed limestone, which consisted of a top size aggregate of 2.5 to 3 inches with very small amounts of fine aggregate (Figure 16). No gradation tests were performed on the backfill sample. The lack of corrosion may be attributed to the backfill. The smallest corrosion rates measured on the four tested walls were two that had large-sized, uniformly graded, backfill.
