KENTUCKY TRANSPORTATION CENTER

EXPERIMENTAL PAINTING OF THE I-64 RIVERSIDE PARKWAY IN LOUISVILLE, KY

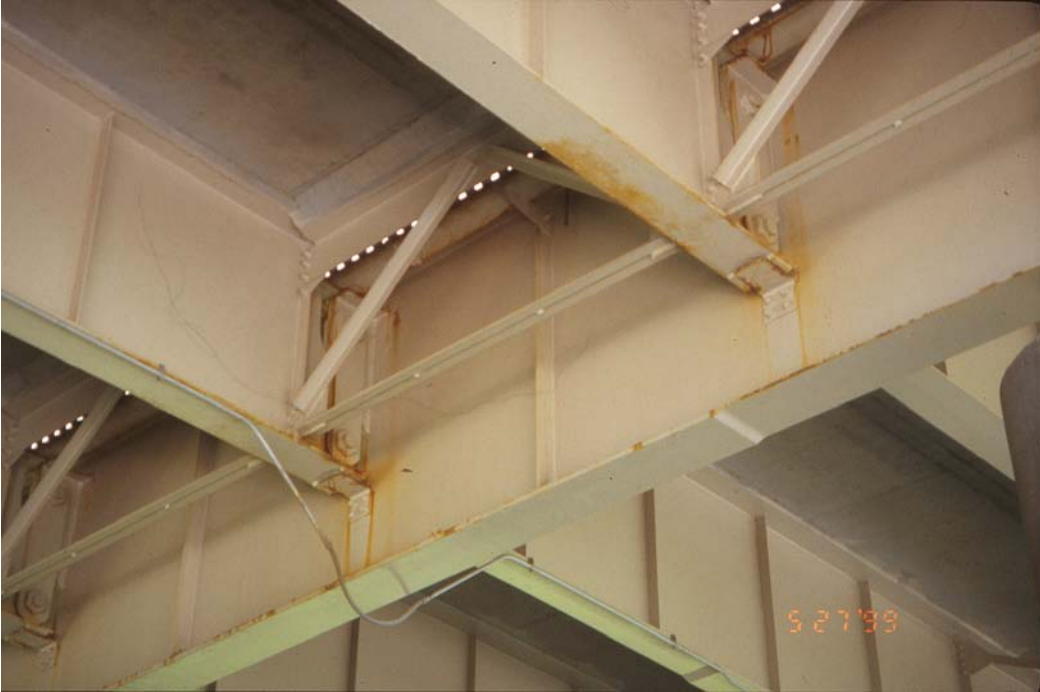
Figure 1. Corrosion on underlying structural steel under open deck joint (1999).

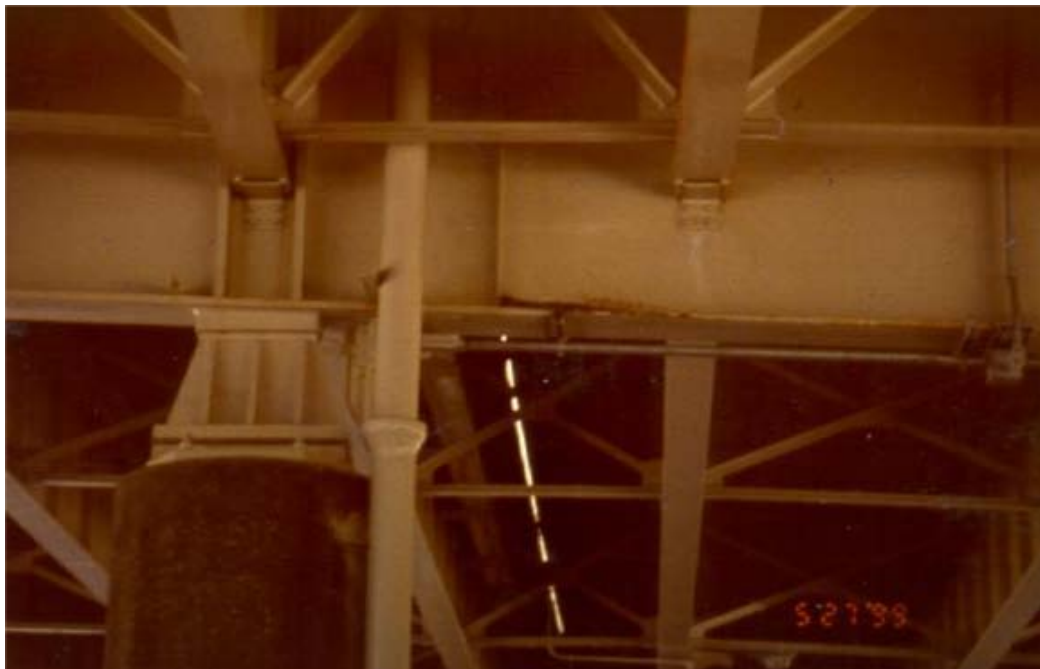
Figure 2. Debris build-up on lower flange due to presence of open deck joint (1999).

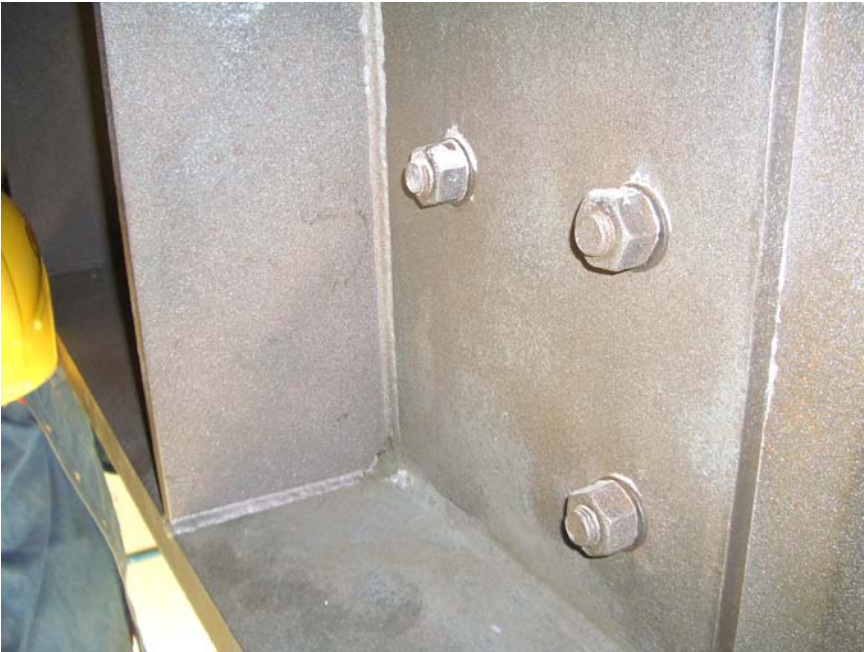
Figure 14. Improperly blast-cleaned bolts with excessive rust residue that had to be re-blasted prior to painting.

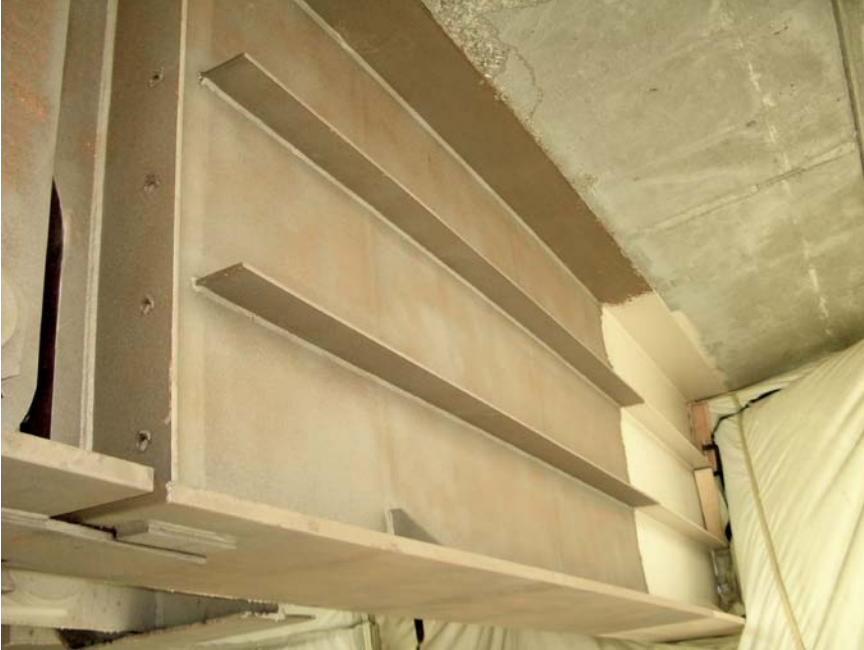
Figure 15. Area near joint that has been blasted and partially painted near a bulkhead.

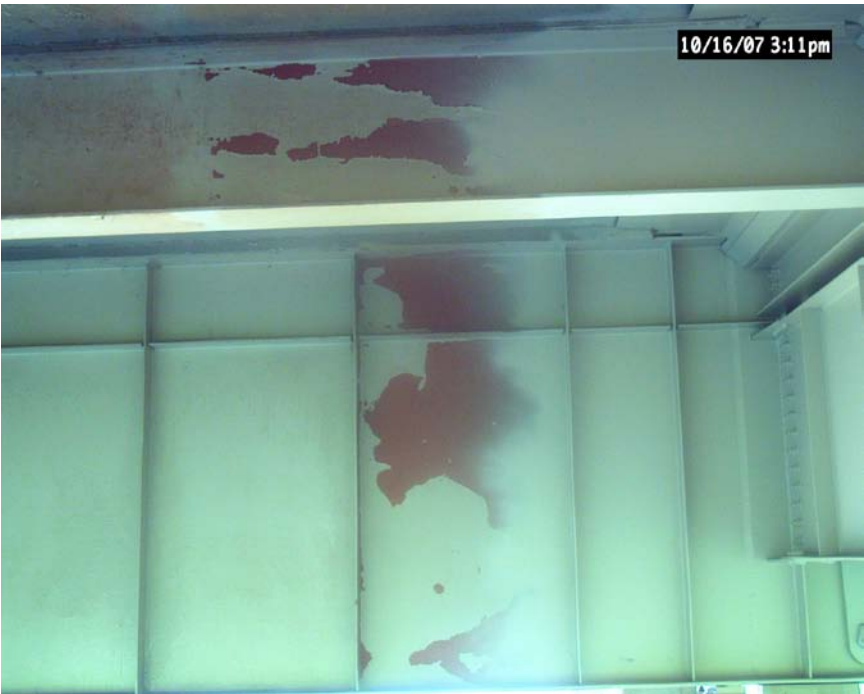
Figure 16. Area near cross-frame repair that has been power tool cleaned and partially painted on bridge B00292.

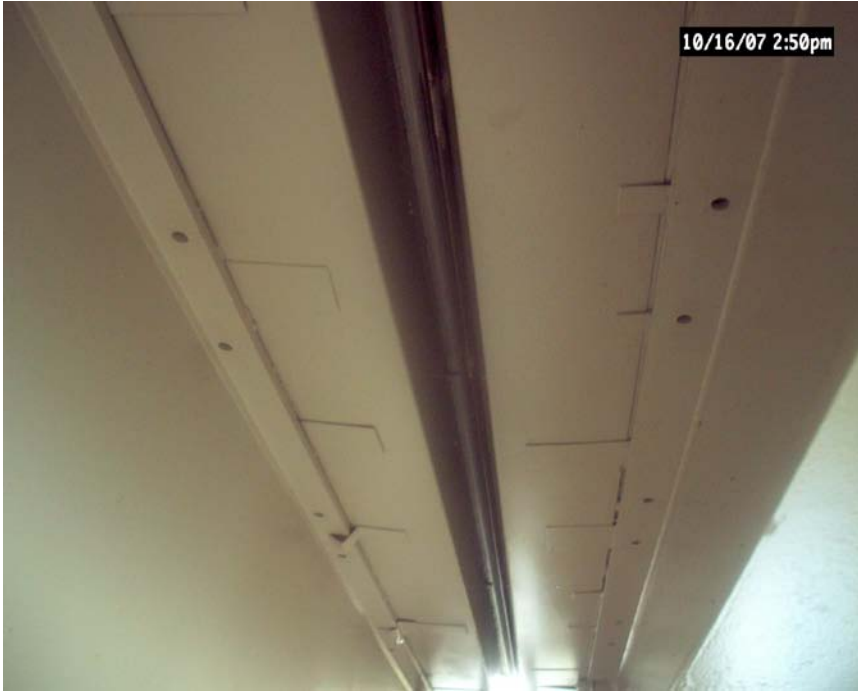
Figure 17. Coating on added steel under decks that is part of the new closed deck joints.

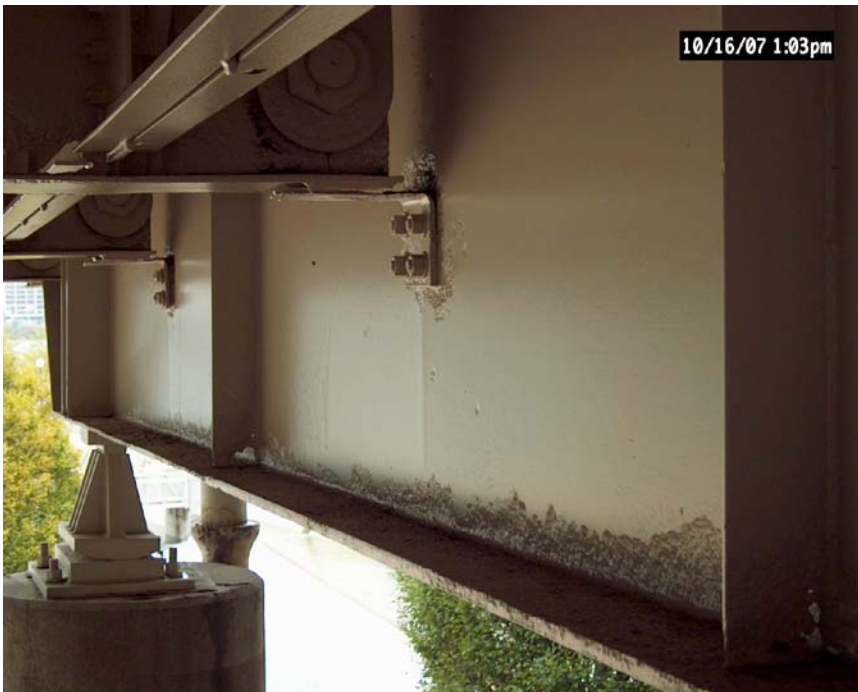
Figure 20. Corrosion damage to a floor beam highlighted by application of the new coating.

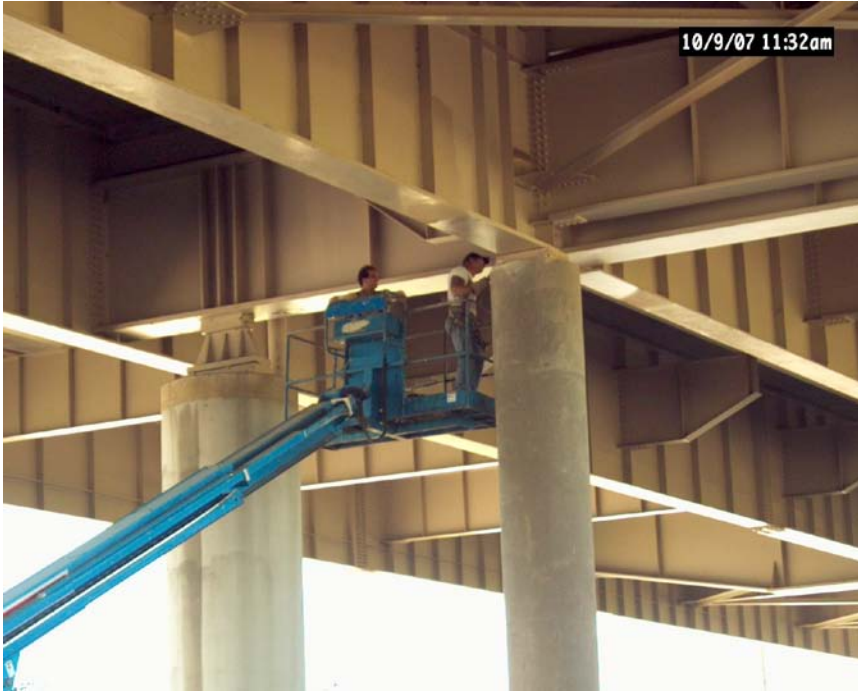
Figure 21. Inspector examining completed coating at joint.

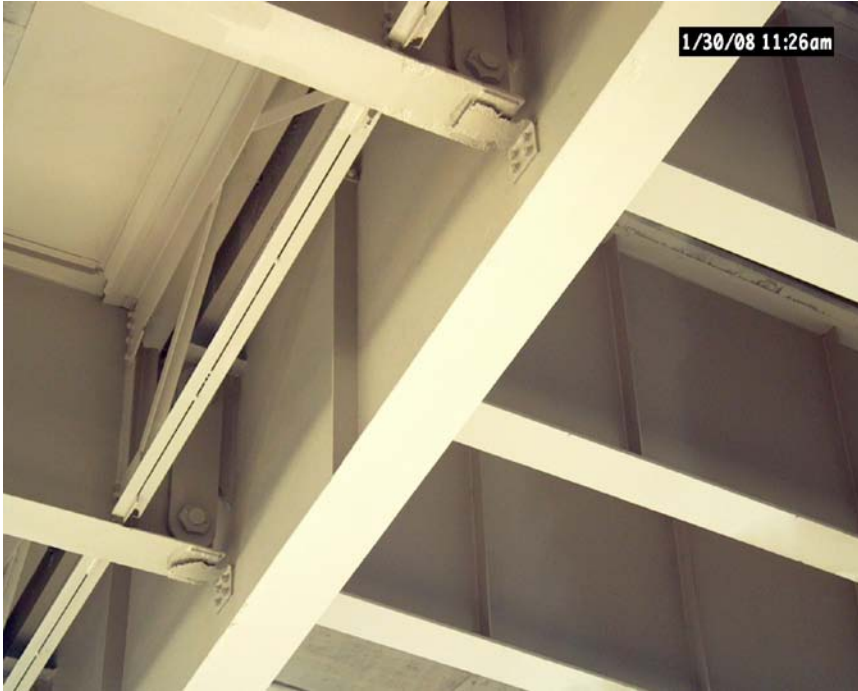
Figure 25. Zone painted floor beam and girders in good condition (January 2008).

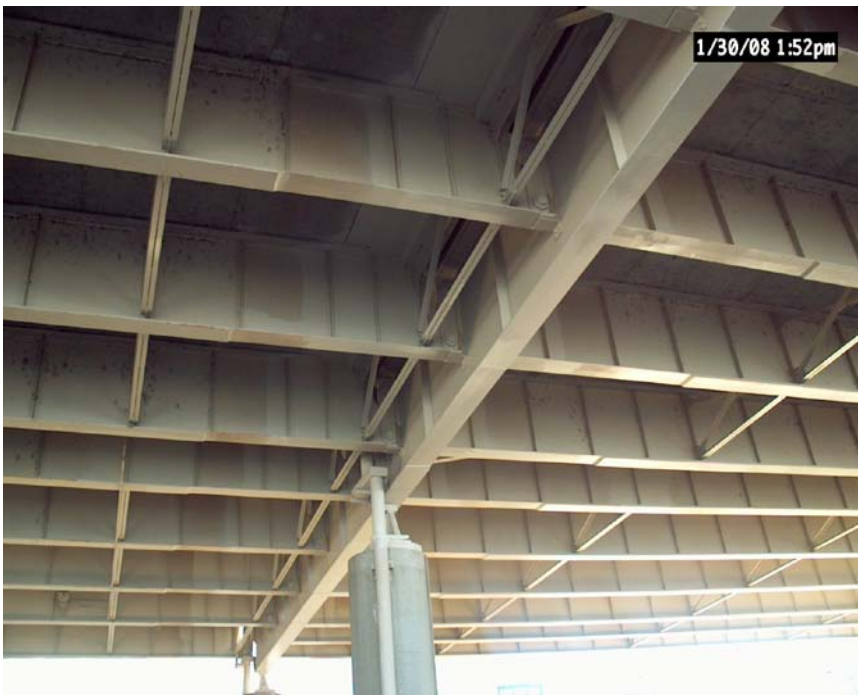
Figure 26. Overall view of zone painted area in good condition (January 2008)

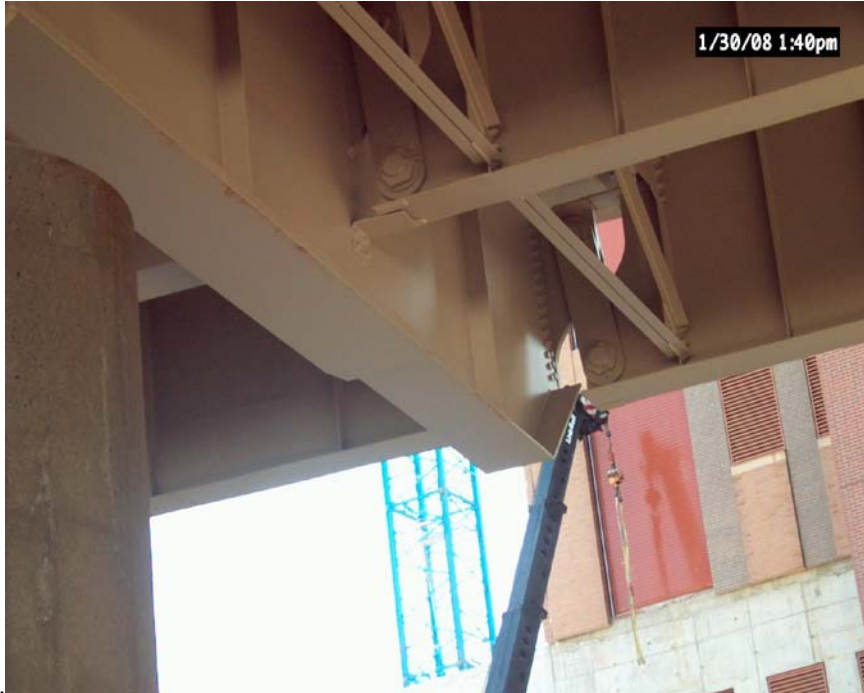
Figure 27. Rust-back at edge of a lower flange on a floor beam at an expansion joint (January 2008).

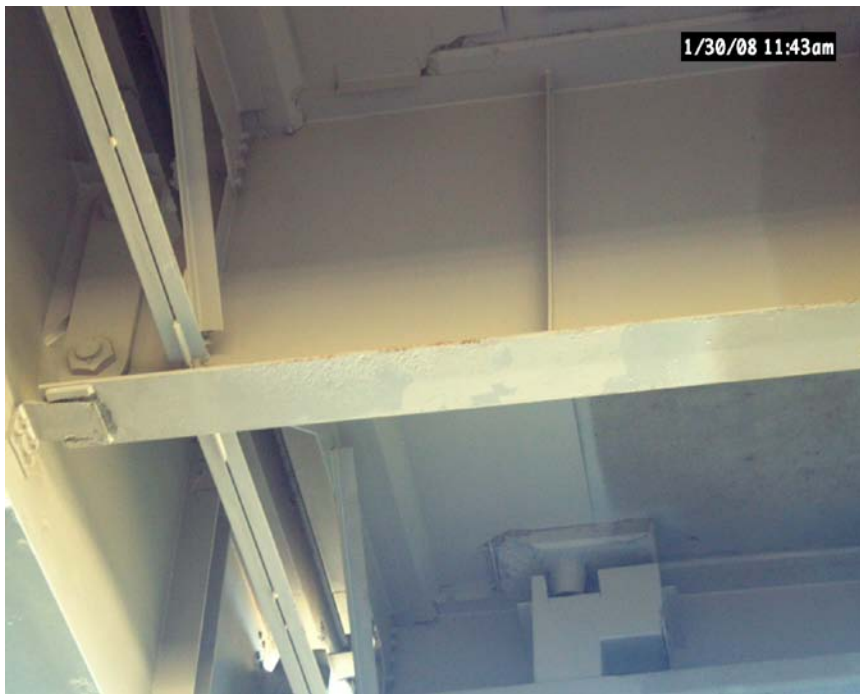
Figure 28. Zone painted area showing rust-back on edge of lower flange of a girder (January 2008).

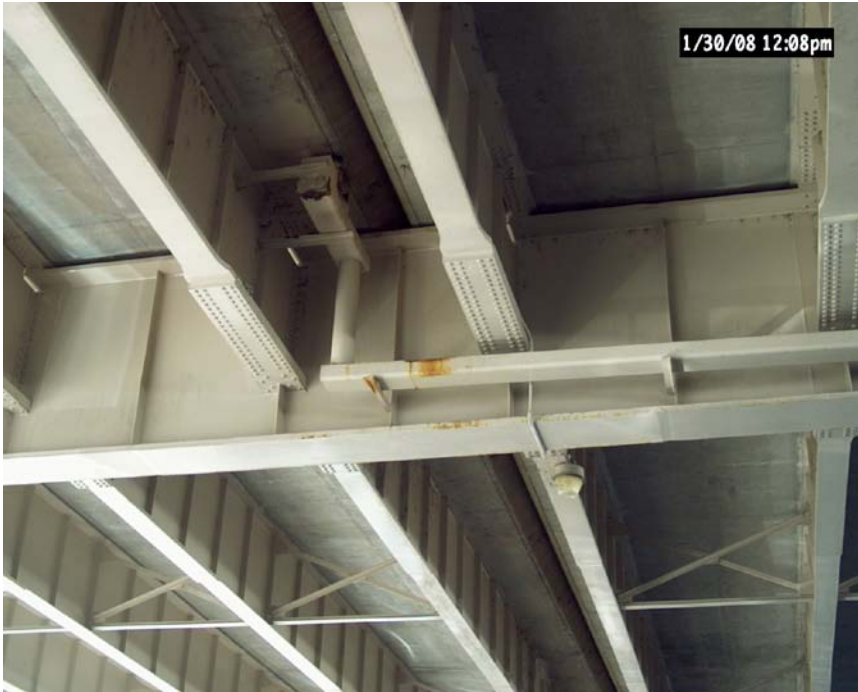
Figure 29. Rust-back and staining due to leakage from longitudinal deck joint (January 2008).

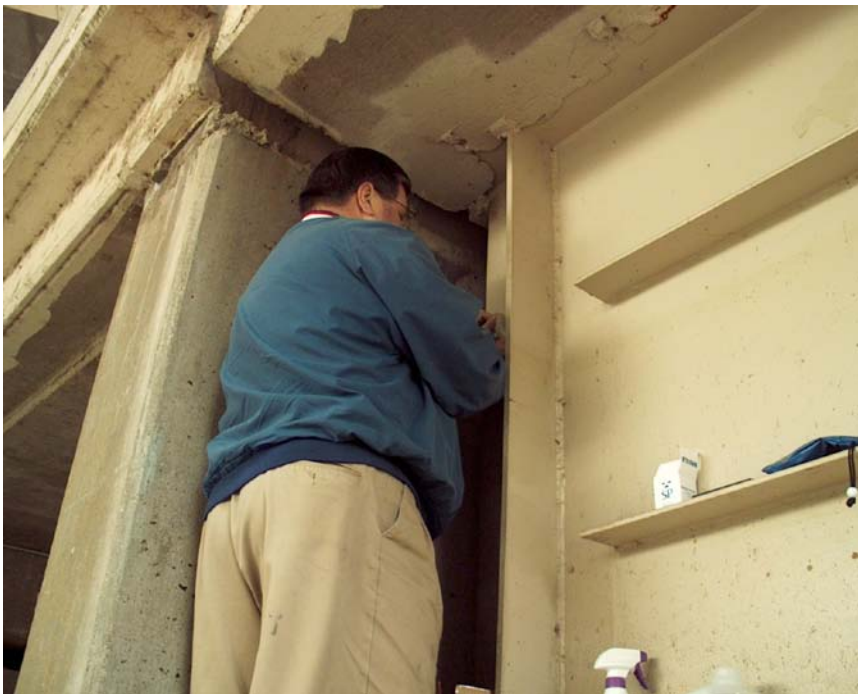
Figure 30. Conducting soluble salt test on steel on deck joint (April 2009).

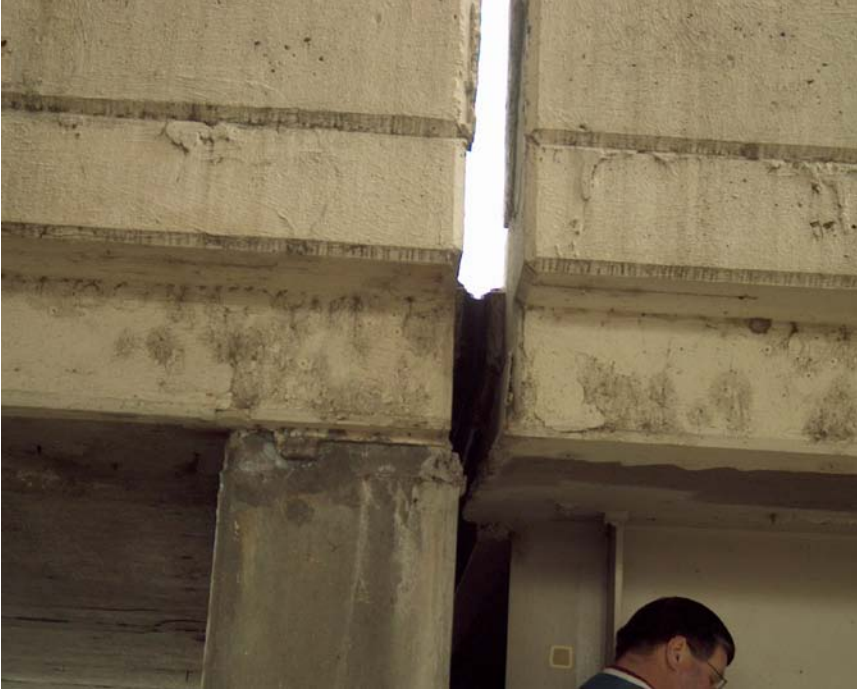
Figure 35. Closed deck joint in good condition (April 2009).

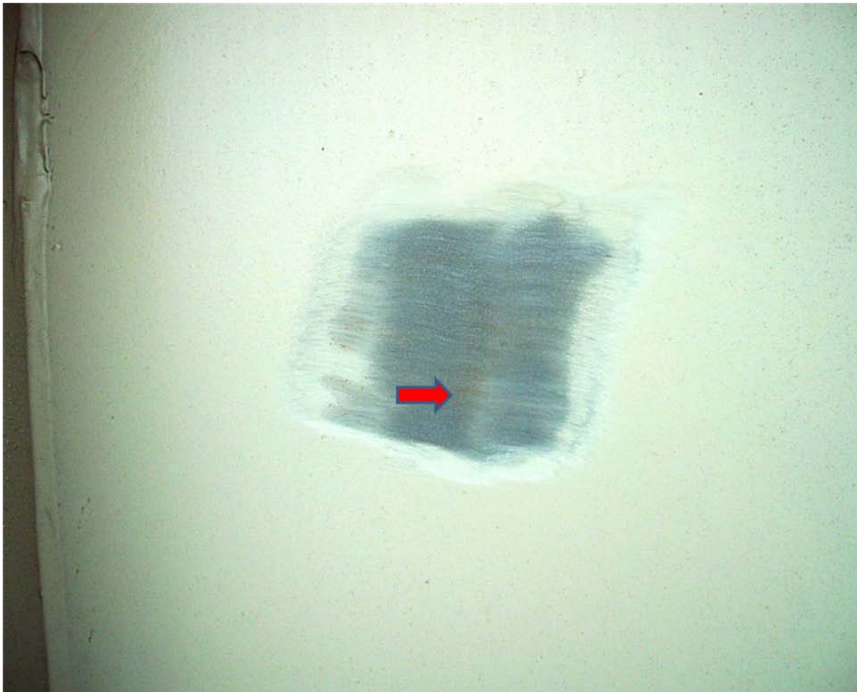
Figure 36. Rust formation in pit at steel substrate (April 2009).

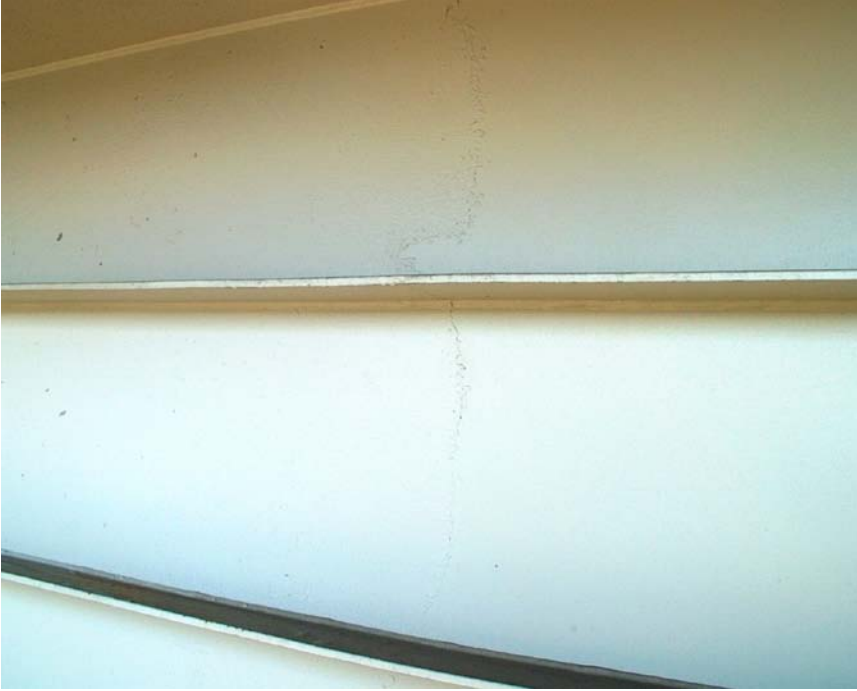
Figure 37. Ragged edge between existing paint on right and new paint on left (April 2009).
