NONDESTRUCTIVE TESTING OF A WELD REPAIR ON THE I-65 BRIDGE OVER THE OHIO RIVER AT LOUISVILLE

KTC-09-17A/SPR 364-07-1F

June 2009

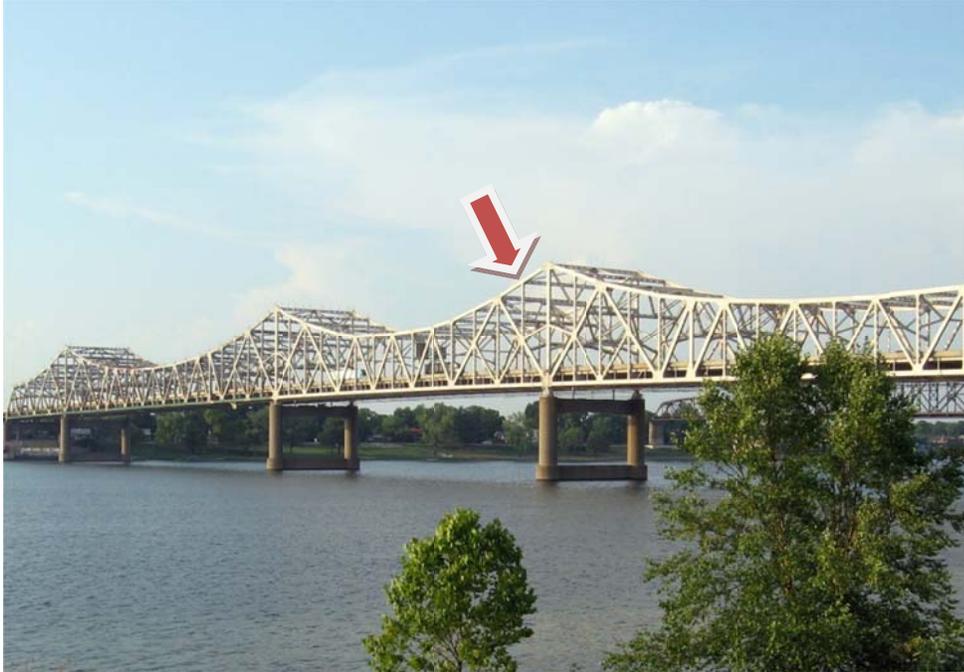
Figure 1. Panel Point 28 on the Upper Chord of the East Truss of the I-65 JFK Memorial Bridge.

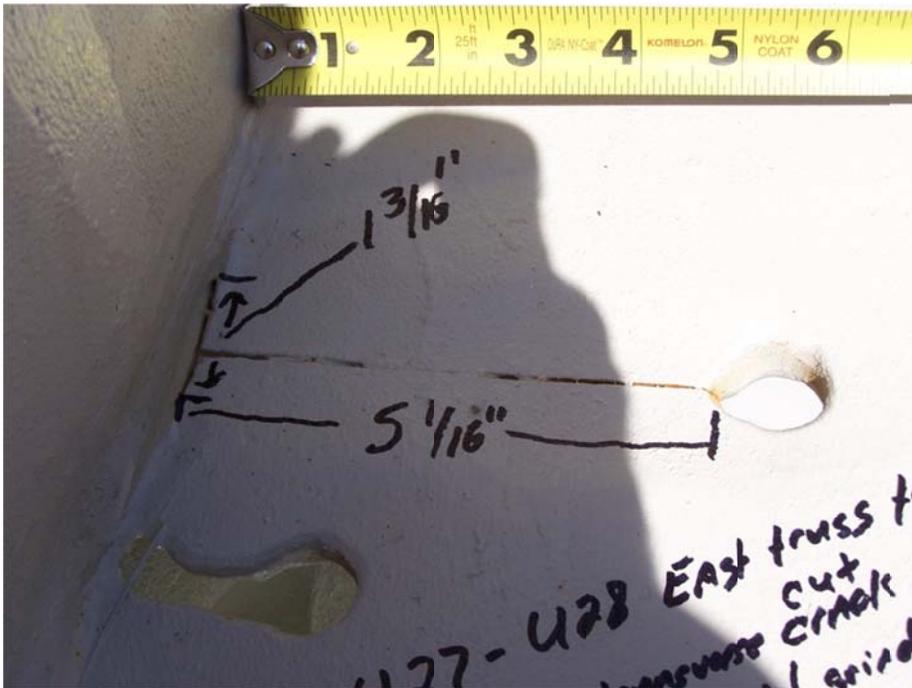
KYTC personnel inspecting the upper chord in 2007 found that the crack near Panel Point U28 previously repaired in 1994 had grown in length to 5-1/16 inches (Figure 2). The crack was readily visible despite painting operations on the bridge. There was a check hole at one end of the crack and what appeared to be a longitudinal saw cut at its other end running along the toe of the flange-to-web fillet weld which was apparently used to dead head the other end of the crack. At the check hole, the crack appeared to penetrate from the top face of the web to about its mid-thickness (Figure 3). A schematic representation was prepared of the H beam in the area of concern along with component terminology and relevant dimensions (Figure 4). The fact that the crack was highlighted by rust along most of its length relates to: 1) the spray painting of the

bridge and 2) the viscous coatings applied which did not penetrate into the crack. At the time of these pictures, the bridge had been painted within 6 months and the presence of rust in the crack is probably not indicative of a working crack.

Figure 2. Weld/Crack Repair in H Beam Web Near Panel Point 28 on East Truss.

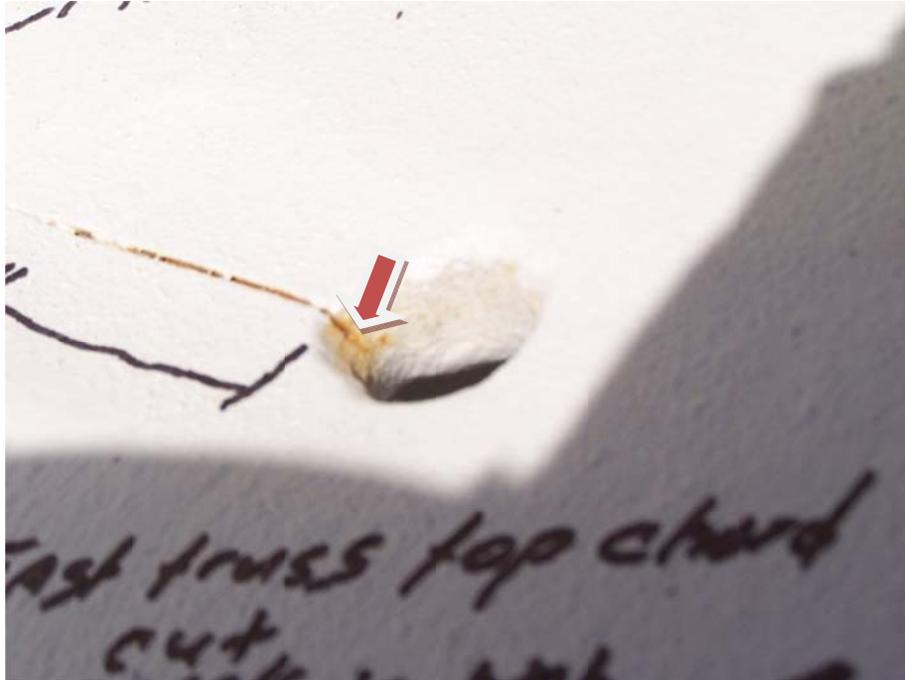
Figure 3. Panel 28 Web Crack Shown to Penetrate about Halfway Into the Web Plate in the Through-Thickness Direction.

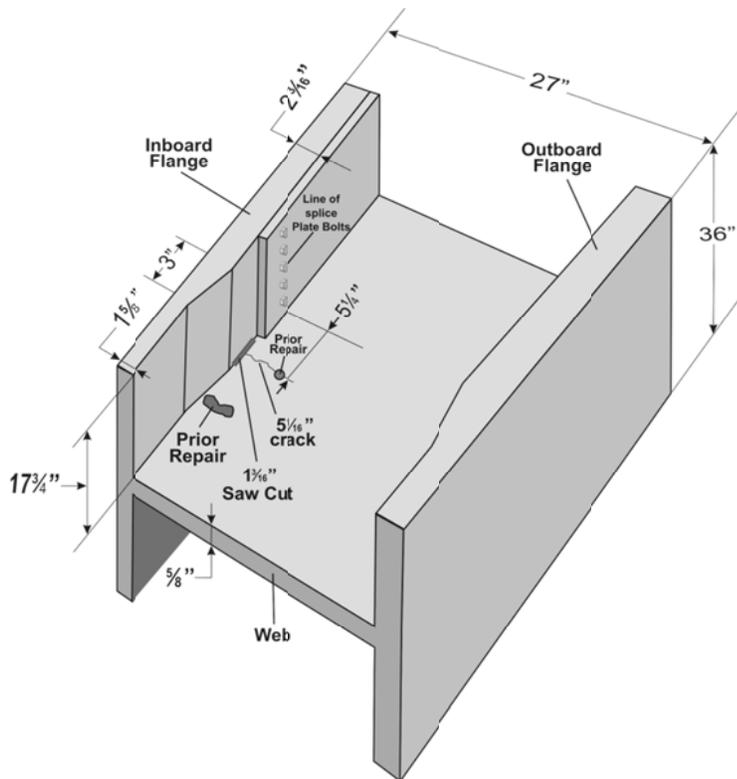
Figure 4. Schematic of H beam in Test Area Showing Locations of Crack, Repairs and Beam/Crack Relevant Dimensions.

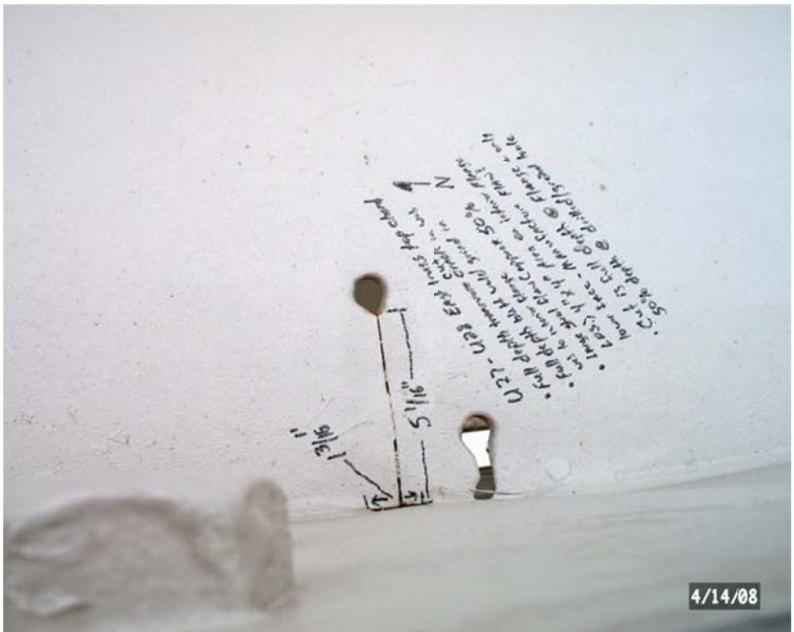
At the onset of the NDE field work KYTC and KTC personnel accessed the test site at Panel Point 28 to inspect the crack/repair. Viewing the upper face of the H-beam web, they determined that there were no apparent changes at the site since the KYTC inspectors took the 2007 pictures (Figure 6).

Figure 6. View of Crack/Repair Looking Down on Upper Face of Web at Panel Point 28 Prior to the Onset of NDE Work.

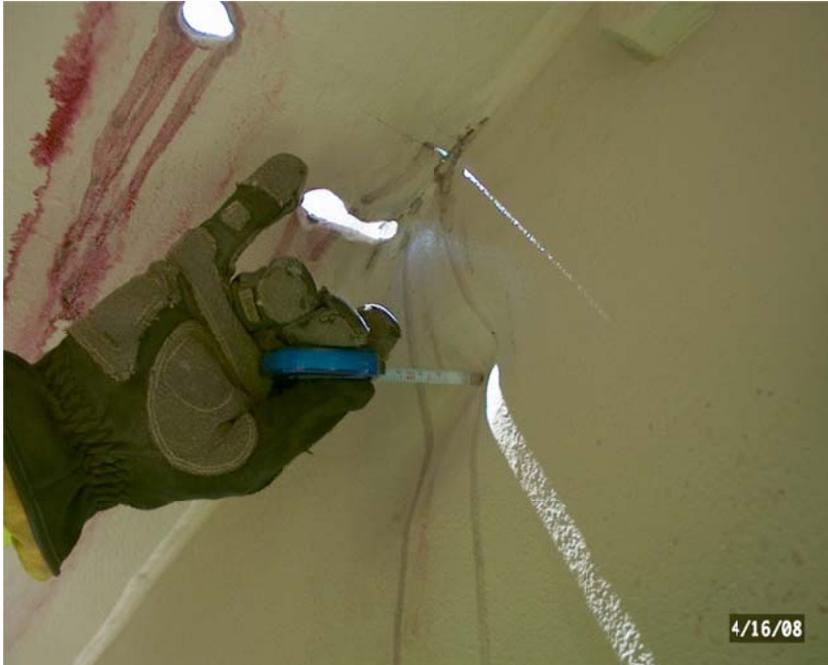
On accessing the underside of the H beam they found that the 5-1/16 inch long crack had opened sufficiently where it intersected the 1-3/16 inch long saw cut at the flange-to-web fillet weld to allow sun light through the crack. They also encountered a deep repair gouge in the inner face of the inboard flange just under the web (Figure 7). The gouge was apparently part of the field repair conducted in 1994.

Figure 7. Gouge in Inboard Flange Due to Past Weld Repair. Note Light Passing Through Crack at the Flange-to-Web Fillet Weld Location.

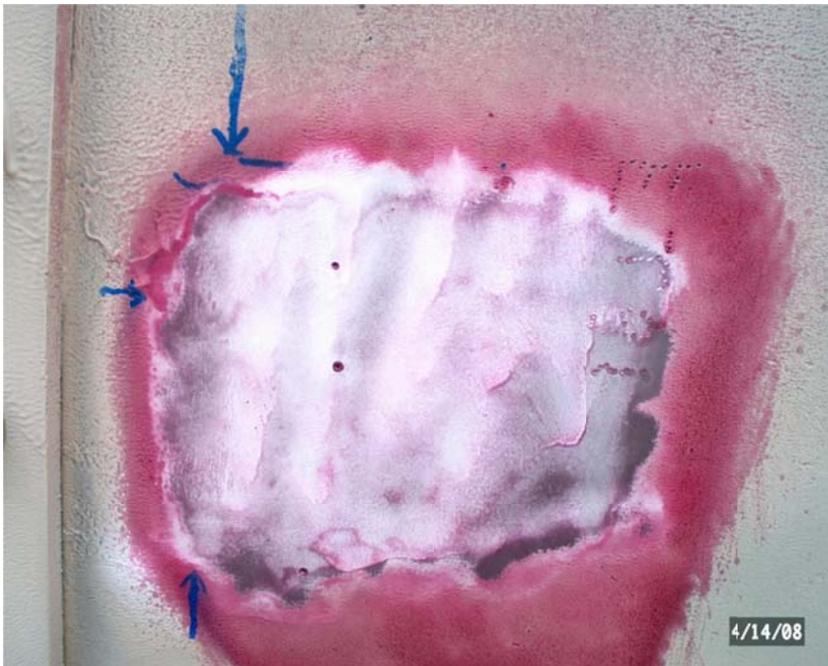
Figure 8. Dye Penetrant Test on Outside Face of Inboard Flange.

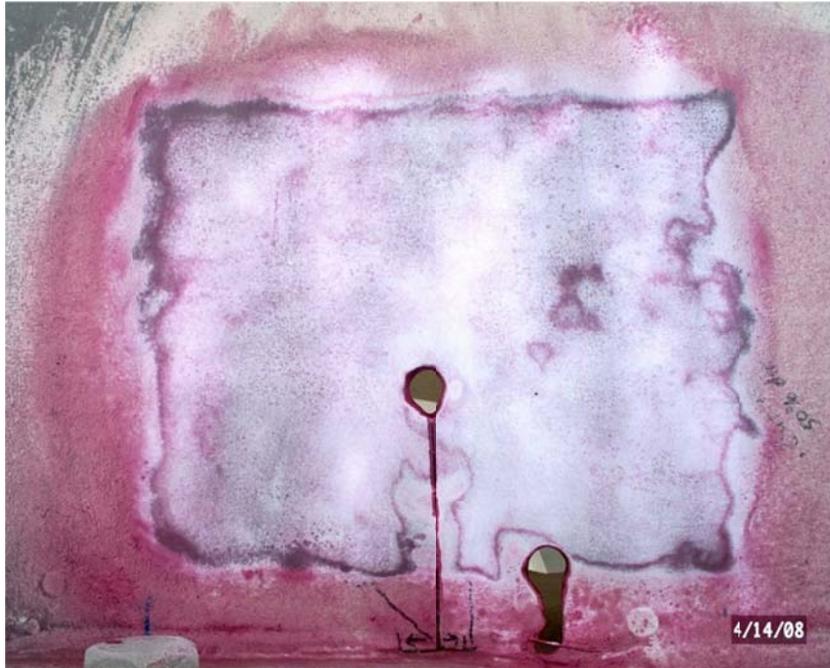
Figure 9. Dye Penetrant Test on Cracked Area on Upper Face of H beam Web.

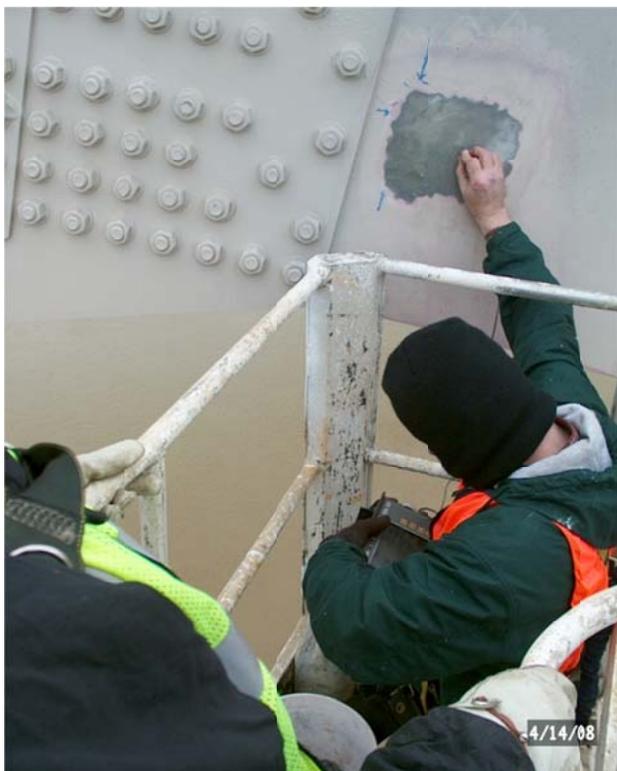
Shear wave UT was performed over the same general surface locations to detect any cracks in the web and the outboard flange (Figure 10). The test equipment included a portable UT flaw detector, capable of longitudinal and shear wave testing and straight and angle-beam transducers (sensors). UT is widely used to detect both surface-breaking and subsurface discontinuities such as cracks. Prior to scanning for cracks, the operator used a straight beam transducer to scan the steel for delaminations which could interfere with the testing for cracks. Then the operator manipulated the angle-beam transducer over the test surface. It alternatively created a directed ultrasonic shear wave into the steel and then passively detected any waves reflected back by discontinuities. The reflected waves are discerned by the operator as peaks on an LCD screen that is calibrated for distance between the transducer and the discontinuity. UT readily detected the 5-1/16 inch crack bounded by a check hole on one end and a saw cut on the other, but did not detect any cracking elsewhere on the web and inboard flange.

Figure 10. Operator Performing Ultrasonic Shear Wave Testing (UT) on the Outer Face of the Inboard Flange of the H Beam at Panel 28.

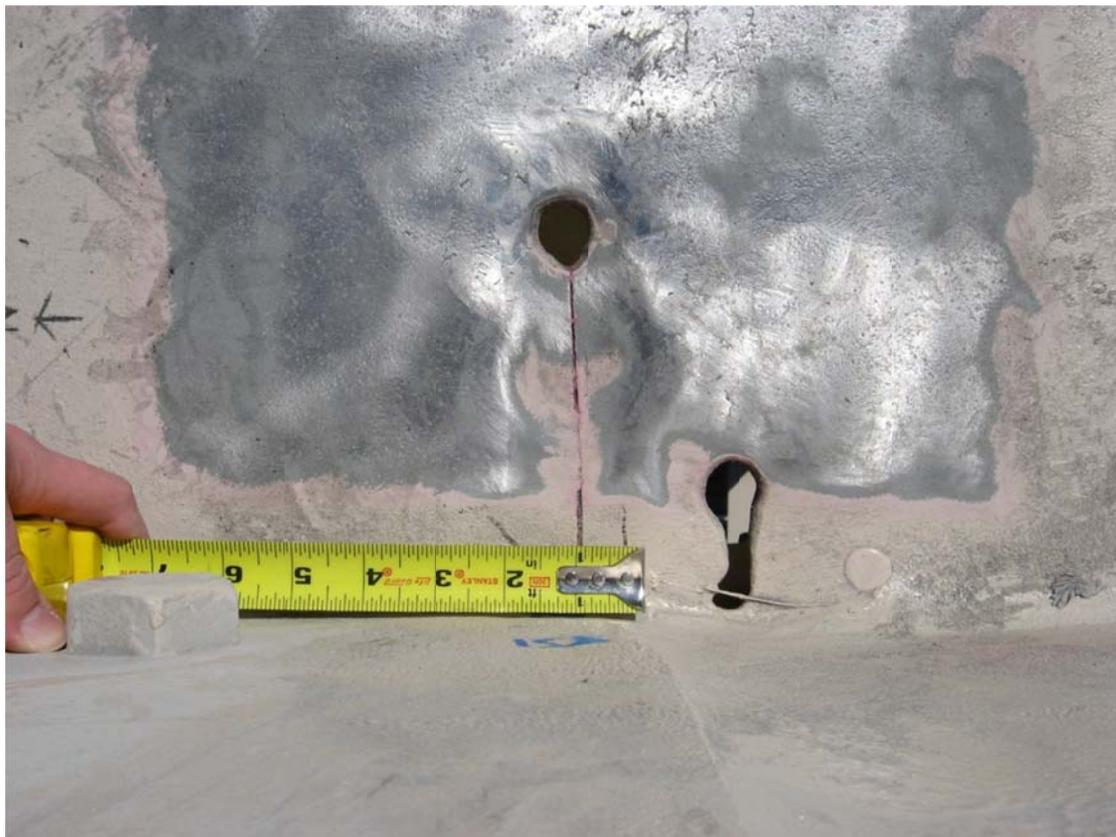
Figure 1: View Down Into Top Chord

Background: Kentucky Transportation Cabinet Bridge # B00214 carries I-65 traffic over the Ohio River between Louisville, Kentucky and Jeffersonville, Indiana. The structure consists of a single through cantilevered truss carrying seven lanes of traffic and has an ADT of approximately 132,000 vehicles. The bridge was opened to traffic in 1963. There is an area near U27-U28 on the East top chord which has a five inch full depth transverse crack in the web with a one inch diameter stop hole, an adjacent irregular hole of unknown origin, and a partial depth saw cut along the web to flange weld at the crack as shown in **Figure 1**.

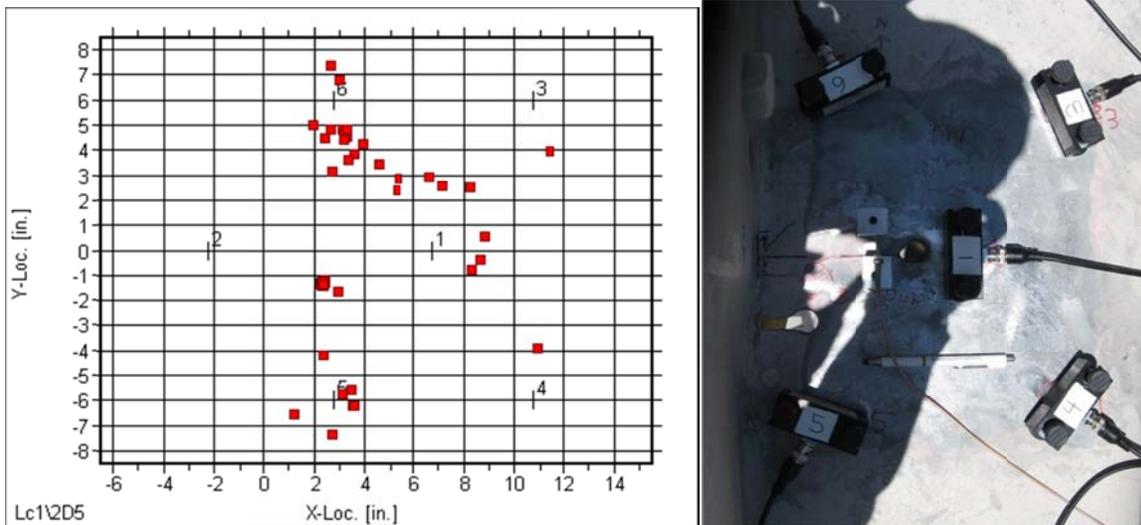
The second technique employed a two-dimensional location analysis using the known position of each sensor and the features of interest on the upper chord. Due to the geometry of this site and the conservative nature of the location determination algorithms, not all acoustic events will yield a location. None of the acoustic events for either of the two vertical flange test runs produced any locatable indications. Both runs on the horizontal web, however, yielded many events whose locations were able to be determined, as seen in **Figure 4**.

Figure 4: AE Locations on Horizontal Web

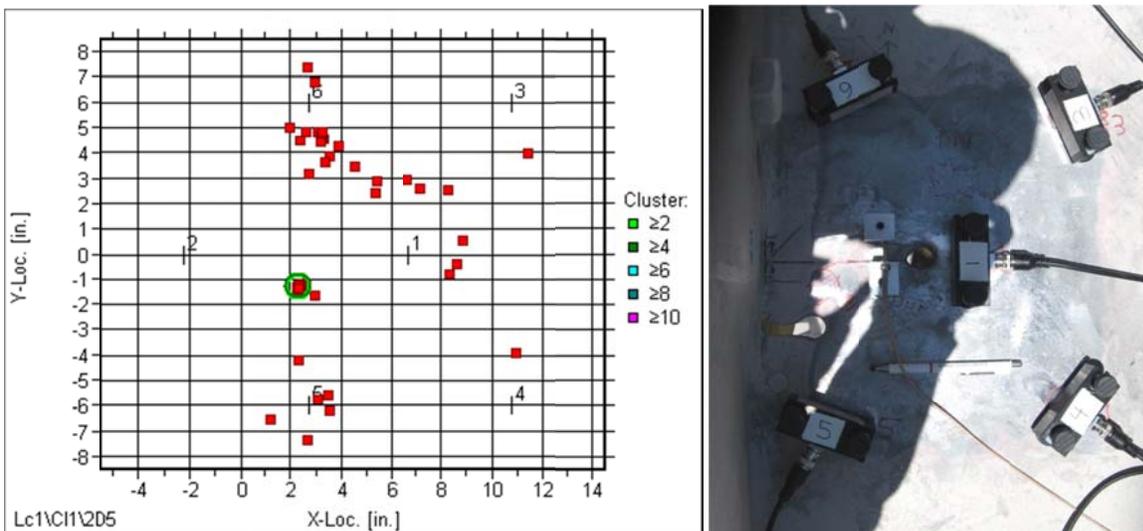
The plot in **Figure 5** shows AE events plotted vs. source location in inches. The events have been subjected to both an energy and amplitude threshold to minimize background noise. The plot shows the locations of groups of filtered events that satisfy the clustering criteria (3 events within 1 inch of each other occurring within a one second interval). A group of clusters centered at (2.62", -1.24") can be observed in the green circle. This observation was confirmed by subsequent radiography to be a slag inclusion introduced during original fabrication. **Figure 6** defines the coordinate system used and gives the precise location of the cluster group due to AE from the slag inclusion.

Figure 5: AE Cluster Location
