### **NONDESTRUCTIVE TESTING OF DEFECTIVE ASTM A 514 STEEL ON THE I-275 COMBS HEHL TWIN BRIDGES OVER THE OHIO RIVER IN CAMPBELL COUNTY, KENTUCKY**

**KTC-10-11/KH60-07-1F**

Nondestructive Testing of Defective ASTM A 514 Steel  
On the I-275 Combs-Hehl Twin Bridges over the Ohio River  
In Campbell County, Kentucky

July 2010

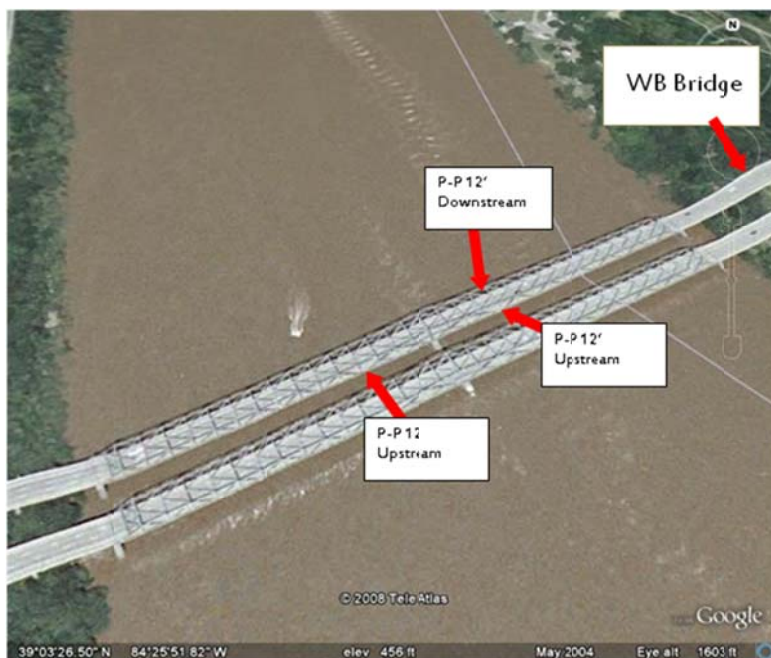
In the fall of 2006, an engineering consulting firm conducting a fracture-critical inspection on the bridge, detected cracks in three splice plates on the lower chords of the westbound bridge (3). Two of the cracked splice plates were located at L12 and L12' on the upstream truss. The third was located at L12' on the downstream truss (Figure 3). The plates measured 3/8" x 31" x 37". The endpoints of the cracks were marked and the splice plates periodically monitored for crack growth. Over time, technicians observed significant crack growth (Figure 4). KYTC officials decided to replace the cracked plates. That work was accomplished under contract in late May 2008 (Figure 5).

Figure 3. I-275 Combs-Hehl Twin Bridges Showing Locations of Cracked Splice Plates on Westbound Bridge.

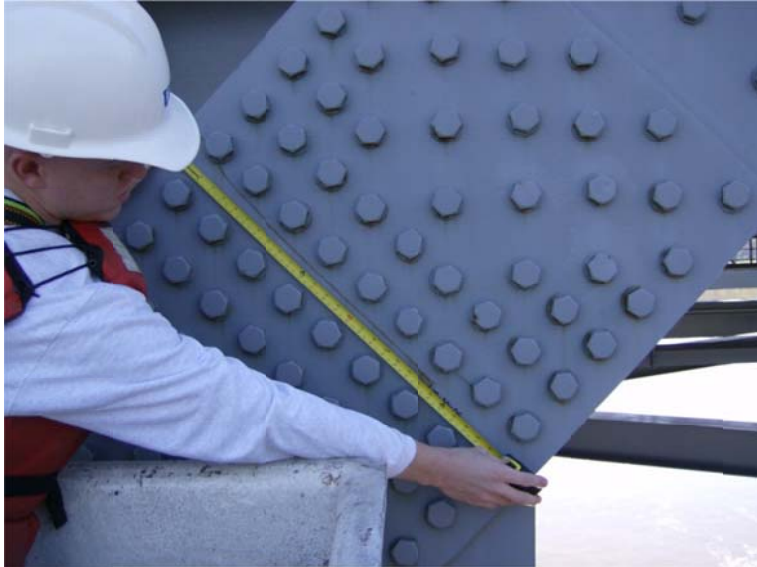
Figure 4. Crack in 3/8-Inch Thick Splice Plate at Panel Point L12' on the Downstream Truss of the Westbound Bridge (Courtesy of URS Corp).

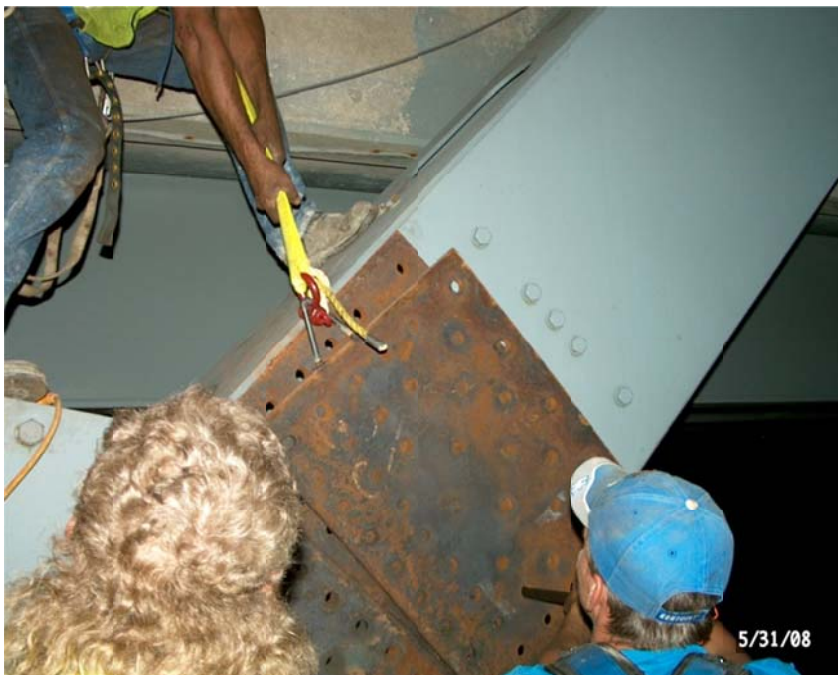
Figure 5. Installation of Replacement 3/8-Inch Thick Splice Plates on May 31, 2008.

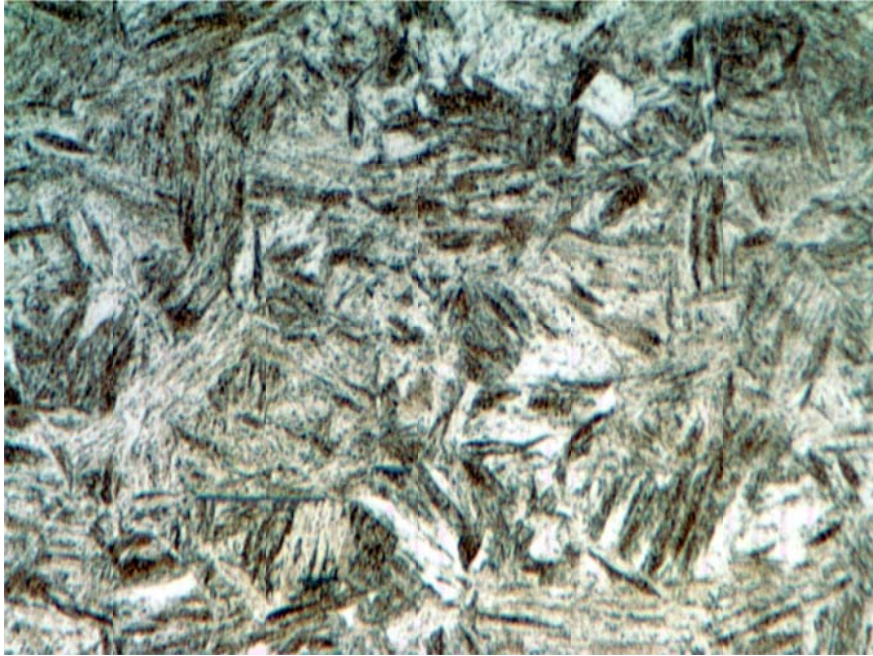
mechanical testing, metallography and fractography on the fractured plates (See Appendix A). From the plans, the splice plates were determined to be made from ASTM A 514 high-strength quenched and tempered (Q&T) steel (also referred to as A 514 steel). The chemical analysis (by optical emission spectroscopy per ASTM E 415-99a and combustion analysis per ASTM E1019-03) of the steel plates indicated that they conformed to A 514 (Table 1). The chemical composition for the three plates was nearly identical indicating that they probably came from the same heat.

Figure 6. Microstructure of Improperly Tempered A 514 Steel from Cracked Splice Plates (1000X Magnification). Etchant: 2% Nital.

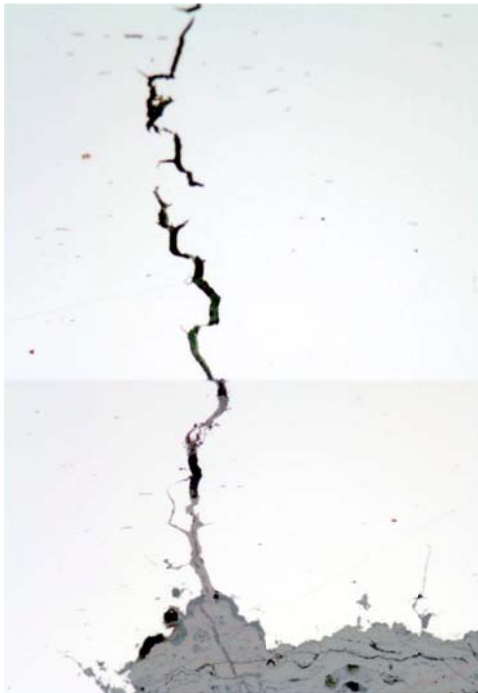
Significant uniform corrosion was observed on the faying surfaces of the plates. Metallography of sections taken at the faying surfaces revealed extensive pitting caused by the corrosion. Ion chromatography was performed on the corrosion products (per ASTM D4327-03) for water soluble anions. Chlorides (4020 ppm), Sulfates (3640 ppm), nitrates (380 ppm), phosphates (80 ppm) and nitrites (188 ppm) were detected. On the polished specimens small intergranular cracks were observed emanating from some of the corrosion pits. Additionally, intergranular branching cracks were observed on a polished section taken at the cracked edge of one plate (Figure 7). These results indicated that the plates were susceptible to stress corrosion cracking/hydrogen stress cracking (SCC/HSC). This was an added concern as the cracks from stress corrosion were generated from the backside of the plates and would not be visible until they had penetrated across the full thickness of the plates. Energy dispersive X-ray spectroscopy (EDS) testing revealed the presence of both calcium and chlorides on the corrosion surfaces on the backsides of the splice plates. It is presumed that chlorides penetrated the interface between the splice plates and filler or gusset plates, promoting corrosion which generated hydrogen resulting in the intergranular cracking.

Figure 7. Photomicrograph montage of Intergranular Cracking Emanating from Corrosion Pit in A Cracked Splice Plate (250X Magnification). As - Polished.

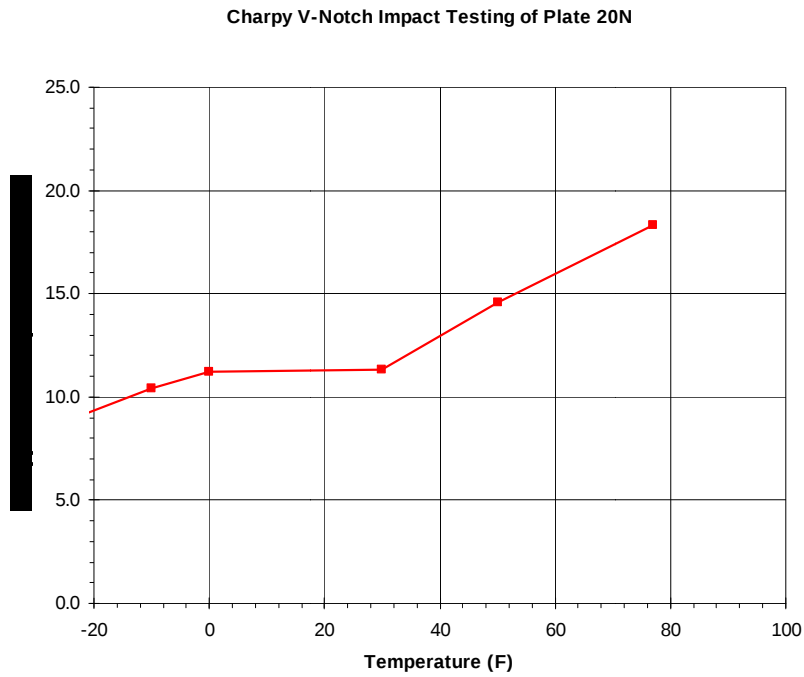
Figure 8. Charpy Impact Values (ft-lb) v. Temperature for Out-of-Spec./Defective A 514 Steel from the I-275 Combs-Hehl Westbound Bridge.

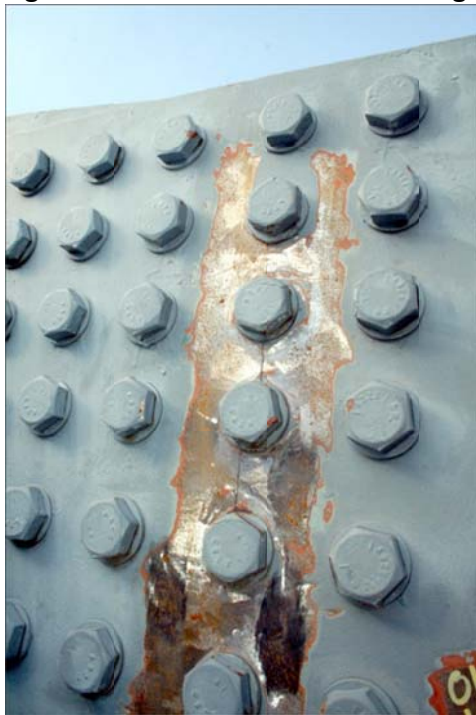
The following day, HTT provided a technician and the supervisor at the jobsite. They both conducted hardness tests at the same sites and achieved good agreement in their test data. Work began on the lower chord of the downstream truss of Westbound Bridge on the Ohio end of the bridge. While that work was going on, personnel from a consulting firm were conducting an annual fracture-critical inspection of the bridges. During that work, they encountered a long crack in an A 514 steel splice plate on the upper chord of the downstream truss of the Eastbound Bridge at the central tower. The splice plate was located at the tower peak, inboard on the Ohio side of the truss.

On October 2, 2008, Intech shifted the lane-closure on the eastbound bridge to the downstream side of the bridge. On October 3, after obtaining a suitable (125-ft reach) man-lift, KTC and HTT personnel inspected the cracked splice plate. The crack had penetrated about halfway across the plate along a vertical line of bolts (Fig. 19). Testing with the *MIC 20* ultrasonic hardness tester provided inconsistent readings. Though the average of the readings was less than 30 HRC, there was extreme variability in obtaining the necessary 10 consistent readings required by the test protocol.

Later that day, the HTT supervisor came to the work site and used a *Telebrineller* to test the hardness on that plate. It provided consistent hardness values in the range of 40 HRC (converted from BHN using ASTM E 140-07) indicating that the cracked plate was made from the defective A 514 steel. After that, impact hardness testers were used to assess A 514 steel plates with ultrasonic hardness test values  $\geq 25$  HRC and the NDE technicians were cautioned to be alert to wide swings in ultrasonic hardness tests and to use the *Telebrineller* when extremely variable ultrasonic hardness values were obtained.

Figure 19. A Cracked 1/2" Inboard Splice Plate at the Tower of the Eastbound Bridge Downstream on the Ohio Side of the Bridge.

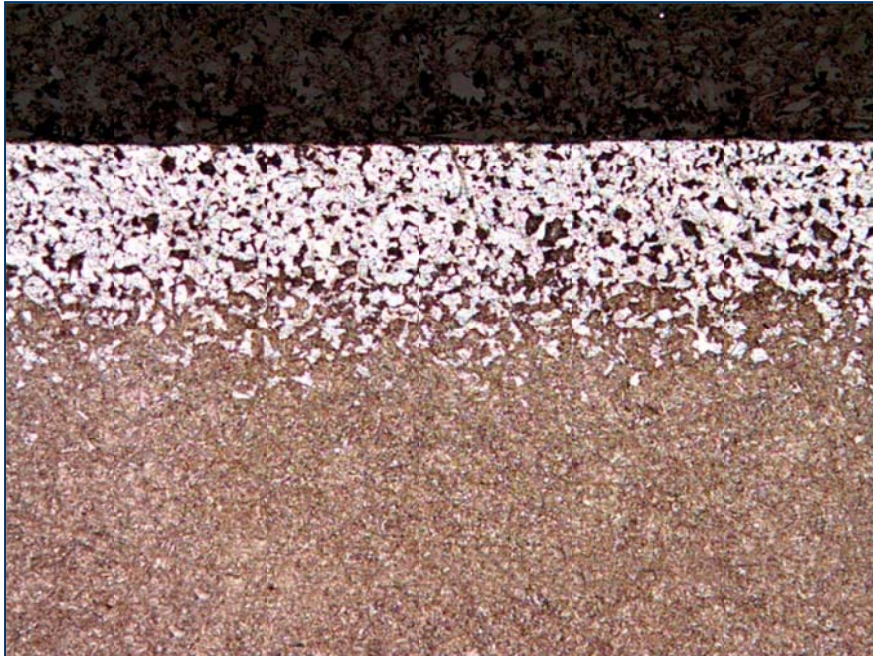
Figure 26. Surface Decarburized Layer-Cross Section from Extracted A 514 Steel Coupon Removed in Figure 24 (~100X).

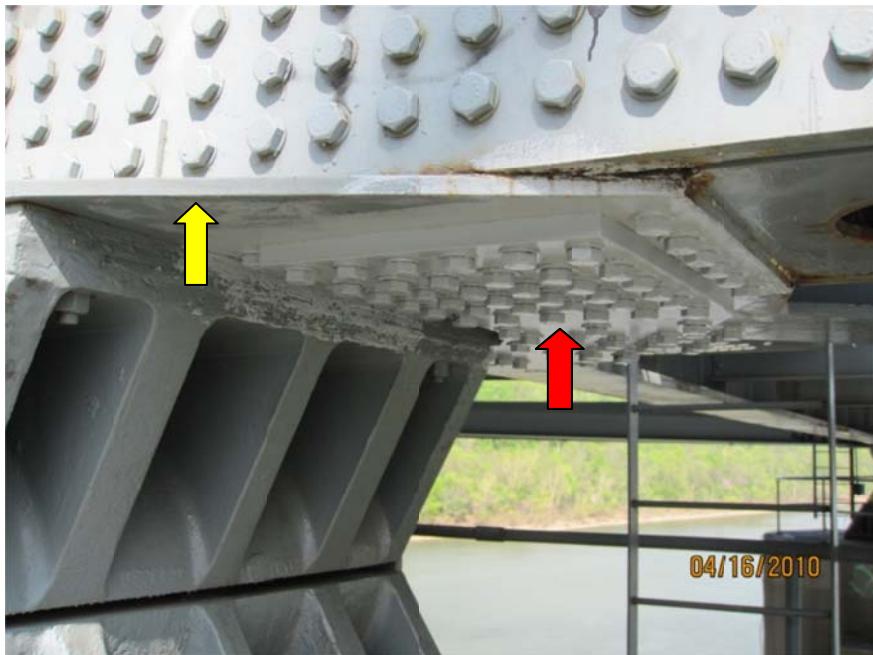
Figure 27. Reinforcing Plate (Red Arrow) Lapped over Defective ASTM A 514 Horizontal Gusset Plate (Yellow Arrow).

All of the out-of-spec./defective ASTM A 514 steel on the I-275 Combs-Hehl Twin Bridges has been detected and replaced/retrofit. The remaining ASTM A 514 steel should be periodically inspected to ensure no other problems arise. KYTC should determine whether it can/should seek restitution for the remedial work from the steel manufacturer.

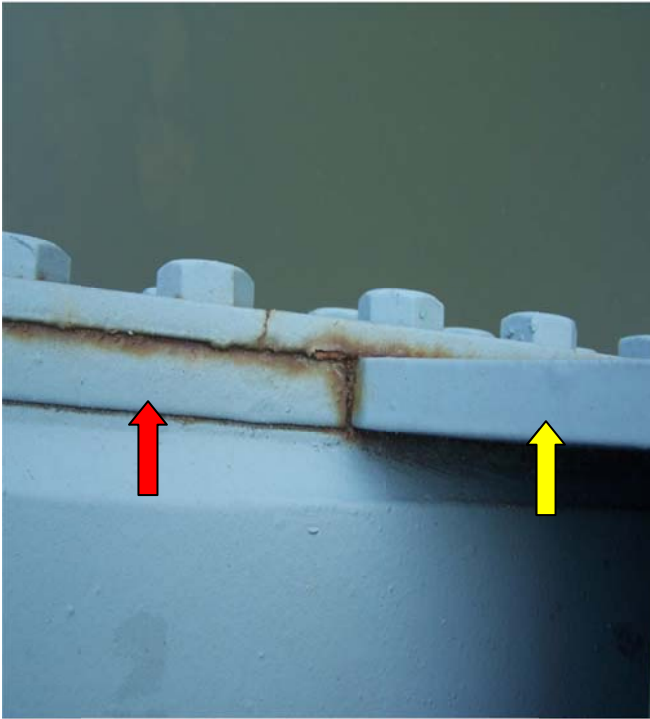
During this project, it was determined that some of the filler plates used in conjunction with the lower chord splice plates did not have the same thickness as the gusset plates to which they were attached. That deformed the splice plates and probably contributed to cracking in the 3/8" lower chord splice plates. The differences in thicknesses between the filler plates and gussets may have contributed to the fracturing of the out-of-spec./defective splice plates, but only because the steel was defective. Other lower chord splice plates at similar locations that were made of acceptable A 514 steel did not crack.

Figure 28. Filler Plate (Red Arrow) Adjacent to Gusset Plate (Yellow Arrow) on Lower Chord of Westbound Bridge. Note the Cracked  $\frac{3}{8}$ " Thick Splice Plate.

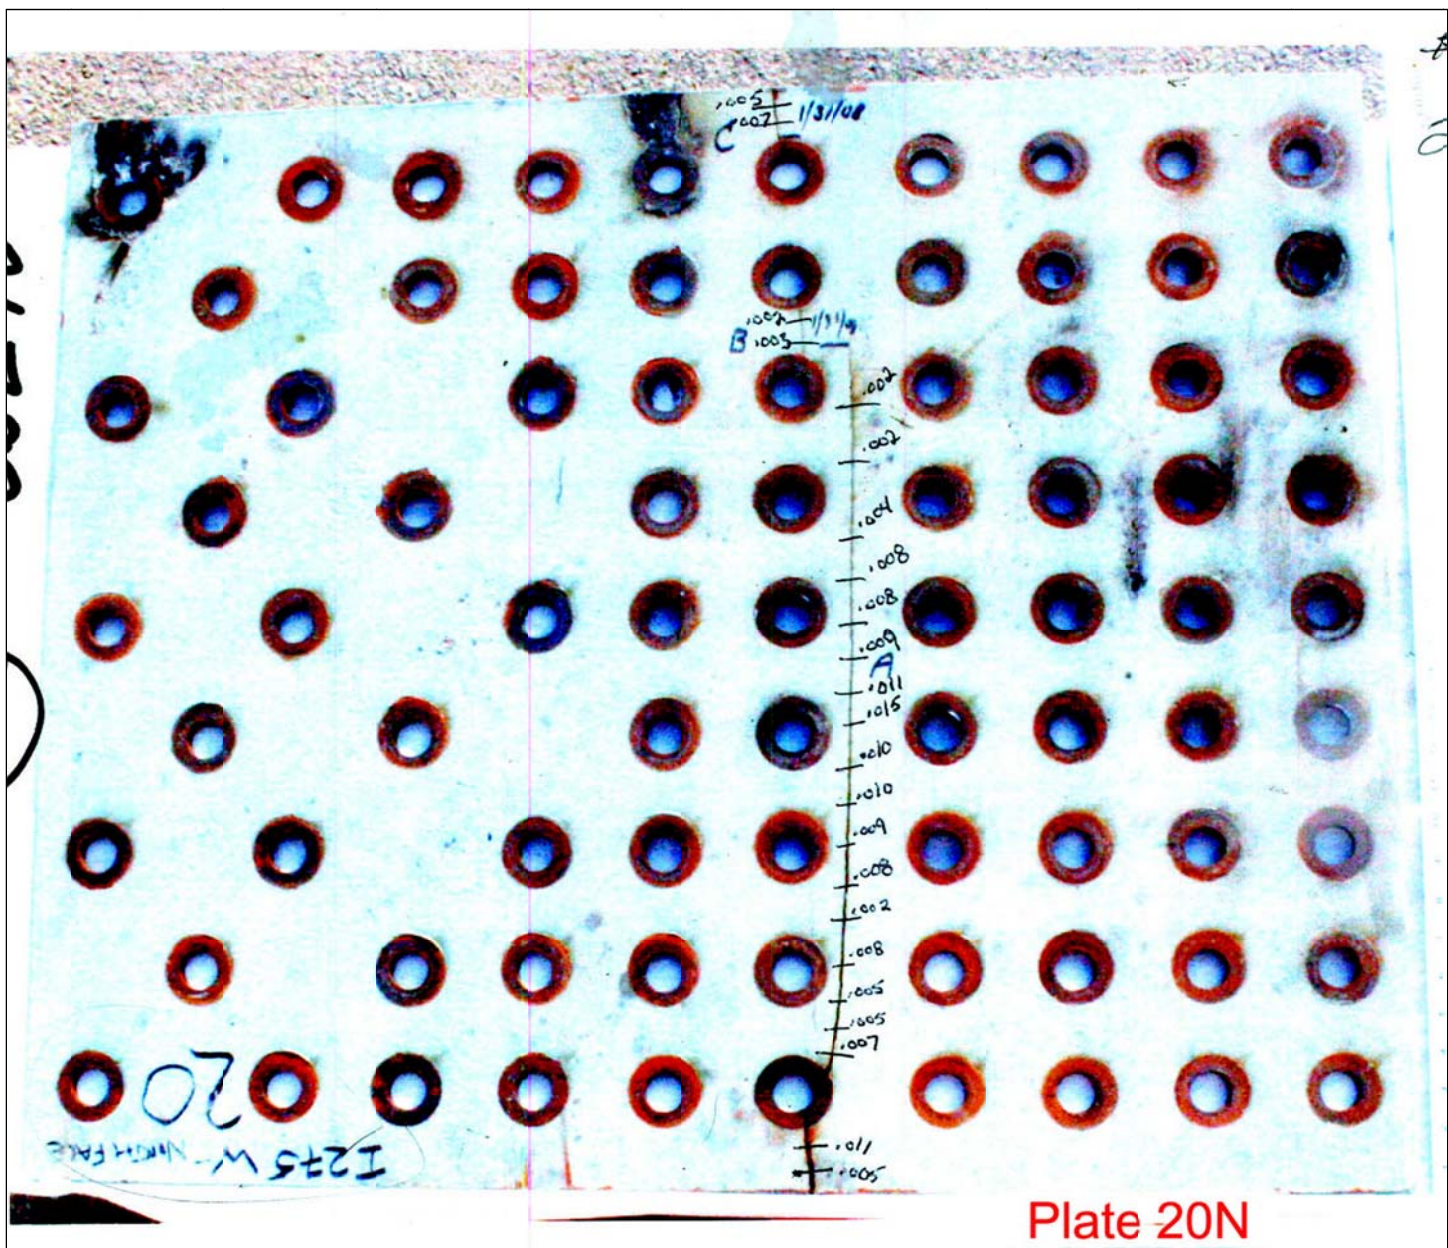
Displacement across the crack from Plate 20N (Values in inches) Range 0.002" – 0.015"

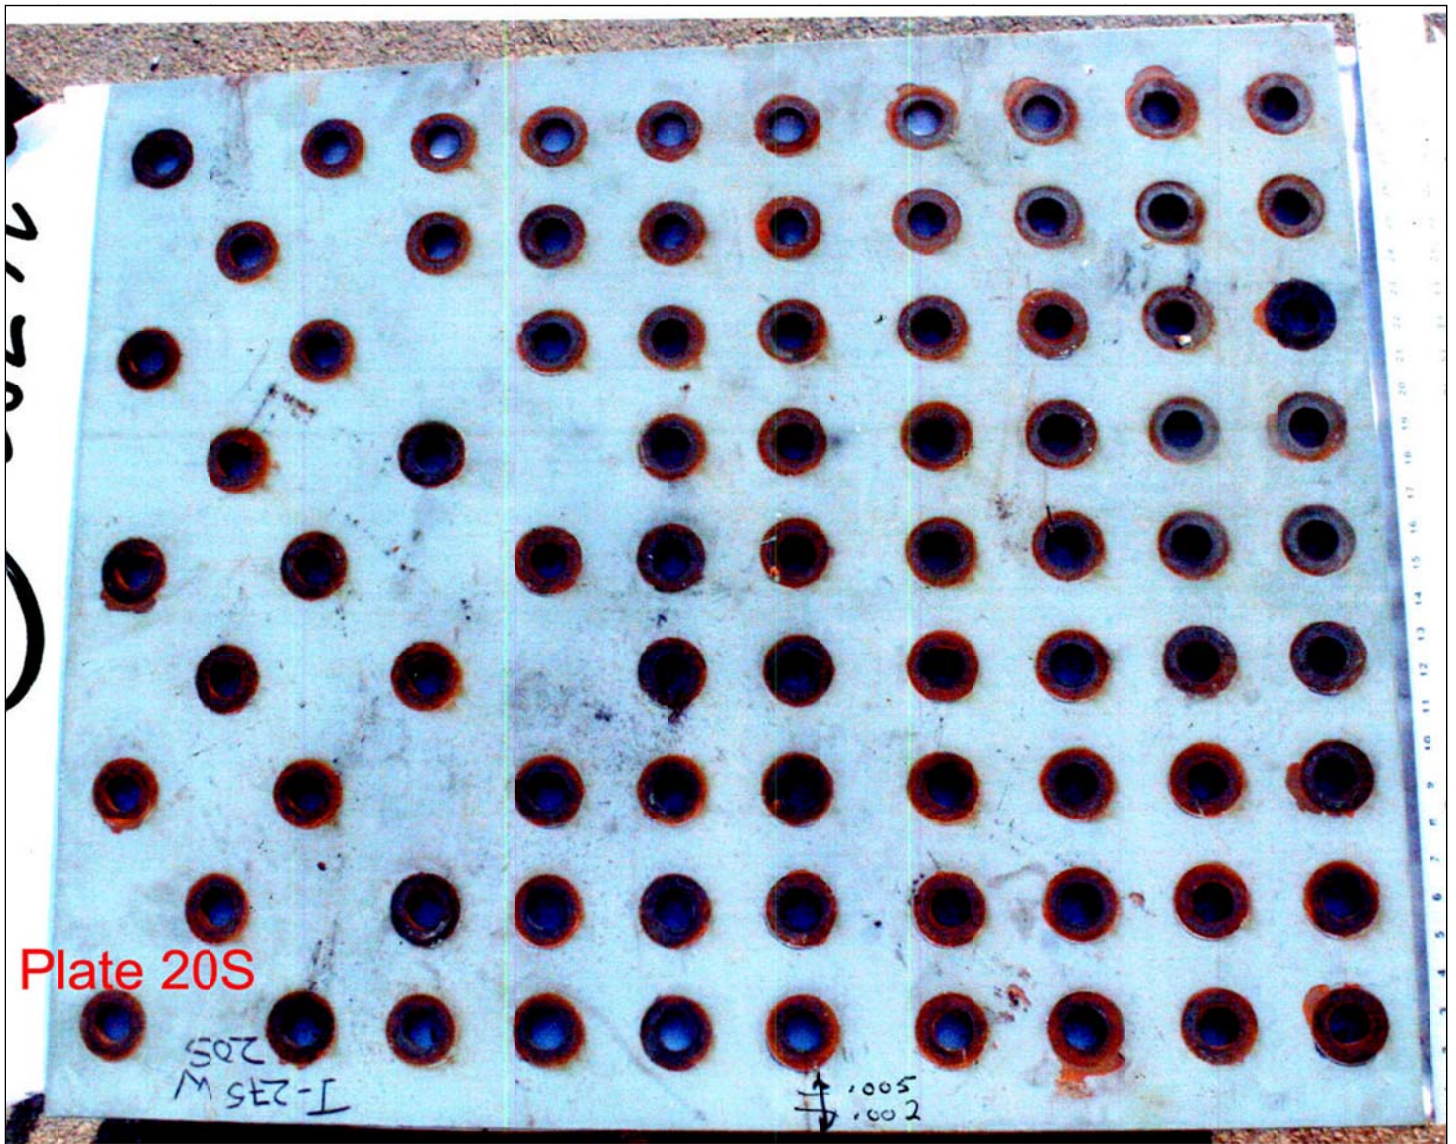
Displacement across the crack from Plate 20S (Values in inches) Range 0.002" – 0.005"

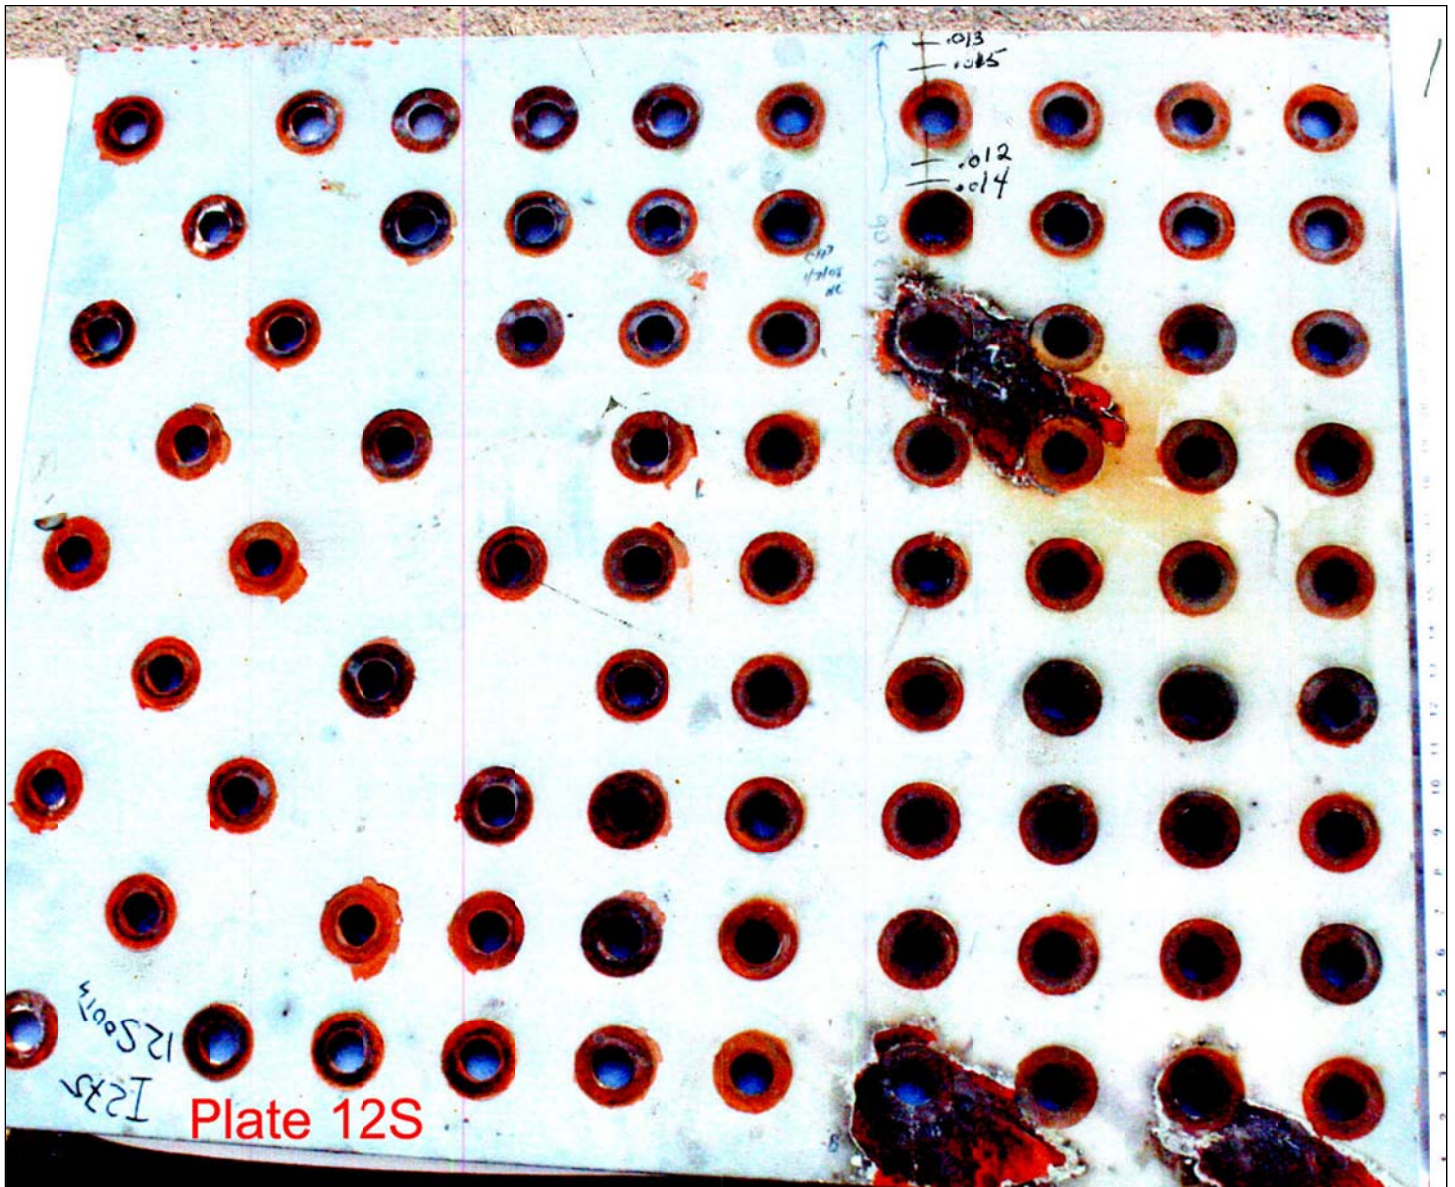
Displacement across the crack from Plate 12S (Values in inches) Range 0.012" – 0.015"
